Semi-Annual Environmental Monitoring Report

Project number: 39405-013

Period: January – June 2016

BAN: Dhaka Water Supply Sector Development Program (Project Loan)

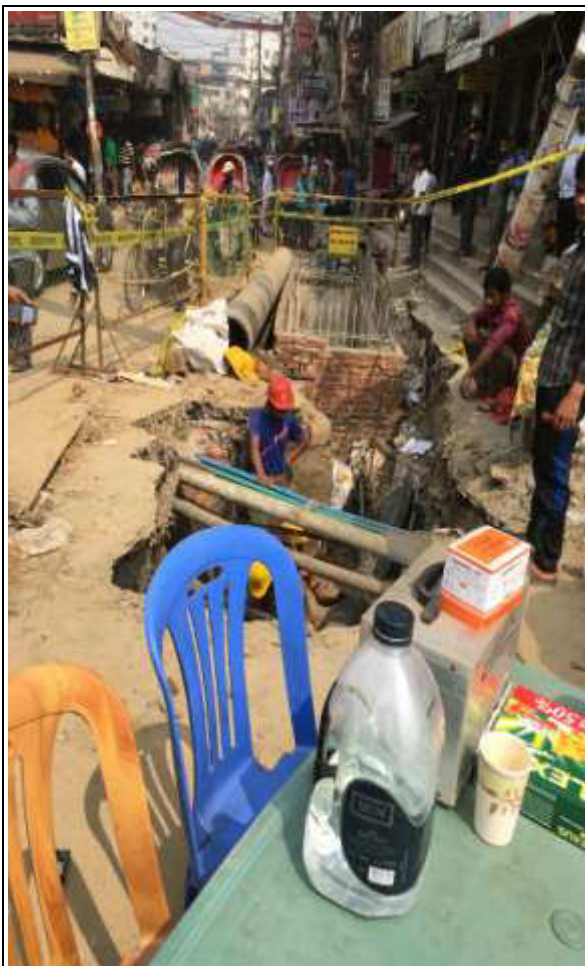
The road of DMA 407, ICB-2.4

In the construction area of DMA 407, most of the facilities like basic first aid facilities and water supply for laborers were present but Mobile toilet for the labor was not present. Most of the PPEs used for the labor were existent in that area. Troubles shooting posters or informatory sign boards were present in the said construction area.

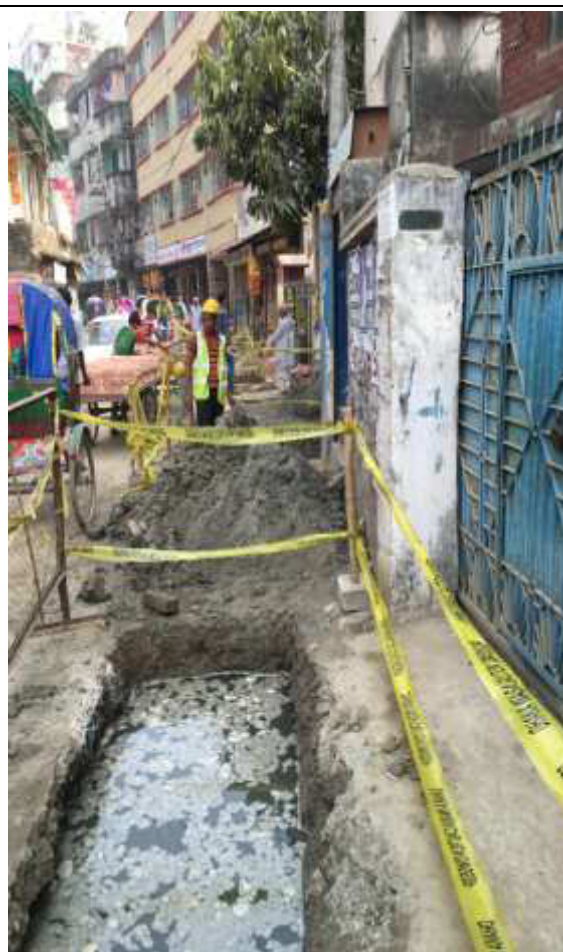
DMA 405 in ICB2.4

In the Construction Area of DMA 405, there are partially basic first aid facilities and PPEs. There are drinking water supply facilities but toilet facilities/ mobile toilet for laborers near to Construction Area s are not present. In some places (Ahmadnagar), there is lack of safety security of the works that have been completed before, even no cover on the opening of the holes done for the house connections were there. This type of faults may create serious accidents.
