Environmental Monitoring Report

**Forth Semi-Annual Report
January – June 2015**

Loan 2789-VIE: Transport Connections in Northern Mountainous Provinces

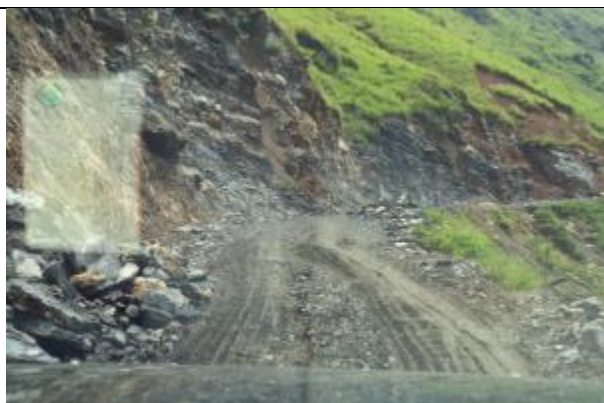
Photo 21. New embankment at km 41, Package HG-PR176-01, April 2015

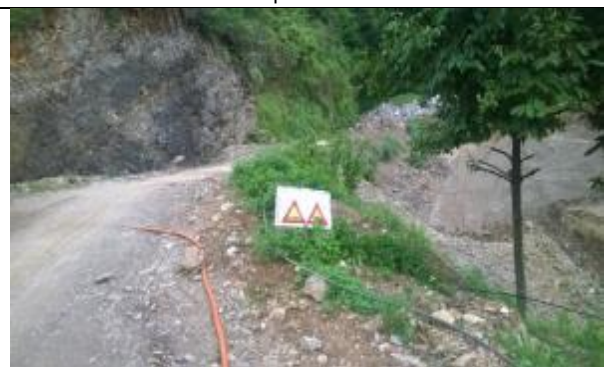
Photo 23. Hazardous warning sign, Package HG-PR 176A-01, May 2015

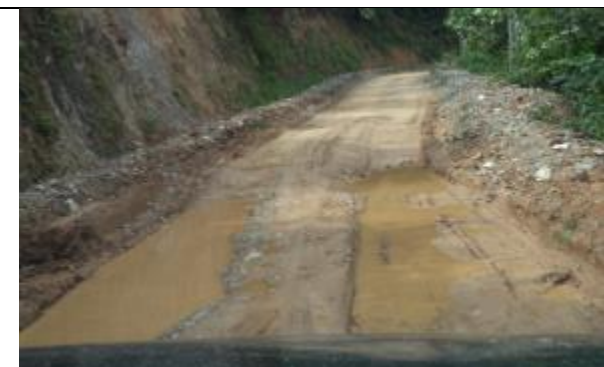
Photo 24. Water stagnant makes difficult for local people, Package HG-PR 176A-02, May 2015

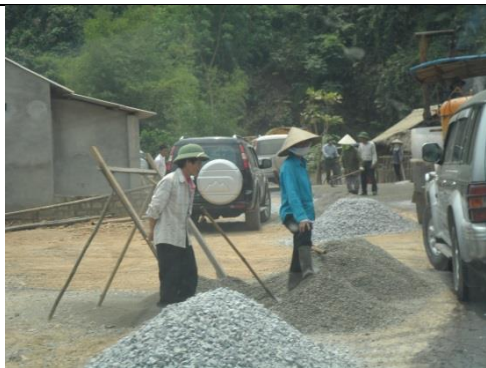
Photo 31. Workers use improper PPE, (Km 5+300), Package TQ-PR187-01, April 2015

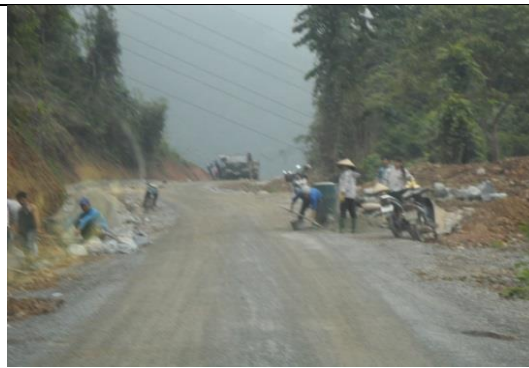
Photo 32 . Workers use improper PPE, (Km 10+100), package TQ-PR187-01, April 2015

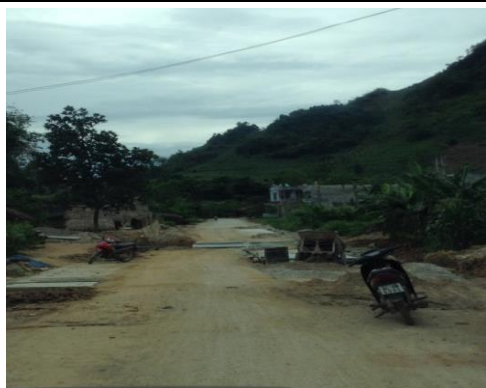
Photo 33. Lack of warning signs and barriers, PackageTQ-PR189-02, May 2015

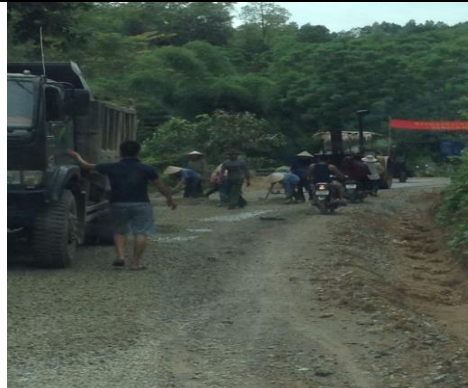
Photo 34. Workers use improper PPE, PackageTQ-PR189-02, May 2015

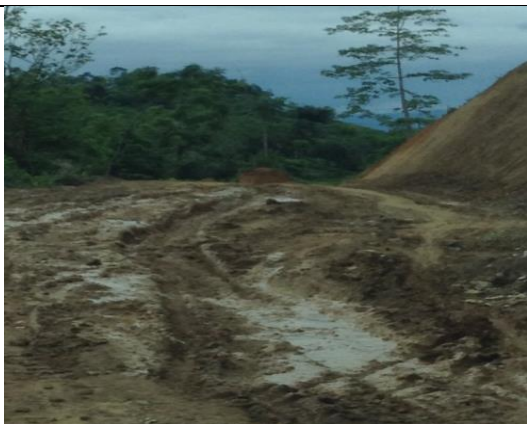
Photo 35. Muddy roads make it difficult for people in traffic (Km 53), PackageTQ-PR189-03, April 2015

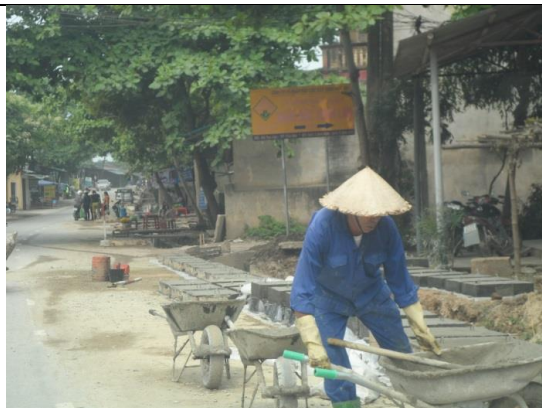
Photo 39. Workers do not use PPE as required and lack construction warning signs, package No. YB-PR163-01, April 2015

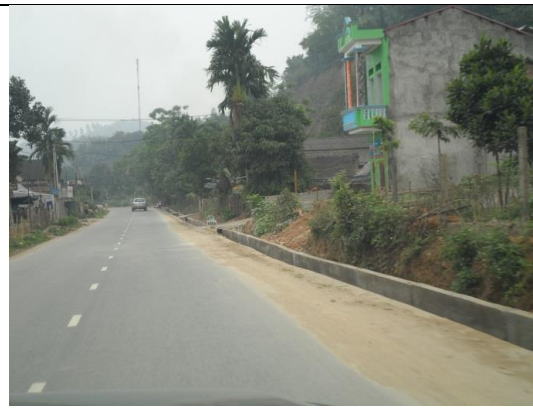
Photo 40. The Ditch without cover, causing unsafe traffic, package No. YB-PR163-01, April 2015

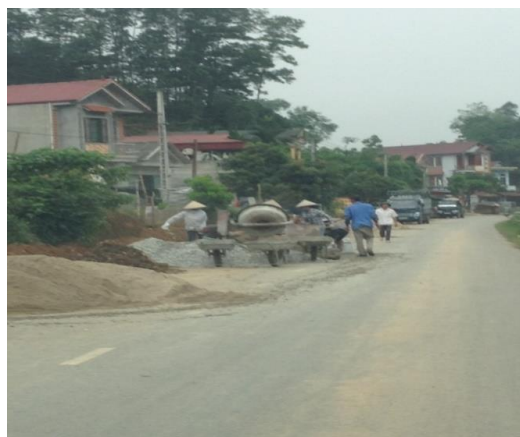
Photo 41. Lack fences during construction, causing unsafe traffic, package No. YB-PR163-01, May 2015

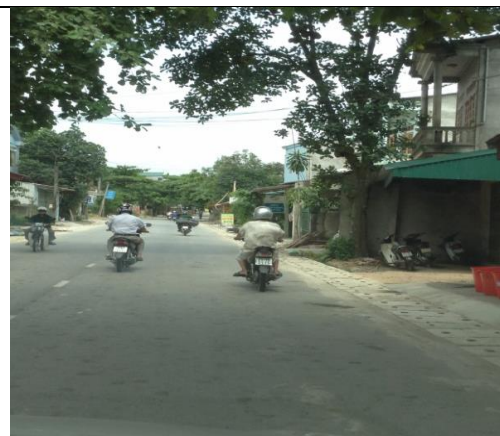
Photo 42. Ditches with cover (Km5+), package No. YB-PR163-01, June 2015

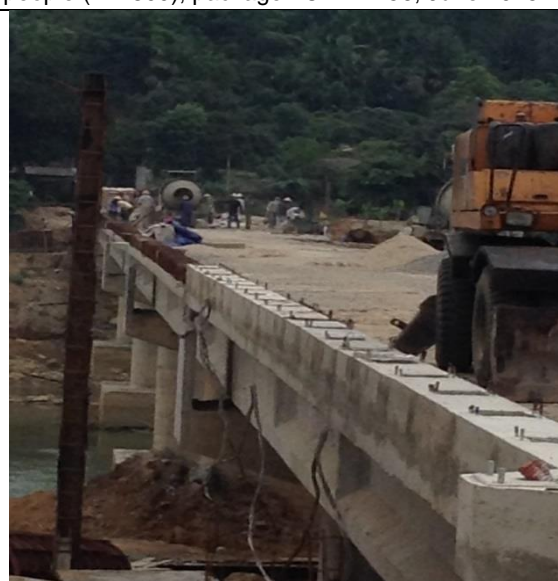
Picture 62. Workers have constructed at construction site of Pho Rang Bridge without PPE, package LC – PR160, May 2015
