# Environmental Monitoring Report

2<sup>nd</sup> Quarterly Report  
September 2016

## VIE: Power Transmission Investment Program - Tranche 2

**ENVIRONMENTAL MONITORING REPORT  
SECOND QUARTER 2016**

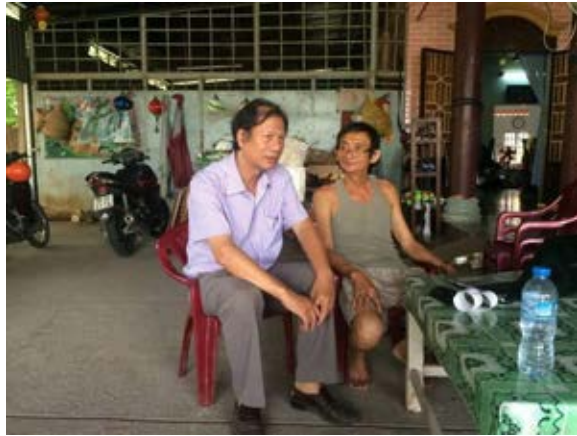
Mr Huy was satisfied with the correction

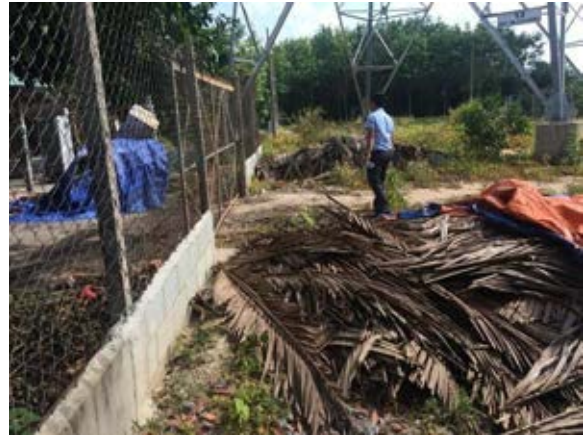
The damaged wall of the property of Mr. Hua Quc Huy which has been reported in previous EMRs has finally been restored by the contractor and Mr. Huy is satisfied with the restoration and compensation.

Hua Quoc Huy's wall was rebuilt

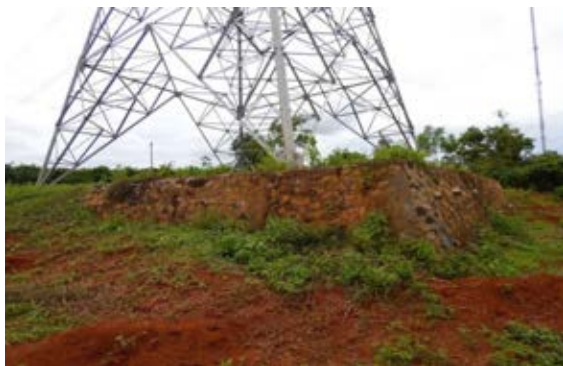
Photo1: The pole ground in Gia Lai province is stable after the two years of operation

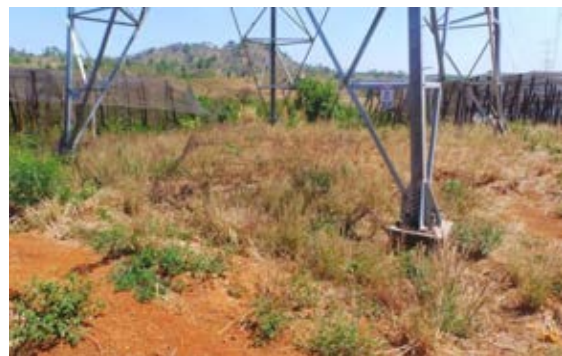
Photo 2: Warning signs at a power pole after the two years of operation

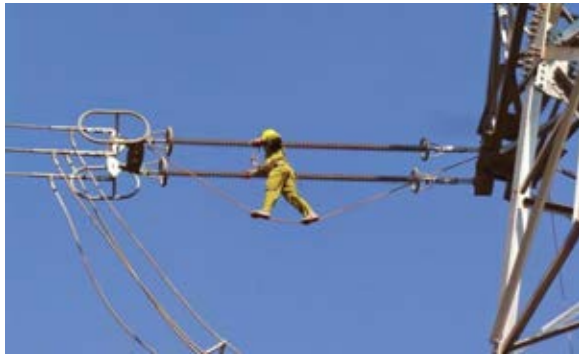
Photo 3: A technical staff of PTC3 checked to maintain the TL

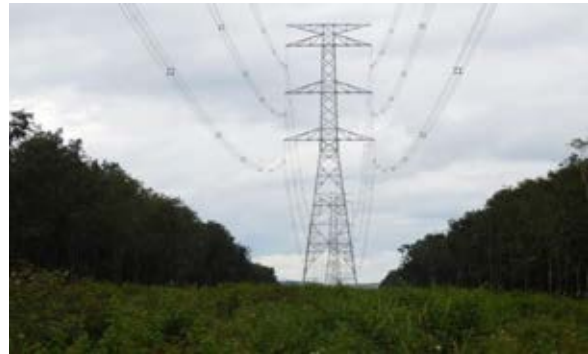
Photo 4: The RoW in Gia Lai province (controlled by PTC3)

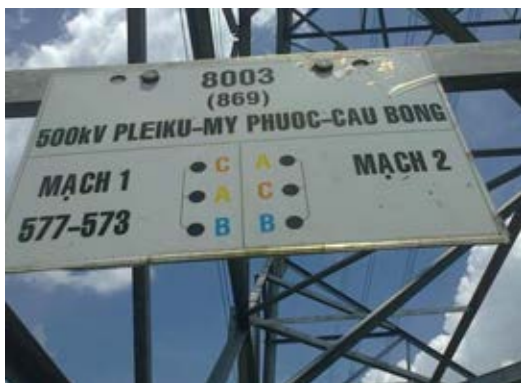
Photo 5: A sign at a power pole in BinhPhuoc province

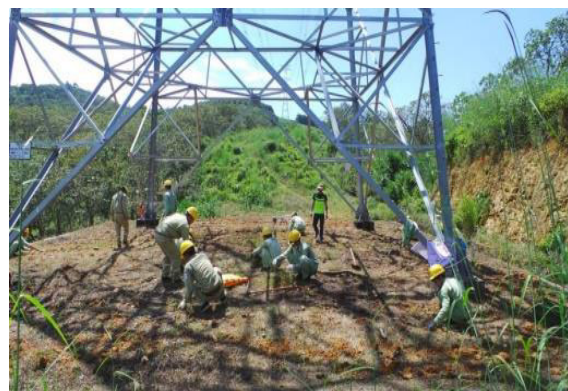
Photo 6: Workers of PTC4 planted pea grass from the pole No. 5016 to 5019 to cover the pole ground, preventing the growing of other types of grasses and controlling soil erosion at slope areas
