Environmental Monitoring Report

Semestral Report
August 2016

BAN: Financing Brick Kiln Efficiency Improvement Project – Panchgaon Auto Bricks Limited

Post Implementation Environmental Monitoring Report

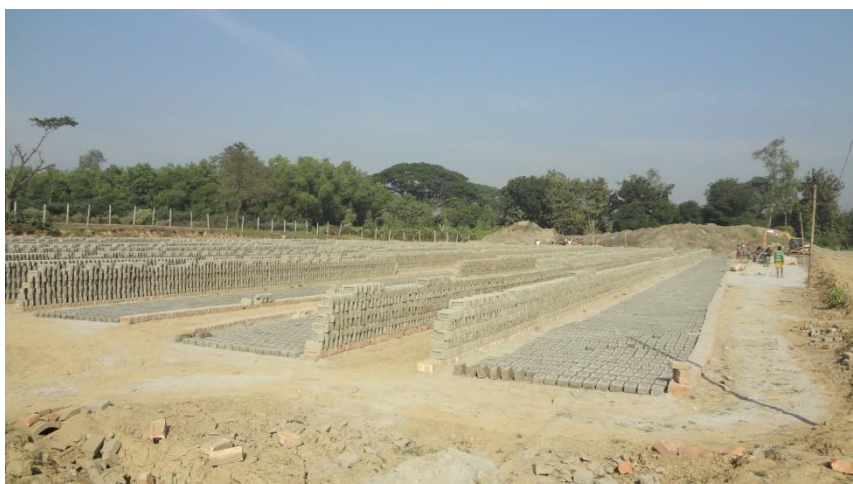
Sun drying of Green Bricks

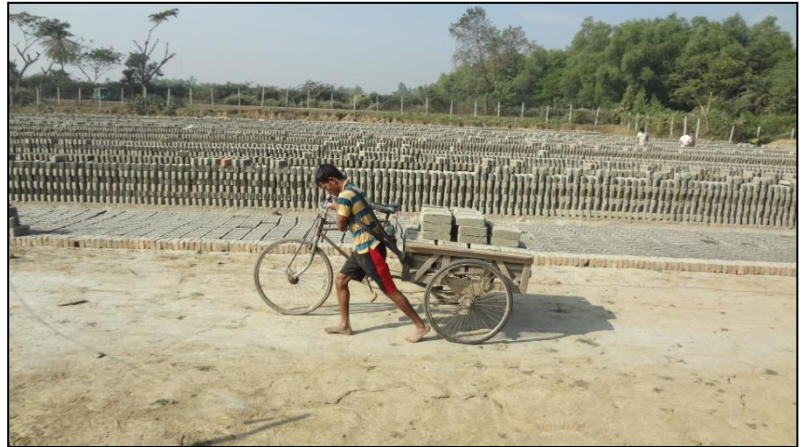
Dried Bricks transported to Brick Kiln for Firing

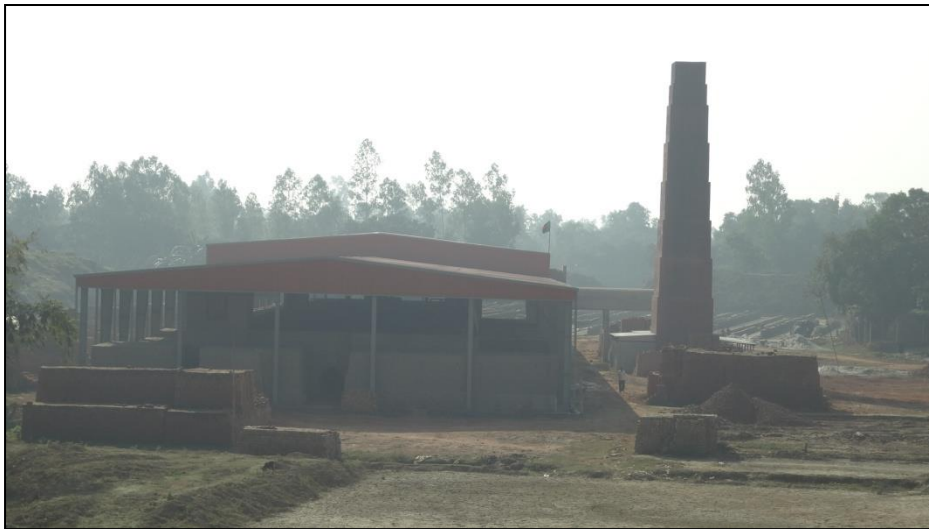
Brick Kiln

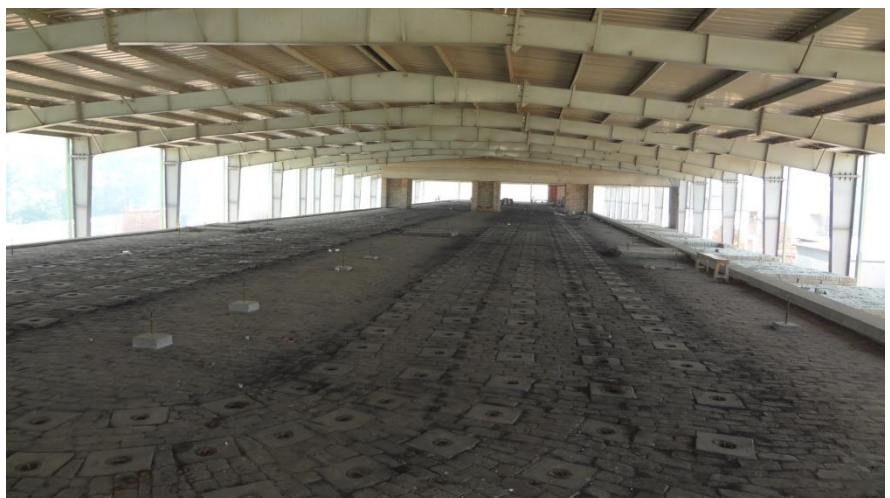
Top of Brick kiln showing holes for coal feeding

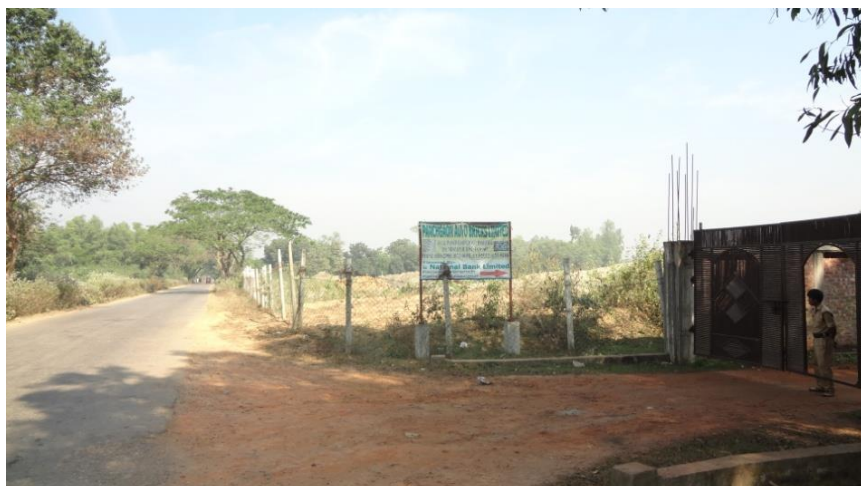
Front Gate with security
Guard
