Environmental Monitoring Report

Quarterly Report
July - September 2013

VIE: Greater Mekong Subregion Kunming–Hai Phong Transport Corridor Noi Bai– Lao Cai Highway Project

Prepared by Getinsa for the Vietnam Expressway Corporation, the Ministry of Transport,
the Government of Viet Nam, and the Asian Development Bank

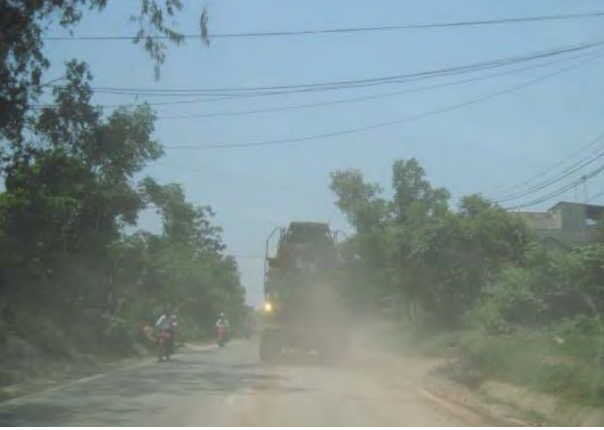
Date first observed: 13/6/2013
25/7/2013	There is much dust on the exist road

Recommendation and Action taken by Engineer: The contactor is requested to spray water frequently in order to decrease dust concentration on the exist road. Refer to the letters GET2-POS-A3-1982; GET2-POS-A3-1985
14/8/2013

14/8/2013	Responsible Party:
	Deadline: Daily
	Current status: Not yet improved

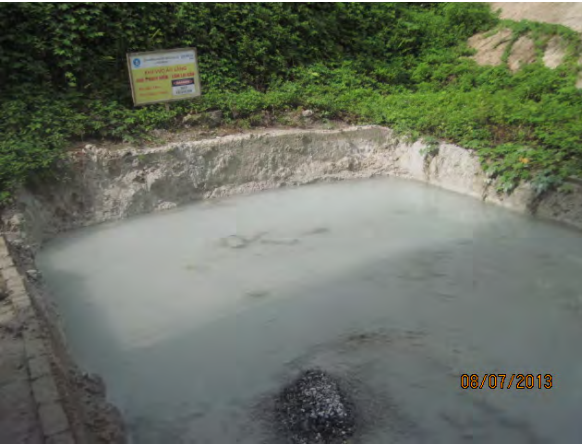
Location: Km53+150
	Site visit: 04, 08, 11, 15, 18, 25/7; 07, 14, 21, 28/8/2013; 04,10,11,18,24,25/9/2013
	Date first observed: 15/5/2013
	Problems description and cause: Soil has been slid into local irrigation canal
	Recommendation and Action taken by Engineer: The Contractor must remove all spoils to approved disposal

<p>14/8/2013</p>	Responsible Party: Posco Contractor
	Deadline: In July and August: 10/6/2013 In September: 10/9/2013
  <p>25/9/2013</p>	Current status: Not improved

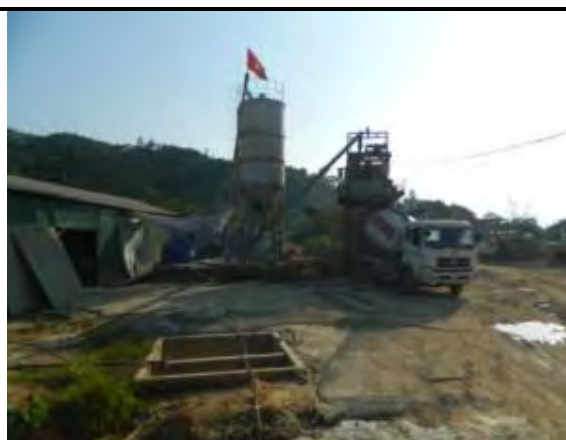
September 16, 2013 (CBP Km 145+300)

Location: CBP in km 145+300 (CBP No.4)
 	Site visit: 22 June, 11 July, 2, 9, 27 August, 2013; 16 September, 2013
 	Date first observed: 22 nd June, 2013
 	Problems description and cause: At the CBP km 145+300 (CBP No.4), the canal that conveys wastewater to the settling pond has been completely filled-up.
	Recommendation and Action taken by Engineer: The Contractor must implement the tasks as follows (For all CBPs in package A5): 1. Undertake dredging of settling pond to ensure efficiency and to avoid spill-overs. Ensure that the canal to the settling pond is free from obstruction; 2. Prohibit discharging the untreated wastewater into the environment; 3. Ensure proper disposal of dredged slurry to avoid impacts to water resources and damage to land resources (e.g., agricultural land, etc.)
	Responsible Party: Keangnam Contractor
	Deadline: Immediate
	Current status: Not yet implemented.

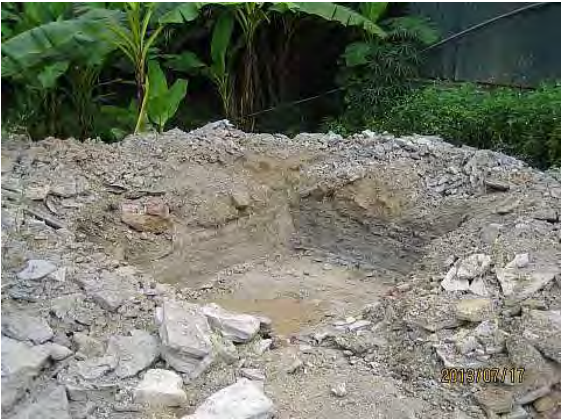
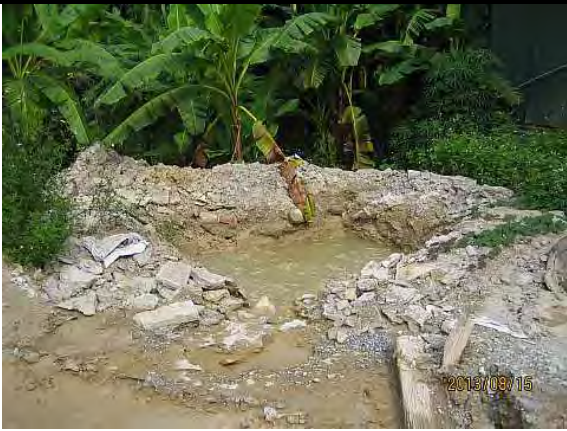
<p>17.7.2013</p>	<p>Location: Suoi Nhu concrete batching plant Km218+040</p>
	<p>Site visit: 25.6 and 17.7.2013; 15.8.2013; 17.9.2013</p>
	<p>Date first observed: 15.3.2013</p>
	<p>Problems description and cause: The wastewater of CBP is not guided into settling pond before discharging surrounding water source</p> <p>Recommendation and Action taken by Engineer: The contractor has to clean the pond and remove the sediments, as well as to</p>

<p>15.8.2013</p>	prepare a canal to collect waters into the pond
	Responsible Party: Deadline: Immediately

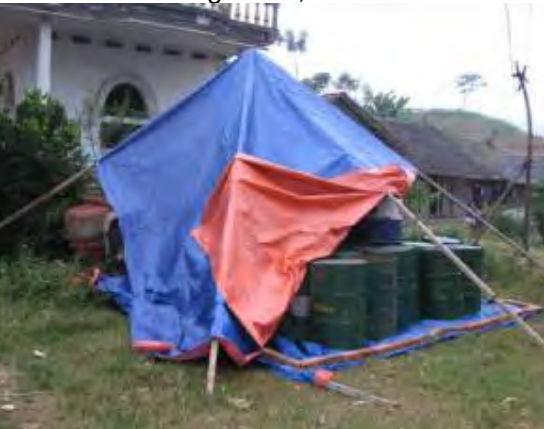
<p>September 10, 2013 (Km166+900)</p>	<p>Location: Km166+900</p>
	<p>Site visit: 13 and 20 August, 10 September</p>
	<p>Date first observed: 13th August, 2013</p>
	<p>Problems description and cause: Fuel control is not well performed. this situation is caused the leak of oil and soil pollution.</p>
	<p>Recommendation and Action taken by Engineer: The Engineer required the Contractor to improve fuel control at this location, at the same time, the Engineer also provided the instruction for this issues through the letter Ref. GET3-DOOSAN-12-A6-300.</p>
	<p>Responsible Party: Doosan Contractor</p>
	<p>Deadline: 20-August-2013</p>
	<p>Current status:</p> <p>In Aug.: Not yet implemented</p> <p>In Sep.: The Contractor improved fuel control at this location.</p>

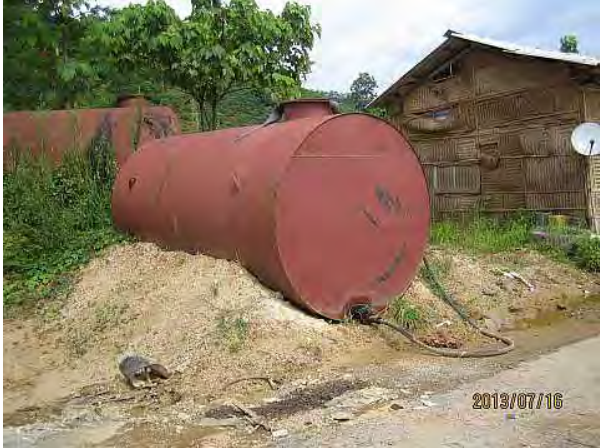
Location: Store place Km213+100
<p>16.7.2013</p>	Site visit: 21.6; 16.7 and 6.8.2013; 26.8.2013; 17.9.2013
 	Date first observed: 21.6.2013
<p>6.8.2013</p>	Problems description and cause: Oil and waste oil tanks are put directly on the ground. This can affect soil quality
 	Recommendation and Action taken by Engineer: Required the contractor to keep oil tanks and waste oil tanks on the concrete floor inside store.
<p>26.8.2013</p>	Responsible Party: GRBCC
 	Deadline: 15.7.2013
 	Current status:
<p>17.9.2013</p>	In July and August: The contractor has not yet improved
 	In September: Improved but not as required by Consultant

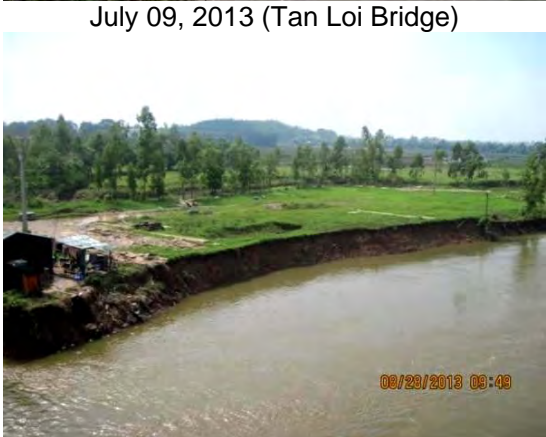
Date first observed:
<p>July 09, 2013 (Xuan Phuong Bridge)</p>	Problems description and cause: due to the unsuitable working methods, the riversides were undermined and this caused landslide on them.
<p>July 09, 2013 (Tan Loi Bridge)</p>	Recommendation and Action taken by Engineer:
<p>August 28, 2013 (Xuan Phuong Bridge)</p>	In July: Request the Contractor to submit the plan to restore these areas through the letter GET/POS/A1/196, 204, 2016, 2091
	In August: Having reviewed, the Engineer already approved the restoration plans of the Contractor and requested the Contractor to comply with the schedules in restoration plans. Refer to letter GET/POS/A1/219
	In September: Having reviewed, the Engineer already approved the restoration plans of the Contractor and requested the Contractor to comply with the schedules in restoration plans. Refer to letter GET/POS/A1/219; GET/MISC/361, 363

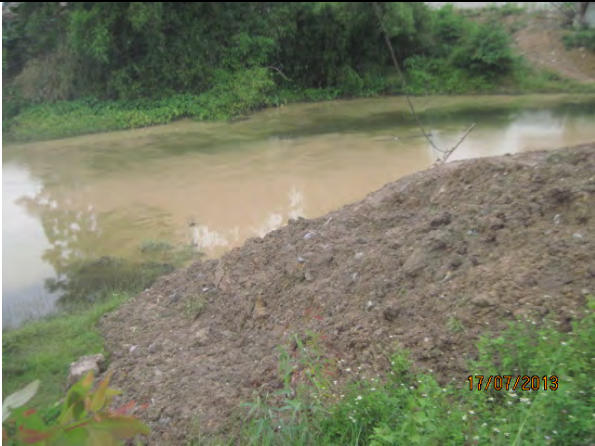
Location: Ngoi Gianh Bridge
17/7/2013	Site visit: 10, 13, 17, 24, 29, 31/7/2013; 02, 07, 08, 15, 16, 22, 29/8/2013; 05, 11, 12, 19, 24, 26/9/2013
 	Date first observed: 23/6/2013
22/8/2013	Problems description and cause: Excavation works for Ngoi Gianh bridge construction resulted to formation of steep slopes along the riverbank and A section of the existing stone masonry along the river embankment was removed due to excavation works for pile construction.
 	Recommendation and Action taken by Engineer: Reduce slope gradient to minimize erosion into the river. Remove soil/fill materials that are not necessary for access to areas where pile construction is on-going and Undertake full restoration of stone masonry.
24/9/2013	Responsible Party:
	Deadline: 15/7/2013
	Current status: improved

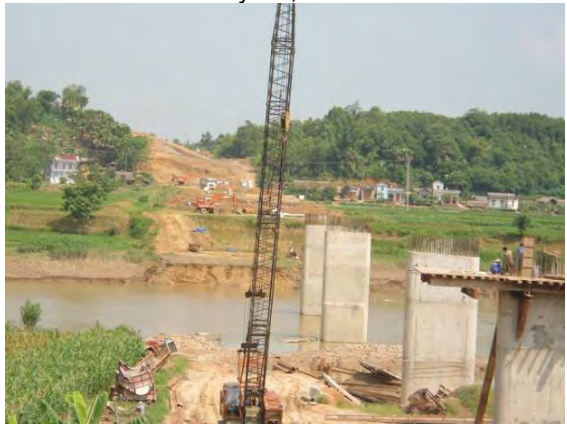
<p>Location: Ngoi Thia bridge's construction site</p>
	<p>Site visit: 22 June and 11 July, 2 August</p>
	<p>Date first observed: 22nd Jun, 2013</p>
 	<p>Problems description and cause: At Ngoi Thia bridge's construction site, the flow of the river was impacted by the Contractor's construction activities.</p>
<p>June 22, 2013</p>	<p>Recommendation and Action taken by Engineer: The Engineer pointed out this problem and requested the Contractor to implement measures through the letters: Ref. Ref. GET3-KEANGNAM-13-A5-291, Require the Contractor to apply measures in order to keep the Project's environment at Ngoi Thia bridge's construction site</p>
<p>July 11, 2013</p>	<p>Responsible Party: Keangnam Contractor</p>

<p>Deadline: 30-June-2013</p>
<p>August 2, 2013</p>	<p>Current status: Mitigation measure has been implemented by the Contractor in July 2013.</p>

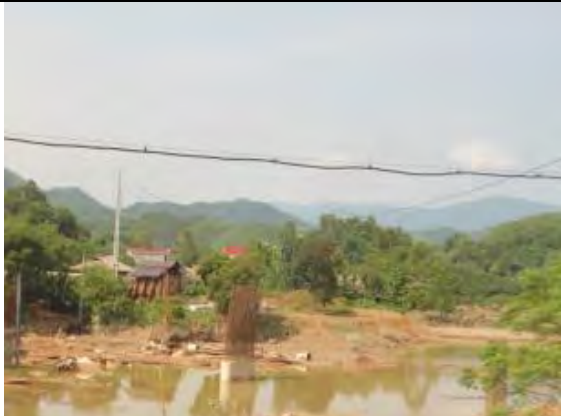
<p>August 2, 2013</p>   <p>August 16, 2013</p>	Location: Ngoi Gua bridge's construction site
	Site visit: 2 and 16 August, 2013
	Date first observed: 2 nd Aug, 2013
	Problems description and cause: At Ngoi Gua bridge's construction site, the flow of the river was impacted by the Contractor's construction activities.
	Recommendation and Action taken by Engineer: The Engineer requested the Contractor to implement the tasks as follows: <ol style="list-style-type: none"> 1.Remove excavated soil from the stream/riverbed at Ngoi Gua bridge site; 2.Undertake regular clearing of the channel section affected by construction; 3.Undertake restoration of channel/stream.
	Responsible Party: Keangnam Contractor
	Deadline: 15-August-2013
	Current status: Not yet implemented

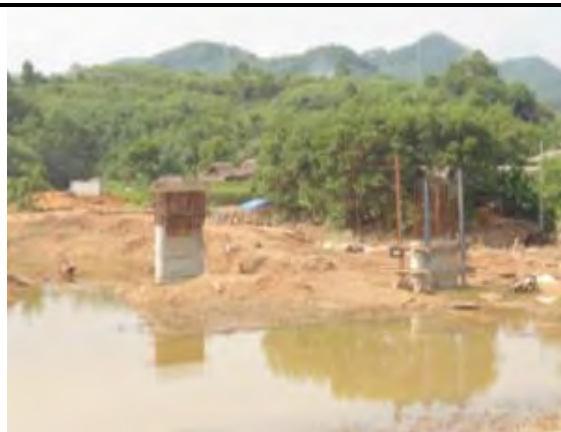
September 13, 2013 (Ngoi Rao bridge)

<p>September 3, 2013 (Ngoi Rao bridge)</p>	Location: Ngoi Rao bridge's construction site
	Site visit: 3 and 13 September, 2013
	Date first observed: 3 rd September, 2013
	Problems description and cause: At Ngoi Rao bridge's construction site, the flow of the river was impacted by the Contractor's construction activities.

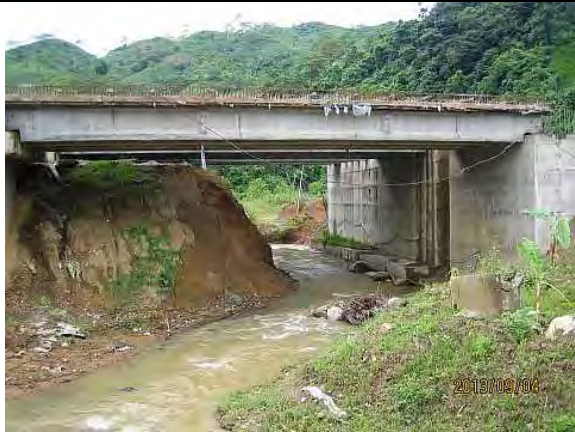
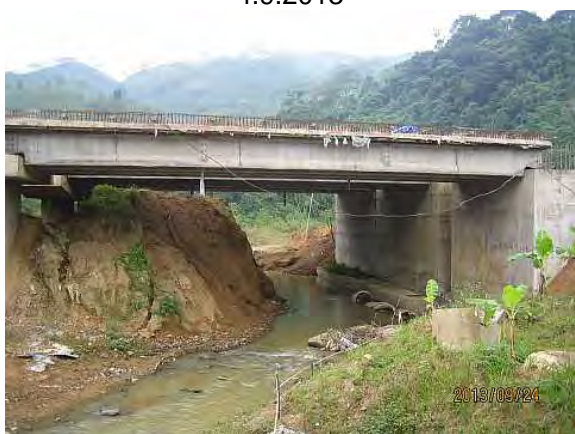
<p>4.9.2013</p>	Location: Km199+050
	Site visit: 4.9 and 24.9.2013
	Date first observed: 4.9.2013
	Problems description and cause: The stream has become narrow because Contractor dumped waste soil
	Recommendation and Action taken by Engineer: Required the contractor to clear the flow and to restore the flow of stream
	Responsible Party: GRBCC

<p>24.9.2013</p>	Deadline: 20.9.2013
	Current status: Not improved

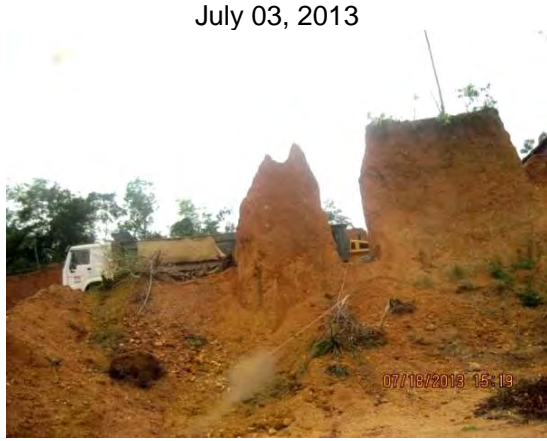
Location: Km 45+900 ~ Km 46+000

Site visit: 3, 10, 18, 25 July;
	Date first observed: 15-Oct-2012
	Problems description and cause: The Contractor did not comply with method statement to carried out the work with upright slope that causes high risk of landslide in this area
	Recommendation and Action taken by Engineer: The Contractor has to submit the plan to restore the affected area. Refer to letter GET1/POS/A2/1849
	Responsible Party: Contractor
	Deadline: 12-Apr-2013 (immediate)
	Current status: The Contractor is exploring soil in this area for embankment work

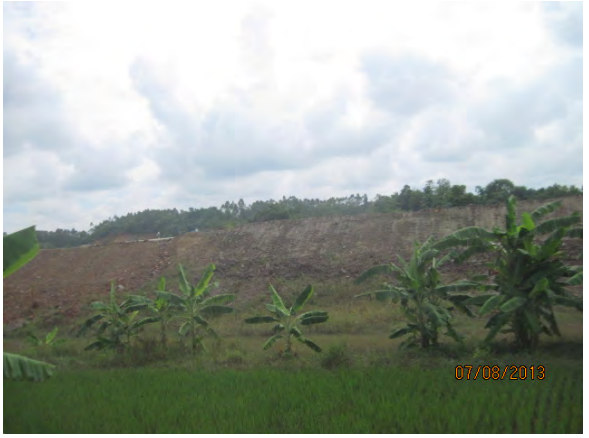
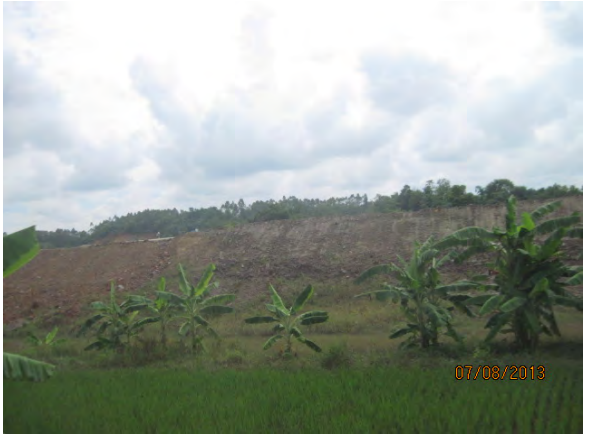
Date first observed: 28/3/2013
<p>28/3/2013</p>	Problems description and cause: The Slope had cracked.

Recommendation and Action taken by Engineer: Request Contractor to plant grass on the slope to avoid erosion and reinforced slope.
<p>24/7/2013</p>	Responsible Party:
<p>07/8/2013</p>	Deadline: 28/7/2013
<p>24/9/2013</p>	Current status: The Contractor has not planted grass yet to prevent landsides and erosion in rainy season.

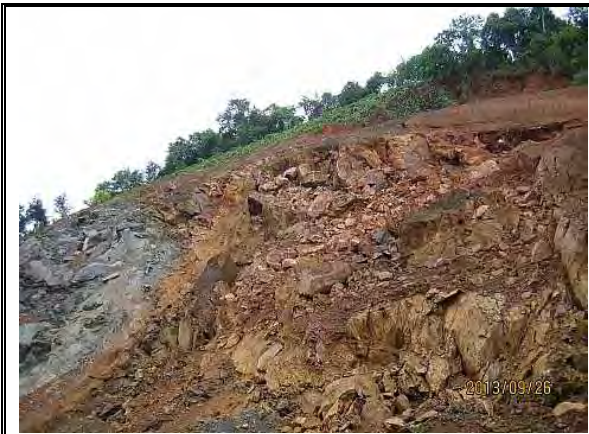
<p>6.9.2013</p>	Location: Excavation slope Km228+100
	Site visit: 6.9 and 26.9.2013
	Date first observed: 22.5.2013
	Problems description and cause: Slope had been landside and erosion by heavy rains
	Recommendation and Action taken by Engineer: Required the contractor to set up safety fence and signpost surrounding landside and erosion areas, after that apply the slope protection method to overcome as soon as possibility.
	Responsible Party: Contractor
	Deadline: As soon as possible

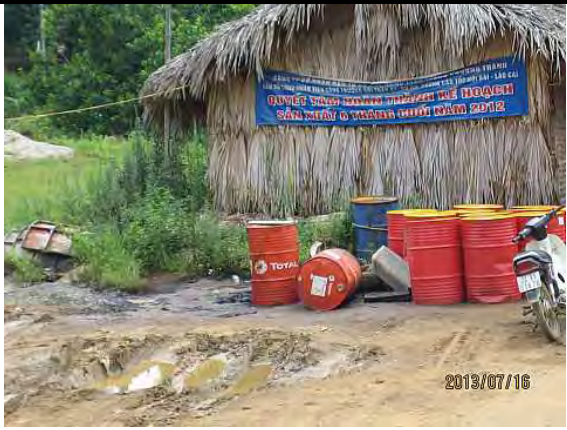
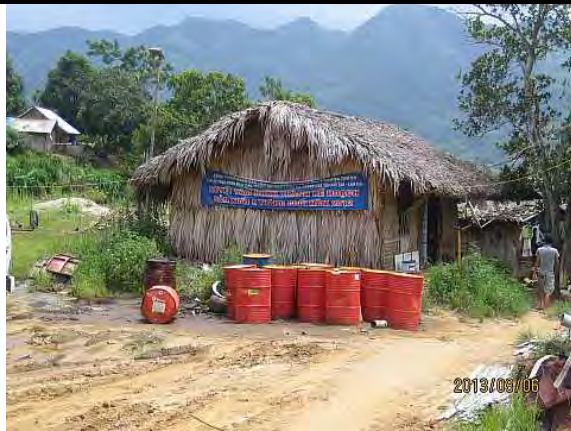
<p>2013/07/16</p> <p>16.7.2013</p>	Location: Store place Km197+080
	Site visit: 16.7 and 6.8.2013; 26.8.2013; 17.9.2013
	Date first observed: 8.1.2013
	Problems description and cause: Oil and waste oil tanks are put directly on the ground, this can affect soil quality
	<p>Recommendation and Action taken by Engineer: Required the contractor to keep oil and waste oil tanks in store with floor concreted.</p> <p>Responsible Party: GRBCC</p>

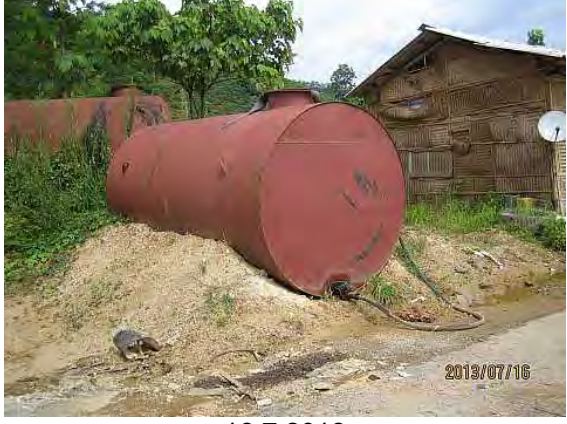
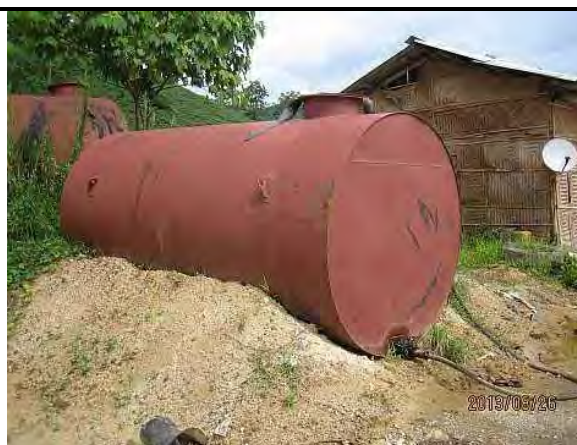
<p>Location: Store place Km203+000</p>
	<p>Site visit: 16.7.2013; 26.8.2013; 17.9.2013</p>
	<p>Date first observed: 21.6.2013</p>
	<p>Problems description and cause: Oil and waste oil tanks are put directly on the ground, this can affect soil quality</p>
	<p>Recommendation and Action taken by Engineer: Required the contractor to keep oil and waste oil tanks in store with floor concreted.</p>
	<p>Responsible Party: GRBCC</p>
<p>16.7.2013</p>	<p>Deadline: 15.7.2013</p>
	<p>Current status: In July and August: The contractor has not</p>

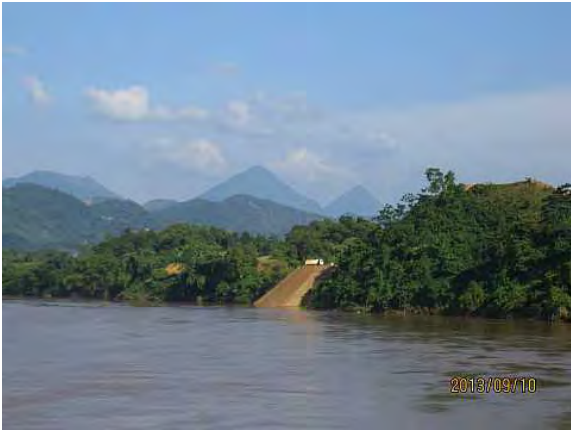
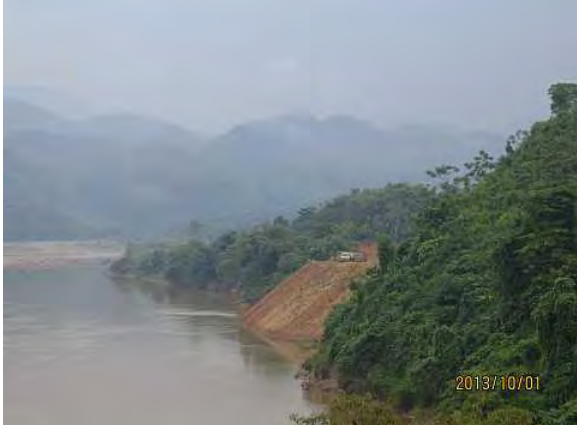
<p>10.9.2013</p>	<p>Date first observed: 10.9.2013</p>
	<p>Problems description and cause: The contractor dumping earth near water source and have not approved by Engineers</p>
	<p>Recommendation and Action taken by Engineer: The contractor was required to provide the documents related to waste disposal and to plant grass to avoid erosion and landside into riverbed, before removal. Consultant had issued several letters to the contractor such as: Get4- GRBCC- 979 and Get4- GRBCC- 988</p>
	<p>Responsible Party: GRBCC</p>
	<p>Deadline: 20.9.2013</p>
	<p>Current status: Not yet removed</p>

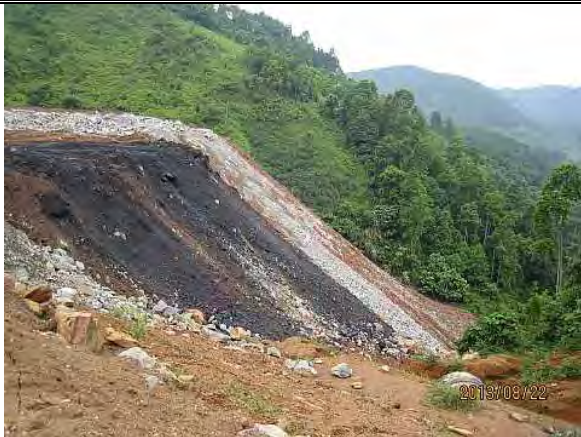
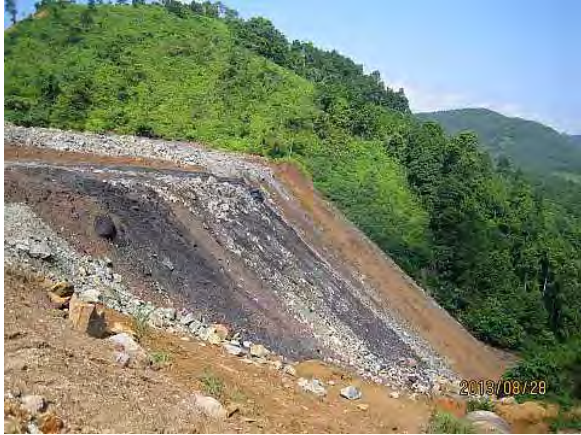
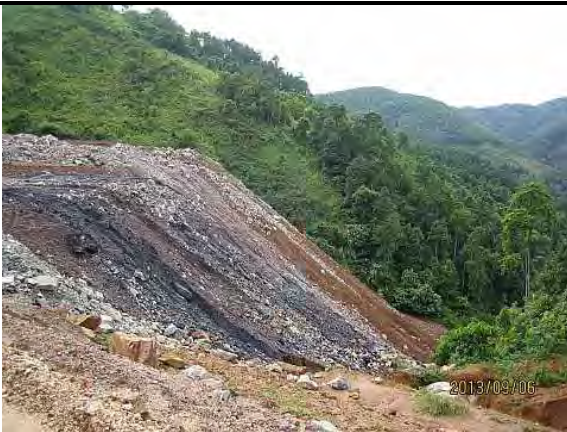
<p>22.8.2013</p>	Location: Km231+100

<p>28.8.2013</p>	Site visit: 22.8 and 28.8.2013, 18.9.2013
	Date first observed: 22.8.2013
	Problems description and cause: The contractor dumping earth in place, which has not been approved by Engineers
	Recommendation and Action taken by Engineer: The contractor was required to submit the documents related to this waste disposal and to plant grass to avoid erosion and landside
	Responsible Party: Contractor
	Deadline: 31.8.2013

<p>6.9.2013</p>	<p>Current status: The contractor has not yet deployed according to consultant's instructions.</p>

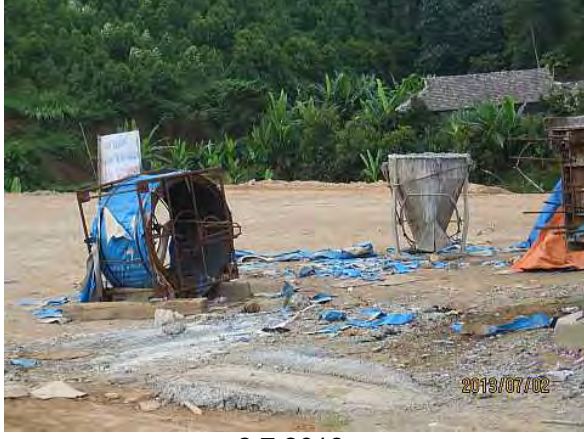
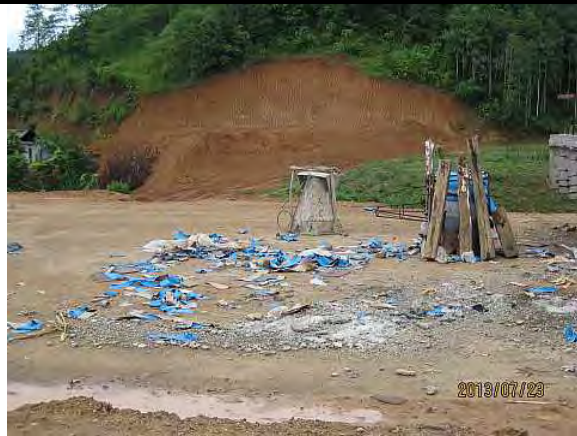
<p>2.7.2013</p>	Site visit: 11.6; 2.7 and 23.7.2013; 6.8.2013
Date first observed: 9.5.2013 Problems description and cause: The construction works are not tidy and there is a lot of rubbish on site	Recommendation and Action taken by Engineer: Require the contractor to arrange the construction work, collect and classify rubbish according to regulation
Responsible Party: GRBCC	Deadline: 20.6.2013
Current status: So far the contractor didn't collect and transfer the rubbish to treatment area according to regulations

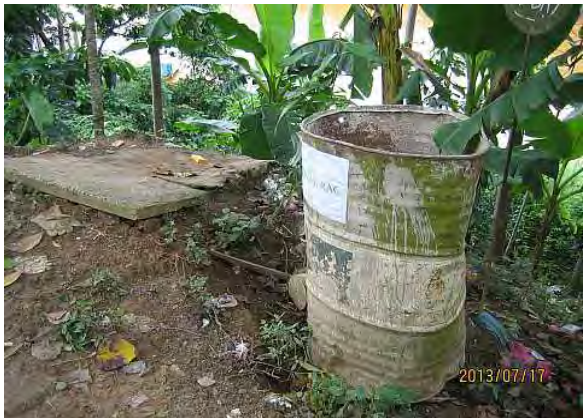
<p>17.7.2013</p>	Date first observed: 21.6.2013
	Problems description and cause: The construction works are not tidy and there is much rubbish on site
	Recommendation and Action taken by Engineer: Require the contractor to arrange the construction work, collect and classify rubbish according to regulation
	Responsible Party:
	Deadline: 15.7.2013
	Current status: Had improve

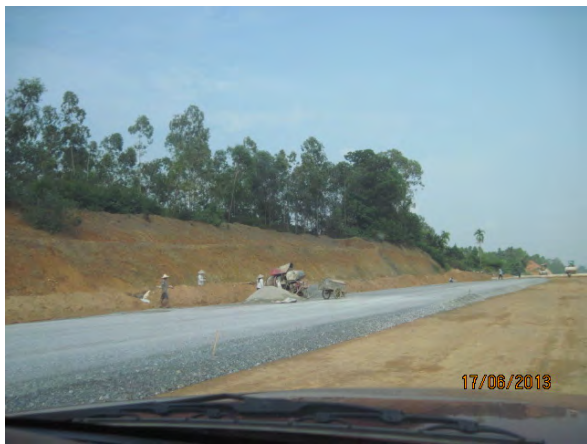
<p>Location: Km52+100</p> <p>Site visit: 04, 08, 11, 15, 18, 25/7;</p> <p>Date first observed: 17/6/2013</p> <p>Problems description and cause: Workers do not use enough PPEs while working on site</p> <p>Recommendation and Action taken by Engineer: Require the subcontractor to remind and propose labour safety for workers. If any worker continues to violate the regulation, he will be fired.</p> <p>Responsible Party:</p> <p>Deadline: Daily</p> <p>Current status: improved</p>

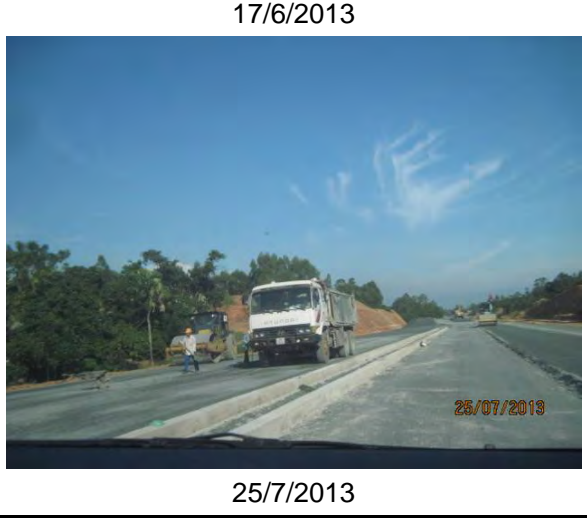
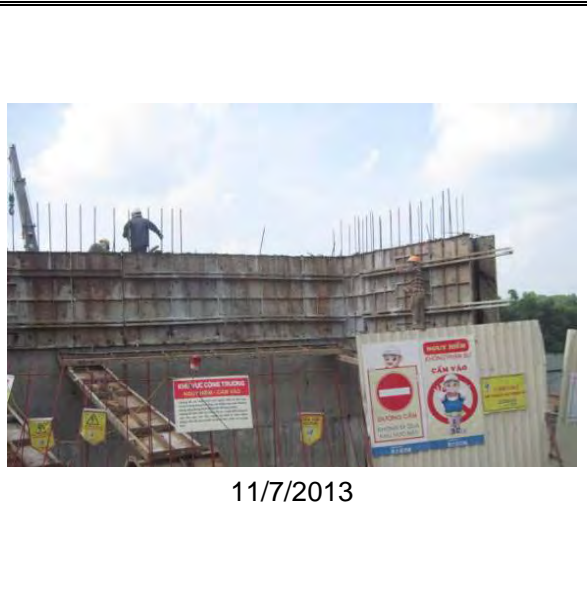
<p>Location: QL2 Bridge</p> <p>Site visit: 04, 08, 11, 15, 18, 25/7; 07, 14, 21, 28/8/2013; 04, 10, 11, 18, 24, 25/9/2013</p> <p>Date first observed: 13/6/2013</p> <p>Problems description and cause: Workers do not use enough PPEs while working on site</p> <p>Recommendation and Action taken by Engineer: Require the subcontractor to remind and propose labour safety for workers. If any worker continues to violate the regulation, he will be fired.</p>

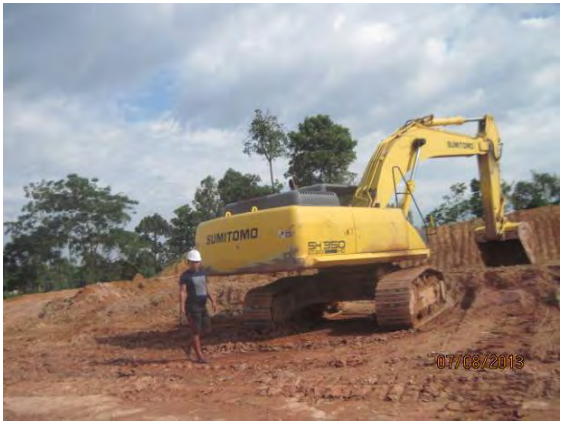
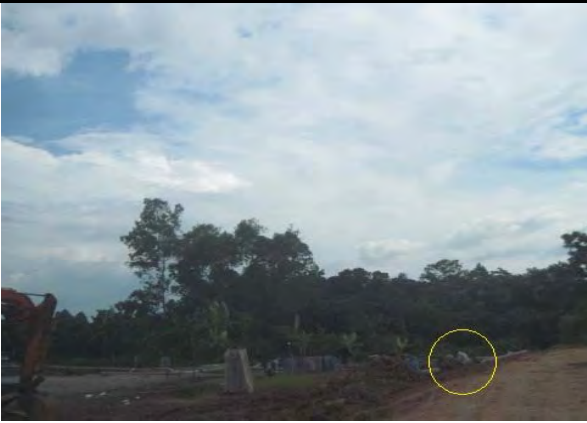
<p>07/8/2013</p>	Location: Km49+100
	Site visit: 07, 14, 21, 28/8/2013
	Date first observed: 07/8/2013
	Problems description and cause: Workers do not use enough PPEs while working on site
	Recommendation and Action taken by Engineer: Require the subcontractor to remind and propose labour safety for workers. If any worker continues to violate the regulation, he will be fired.
Responsible Party:	
Deadline: Daily

<p>Current status: Not improved</p>
<p>14/8/2013</p>

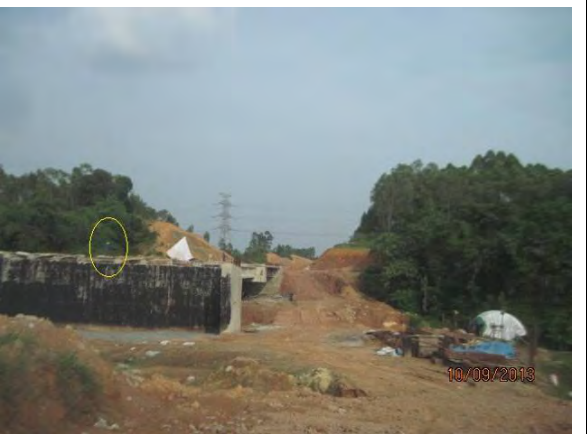
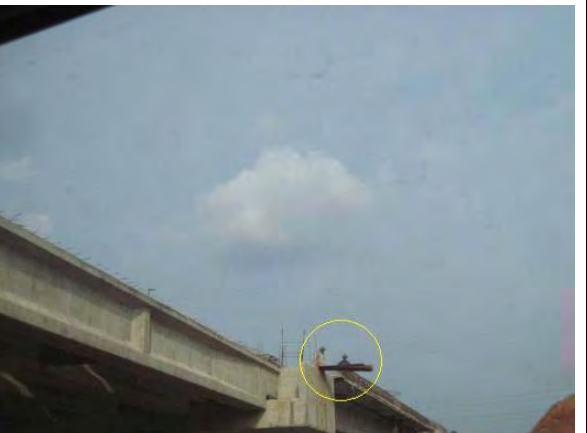
<p>Location: Cam Phu Bridge</p>
	<p>Site visit: 04,10,11,18,24,25/9/2013</p>
	<p>Date first observed:10/9/2013</p>
	<p>Problems description and cause: Workers do not use enough PPEs while working on site</p>
	<p>Recommendation and Action taken by Engineer: Require the subcontractor to remind and propose labour safety for workers. If any worker continues to violate the regulation, he will be fired.</p>

<p>Responsible Party: Posco</p>
	<p>Deadline: Daily</p>
	<p>Current status: Not improved</p>
<p>10/9/2013</p>	
<p>18/9/2013</p>

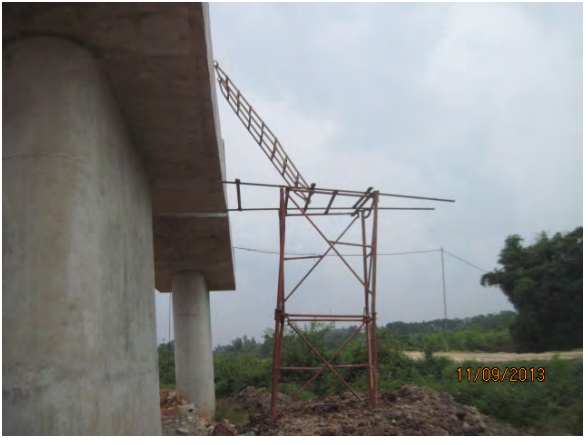
<p>11/9/2013</p>	Location: Ngoi Van bridge
	Site visit: 05, 11, 12, 19, 24, 26/9/2013
	Date first observed:
	Problems description and cause: scaffoldings were not safe enough to use.
	Recommendation and Action taken by Engineer: The Consultant requests the Contractor to stop construction and overcome the matter of scaffoldings to ensure safety during construction process. Until you ensure the safety of scaffolding, you can continue construction. Also, the Contractor is requested to force the workers to wear labor protection during construction time.

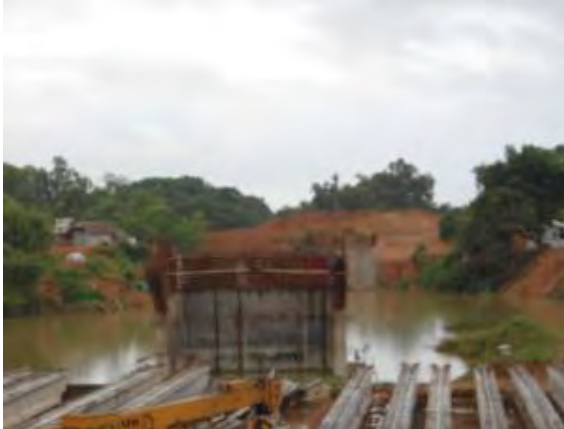
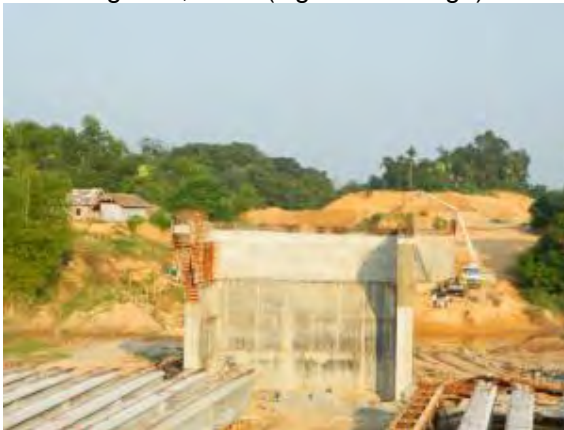
Location: Ngoi Gua bridge's construction site
	Site visit: 9 August, 3 September, 2013

Date first observed: 9 th August, 2013
	Problems description and cause: Lack of safety fence and signboards at dangerously areas
	Recommendation and Action taken by Engineer: The Engineer required the Contractor to install fully safety fence and signboard at dangerous areas in order to keep the Project's safety.
	Responsible Party: Keangnam Contractor
	Deadline: Immediate
	Current status: No improvement seen
