# Environmental Monitoring Report

Semestral Report  
January-June 2011

## VIE: Song Bung 4 Hydropower Project

Prepared by Song Bung 4 Hydropower Project Management Board (SB4HPMB) for Vietnam Electricity and the Asian Development Bank.

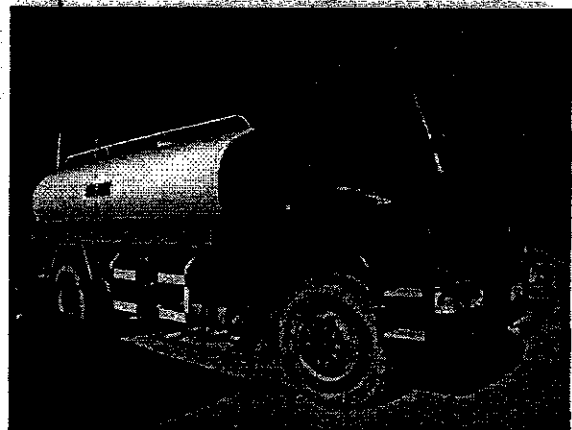
### 2. Water truck for reducing dust on the access roads and worker cleaning settlement pond at the explosive store

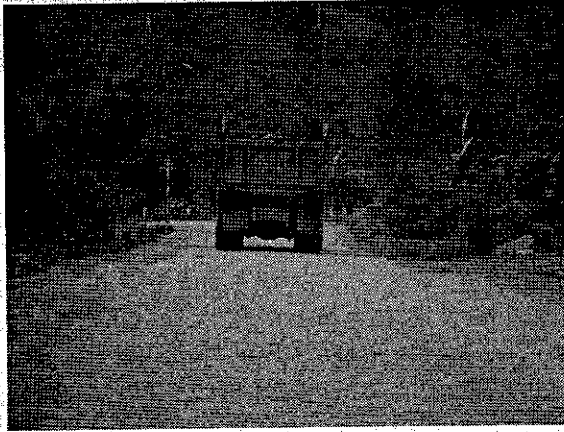
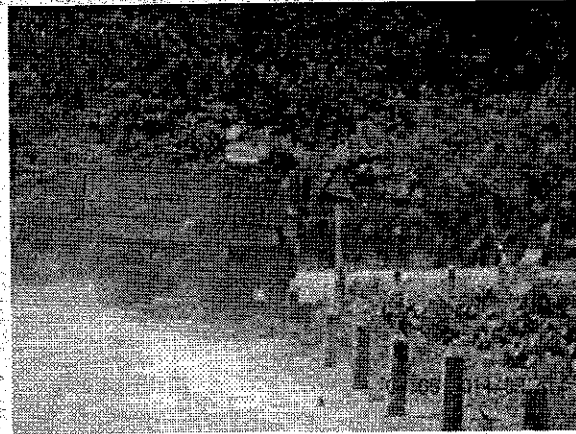
**1. Overloading of trucks causing damage to roads and spillage of material onto roads.**

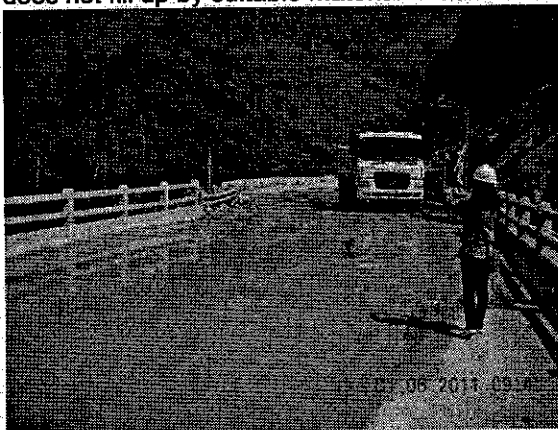
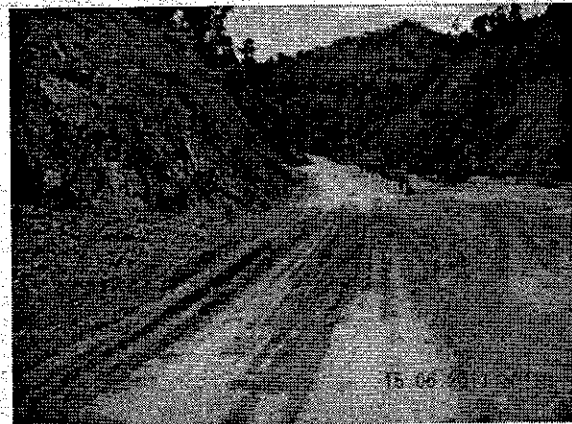
The Contractor's maintenance of the access roads continues to be very poor. During April and May, there was heavy rain that caused several small landslides on the access roads and there are numerous drains that are now blocked. SCL hired small team local people working on keeping the road ditches clean by using hand shovels. However, they do not fill up potholes on the road with suitable material, and the drains are not cleared. Recently this team have disappeared and with the trucks continuing to be overloaded the road surface deteriorates further. Landslide still remains on the road and the Contractor do not wash well of truck before out of working area. This has caused the roads to become very dirty and slipper in wet condition.

**2. Landslide on Road D1 that has not been cleared leaving the road in a poor condition and potholes does not fill up by suitable material**

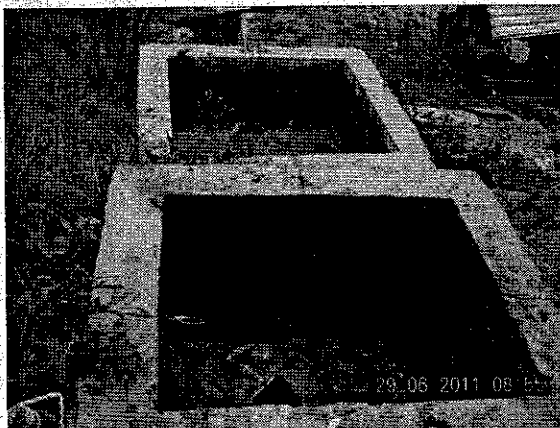
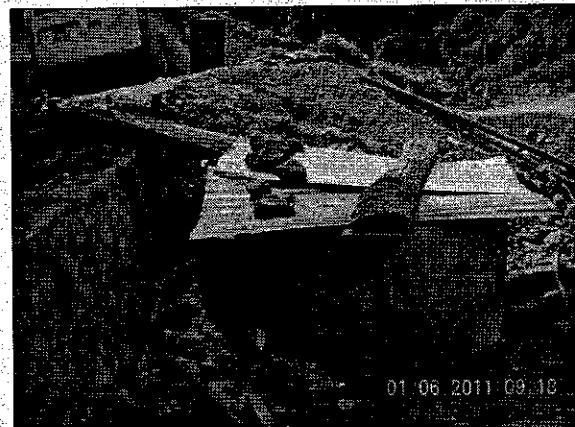
The bold values in the table above indicate the tests that have exceeded the values permitted by the Vietnamese standards. These results suggest that the septic tanks at the Main Camp and at Camp 45 are not operating efficiently. This problem has been raised regularly with SCL but they have still to carryout remedial work, which will require the rebuilding, or refurbishment of the septic tanks and the waste disposal system. It should be noted that Social Consult are taking their measurements at slightly different locations from SCL.

**3. Settlement pond is not working and wastewater is not treatment correctly before discharge to environment at the Main camp and Camp area 45**
