VIE: Song Bung 4 Hydropower Project

SONG BUNG 4 HYDROPOWER PROJECT
Monitoring and Assessment of Environmental Quality

**THE 12th ENVIRONMENTAL MONITORING
REPORT**

Construction phase

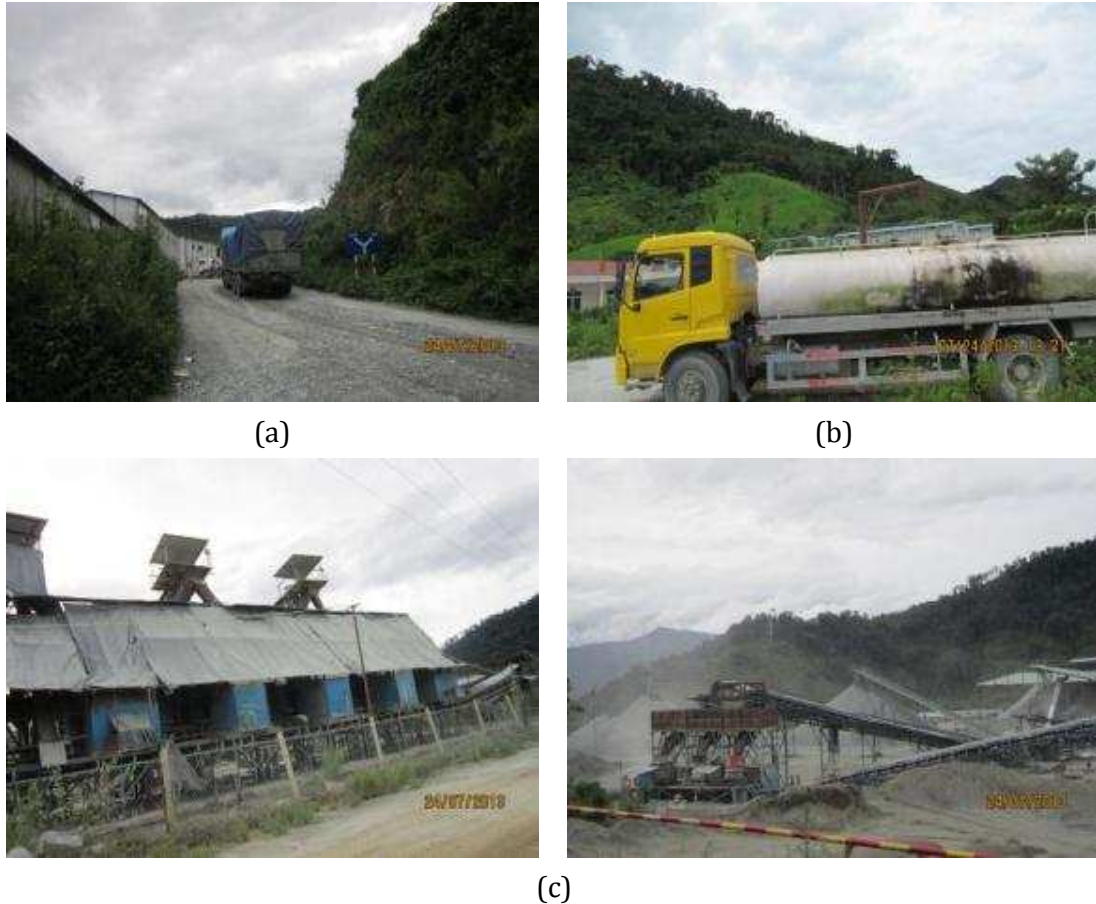
- To cover the vehicles that transport construction materials and refuse soil and rock to reduce dropping soil and rock on the transporting routes and mitigate dust as well;
- To water the transporting routes to minimize dust: Contractor SinoHydro conducts the watering 05 times/day in sunny days –each time includes one outward journey and one return journey; Contractor Song Da 5: the watering has been conducted by a home-made tank truck;
- To water the construction materials before crushing step and covering the crushing chutes to reduce dust.

*Figure 7: Compliance in the implementation of the mitigation measures for dust
a. Transporting truck with canvas covered; b. Watering the transporting routes; c.
Covering the crushing chutes*

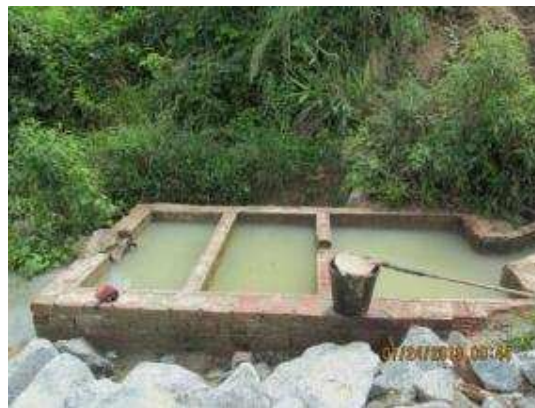
- Wastewater from the refuelling area at the rock quarry is led into a three-compartment sedimentation tank before discharging into the environment. The tank has been provided with an oil screen to collect leaked oil in the wastewater.

Figure 9: Sedimentation tank in the refueling area at the rock quarry

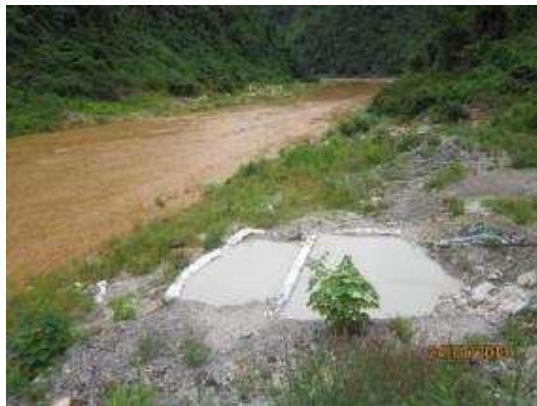
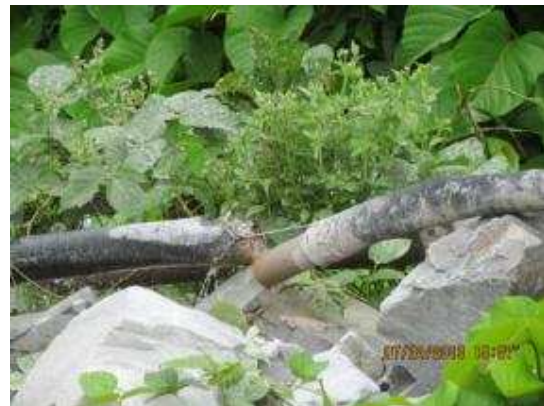
Wastewater from the plant has been led into a sedimentation tank in the bank of Bung River. The tank has a thick layer of sediment and has not been cleaned regularly so the capacity of sedimentation has reduced. As observed, the height of the tank does not meet the requirement because when the flood season comes, water in Bung River can overflow this tank. In addition, the pipe conducting construction wastewater from the plant area has been being broken, leaking wastewater into the environment. The contractors should apply corrective measures urgently.

(a) Sedimentation tank

(b) Broken wastewater pipe

❖Conclusions: Construction wastewater from the plant, the concrete mixing plant, the refueling area and the rock crushing plant at the rock quarry is treated by the preliminary sedimentation tanks before discharging into the environment. However, the tanks do not meet the requirement on capacity of sedimentation so that the wastewater after being treated has still been turbid. The sedimentation tank in the plant area should be located in a higher position and the broken wastewater pipe should be repaired promptly.

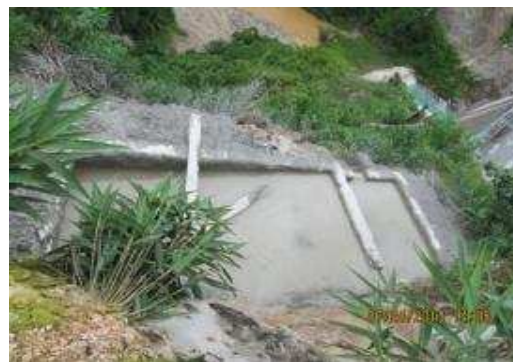
Wastewater from the concrete mixing plant has also been treated by the three-compartment sedimentation tank. However, the tank has not been cleaned regularly so that the wastewater after being treated by the tank has high content of turbidity. The contractors have been reminded of this issue by the construction monitoring consultant Mott MacDonald and the EMC through many monitoring visits; however, until now the tank has not yet been cleaned seriously.

Figure12: Sedimentation tank in the concrete mixing plant

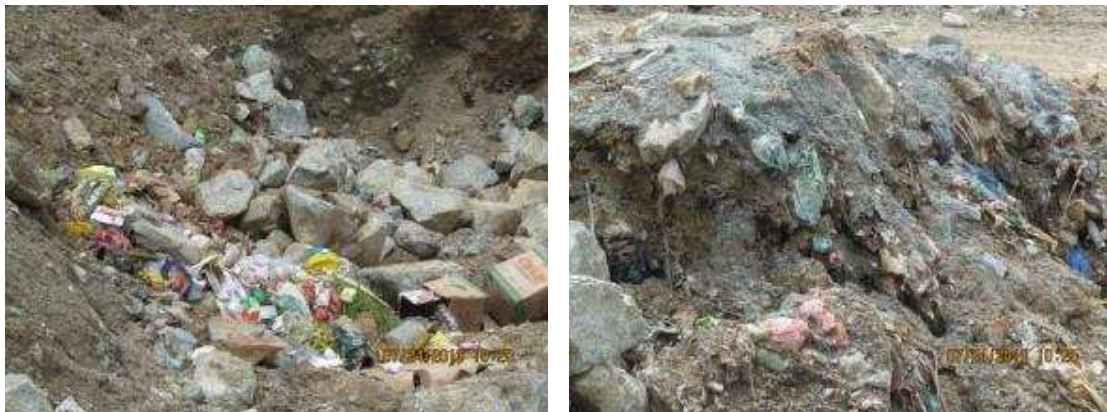
Burying of domestic waste in the main camp of contractor SinoHydro and other camps in the construction site is conducted in the waste disposal site No. 1. Domestic waste in the camp areas is collected to bury once or twice a week depending on the volume of waste. The EMC has monitored the burying of domestic waste in the waste disposal site No. 1. The EMC observed that the burying has not been well-implemented: the soil layer covering the waste is not thick enough so that the waste has still been exposed. Additionally, the waste for burying has not yet been classified so there are still many plastic boxes and other reusable things in the waste. The EMC proposed contractor SinoHydro to remind the workers to bury the waste in compliance with the regulated process. Reusable things should be classified and sold to the scrap dealers.

Figure18: Waste burying is not in compliance with the regulated process in the waste disposal site No.

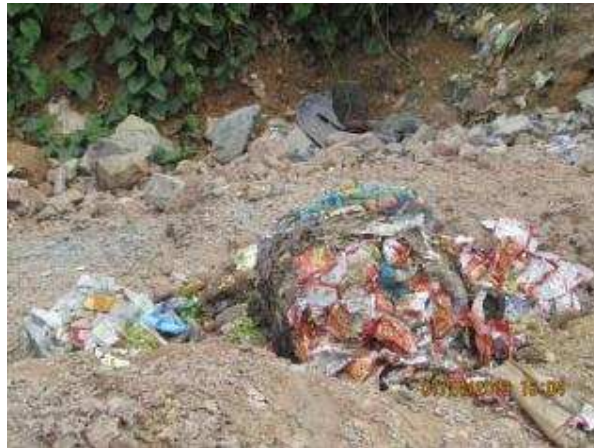
The EMC noted that the burying of waste has been carried out near the camp area in the left abutment. In the area, the waste burying does not meet the requirement: the covering soil layer is not thick enough so that the waste causes bad odor.

Figure 19: Waste burying in the camp area in the left abutment

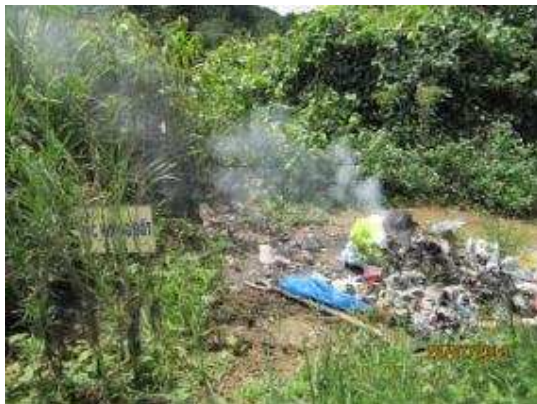
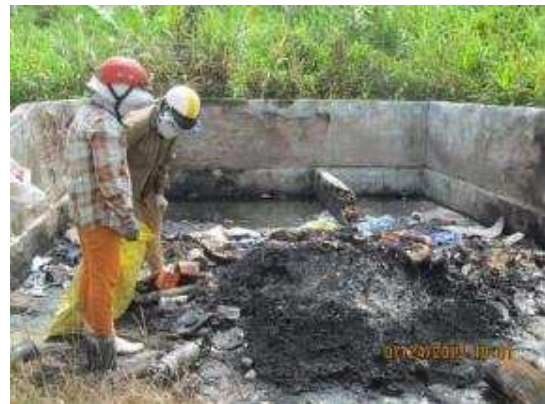
- In camp area of contractor Song Da 5 – rock quarry, waste burning has not been complied with the regulated requirements. Plastic bottles and nylon bags have still included in the waste for burning and the burning has been conducted in the area with the “Waste is not for burning” sign;
- Camp area of the Chinese contractor in the rock quarry: There are many nylon bags and oil filters that have been burned. The holes for waste burning have been waterlogged by stagnate water.

(a) Camp area of contractor Song Da 5 - rock quarry

(b) Camp area of the Chinese contractor – rock quarry

Figure 20: Waste burning is not complied with the regulated requirements

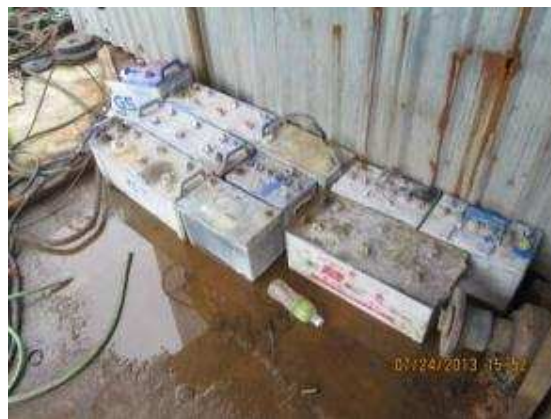
- (i) Although the collection of used batteries has been done, the EMC observed that the collecting area has no roof and there is stagnant water that cause risk of hazardous chemicals into the environment. The EMC advised that the contractors should place the used batteries in dry place with roof or covering canvas.

Figure 22: Battery collecting area with stagnant water

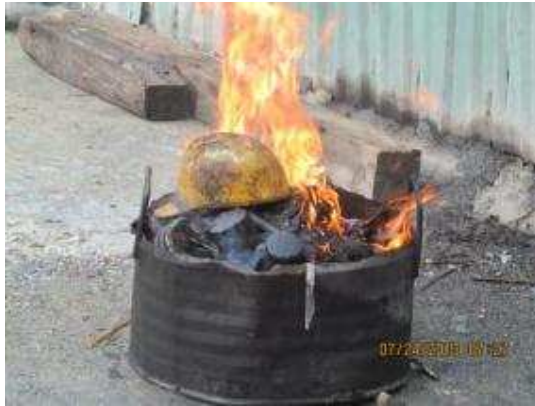
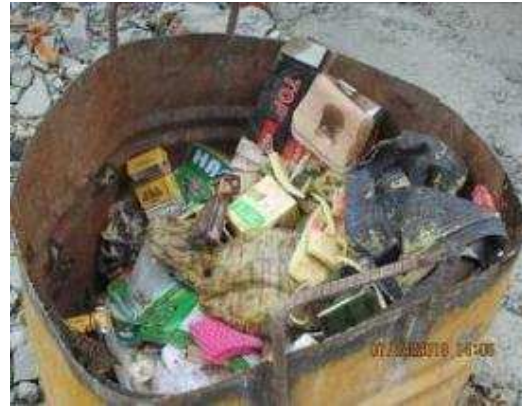
- (ii) Used lubricant containers have not yet been collected in the regulated places. The containers have still been thrown away in the construction area or burned together with domestic waste. Oil clouts have been collected in domestic wastebaskets and burned instead of being treated by the treatment unit.

(a) Oily hard cap, clouts and oil filters have been burned in an iron barrel—in the left abutment

(b) Oily clouts in domestic wastebasket – in the concrete mixing plant

Figure 23: Hazardous waste treatment has not been complied with the regulated requirement

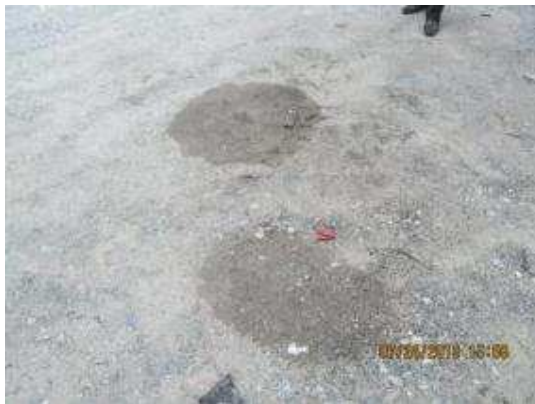
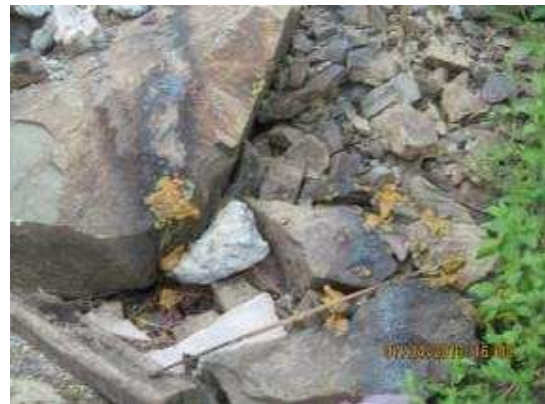
- (iii) Vehicle repairing in the left abutment has caused lubricant leakage on the ground.

Figure 24: Lubricant on the ground in the vehicle repairing area in the left abutment

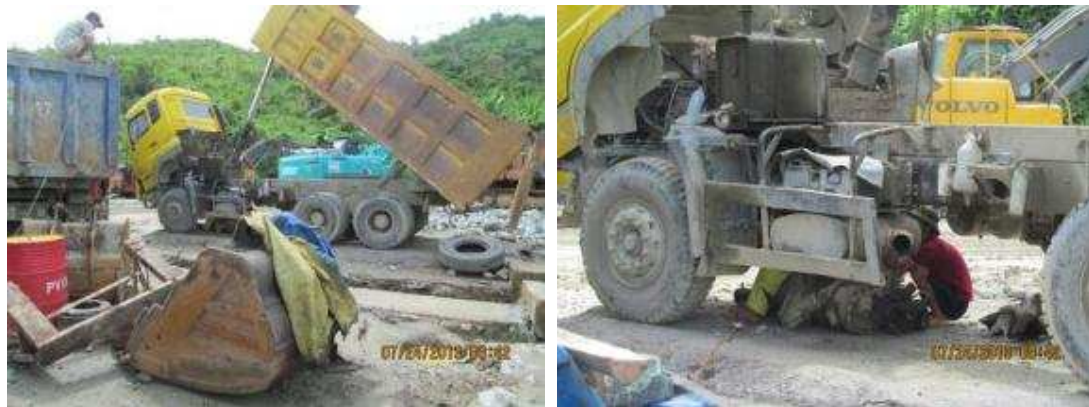
- (iv) Vehicle repairing of contractor Song Da 5 in the rock quarry has carried out in the open air while the vehicle gathering area has not yet been provided with a waterproof sheet; therefore, the lubricant has still been leaked into the environment.

Figure 25: Vehicle repairing area in the rock quarry of contractor Song Da 5

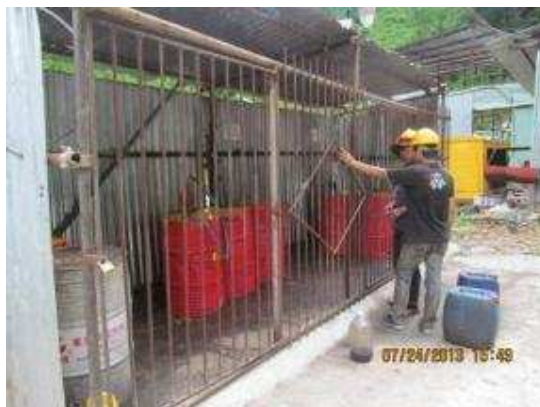
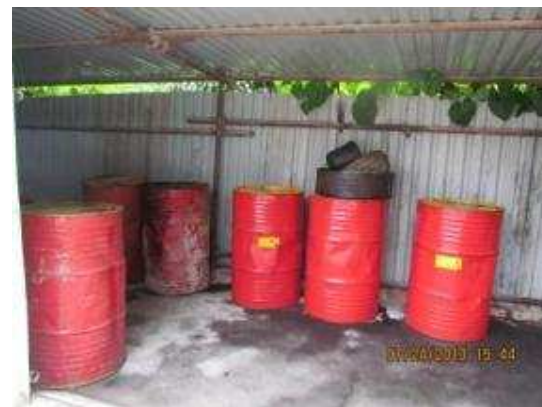
Machine oil and redundant lubricant in the vehicle repairing area in the left abutment have still been restored in a special place with roof and waterproof cement floor and enclosed by wall to prevent oil spill. Monitoring of the refuse oil storage showed that the oil has still been leaked on the ground. Oil leakage in the gathering of refuse oil is unavoidable so to overcome the problem, the contractors should remind the workers not to drop or spill the lubricant onto the ground. In addition, lubricant collecting gutters have been provided with clouts to collect oil in wastewater.

Figure 26: Machine oil storage and refuse oil storage in the vehicle repairing area in the left abutment

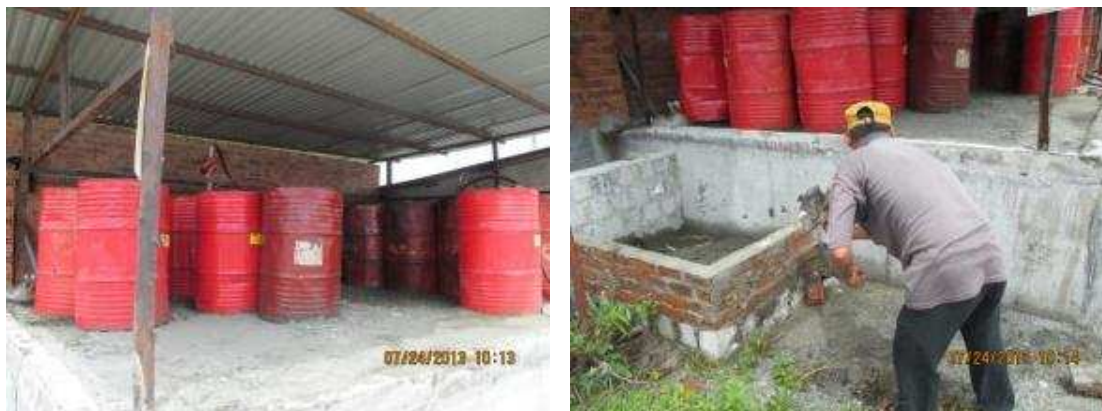
The contractors have arranged lubricant storage with roof and wall at 10 cm in height to prevent oil spill. In the previous monitoring visits, the EMC advised the contractors to build the wall with the height of 30cm to prevent oil leaking in case of break-down. The floor of the storage is water-proof cement floor. In addition, the floor is covered with sand to prevent lubricant from leaking on the floor. According to the collecting workers, the volume of sand has been collected in adjacent cement tank and transported to the treatment area when the tank is full of sand.

Figure27: Lubricant storage in the camp area of Chinese contractor

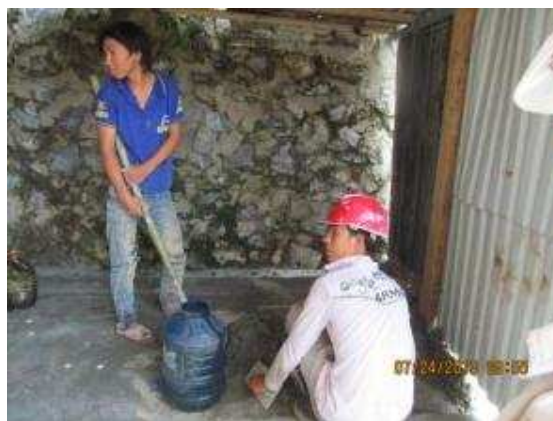
Storage for refuse lubricant in the area has been being established by the contractor. It is expected that the storage will be completed and put into effect in August 2013.

Figure28: The refuse lubricant storage has been being constructed in the rock quarry

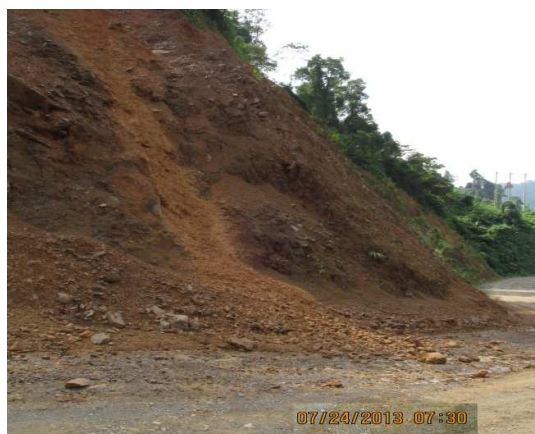
It is the rainy season in the project area at the time of the 12th environmental monitoring so erosion and landslide have still appeared along mountain slopes in the construction areas and Pa Pang road. There have not yet been mitigation measures for the erosion and landslide given in the 11th environmental monitoring including landslide at the bridge km 8 + 909.61 and along Pa Pang road. Soil excavation caused by the illegal gold exploitation along the river banks has made the erosion and washout increase, especially in waste disposal site No. 3.

Landslide at Km 8+909,61

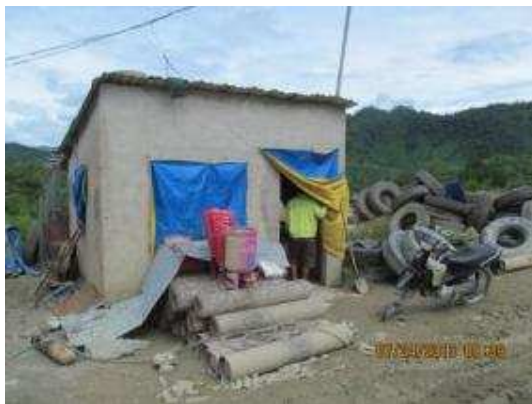
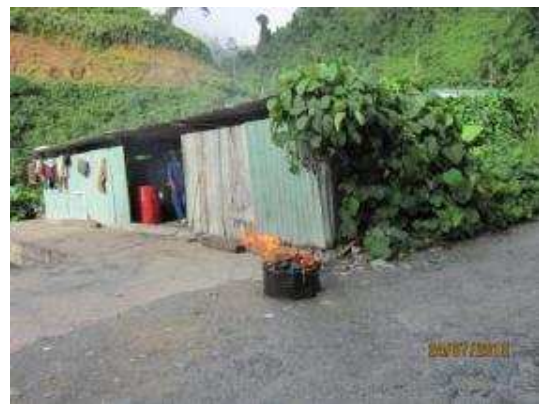
- Gas and oxygen tanks in the vehicle repairing area near the rock quarry have been placed open- air without controlling or warning signs(Figure 31-a).
- In the storage of refuse lubricant in the left abutment, waste has been burned right near the storage. The EMC advises the contractor to remind the workers not to burn the waste as well as install warning sign in this area because the lubricant is flammable (Figure 31-b).

(a) Vehicle repairing area near the rock quarry

(b) Refuse lubricant storage in the left abutment

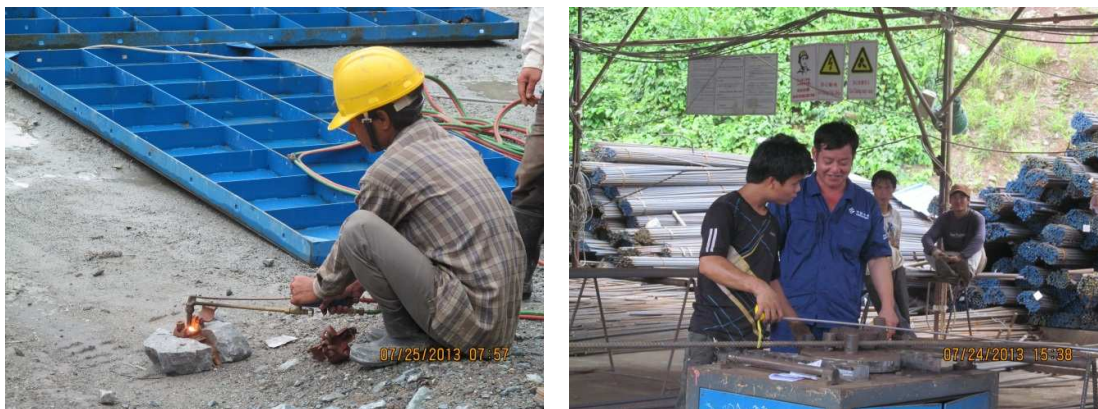
Protective equipment for workers includes protective clothing, hard cap, mask, gloves and boots. Additionally, the workers who work on high positions have been provided with protective belt. However, The EMC recorded that the equipment has sometimes not been used by the workers, for example: some workers in metal processing shop did not use gloves and hard cap during their working time or a worker did not wear protective glasses when welding.

Figure34: Workers working without protective equipment

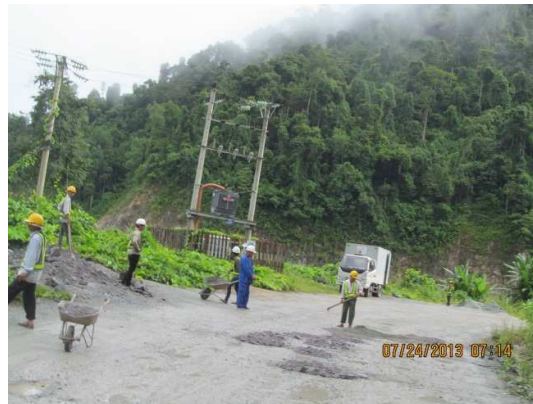
Warning signs, prohibition notices and signs and propaganda signs on driving safety for workers have still been installed in the construction site. Convex mirrors are well-equipped along the road. Regulations on traffic safety have been posted in the camp areas: vehicles transport on the construction road and adjacent road in the project are allowed with limited speed 40 km/h. To ensure the traffic safety, the contractors have arrange workers to clean the dropping rock and soil on the transporting route and maintain degraded road sections as well.

Figure35: Workers are repairing the degraded road section
