PRC: DALI-LIJIANG RAILWAY PROJECT Environment Monitoring Report (June 2007)

Prepared by Beijing Oasis Environment Protection Technology Co., Ltd.
Yunnan, People's Republic of China

For West Yunnan Railway Co. Ltd.

(June 2007)

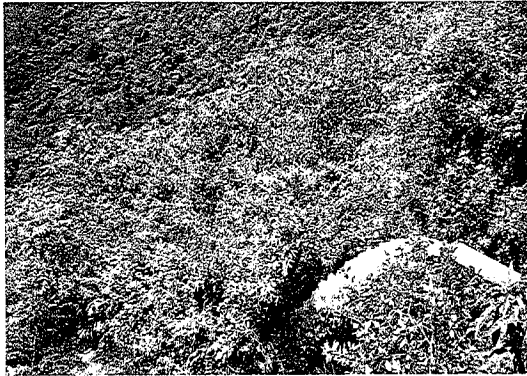
Large amount of water inflow occurs at the exit of Bijia Mountain 1[#] tunnel (see Photo 1). Since the farm field at the bottom of Bijia Mountain belongs to water-deficient area, the construction unit advises the villagers to build pools for water storage at the end of ditch for the purpose of irrigation of agricultural land.

Picture 1 Large amount of water flow occurs in Bijia Mountain 1# tunnel

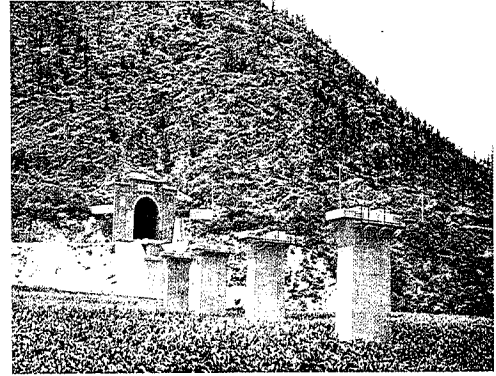
Picture 2 Corns between Wase Ultra large bridge piers grow well

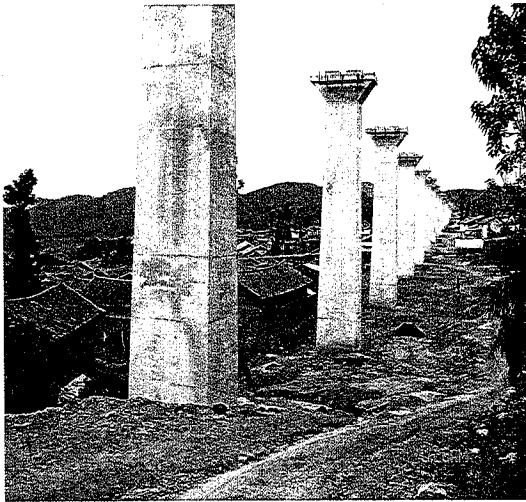
Picture 3 The grounds between Xinwo Ultra large bridge piers have been cleared and leveled up.

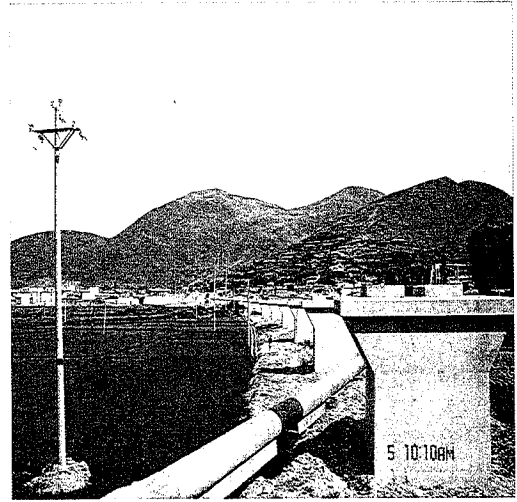
Picture 4 The grounds between Haidong ultra large bridge piers have been basically leveled up.

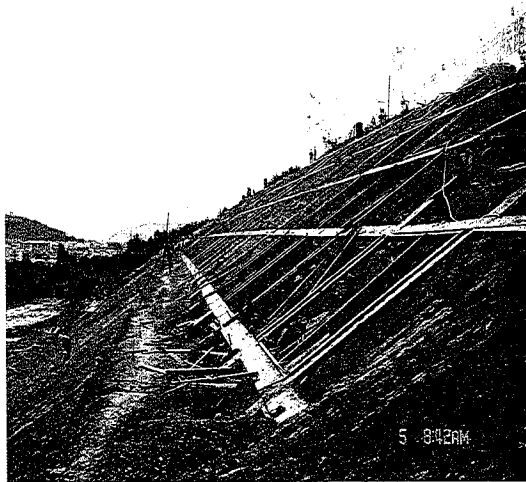
Picture 5-1 The protection skeleton for the borrow pit ground and excavated surface on the back of Dali Station is under construction

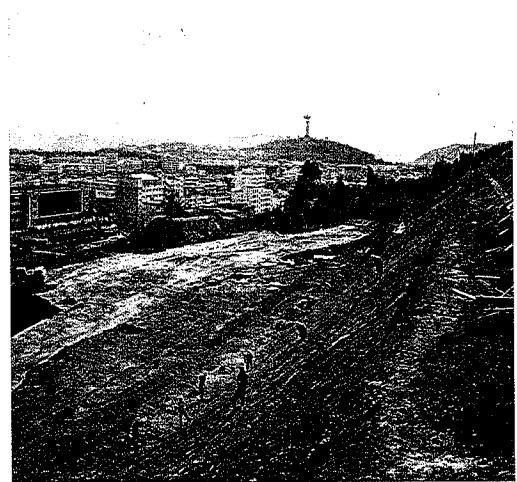
Picture 5-2 After borrowing soil, level up the grounds for extension of Dali station

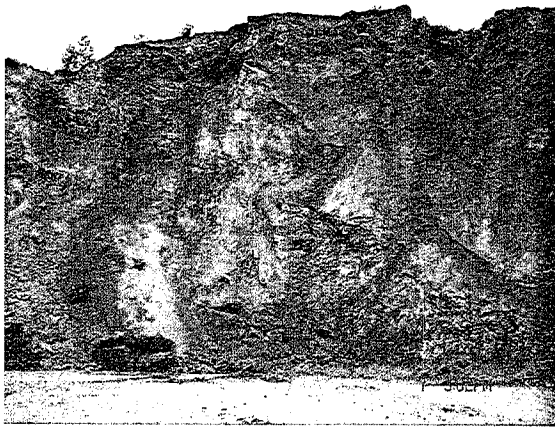
Picture 6 The borrow pit ground on the back of Heqing station needs slope cutting protection

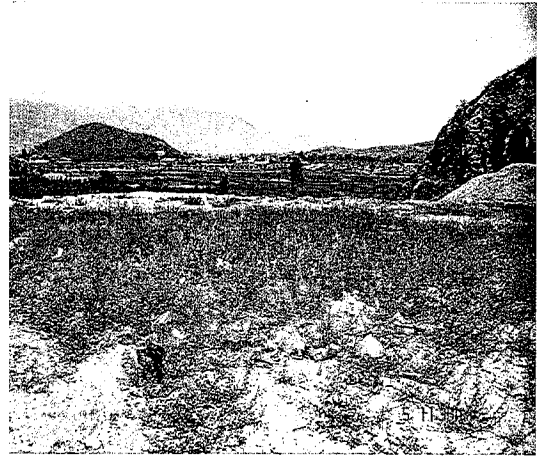
Picture 7 Partial grounds of the waste debris field at the Haiyin tunnel exit have naturally recovered vegetations.

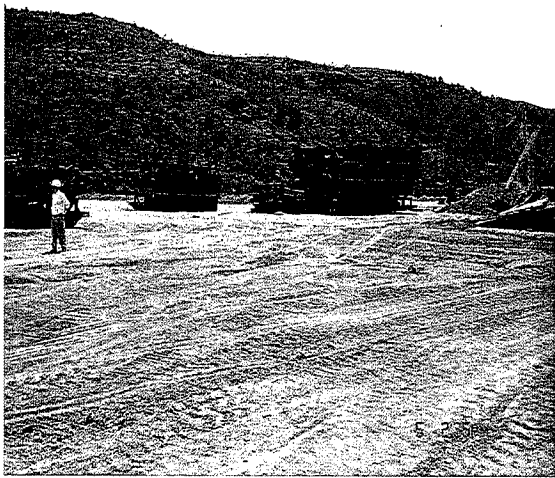
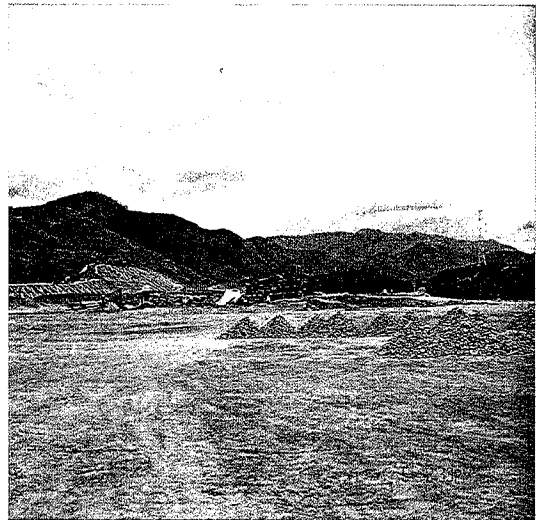
Station is reconstructed as track-laying base (See Photo 8). The retaining walls for the waste debris field at the entrance of Songgui 1[#] tunnel have been basically completed, and most of grounds in this area have been leveled up (see Photo 9). As we have discovered during the survey period, partial tunnel waste debris fields still failed to adopt protective measures according to the requirements of "retain first and then abandon" or failed to discard the stone ballasts within the specified range although the retaining walls have been provided (see Photos 10 and 11). As shown in Photos 12 and 13, in the waste debris fields at the exit of Heluo Mountain tunnel and at the position of transverse hole, no retaining wall is built and no classified protective measure is adopted. In partial waste debris fields, stones and soil are stacked so high and steep that it is possible for the debris body to collapse during rainstorm season and thus invade the agricultural land at downstream (see Photo 14). It is suggested to conduct grading on debris body and reduce the load and height of debris body.

Picture 8-1 The spoil ground near Shangguan station has been reconstructed as the track-laying base.

Picture 8-2 The spoil ground near Shangguan station has been reconstructed as the track-laying base.

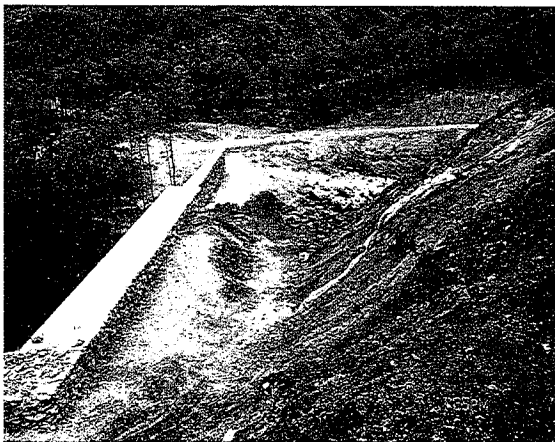
Picture 9-1 The retaining wall of the waste debris field at the 1[#] tunnel entrance of Songgui

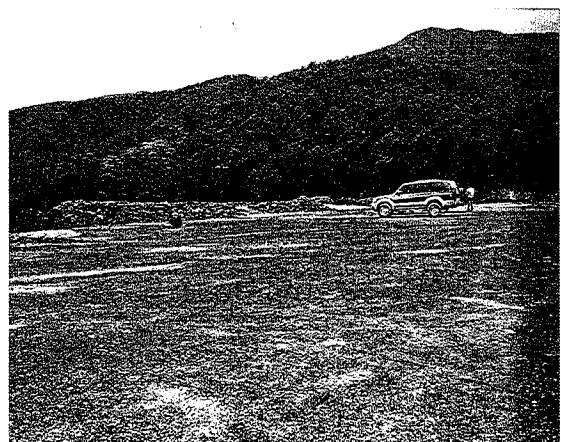
Picture 9-2 The ground of the 1[#] waste debris field of Songgui

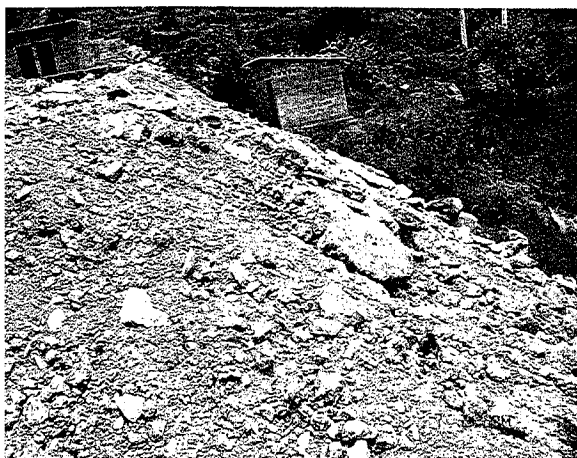
Picture 10 The tunnel of Zhaojiadeng tunnel exit

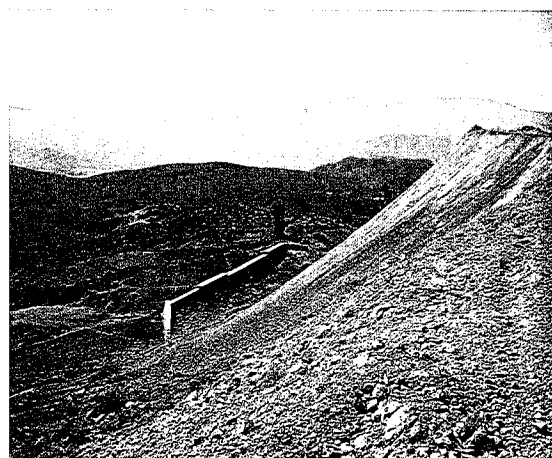
Picture 11 The waste debris field at the transverse hole position of Beiya tunnel

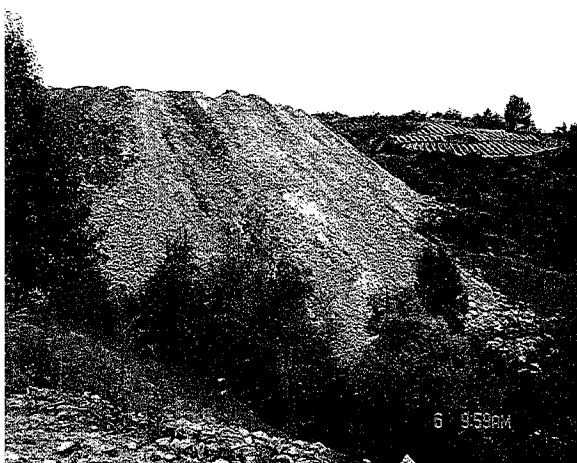
Picture 12 Retaining walls are not built in the waste debris field at the tunnel exit of Heluo Mountain

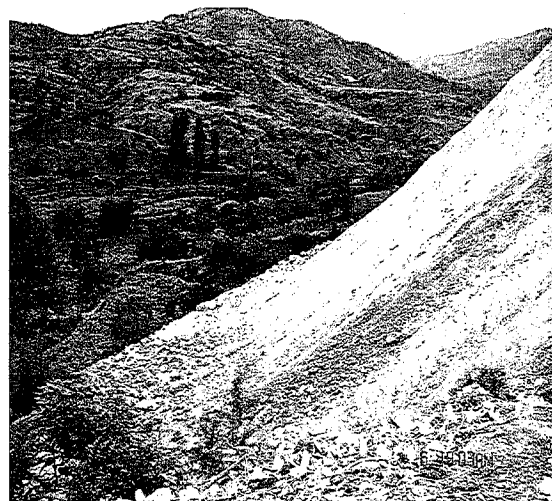
Picture 13-1 The waste debris field at the transverse hole position of Heluo mountain tunnel

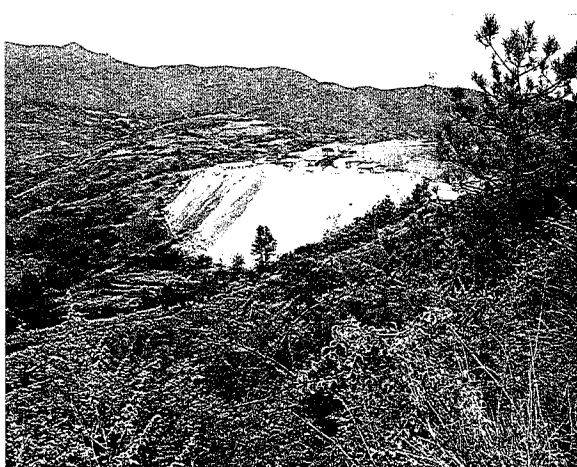
Picture 13-2 The stacking in the waste debris field at the transverse hole position of Heluo mountain tunnel is so high that the classified protection is needed

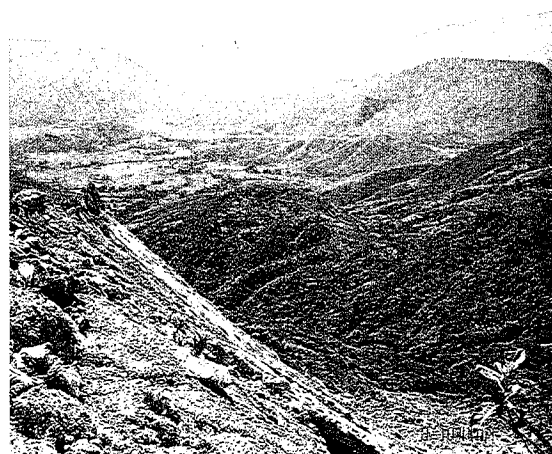
Picture 14 Since the debris body of the waste debris field between Bijia mountain 1[#] tunnel exit and 2[#] entrance is stacked too high and steep, it is required to conduct deloading and classified slope cutting protection

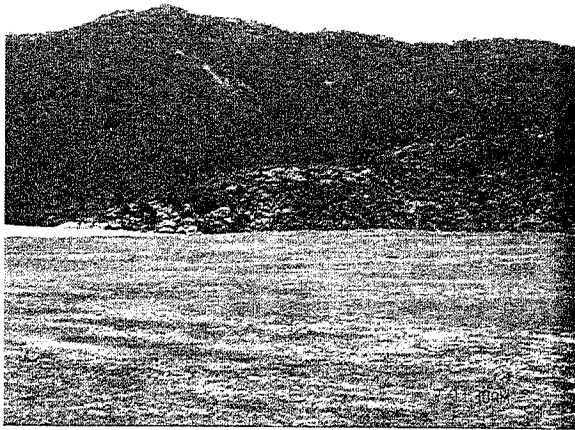
Picture 15-1 Apron of Xiyi Station

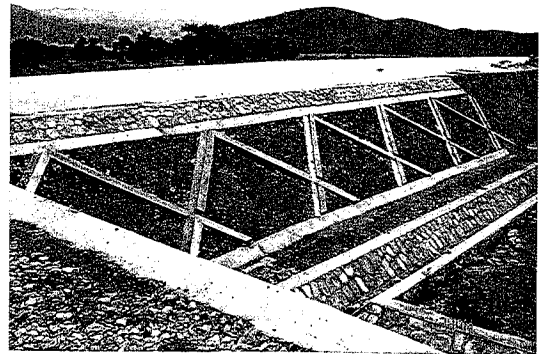
Picture 15-2 The skeleton protection for the roadbed slope of Xiyi station apron

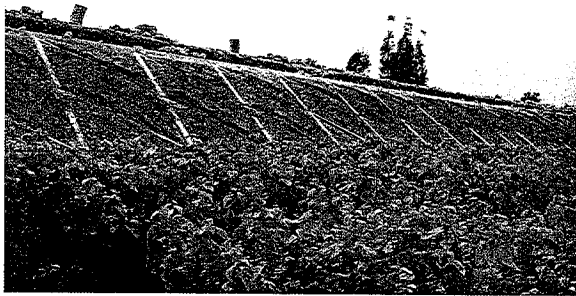
Picture 16-1 The slope skeleton protection for the roadbed between DK125+500 - DK139+300

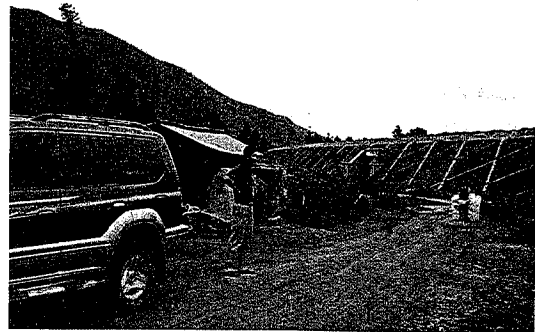
Picture 16-2 The traffic culvert of roadbed has been opened to traffic

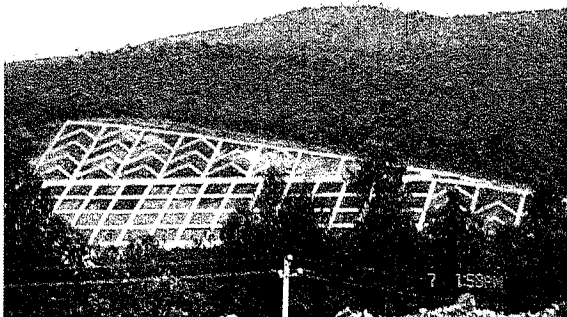
Picture 16-3 Slope skeleton protection

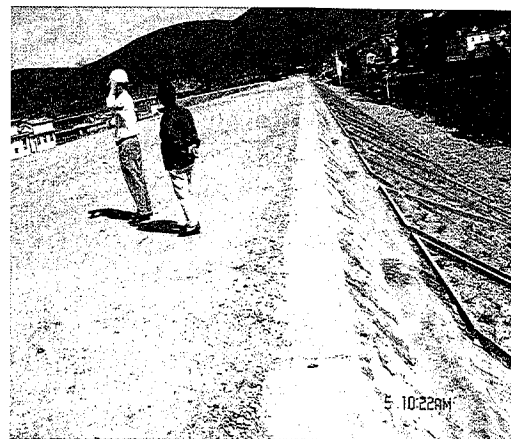
Picture 17-1 Haidong station apron

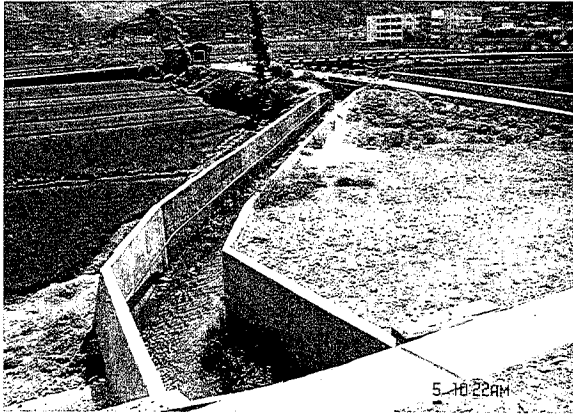
Picture 17-2 The ditches of Haidong station matching the station yard have been put into use

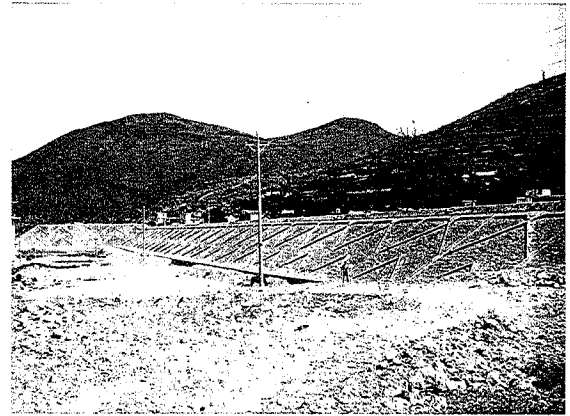
Picture 17-3 The slope skeleton protection of Haidong station

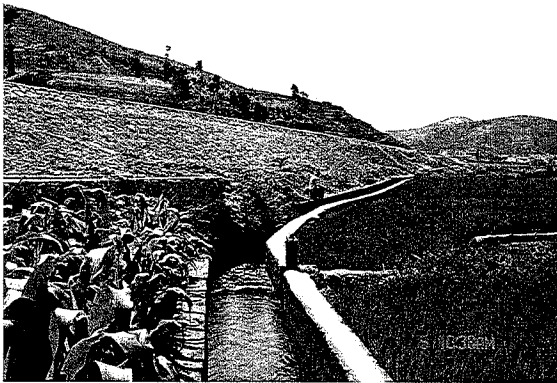
Picture 18 The roadbed side canal at the entrance of Ta mountain tunnel has been supplied with water

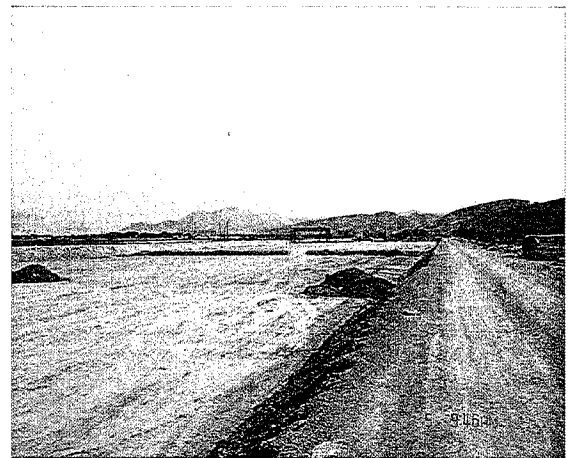
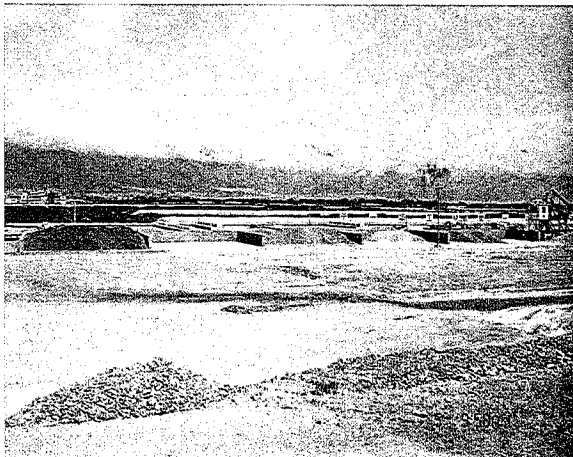
This time, we have surveyed the construction site, culvert, and ditch construction of Dali East Station, Dali North Station, Haidong station, Wenbi station, Shangguan station, Renhe station, Xiyi station and Heqing station as well as the roadbed slope protection conditions. The station yards of Haidong station, Wenbi station, Shangguan station, Renhe station and Xiyi station have been reclaimed in place, and the skeleton slope protections for the side slopes of these station yards are being established. The culverts and ditches matching these station yards have also been completed and put into use (see Photos 15 - 18). The soils for Dali North Station are supplied by the borrow pit ground on the back of Dali station, and its station yard has been formed preliminarily, and partial yard will be used as track-laying base, so as to reduce temporary use (see Photo 19).

Picture 19-1 Dali north station is under reclamation

Picture 19-2 Partial aprons are used as track-laying base

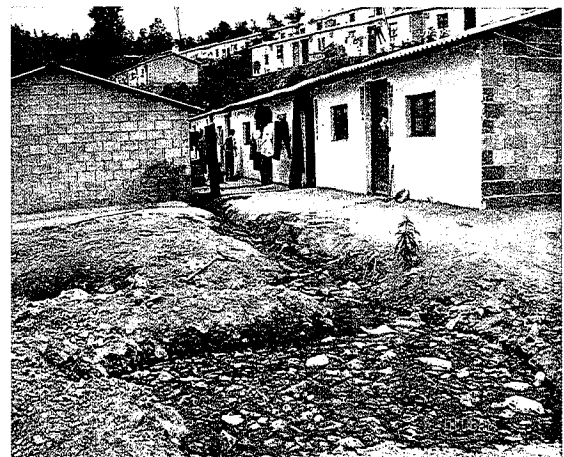
We have surveyed the camps of the construction workers at the entrance of Xinyulongshan tunnel, the transverse hole of Heluo Mountain tunnel, and the Bijia Mountain 1[#] tunnel. The conditions of the construction camps at the exit of Bijia Mountain 1[#] tunnel have been reported in the previous environmental monitoring report. These camps are neat, and the dwelling sanitary conditions of construction personnel can be kept all the time. Since all kinds of domestic wastes are floating in the sewage tank of construction camp at the entrance of Xinyulongshan tunnel and the transverse hole of Heluo Mountain tunnel, it is required to conduct cleaning and rectification on this tank (see Photo 20).

Picture 20 The sewage tank of construction camp at the transverse hole position of Heluo mountain tunnel needs cleaning.

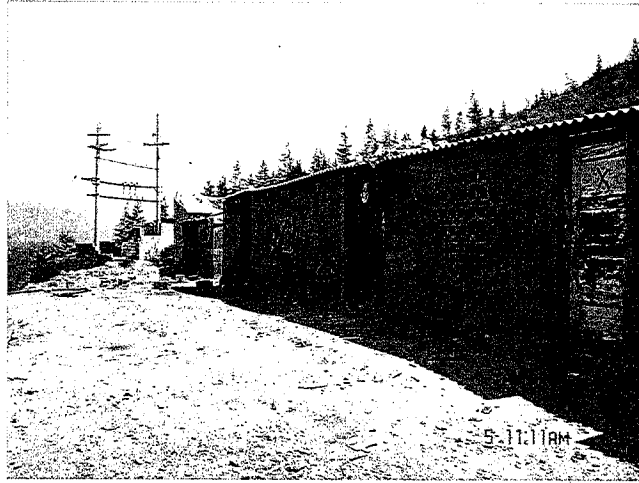
Picture 21 The vacant construction camps
at the entrance of Songshuyuan tunnel
