# Environmental Monitoring Report

## AZE: Road Network Development Program, Tranche 4

# Final Environmental Monitoring Report

Republic of Azerbaijan:  
Road Network Development Program – Tranche 4

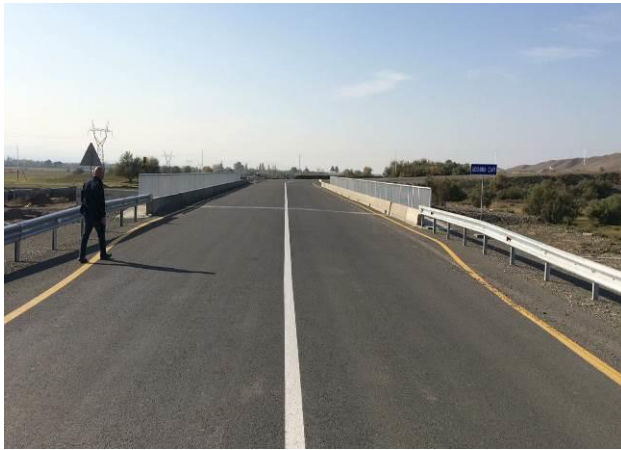
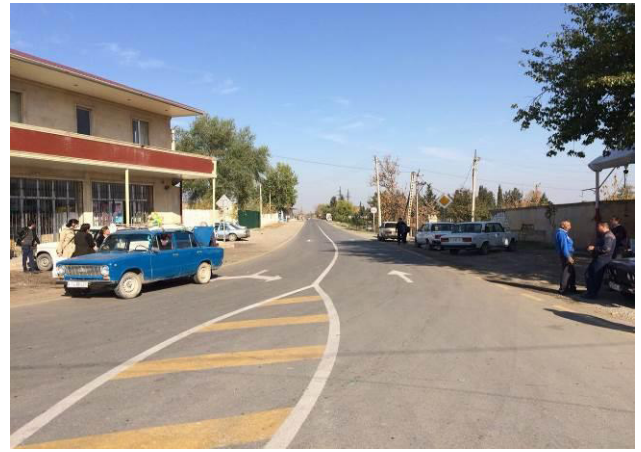
40. As mentioned above four all construction works are complete now, with all bridges and local roads asphalted and central reservations completed. Bridges and its approach roads are completed, road furniture and line paintings also completed.

**Figure 3:** Completed bridge and village road with all necessary road signs and line paintings.

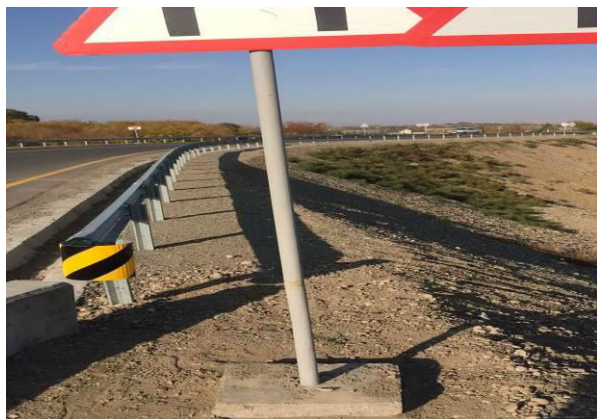
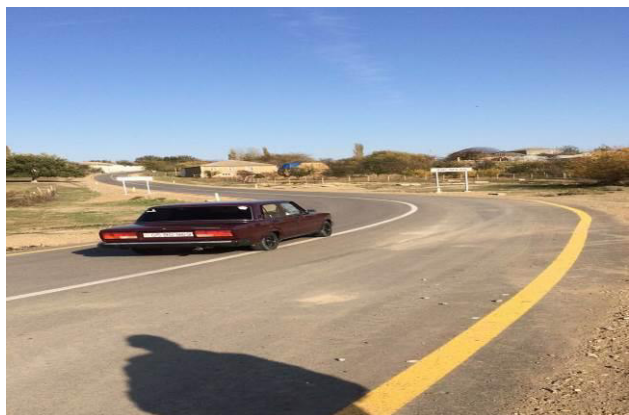
41. Contractor did not have any stockpile as the material were provided by third party on a need base and there was not need to do any reinstatement work related to the stockpile and top soil. All along the bridges alignment, the Right of Way has been smoothed, and compacted where necessary. The site was found to be clean and tidy, with no evidence of waste, equipment, or materials from the construction works.
42. Culverts inspected were all clear and running, and vegetation is starting to re-establish itself on worked ground.

**Figure 3:** Clean and smoothed alignment with natural vegetation re-establishment; open village road to traffic.

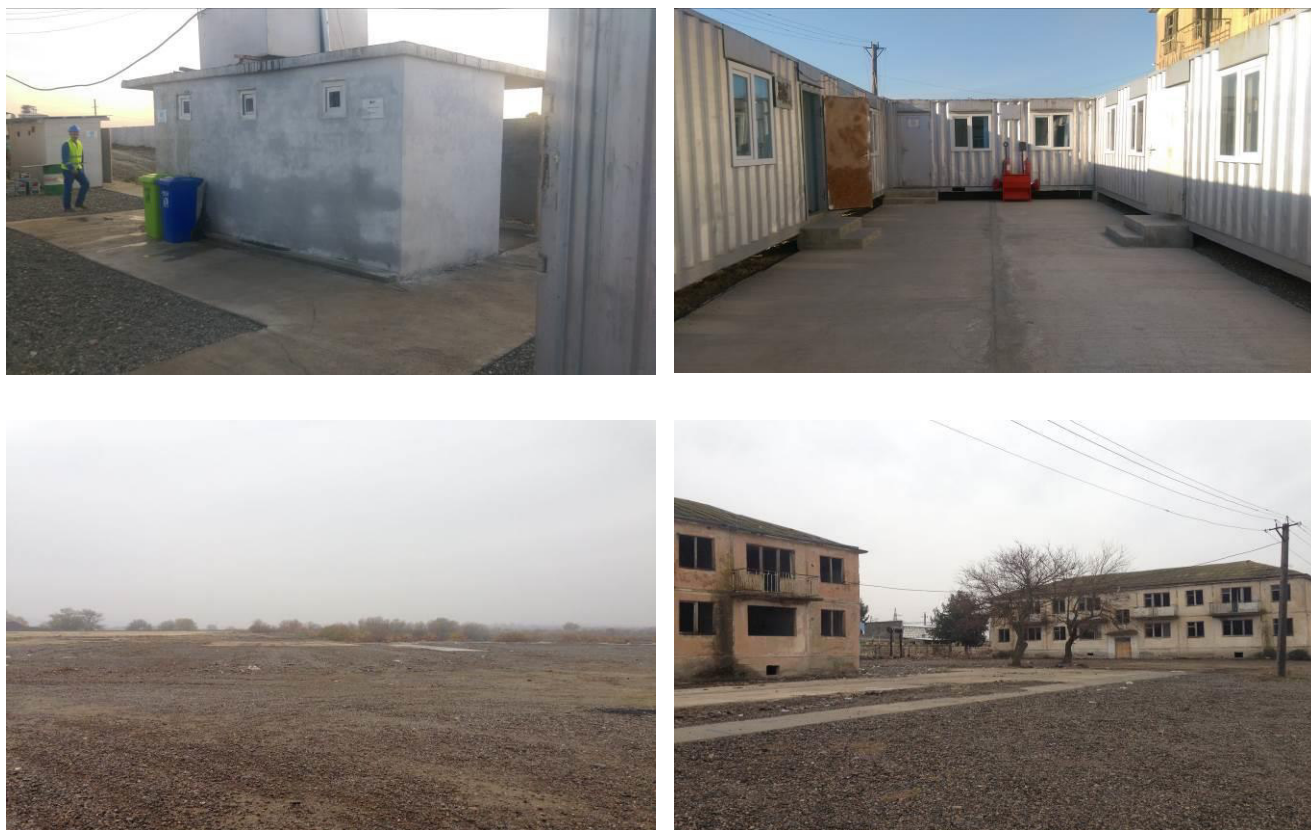
45. Contractor operated one camp at Poylu village. The camp was completely cleared and well reinstated during the audit. No issues or problems were recorded during the audit.

**Figure 4:** Camp site at Poylu village has completely removed and reinstated as was requested by land owner: Upper photos from construction period and below photos is current situation.
