## **PNG: HIGHLANDS REGION ROAD IMPROVEMENT INVESTMENT PROGRAM (HRRIP) – TRANCHE 3**

### **GEWA-GEMBOGL ROAD SUB-PROJECT**

# **SEMI-ANNUAL ENVIRONMENTAL SAFEGUARDS MONITORING REPORT**

**(JULY TO DECEMBER 2019)**

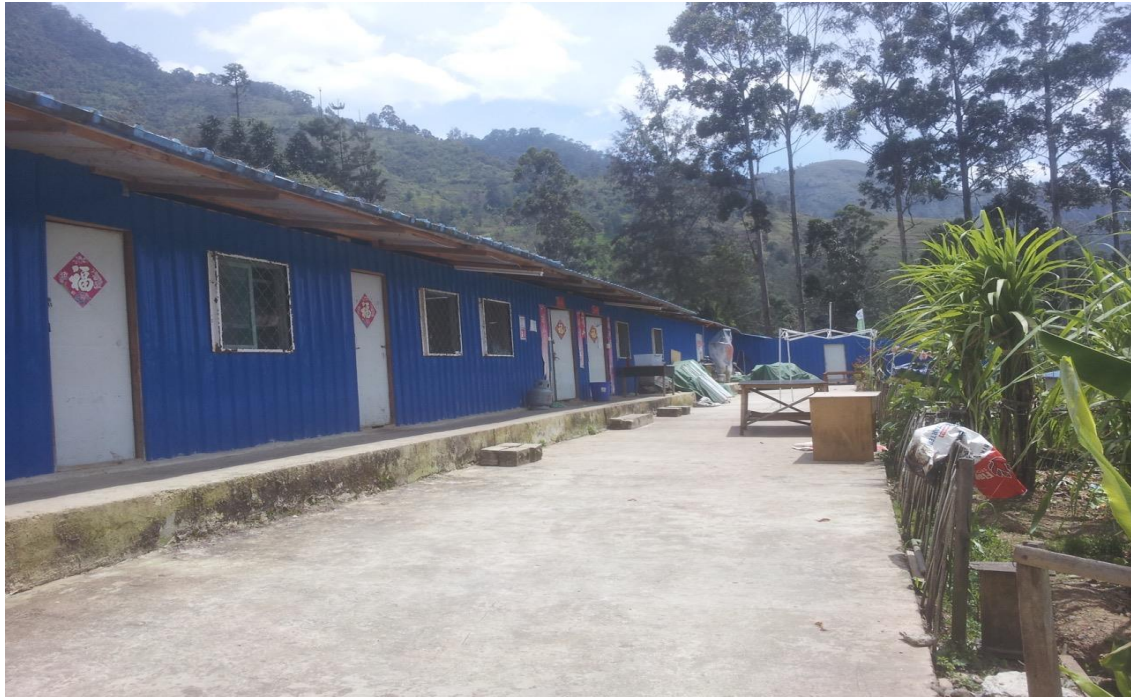
During site visit November 2019, the camp was seen nearly empty. Most foreign workers already left since nearly all work is completed. Less number of people means less waste and rubbish.

**Picture 1:** Kitchen area at Contractor's camp at Goglme looked deserted.

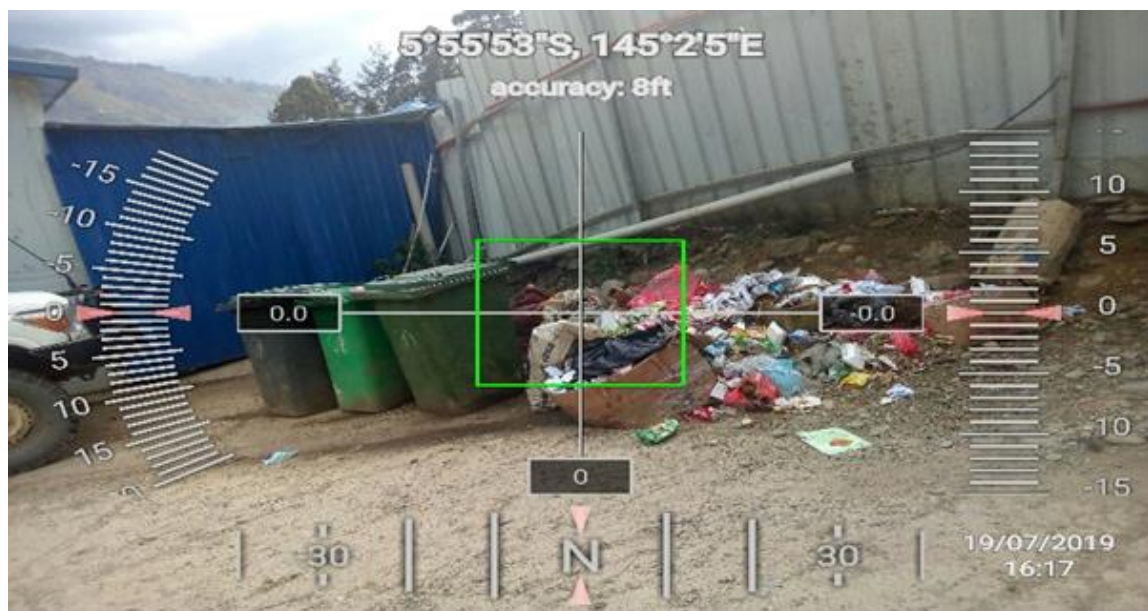
**Picture 2:** Household waste holding area at the camp site.

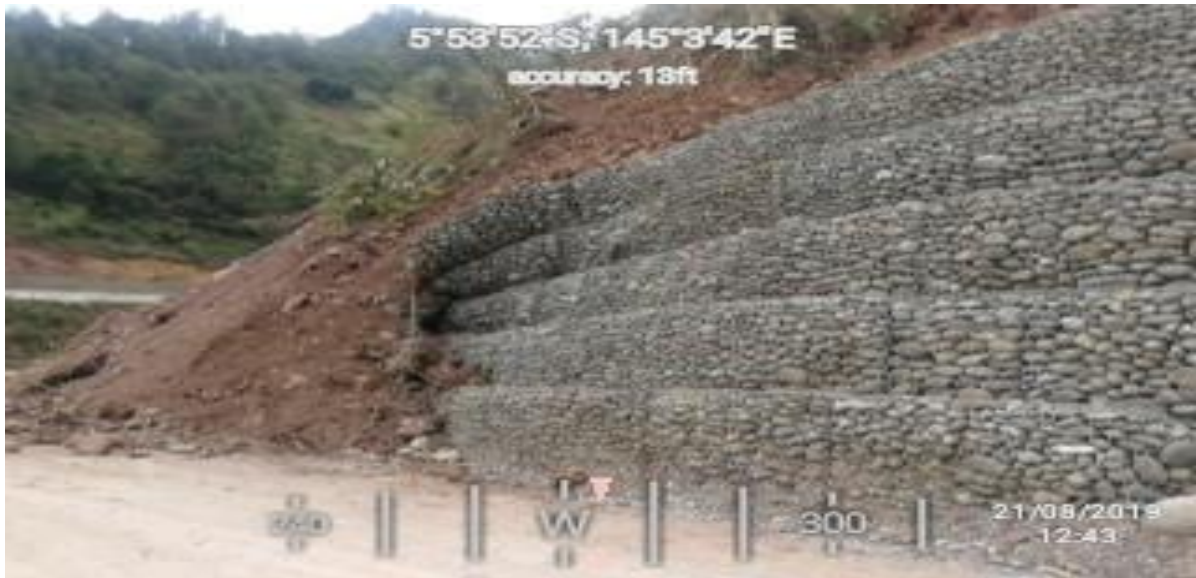
Geographical location (hilly terrains) of the project area is another major contributing factor to high rate of erosion. The contractor has mitigated this concern by constructing gabions walls and reworks on walls destroyed by landslips (Photograph 3).

**Picture 3:** Landslides on top of gabion baskets protection walls

Landslide and soil erosion seem to be on going due to the hilly landform and rainy climate conditions of the area. Land slide onto built gabion basket and walls have been common at various sections of the road this reporting month. Contractor is still doing maintenance work after landslide and slips.

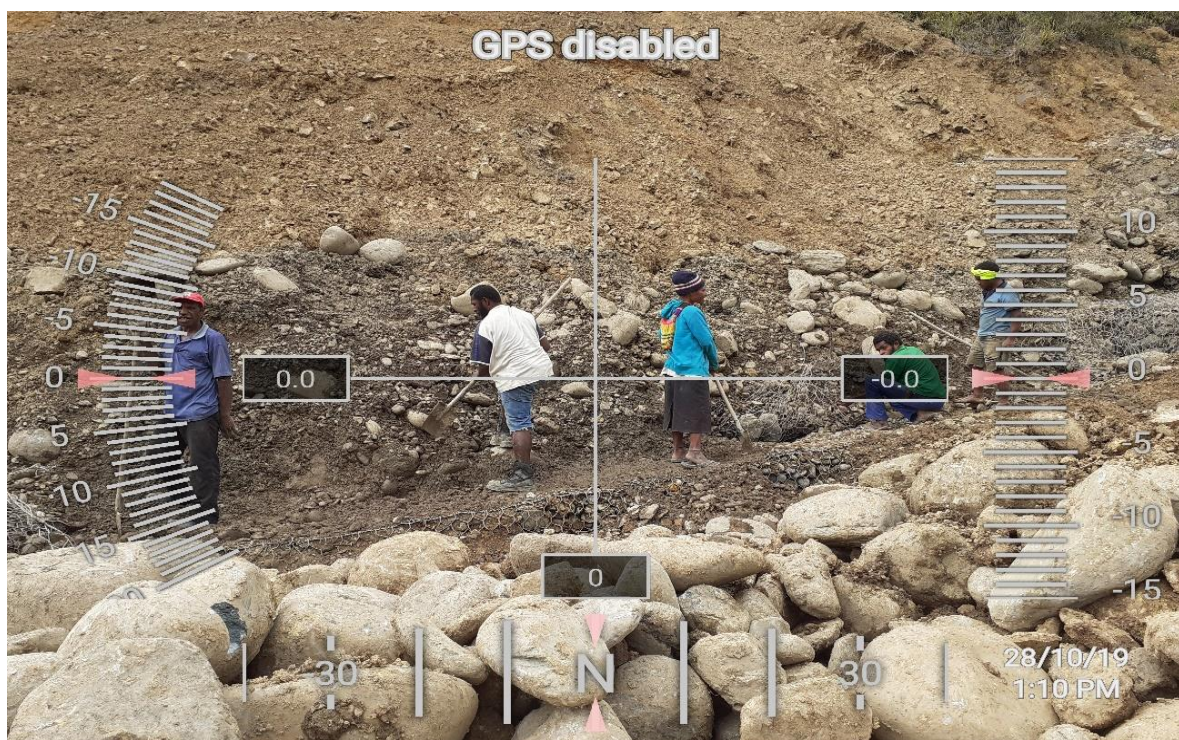
Despite the continuous landslide experienced along the construction corridor, the contractor is constant in rebuilding of gabion baskets and other retaining walls structures when destroyed (Photograph 4).

**Picture 4:** Reconstruction of gabion basket walls at Ch.27+000

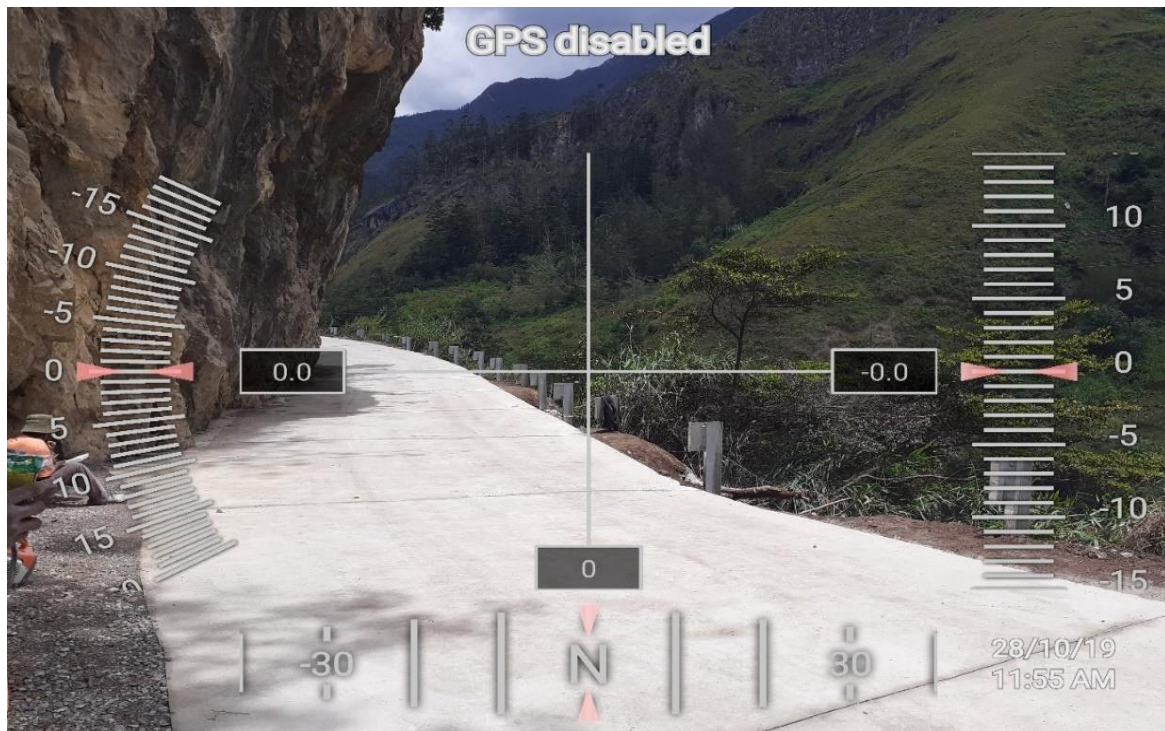
**Picture 5:** Cement sealing of road to prevent erosion.

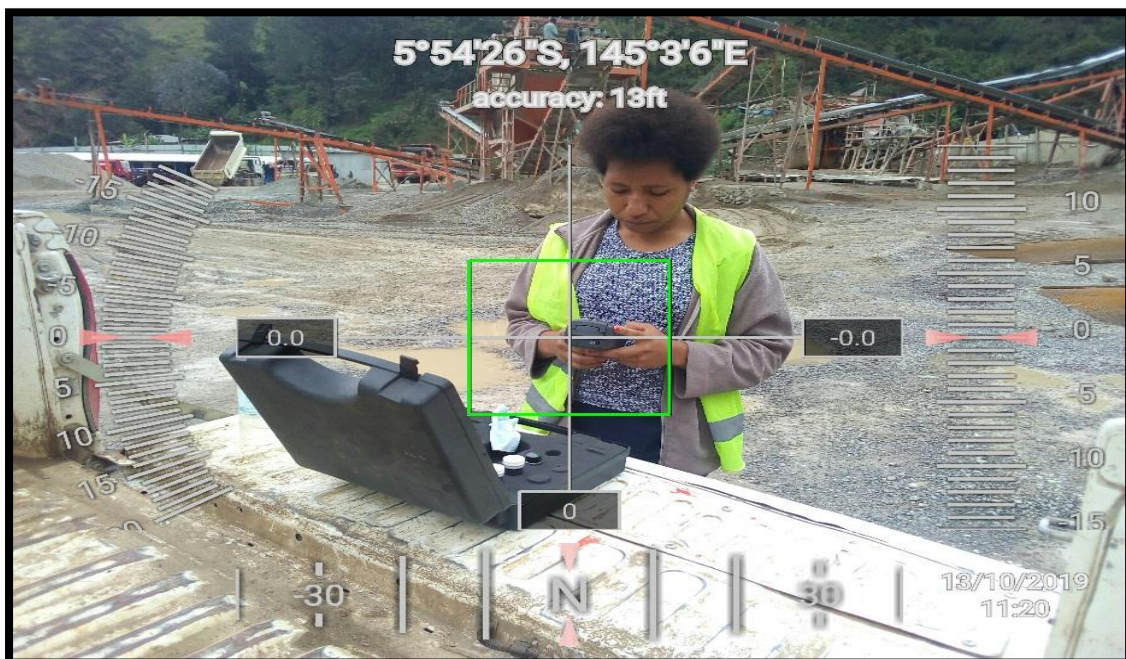
**Picture 6:** Environment Officer Collecting and testing Water Samples at Sta.24+300

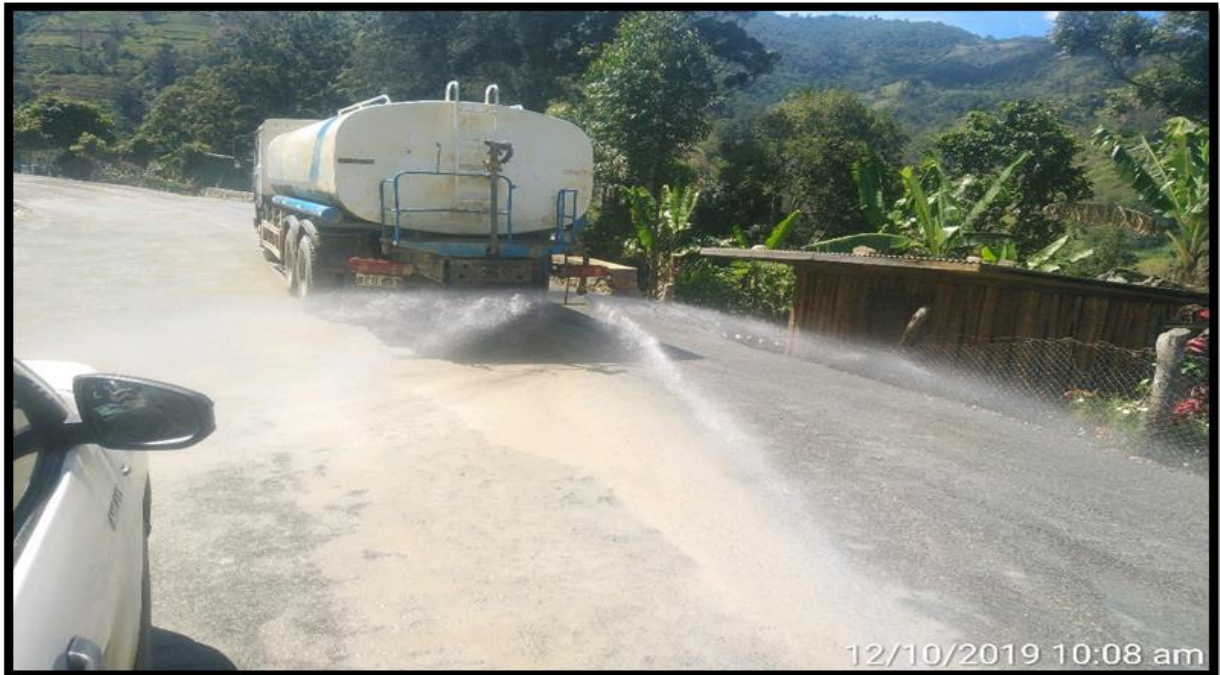
Water trucks were seen spraying water to minimise dust circulation in public marketplaces, near homes along the road and travelling public along the construction corridor. At Sumburu Quarry, they use water hoses to water crushed rocks to prevent circulation of dust particles into the air and to the nearby bushes.

**Picture 7:** Water Sprinkler suppressing dust on the road

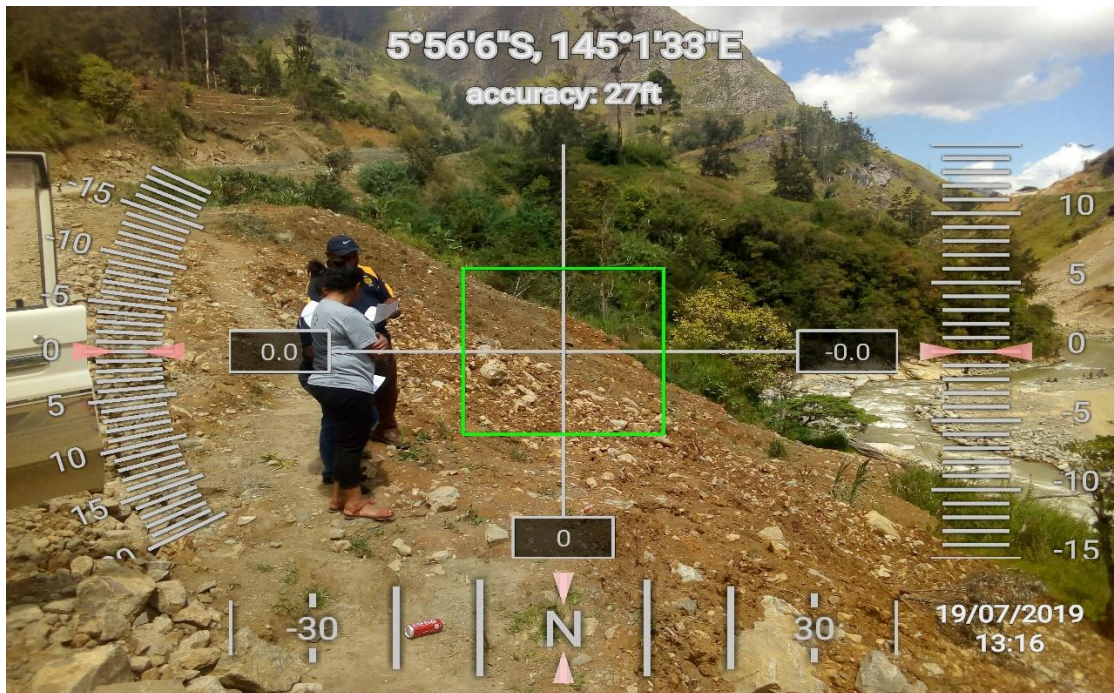
In the second quarter of the year, contractor was seen to dispose spoils in very steep slopes impact not only the trees and vegetation that hold the soil but also pollute the water bodies downstream. HRMG has put measures and provide notice to contractor to avoid such practice. Towards the third quarter and onwards, contractor has complied and disposed spoils at proper disposal designated areas.

But because of the geographical setting of the area and mountainous, disposals of spoils during clearing and grubbing down steep slopes is unavoidable, therefore have caused soil erosion onto underlying vegetation and eventually into streams. This is anticipated since the slopes are too steep to manoeuvre the trucks during clearing and grabbing. Also, some landowners want the waste materials to be poured on there land to reclaim some parts of the and that is lower. This was part of community initiative help and support help improve the land area for locals to build their structures since there is fewer flat lands.

**Picture 8:** Soil materials been cleared and disposed on hillside after blasting

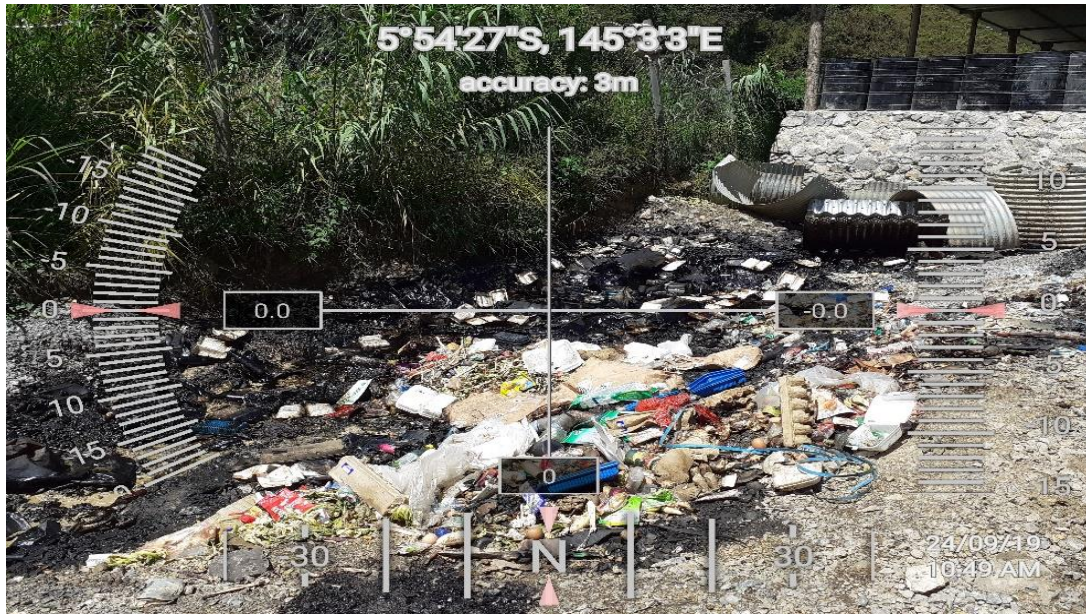
The temporary landfill at Sumburu Quarry was filled up with excessive wastewater from crusher so was closed. After landfill was closed, household waste was seen dumped on top of closed landfill. Waste oil was also seen dumped on top of closed pit. Together with wastewater from the crusher, the closed pit over flew with oil and water plus household waste. NOV was issued 28<sup>th</sup> October.

**Picture 9:** Household rubbish dumped on surface near quarry camp site

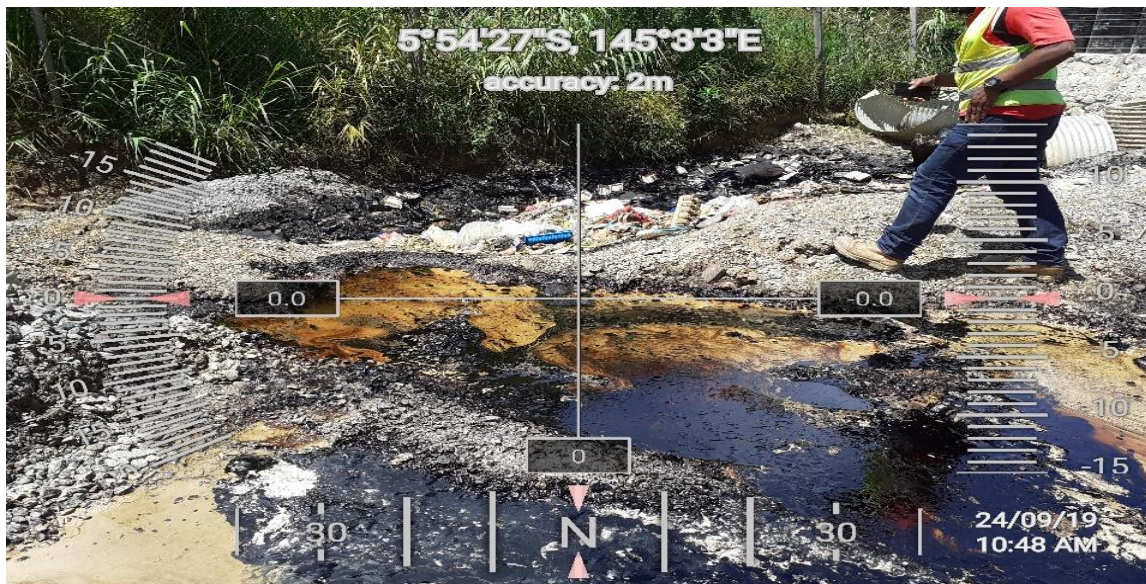
**Picture 10:** Mixture of Oil and Wastewater spilled at Surumbu quarry

Due to no proper outlet to discharge wastewater, wastewater and oil from the bitumen preparation area permitted to drain out at the back of the workshop into the receiving Simbu River. After two months of non-compliance in mitigating and managing wastewater, tests were conducted on the 15<sup>th</sup> of October by RSA team and confirmed highly alkaline at one station. Tadpoles, fish and other living organisms in the river are affected, bioaccumulation will also affect species at the top of food chain including human in the long run. Notice of environmental violation has been issued October 28<sup>th</sup> and compliance is expected. Coliform test was supposed to be conducted at several stations along rivers but was cancelled due to project closure and no reported pollution or grievances.

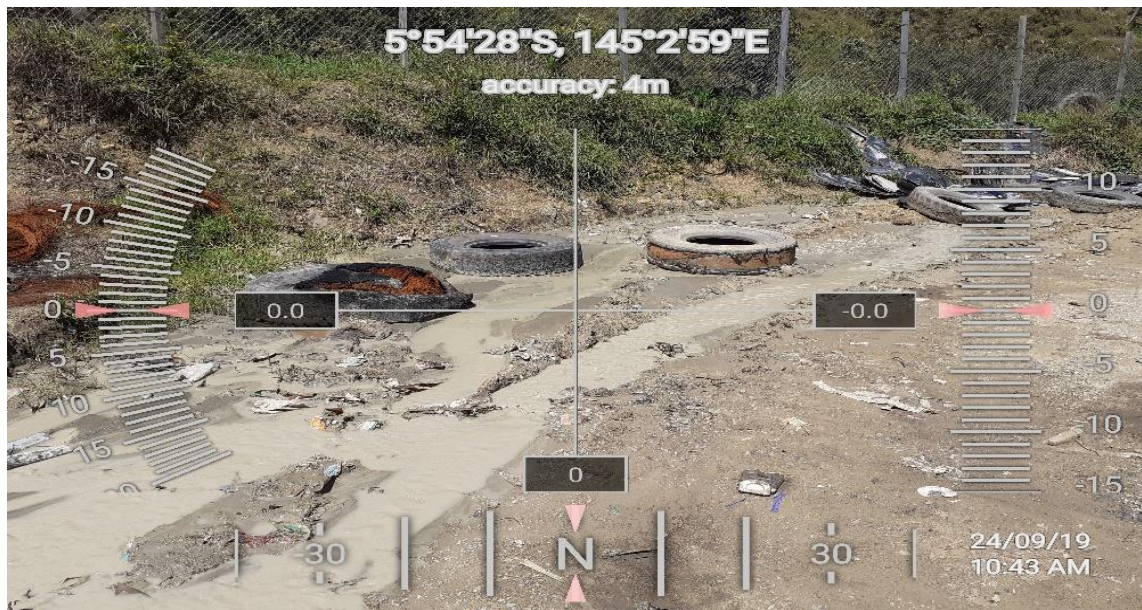
**Picture 11:** Water from crusher at Sumburu overflowing

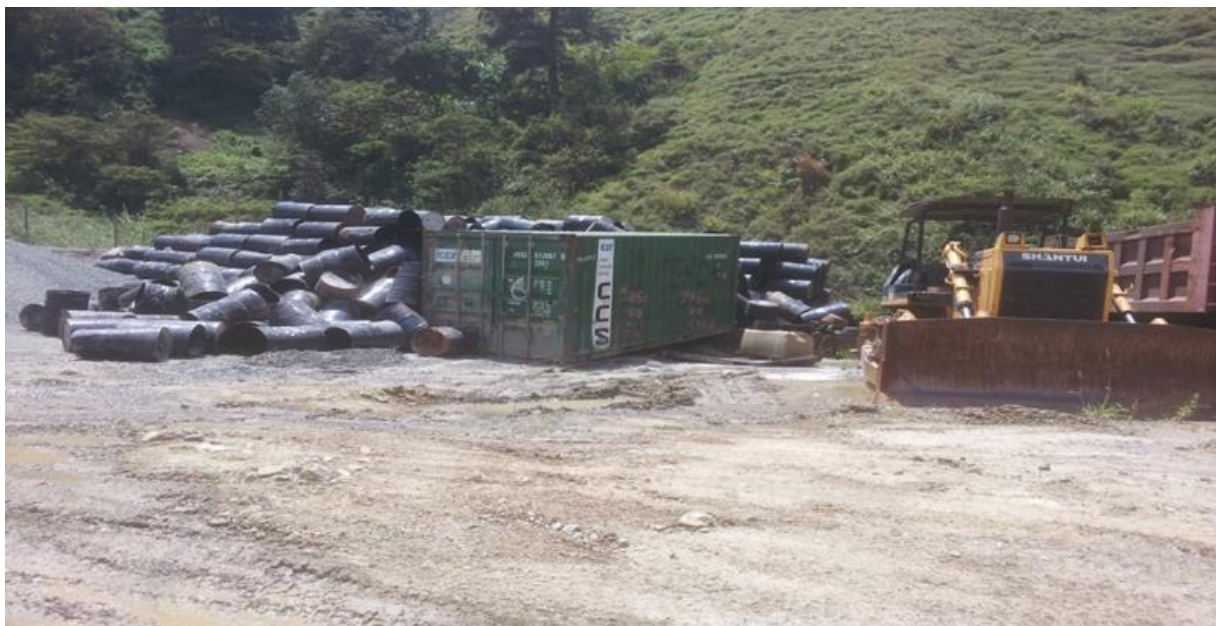
Waste oils are stored in sealed trimmed drums, some are distributed to locals for timber treatment. Empty bitumen drums are piled up ready to be painted and distributed to the Kundiawa town authority to serve as rubbish bins in town.

**Picture 12:** Empty drums ready to be transported to Kundiawa town for reuse.

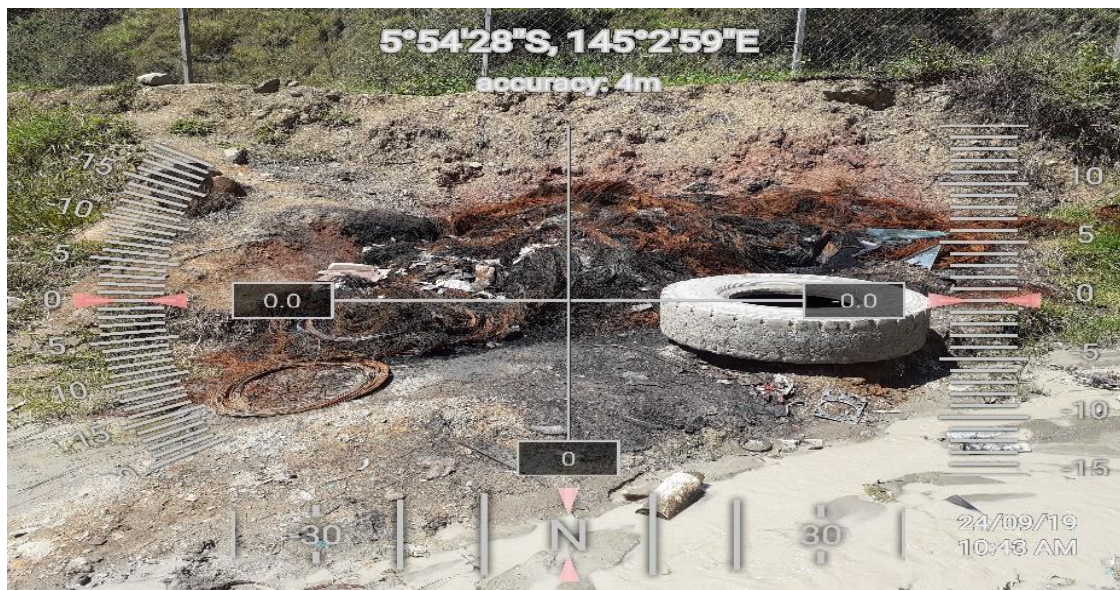
There has been continuous burning of waste tyres and oil wastes inside Sumburu Quarry yard and aware from people (Picture 13). A Notice of violation (NOV) was issued on October 28<sup>th</sup>, 2019 due to air pollution but still the contractor failed to comply. All these issues are now minimised due to Quarry closure and project completion.

**Picture 13:** Burning of old tyres at quarry site.

Burning of old tyres including used oily rags and oil filters produce strong fumes that can cause dizziness, headaches and can cause heart and lung problem in the long run.

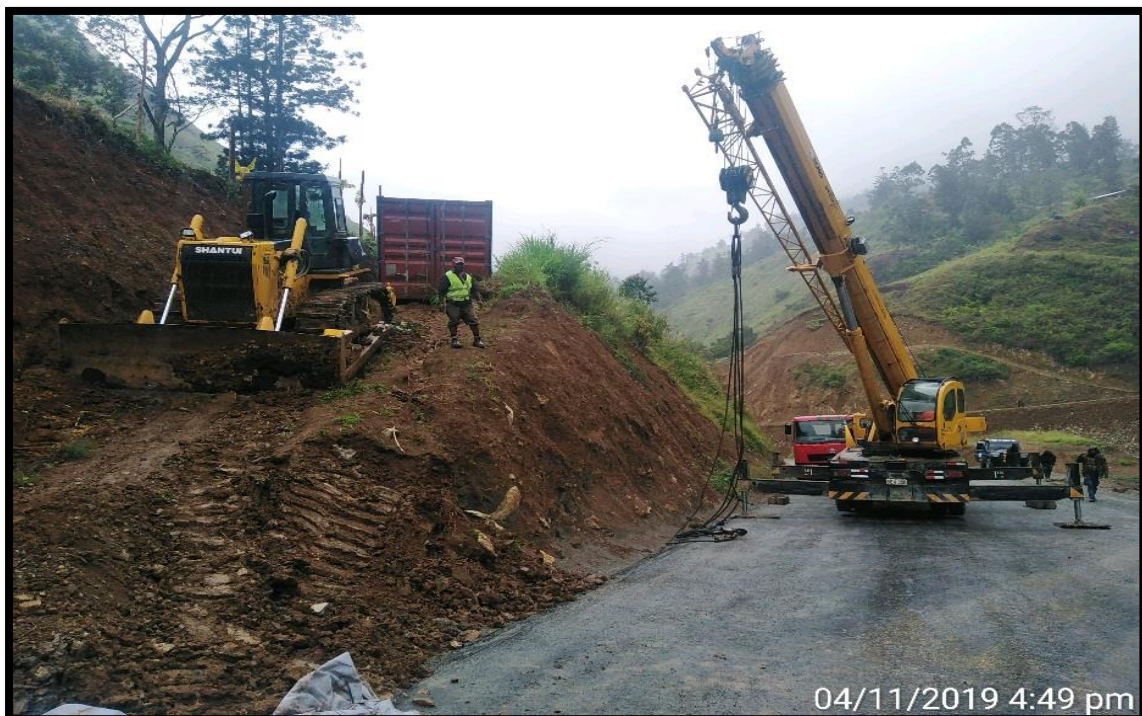
The explosive store at sta. 17+200 were already being decommissioned on the 4<sup>th</sup> Of November 2019.

**Picture 14:** Container packed with explosives relocated to Kundiawa

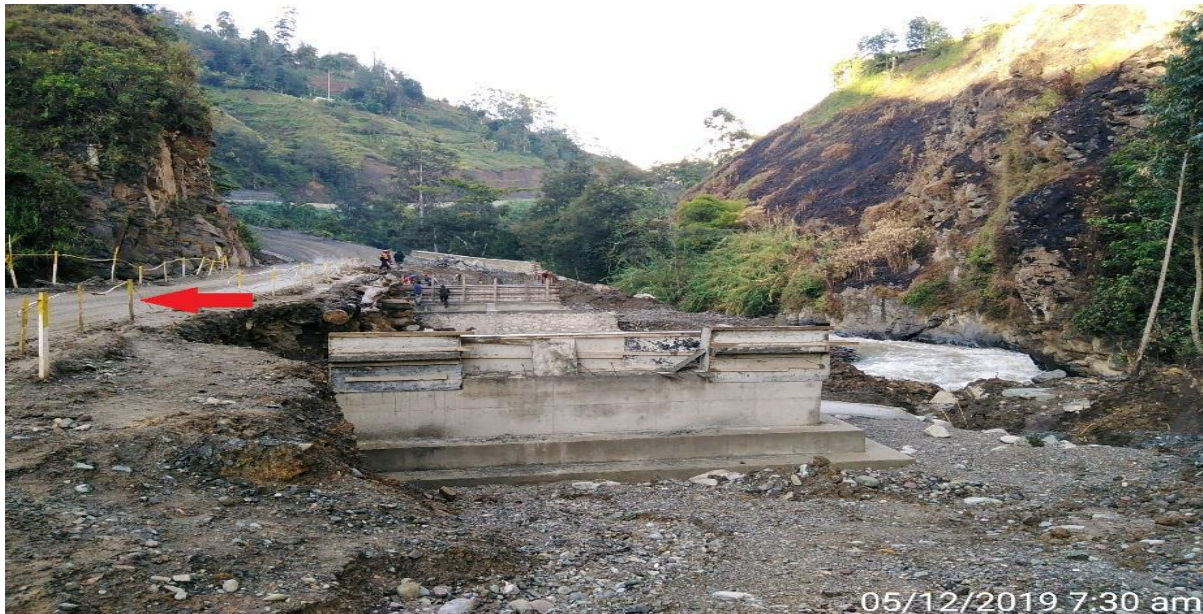
**Picture 18:** Safety Lines placed at sta.23+000 bridge construction site

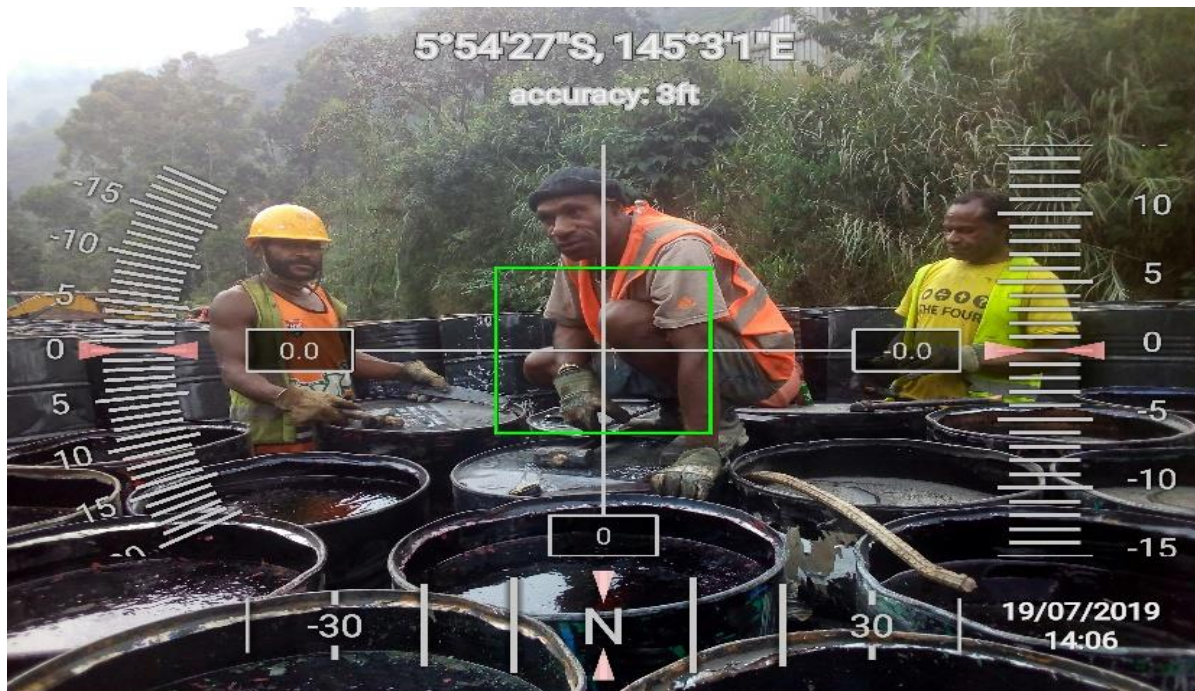
At Ch. 24+350 Sumburu Quarry, there is non-compliance with PPEs. The workers at the Bitumen and Concrete Batching plant have been at high risks of health and safety issues since they were working without proper nose or facial/dust mask, safety wear and hand gloves. This was reported but there is no change his month. Contractor have not re-issue PPEs to its workers.

**Picture 19:** Workers at bitumen storage yard without safety nose mask.

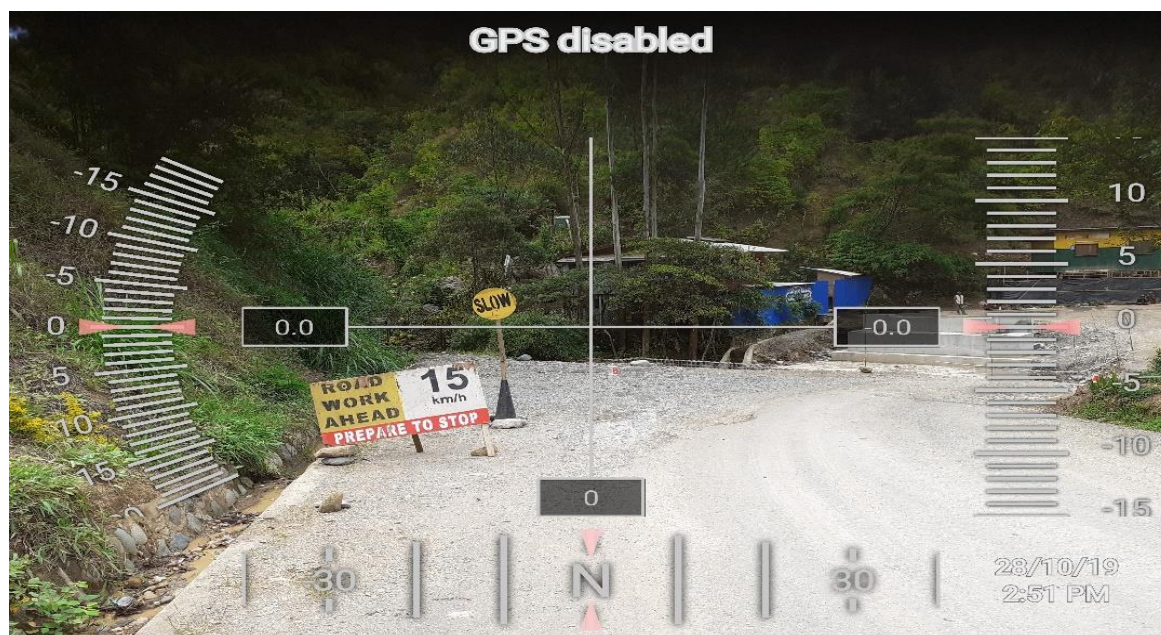
The Contractor has provided traffic signage for public traffic (Photograph 21). However, this sign could have been more visible if mounted on a traffic post. Women were employed by the contractor as traffic aides and are utilized to control the traffic during the construction (Photograph 22).

**Picture 21:** Traffic sign board with speed limits at Gewa station
