Semi-annual Report

August 2020

PNG: HIGHLANDS ROADS IMPROVEMENT INVESTMENT PROGRAM (HRRIP) – TRANCHE 3

HENGANOFI-NUPURU ROAD SUB-PROJECT

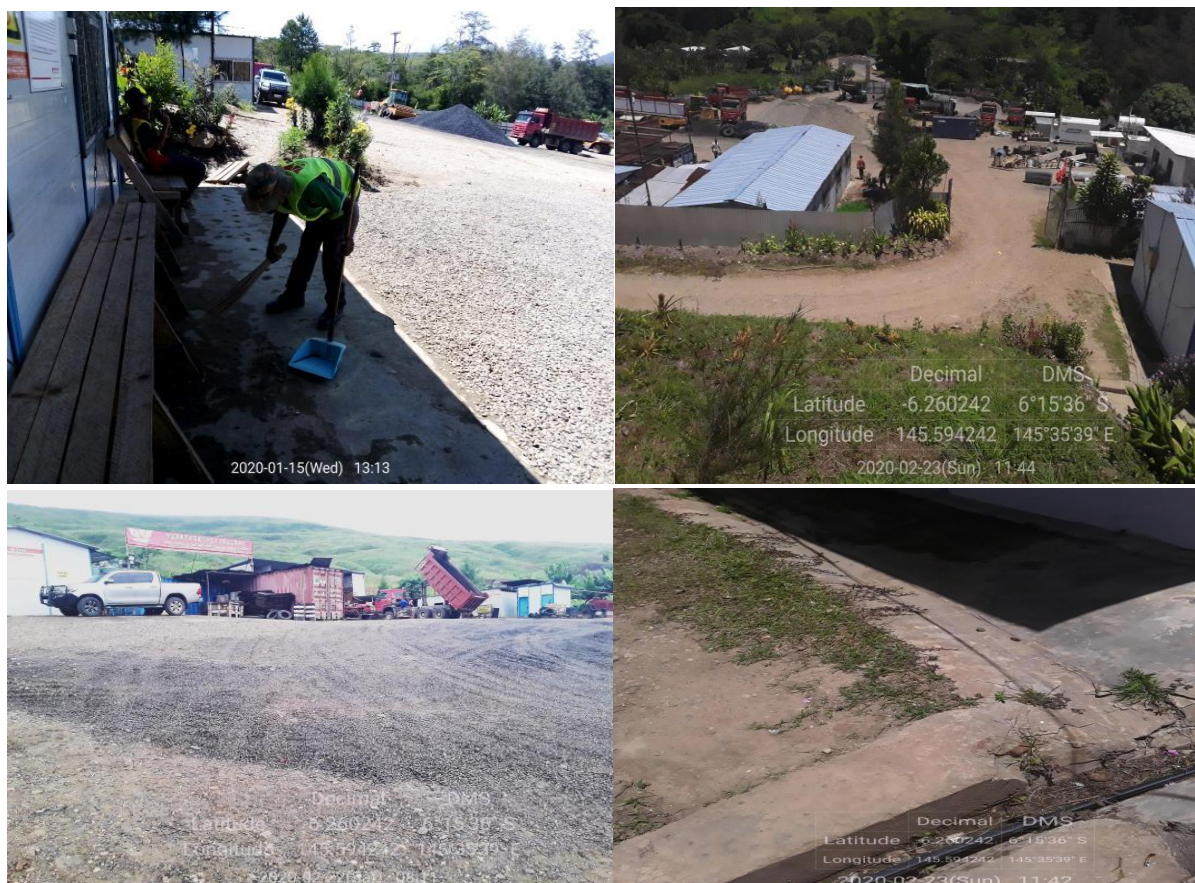
49. The campsite yard was generally well maintained and properly supervised.

Photographs 1-4: Clean and well-maintained camp site and yard

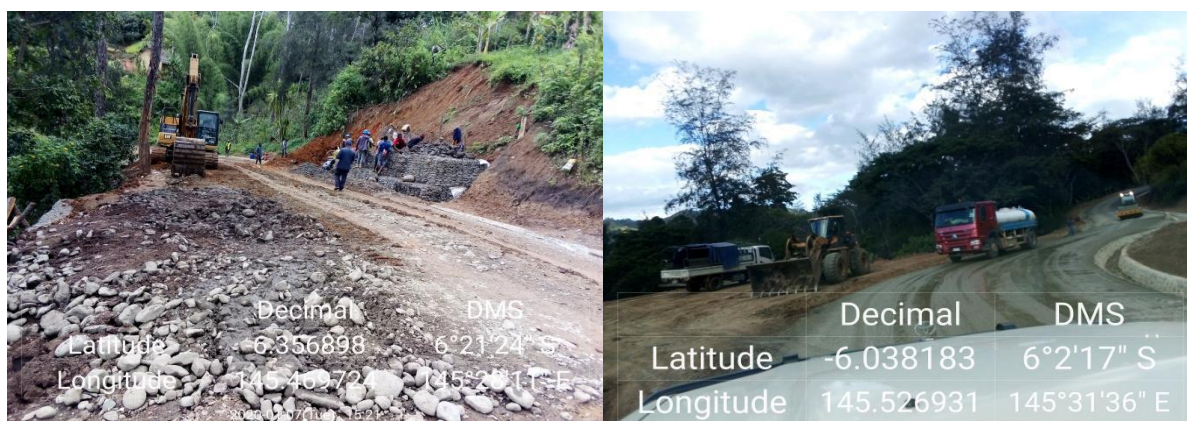
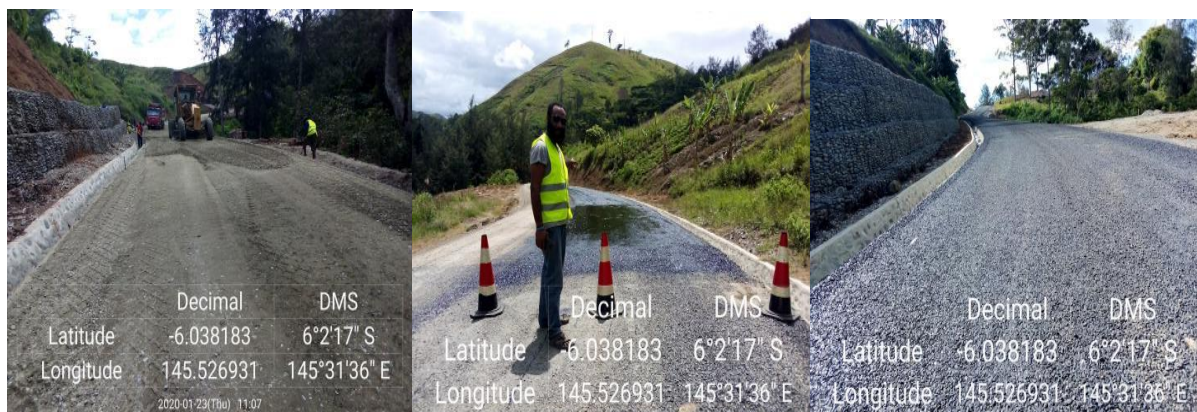
Photographs 5-9. Showing the status of Road Construction activities progressed on the environment in January 2020. (Source: CWYC)

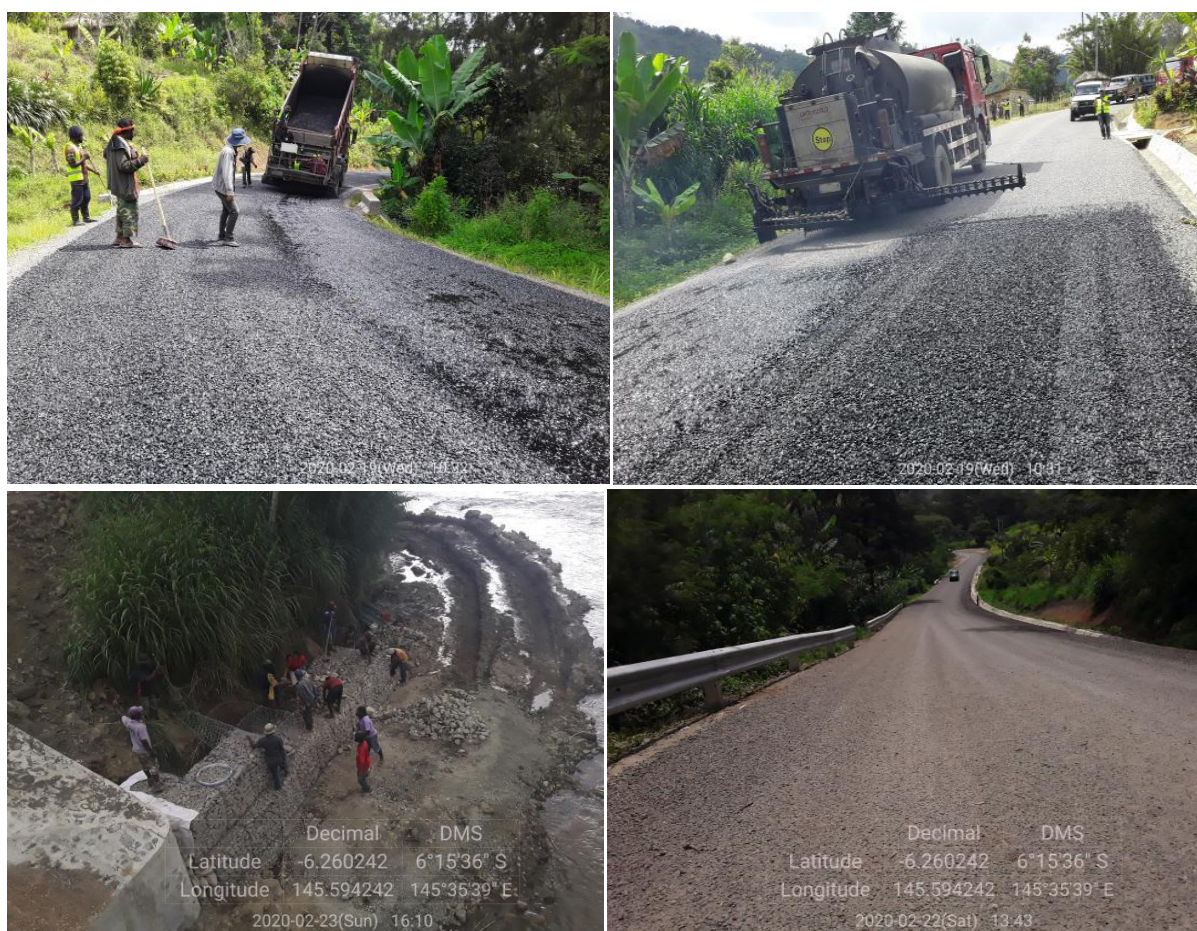
Photographs 10-13. Showing the Final Road Construction activities along the project corridor in February 2020. (Source: CWYC)

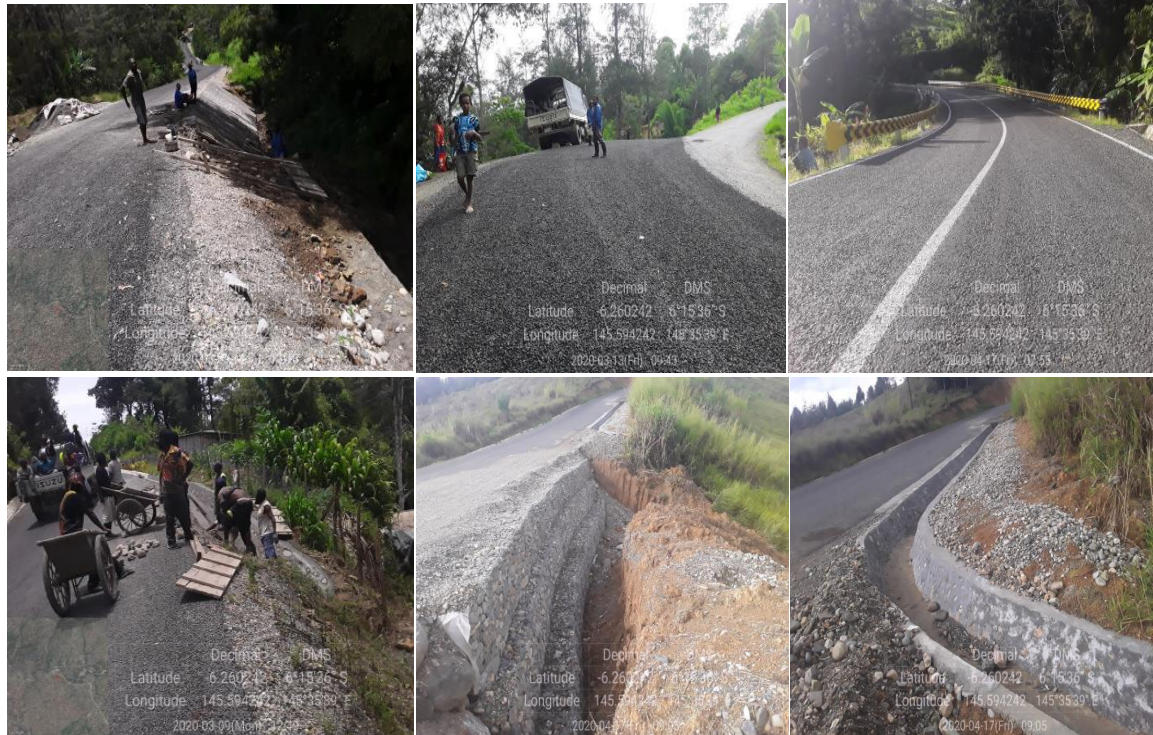
Photographs 14-19. Showing the Final Road Construction activities along the project corridor in March and April 2020. (Source: CWYC)

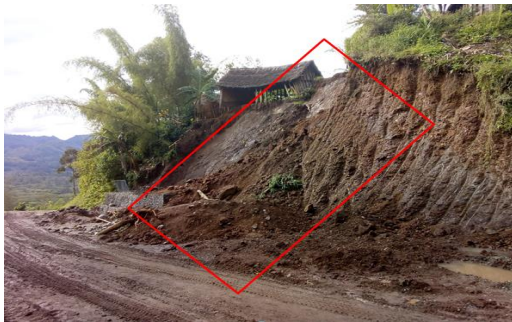
Location	Photograph	Description/Remarks
Km33+ 300

<p>There was an additional landslide at km 33+300 due to excavation to construct a gabion basket and covered the local casual workers working on packing stones in a gabion basket. This issue was addressed well by the contractor and the work has been proceeding well next day after the incident.</p> <p>Now, this gabion is already completed.</p>
Km 32+270

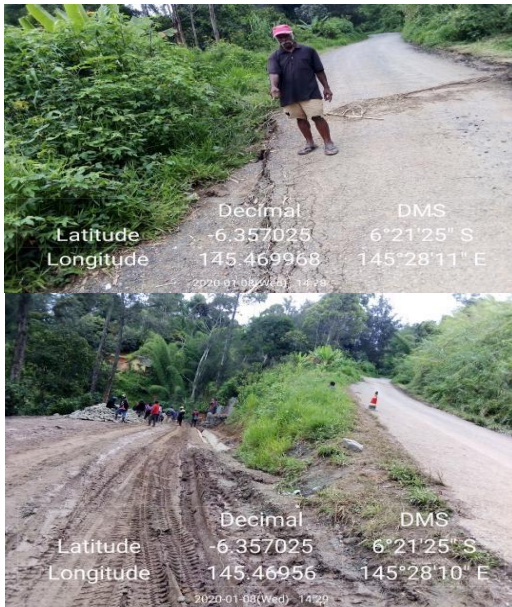
<p>Also there is a road depression at the Nupuru junction km 34+040, the road leading to Okapa District due to Contractor's earthworks. However gabion baskets were built to contain this depression.</p>

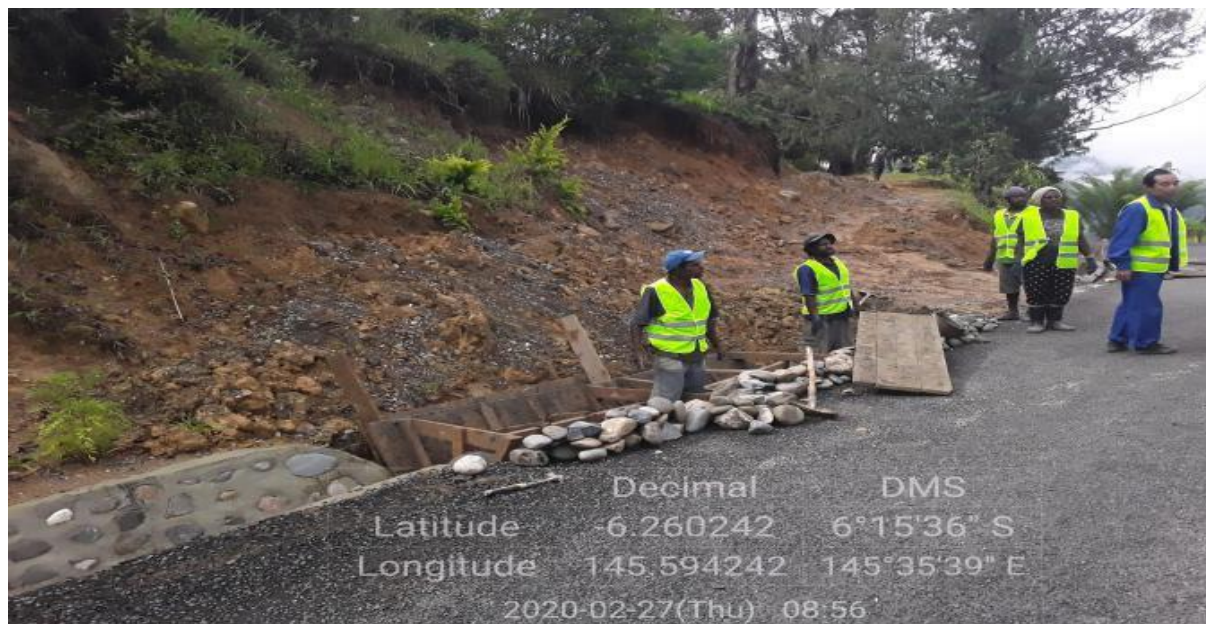
Photograph 20: Workers cleaning the sediments eroded down to road side at CH 18 +060. The sediments have damaged the line drain where re-work is needed.

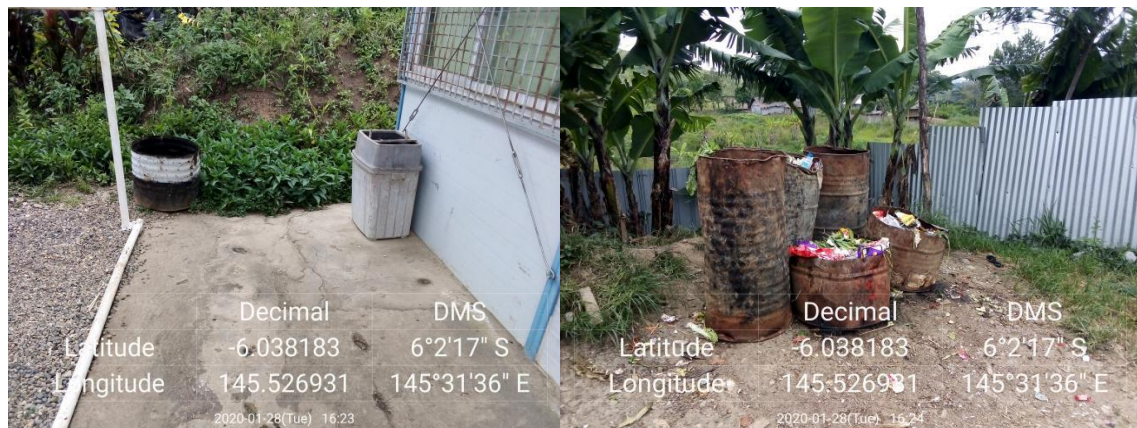
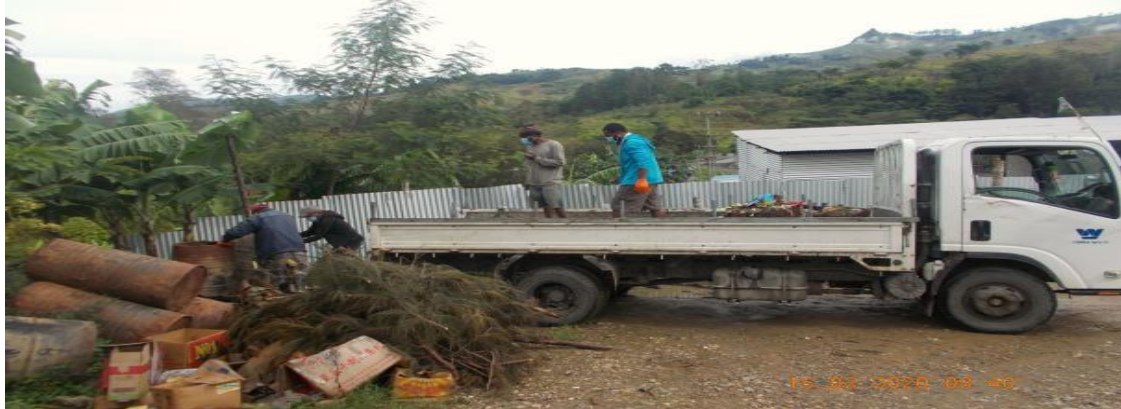
Photographs 21-23: Showing the waste management undertaken by the Contractor.

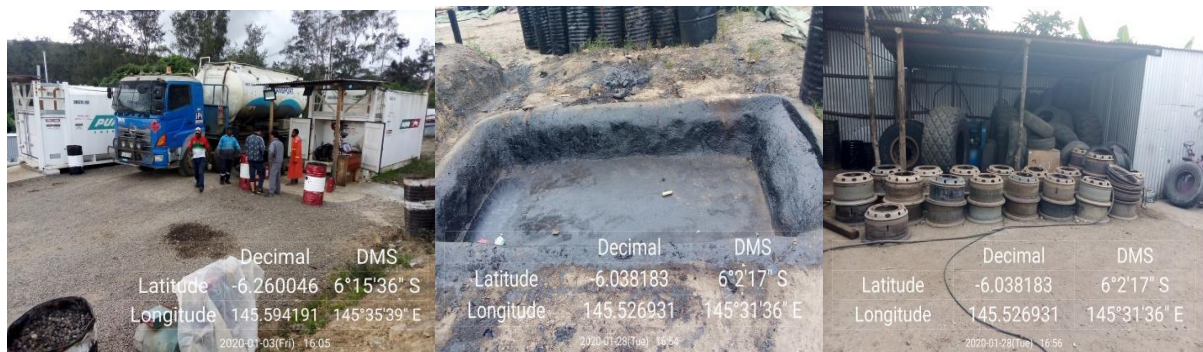
Photographs 24-26: Showing the Hazardous Waste Management undertaken by the contractor.

80. Used tyres has many other uses and should not be burnt. The current arrangement of dishing out to locals for other uses is all right, however instruction should be given so that they should not burn tyres.

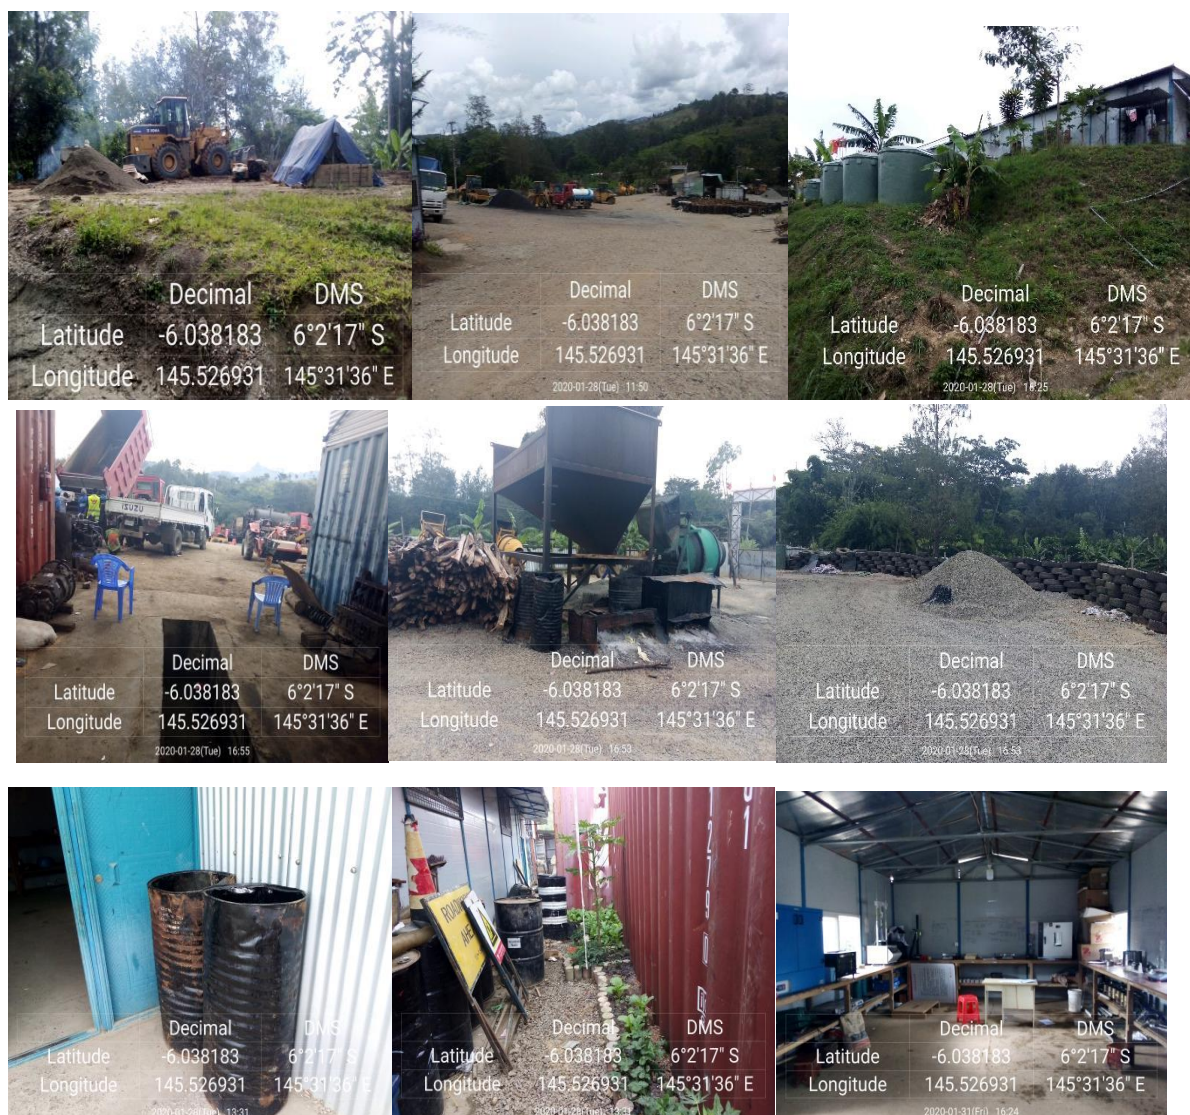
Photographs 27-32: Showing the facilities management at camp and along the project road corridor.

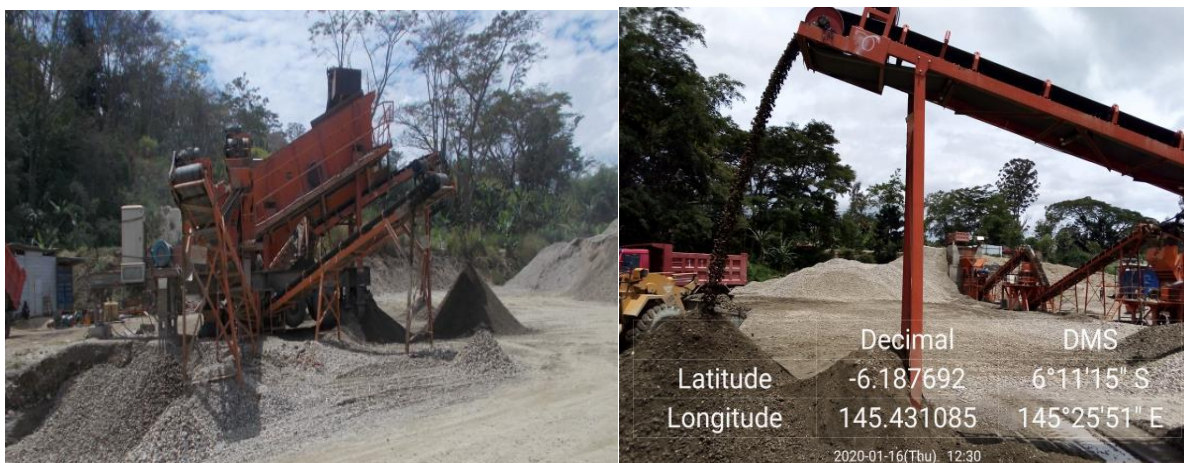
Photograph 33-34: Upegu riverine quarry operation in 2019, before it ceased its operation and Showing Aggregates extraction at Bena Bridge quarry site operated by SHHIP-CW2

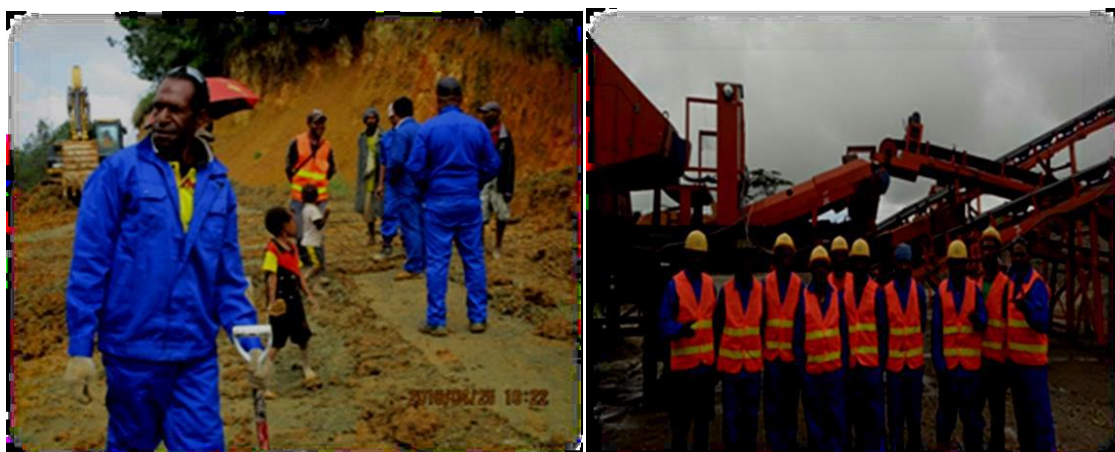
Photographs 35-36: Employees with PPE along the project road corridor during Earth works. Quarry workers with PPE after reaching probation period at the work site

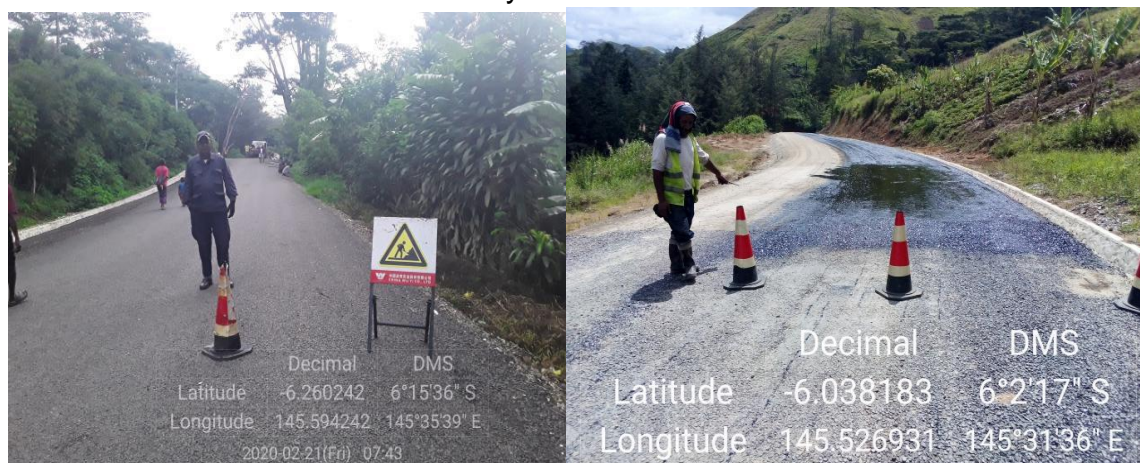
Photographs 37-38: Traffic management during priming and sealing of the road project
