Semi-Annual Report

January 2019

PNG: HIGHLANDS REGION ROAD IMPROVEMENT INVESTMENT PROGRAM (TRANCHE 3)

Gewa-Gembogl Road Sub-Project

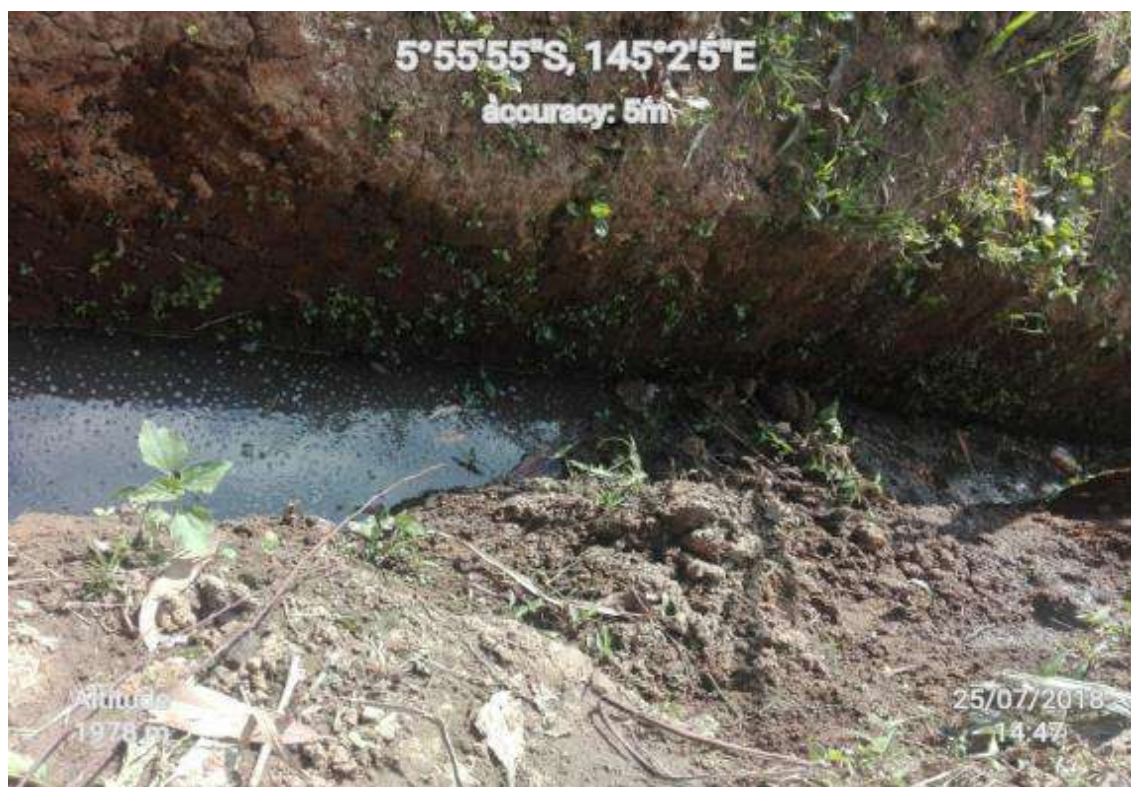
41. The foul odor (stinky smell) coming from the septic tank at the camp site is being mitigated by the contractor (Photograph 2). The measures under taken includes covering the canal with ploy plastic and application of chlorine (Photograph 3). However, the design of the septic tank should be reassessed to determine if it is of the appropriate design.

42. The sewage disposal has contaminated the community's water system but these has been mitigated by the application of chlorine though this is not a best practice. The contractor was advised to monitor and ensure the disposal of wastes is contained as seen in photograph 2 and 3. The issue on disposal of sewage waste has been controlled therefore no more issue.

Photograph 2. Leak sewerage into the eroded open drainage at the contractor's camp

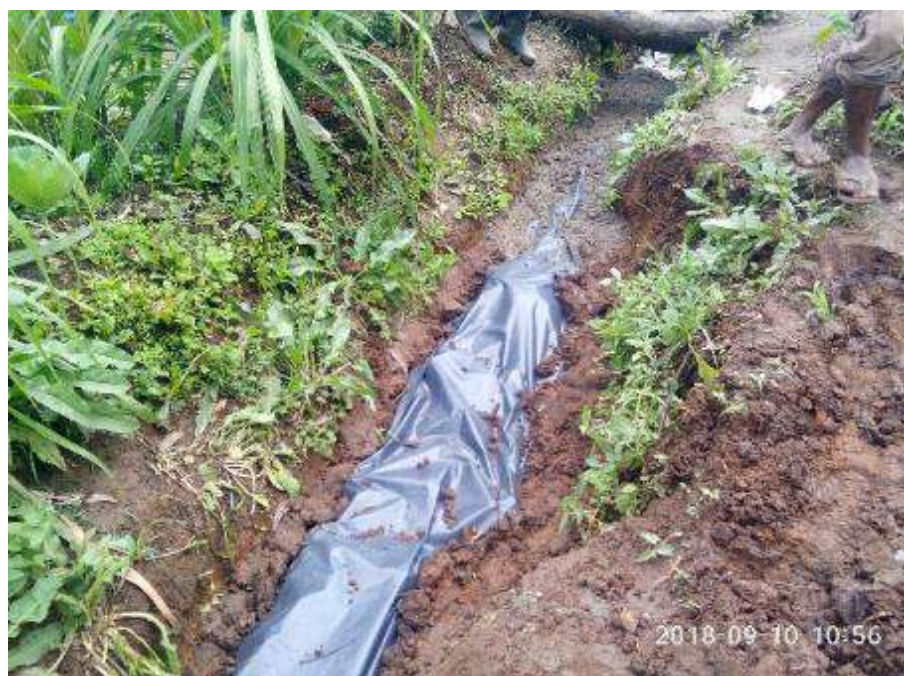
Photograph 3. Covering the septage canal with plastic.

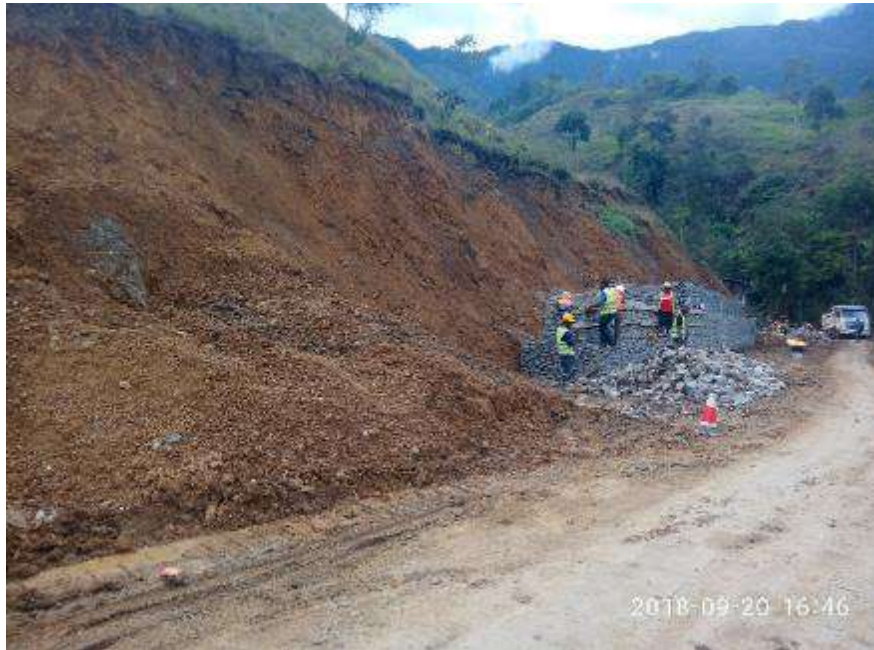
Photograph 4. Gabion construction in eroding road section.

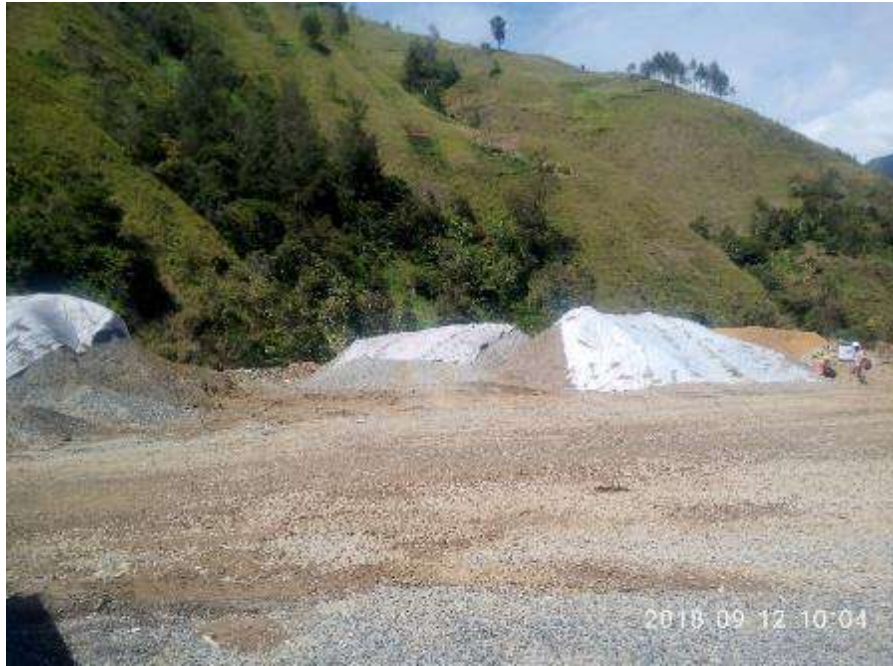
45. Some practices as adopted by the contractor is the covering the processed quarry materials with tarpaulin to prevent it from erosion downstream is evident (Photograph 5). The crushed quarry materials are covered using tarpaulin canvas to protect the material from rain and sun's heat.

Photograph 5. Aggregate materials covered in tarpaulin.

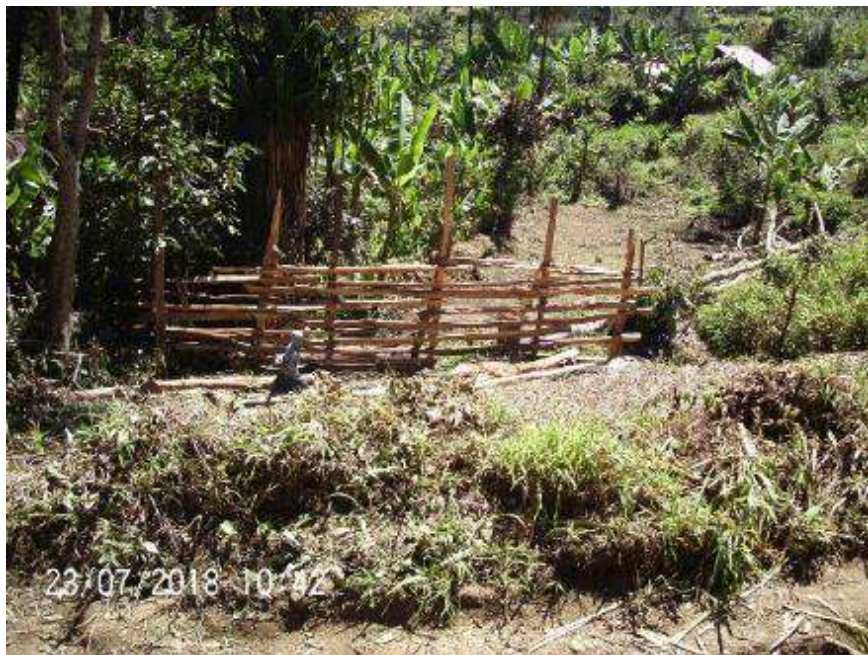
46. Simple bioengineering practices such as fascines which are used to protect banks and soil from washout and seepage. Live fascines could be providing more protection in the long run through its root system (Photograph 5).

Photograph 6. Fascines locally used to protect slopes from erosion.

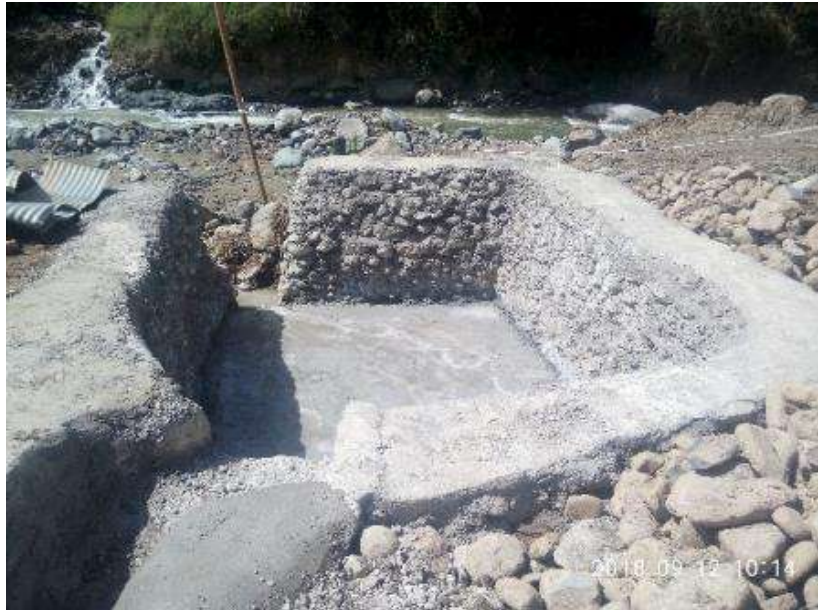
47. The contractor has identified a structure which it called a silt pond (Photograph 7). However, the size, location and design of the structure could be further improved. The CSC is discussing the design of the silt pod with the contractor.

Photograph 7. Contractor's silt pond design.

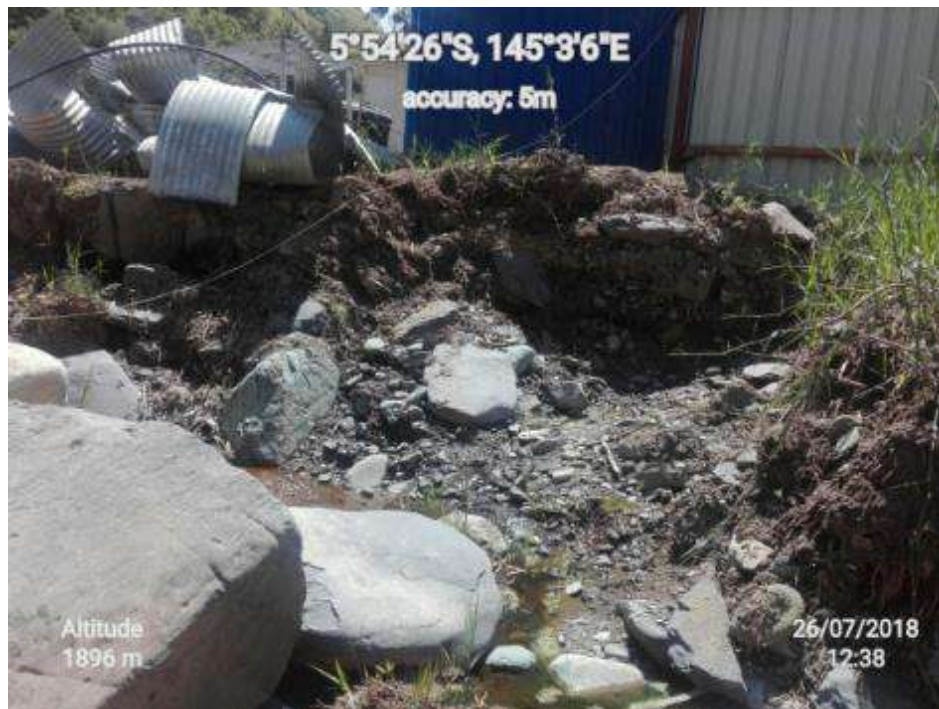
49. There was a leaking sewer at Sumburu quarry (Photograph 9). The contractor was tasked to fix the sewer immediately after the incident was reported.

Photograph 9. Leaking sewer at Sumburu quarry.

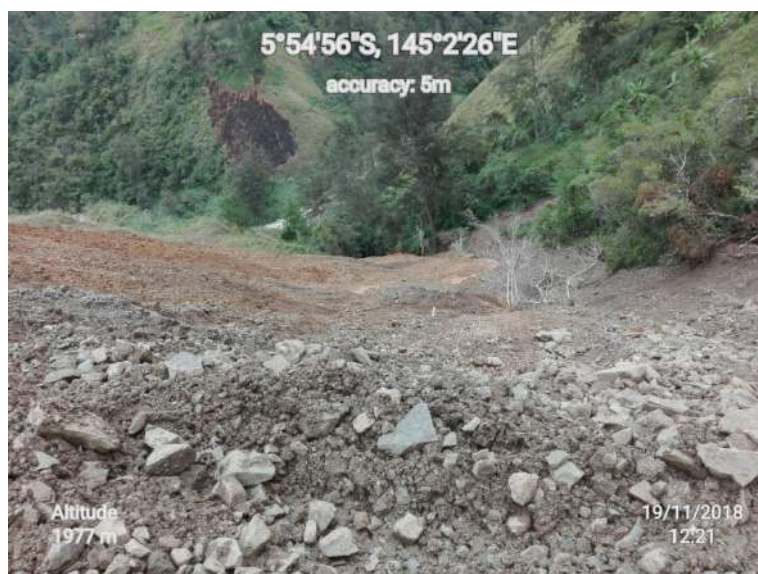
Photograph 12. Deposition of spoils along Ch. 20+300 and Ch.22+230.

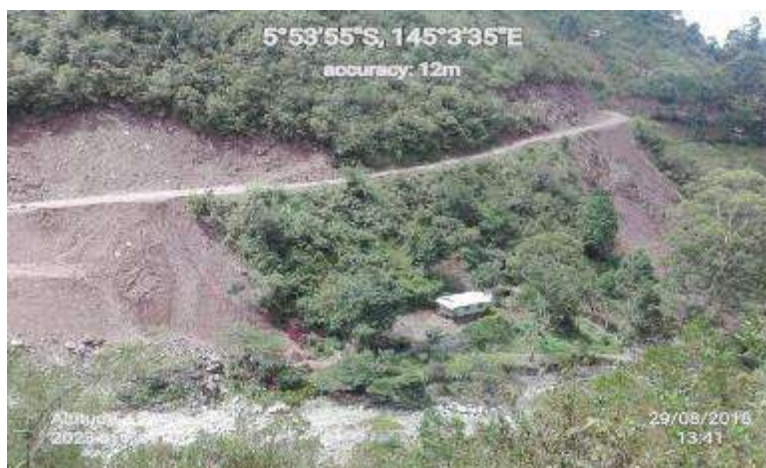
55. The unwarranted disposal of spoils in very steep slopes impact not only the trees and vegetation that hold the soil but also pollute the water bodies downstream (Photograph 13).

Photograph 13. Tree and shrubs destroyed and water body is affected by sedimentation.

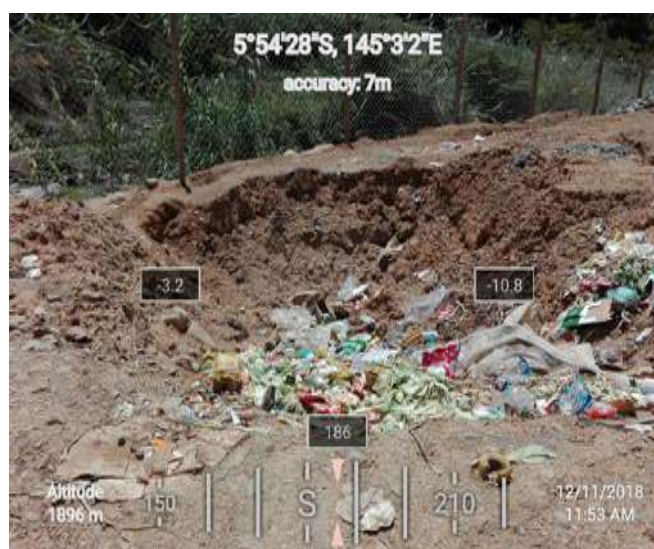
56. Unsorted solid waste are also thrown in a dump in Sumburu quarry in violation of the contractor's CEMP and associated waste management plans (Photograph 14).

Photograph 14. Dump at Sumburu Quarry where waste is being disposed near the river.

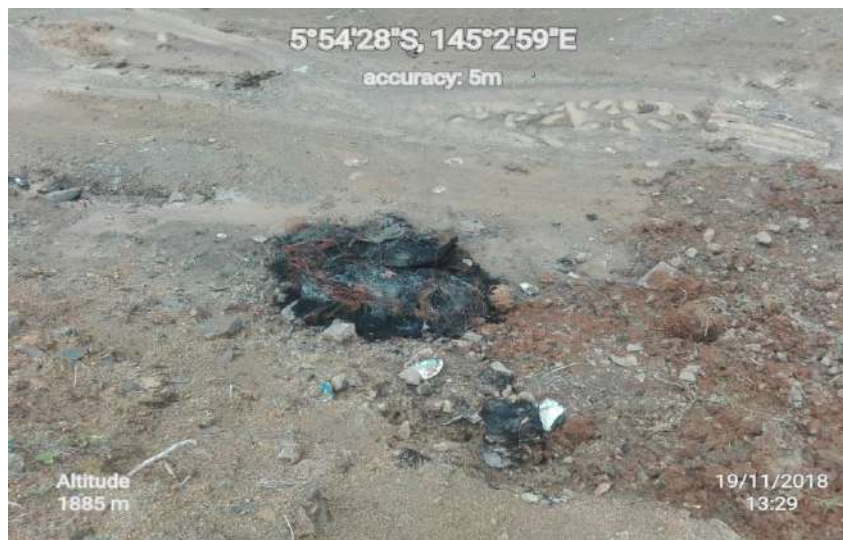
58. The monitoring period show that used tires are not disposed properly and are burned at the site (Photograph 15).

Photograph 15. Burning of used tire at the camp area.

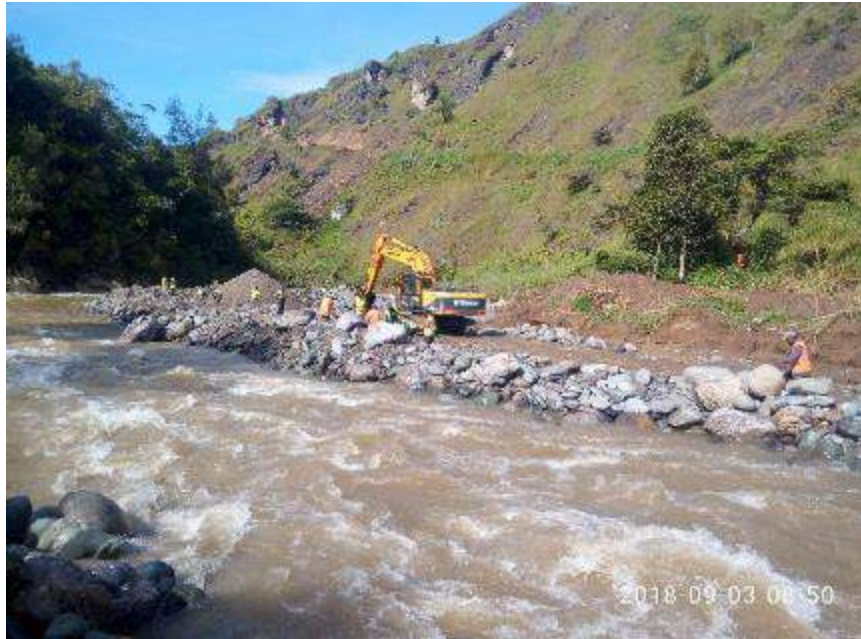
62. A total of three river quarries and four rock or limestone quarries need Quarry Management Plans before they could commence extraction. Prevention of pollution of the river is a continuing concern (Photograph 16).

Photograph 16. River quarry require soil conservation to prevent deposition to the river.

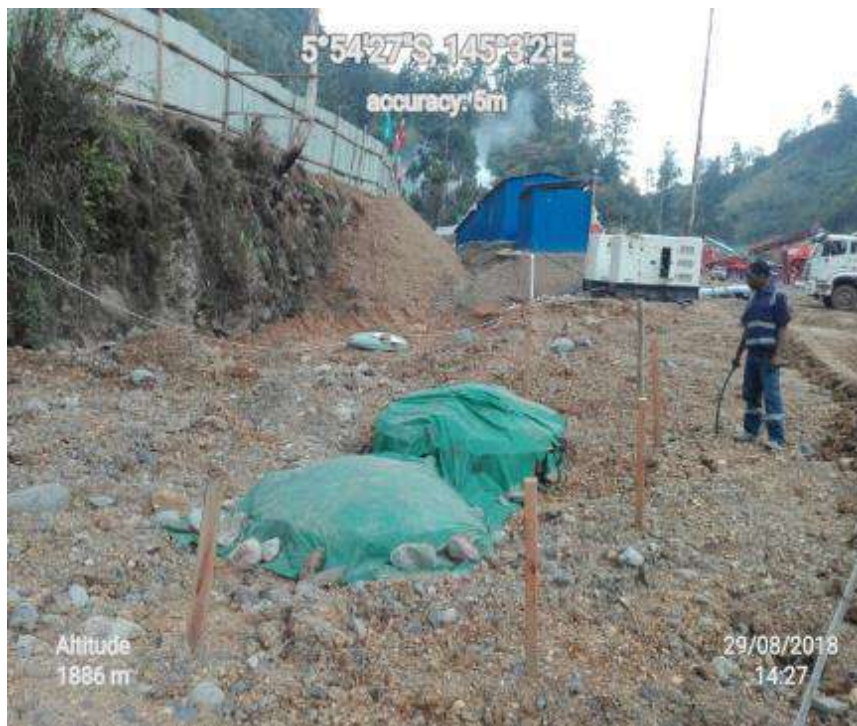
63. Other issues in the Sumburu Quarry site is pollution from the sewerage system which contaminates the river and nearby households (Photograph 17). Efforts were made to rectify and mitigate the problem (Photograph 18).

Photograph 17. Defective or inappropriate plastic septic tanks.

90. The problems in Sumburu quarry has been addressed except for its septic tank which will again fail due to faulty design.

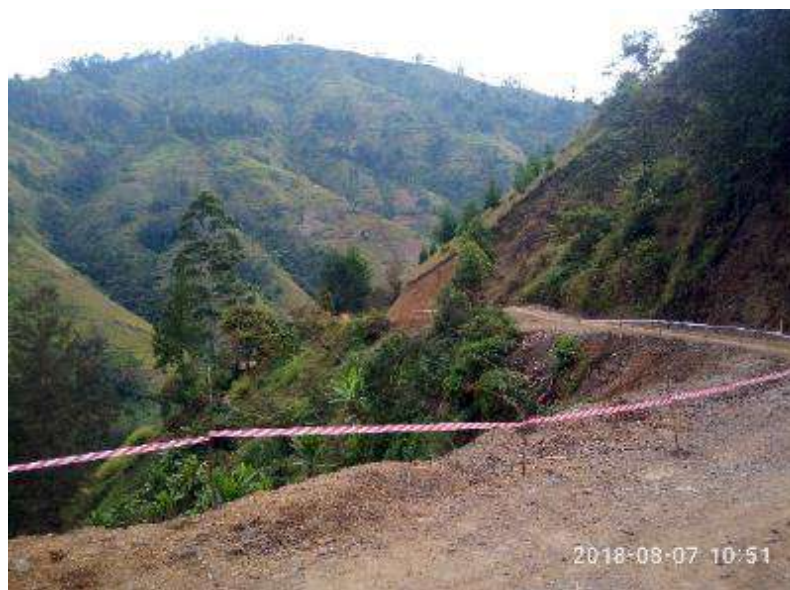
73. The contractor has provided warning tapes for sharp road bends (Photograph 23). Other traffic warning barriers would have been more appropriate.

Photograph 23. Warning tapes in sharp bends for public safety.

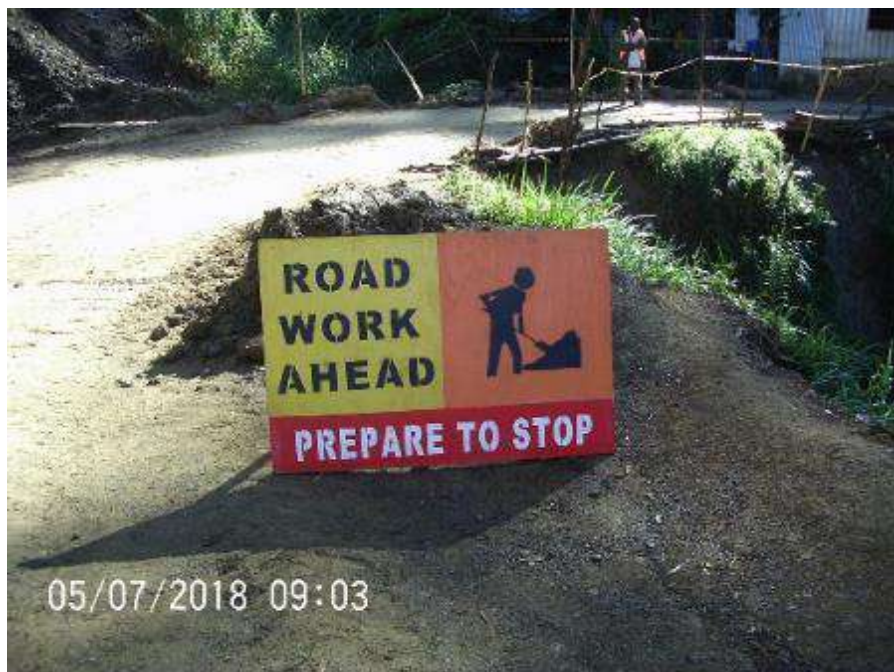
76. The Contractor has provided traffic signages for public traffic (Photograph 27). However, this sign could have been more visible if mounted on a traffic post.

Photograph 27. Traffic signage along the road surface.
