Semi-annual Report

January 2019

# **PNG: HIGHLANDS REGION ROAD IMPROVEMENT INVESTMENT PROGRAM (TRANCHE 3)**

## **Henganofi-Nupuru Road Sub-Project**

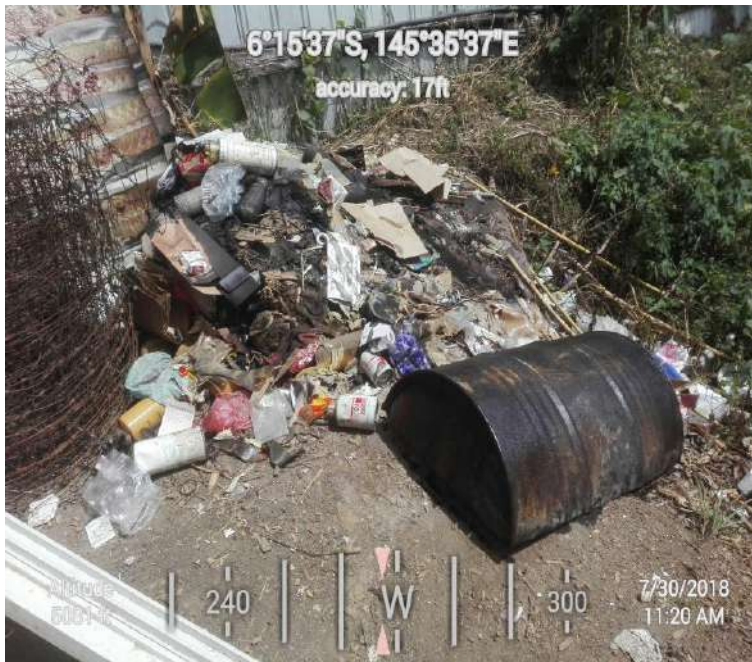
The absence of proper disposal of solid wastes is in violation of the CEMP's provision (Photograph 1). The contractor needs to implement its solid waste management plan to ensure that wastes are reduced, reused and recycled. Materials were provided to the contractor to implement a composting activity. This could also serve as a demonstration activity for other households and schools.

Photograph 1. Improper disposal of solid wastes in the contractor's campsite.

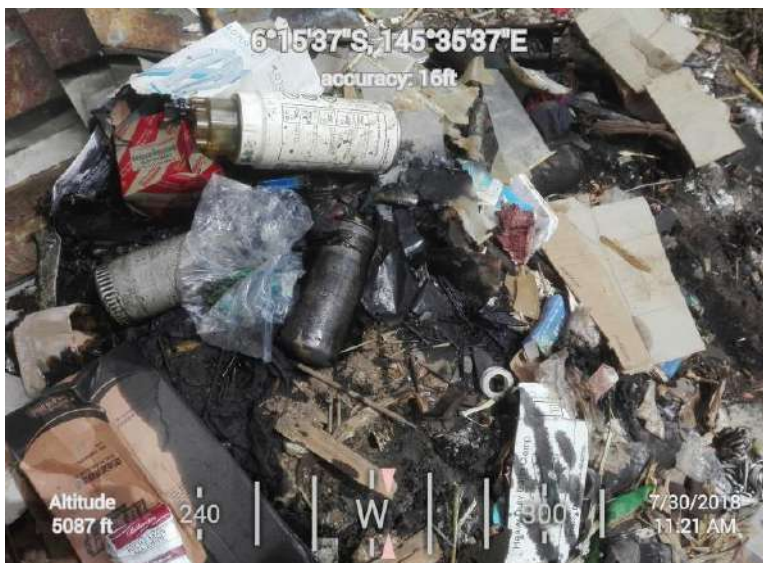
Close monitoring need to be conducted for solid waste, liquid waste and hazardous waste management plan compliance. The contractor has to provide strict rules to ensure that motor pool components are not burned and disposed properly (Photograph 2).

Photograph 2. Burning trash containing motor parts could be hazardous.

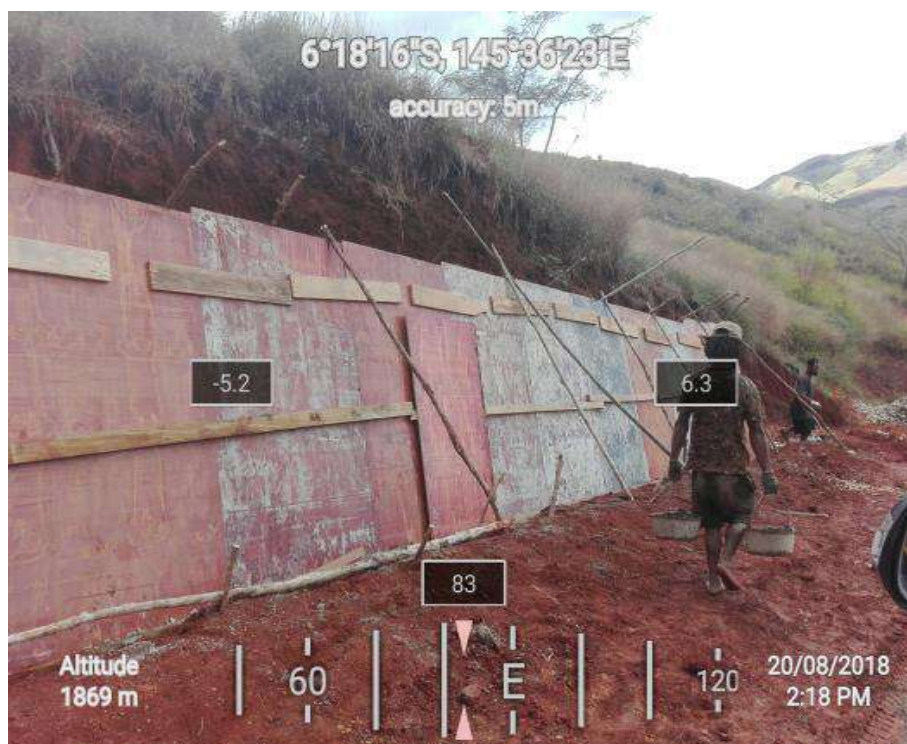
The previous report has shown responsible soil erosion control through the hauling of soil spoils to approved dumpsites and construction of temporary retaining walls to protect erosion prone slopes (Photograph 3).

Photograph 3. Temporary retaining wall to contain landslips at Ch: 7+200-350

Monitoring should be done in the clearing and grubbing area at Km 10+700, excavation and earthworks at Km. 7 and culverts installation at Km 0 – 10+700. An important resource is the Erosion and Sediment Control Best Management Practices Manual which was provided during the Induction Meeting.

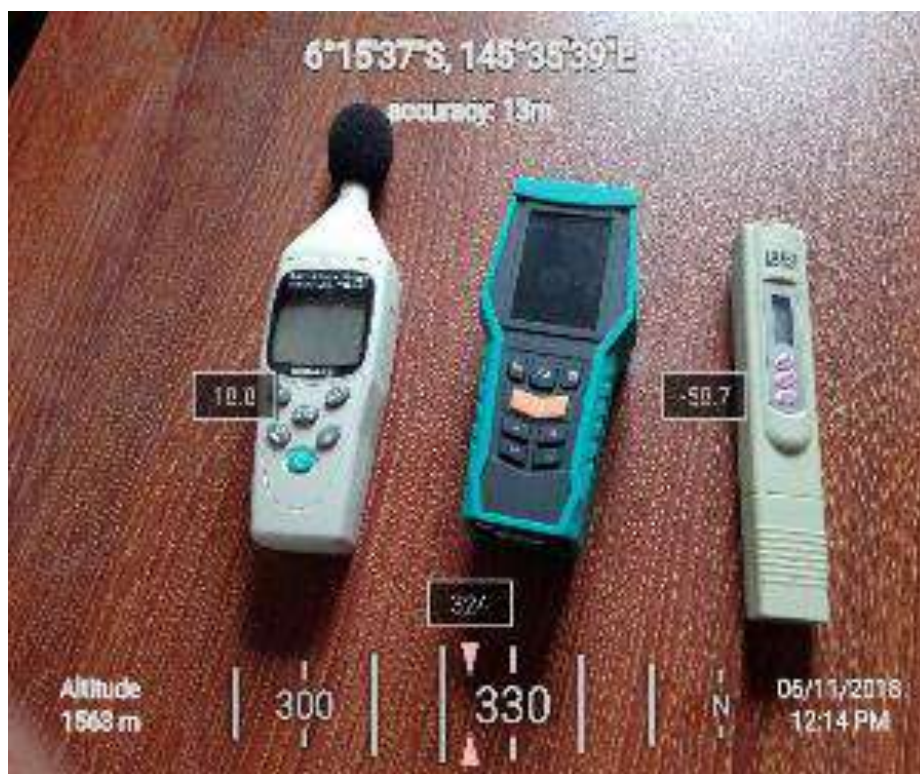
Photograph 4. In-situ equipment procured by the contractor for water, air and noise.

It is recommended that the contractor conduct regular monthly monitoring for the identified environmental parameters for water, air and noise in the environmentally sensitive receptors.

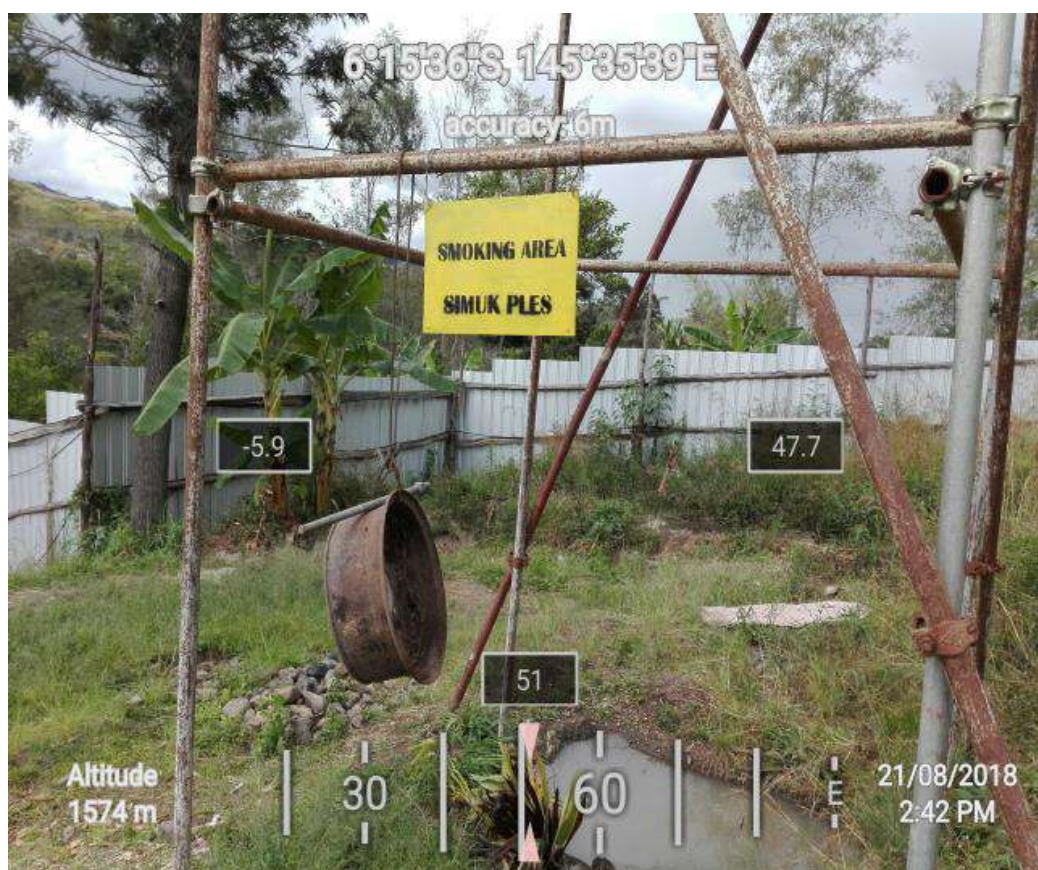
Photograph 5. Designated smoking area in the campsite.

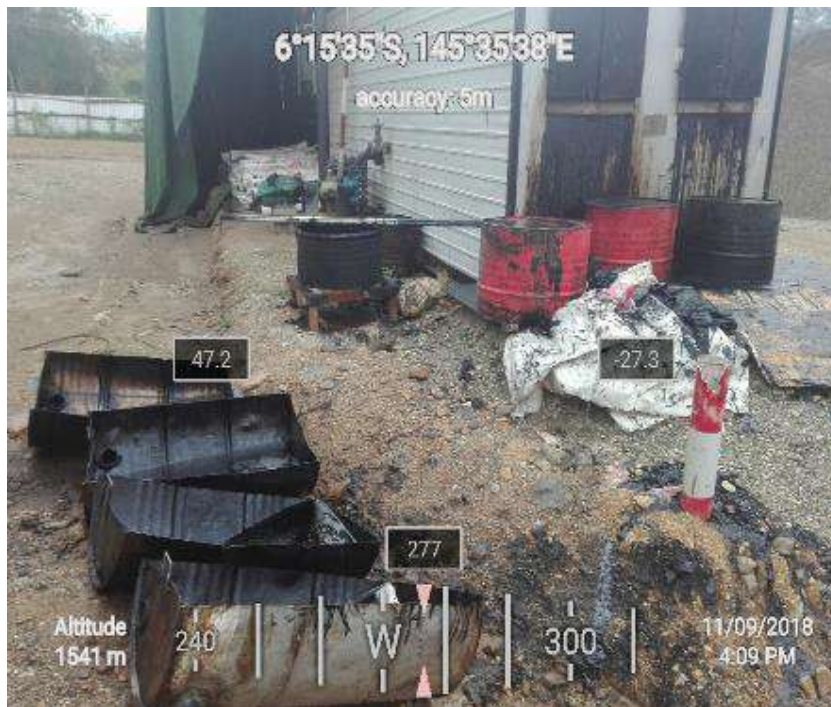
The hazardous wastes from the camp consist mostly of leaking lubricant drums and burning of residue (Photograph 6). The hazardous waste management strategy is to ensure that the soil is not contaminated by cementing the storage area and providing bunds to prevent leakage into other parts of the workshop area.

Photograph 6. Leaking lubricant drums seeping into the soil and storm drain.

The management of hazardous wastes include their storage and ultimately disposal of fluorescent bulbs, computers and peripherals, printers and other equipment. This also includes used batteries, battery fluids, oils, lubricants, and asphalt products (Photograph 7). There is a need to regularly monitor the implementation of the Hazardous Waste Management Plan.

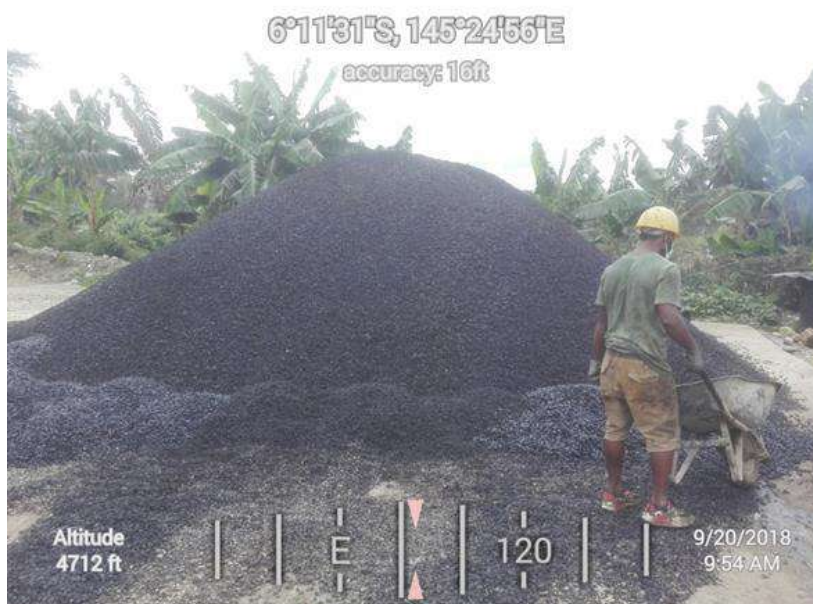
Photograph 7. Bitumen application in aggregate materials.

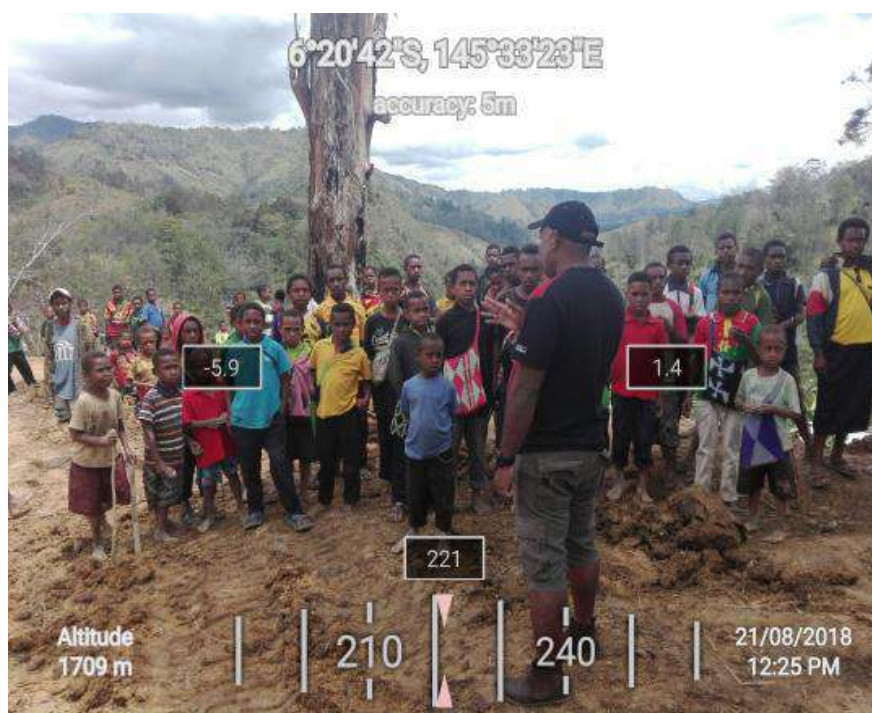
The Contractor has initiated community meetings to discuss the project and the impacts it would have on the community. Other stakeholders including young students are also provided with short consultation meetings (Photograph 8).

Photograph 8. Consultation meeting with young stakeholders of the project.

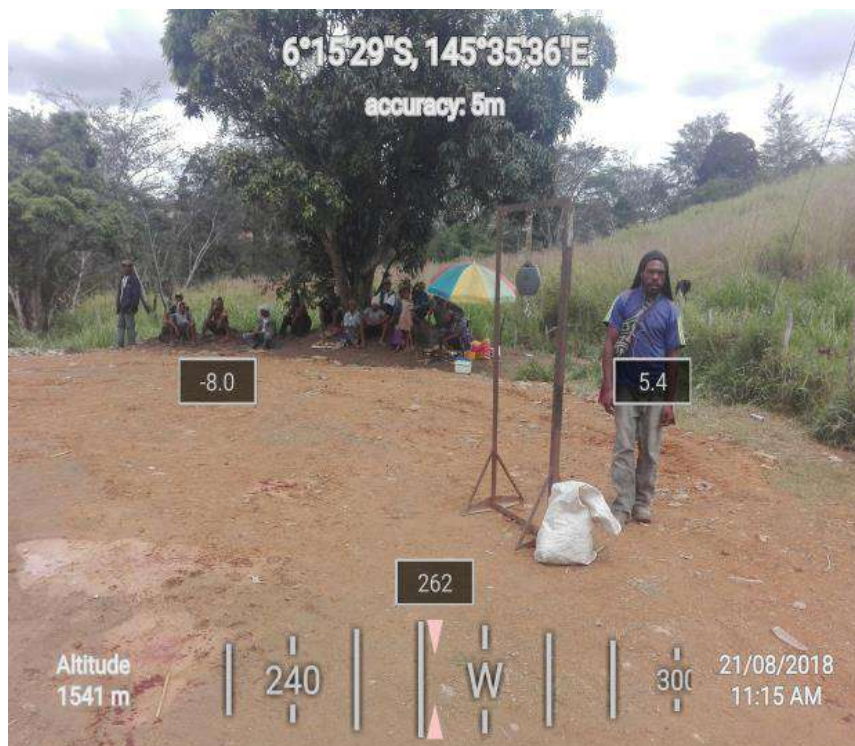
Photograph 9. Coffee buyer in Henganofi – Nupuru road.

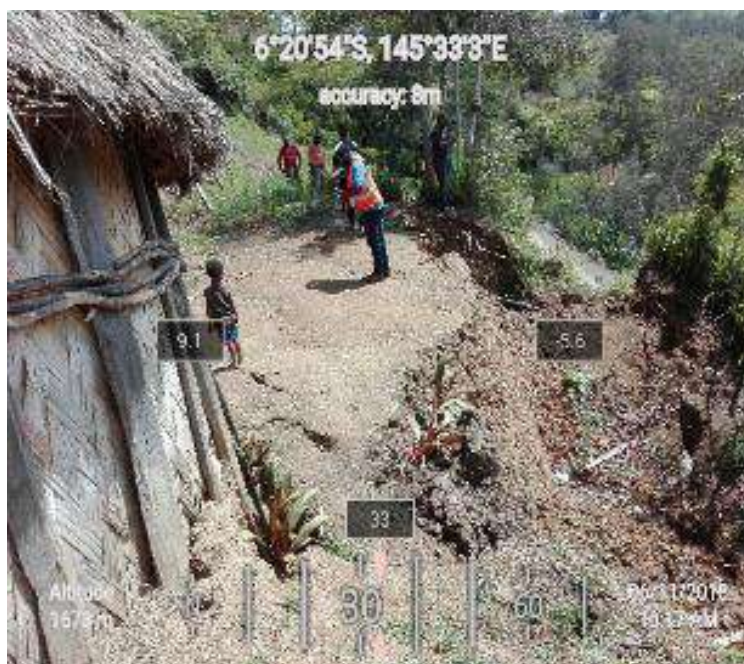
The steep slopes of the project site are continuing public safety concerns. Houses near the construction site at the most risk (Photograph 10).

Structure  
due to

Photograph 10.  
affected by landslip  
excavation work at  
Ch:20+400

Monitoring the implementation of the Contingency Emergency Response Plan prepared by the contractor should be closely monitored.

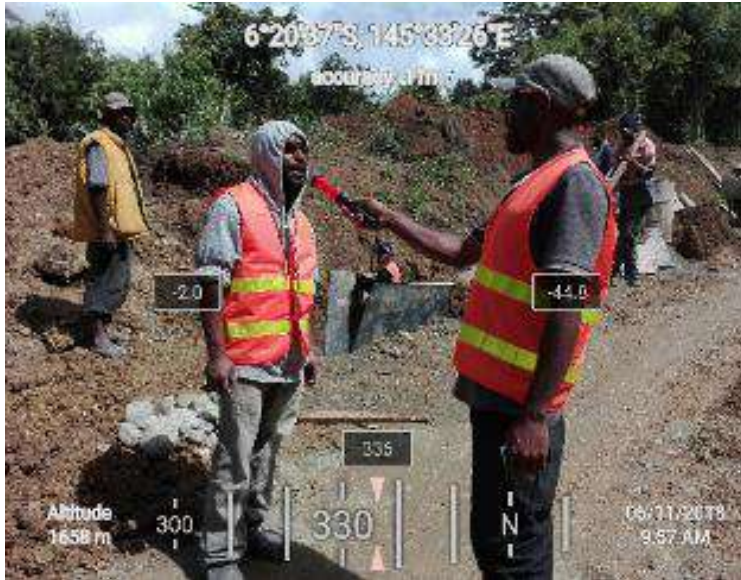
The contractor has also provided an equipment to monitor drugs and drunkenness in the workplace (Photograph 11).

Photograph 11. Worker Tested for Alcohol and Drug by the Health and Safety Officer.

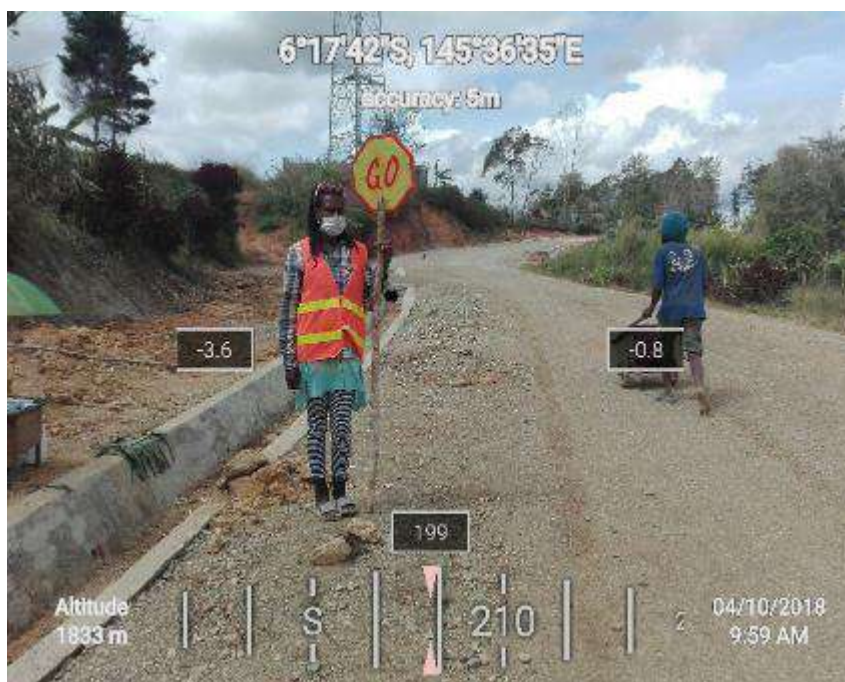
The contractor's Traffic Management Plan is being implemented and employs mostly women workers. However, the traffic signages and warning placards do not follow the traffic requirements and standards (Photograph 12).

Photograph 12. A female traffic aide provides assistance to motorists.

The contractor also has to provide signages warning motorists and the public with potentially hazardous situations including eroding areas and landslips.

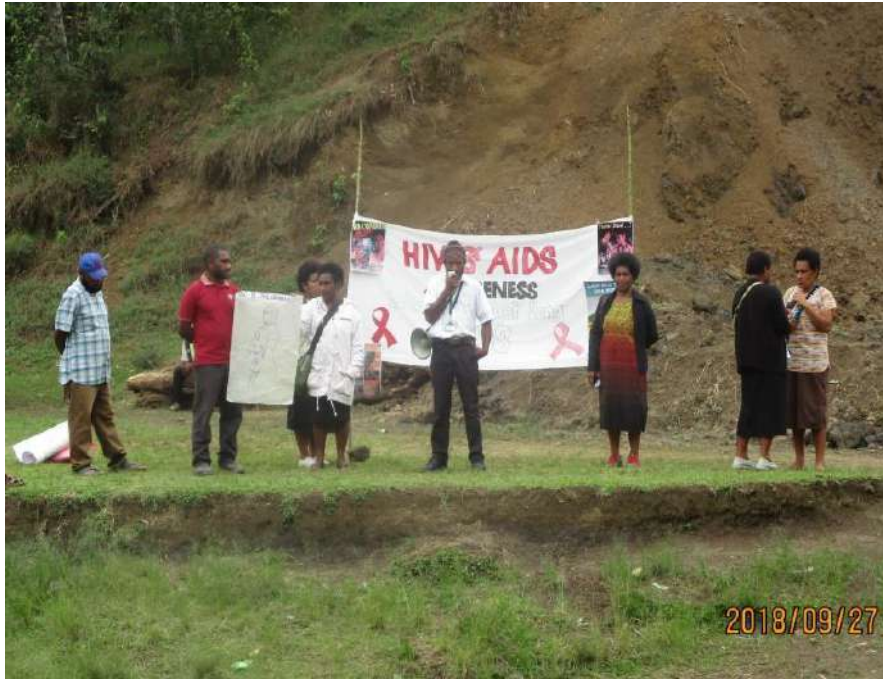
Photograph 13. Service provider FORE providing HIV/AIDS awareness campaign.

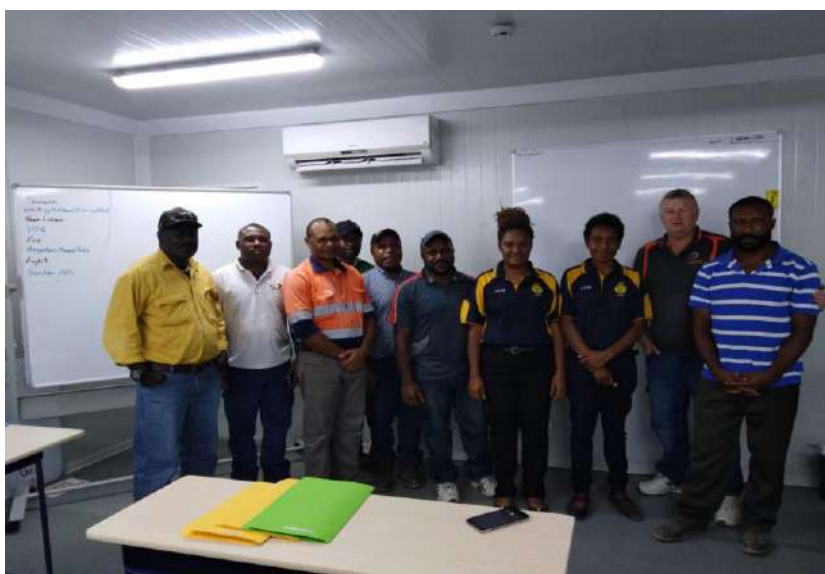
A Workplace Health and Safety Training held in Port Moresby was participated in by selected Environment Officers from both the contractor and HRMG (Photograph 13). A seminar workshop on Technical Report Writing was provided for all environmental and social safeguards officers of the contractor, PSC and HRMG last November 31, 2018

Photograph 14. Attendees of the Workplace Health and Safety Training.
