Semi-Annual
Report

PNG: HIGHLANDS REGION ROAD IMPROVEMENT INVESTMENT PROGRAM (TRANCHE 3)

Henganofi-Nupuru Road Sub-Project (January to June 2019)

Prepared by Highlands Road Management Group (HRMG) of the Department of Works for the Asian Development Bank

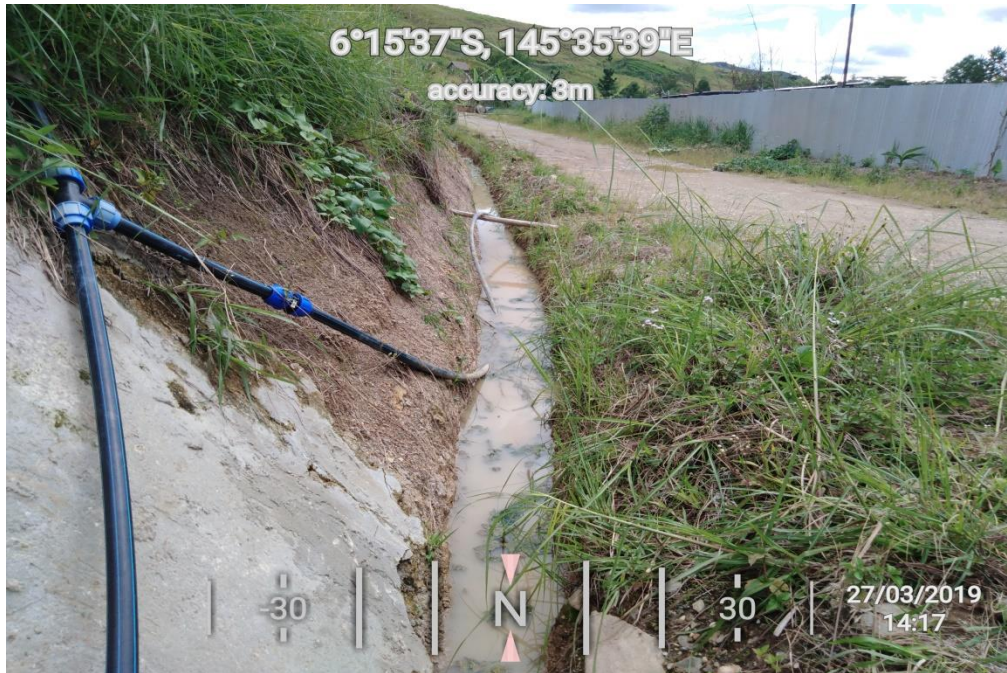
47. Drainage system in the camp yard is kept clean around some areas while others especially on the side of the fences are covered by weed and grass. The drainage near the garage areas is sometimes or most of the times covered with or have spills of used oil in it. Thus, the drainage system in the camp yard all lead to one big drain which leads right into the Konemempi River.

Figure 2 Drain not cleaned causing stagnant water can lead to breeding of mosquitoes. This drainage is near the office spaces.

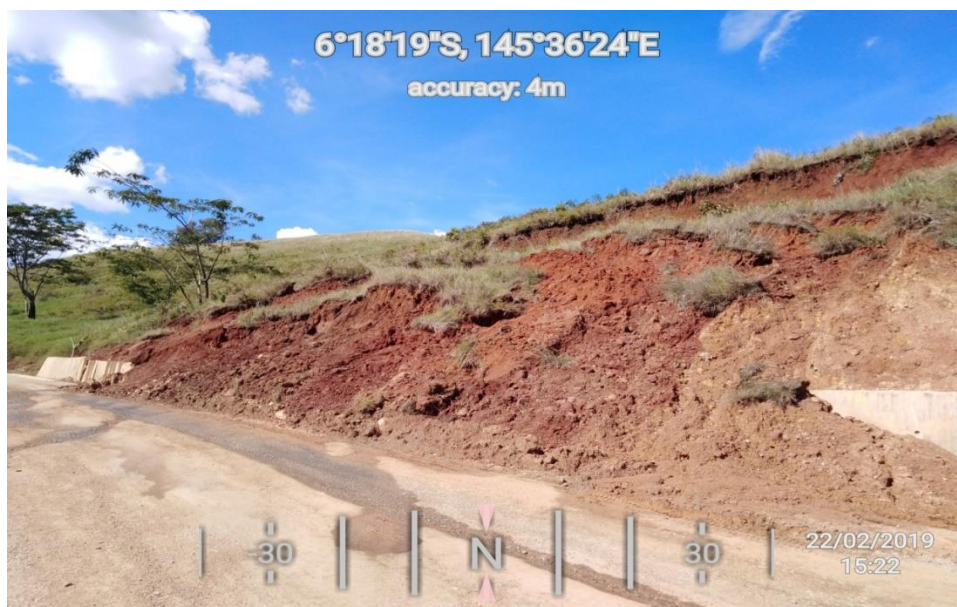
51. There were several landslips during the month of January and February along CH 6+ 000 and CH 7+ 000 due to too much water contain in the soil during the rainy period. These landslips caused a lot of damages to the road that where already sealed, line drain and retaining walls. Theses damages are yet to be reconstructed.

Figure 4 Eroded soil covering sections of the road also causing damages to line drain and retaining wall at CH 7+ 400 (left side)

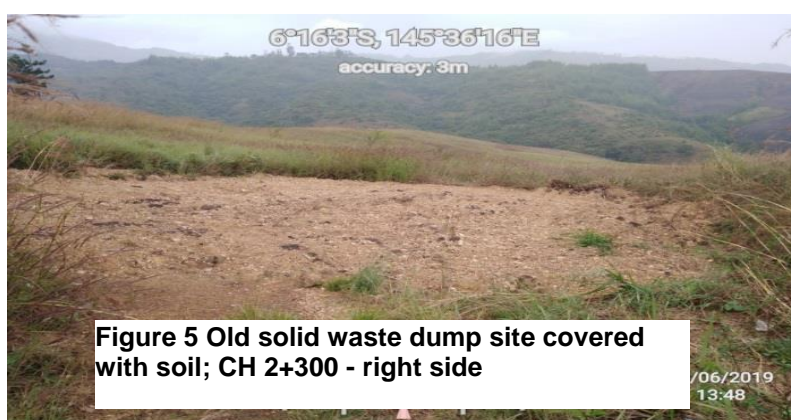
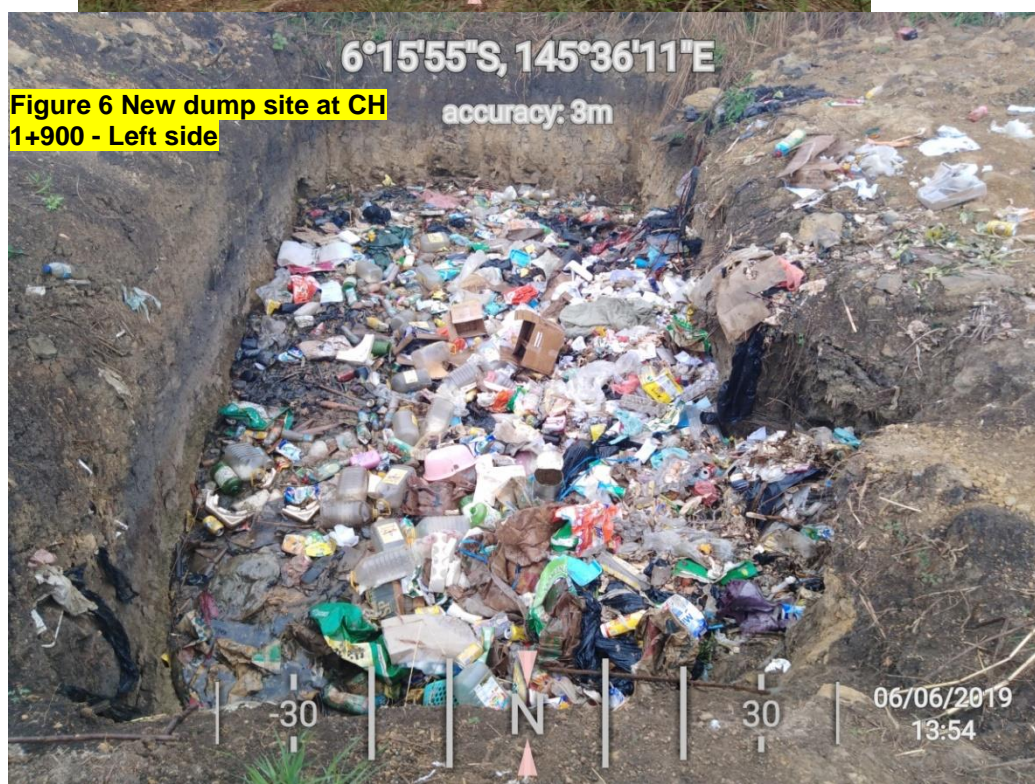
64. A new solid waste dump site was dug at CH 1+930 (left side) about 12m out from the edge of the new sealed road. The previous dumpsite is about 1.3km up at CH 2+ 300 which was full and is now covered up with soil.

65. Other materials like empty drums and old tyres are re-used as storage vessel for bitumen and used oil at the campsite and tyre are re-used as barrier for chips stockpile inside the camp yard.

62. The contractor disposes its unsegregated solid wastes into open dump areas which could be breeding grounds for diseases. There is also the possibility of the wastes or leachate seeping into the groundwater. It is recommended that the contractor segregate its waste and follow best practices for solid waste management including composting and the principles of reduce, reuse and recycle.

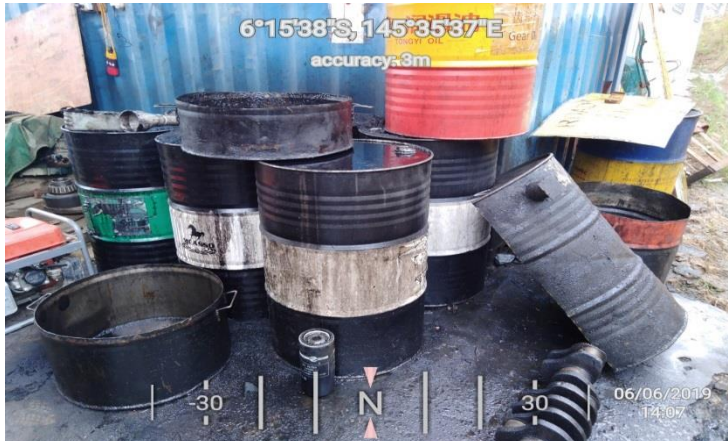
67. The hazardous wastes from the camp consist mostly of leaking lubricant drums which has seeped into the soil and nearby drainages. The hazardous waste management strategy is to ensure that the soil is not contaminated by cementing the storage area and providing bunds to prevent leakage into other parts of the workshop area.

Figure 7 Storage drums leaking with used lubricants

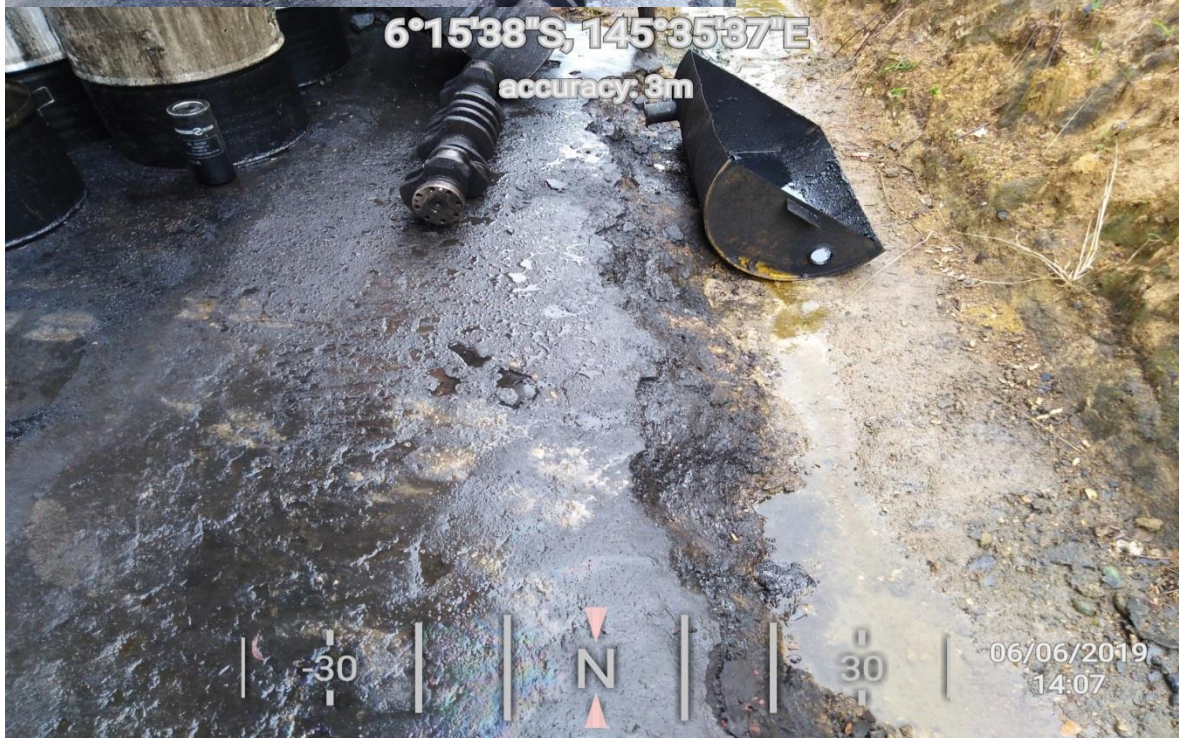
Figure 8 Oil spilling into drainage near garage area

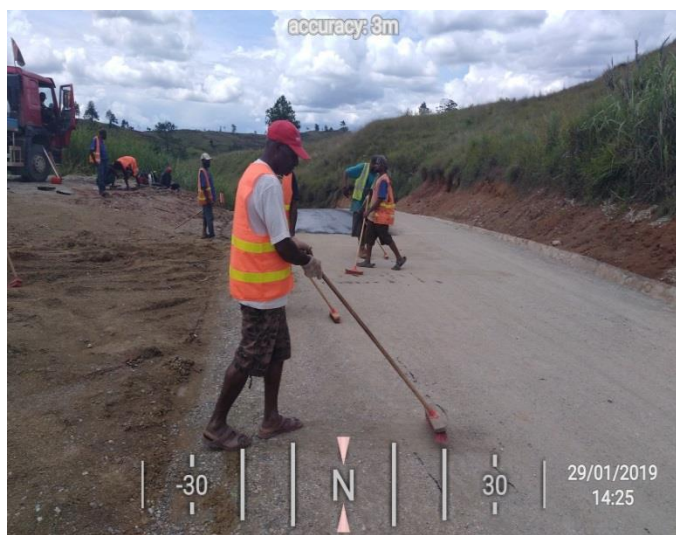
74. Workers health and safety is an ongoing issues with the Henganofi-Nupuru project, this parameter has been given less effort of improvement since the beginning of the project. For the concerned period PPEs has not improved until mid-May to June only when there were some improvements observed. However, there is still much improvement needed in the provisions of Personal Protective Equipment. The following images shows improvements on certain PPEs.

Figure 9 In January when no PPE was issued

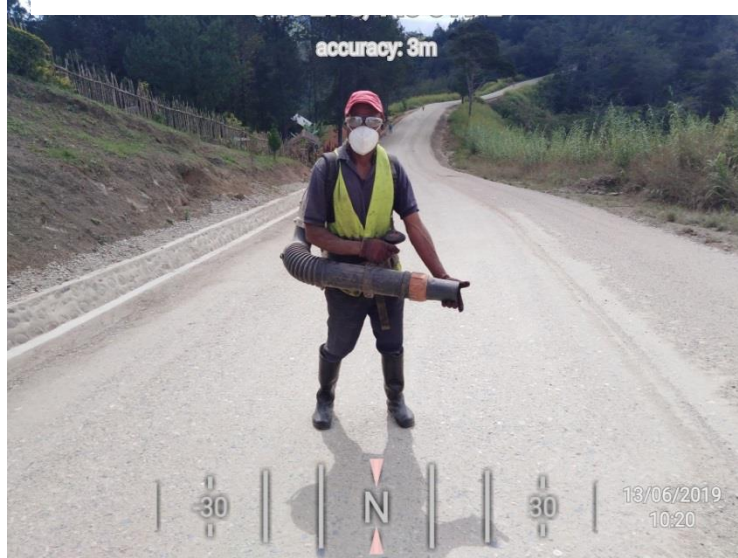
Figure 10 In June when appropriate PPEs was provided

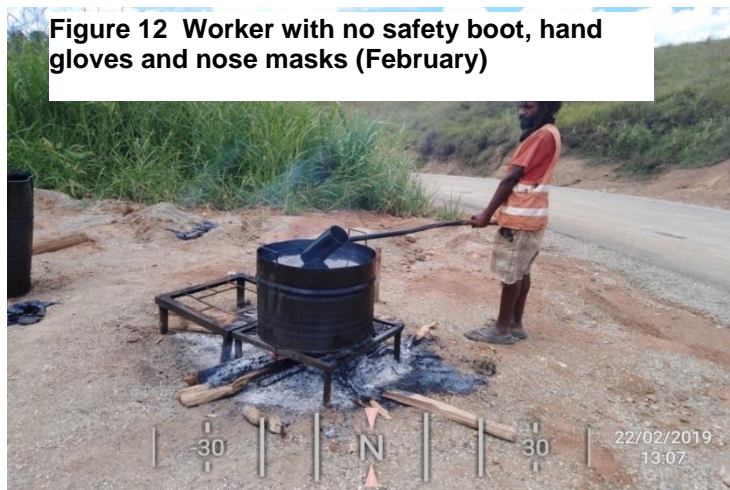
Figure 12 Worker with no safety boot, hand gloves and nose masks (February)

75. The contractor must regularly conduct a toolbox meetings with their workers. Thus, most of the local workers are unaware of safety procedure they should take or abide by during working hours. As a result, an incident occurred early this year (2019) in January; where a local employee got stuck between the wheel of a grader machine.

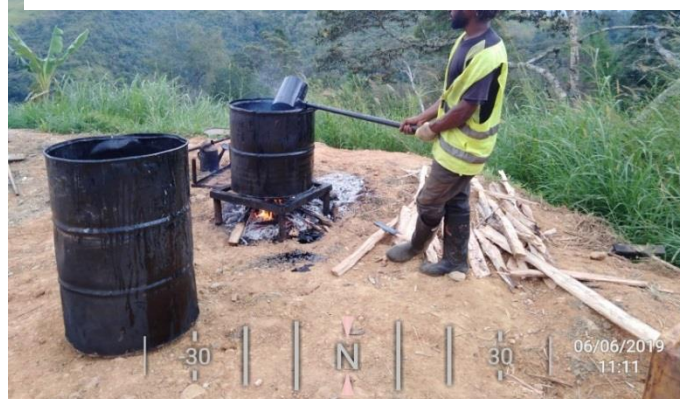
Figure 11 Rubber boots and gloves provided in June, still needs mask and stronger boots.

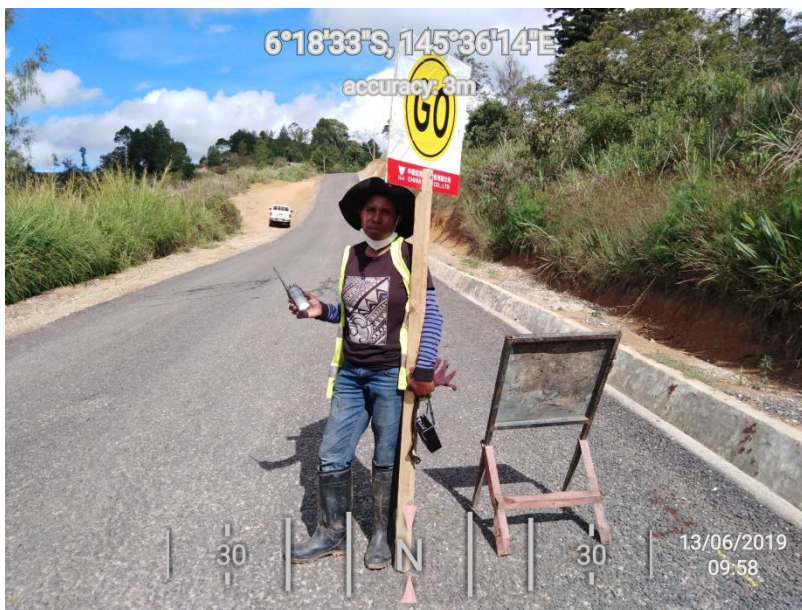
78. The contractor maintains good traffic management practices. Small communicator radios are provided for spotters to use.

Figure 13 Female spotter posing with the new issued radio to communicator with spotter on the other hand.
