Environmental Monitoring Report

Semi-Annual Report
January-June 2014

INO: West Kalimantan Power Grid Strengthening Project

SEMI-ANNUAL REPORT **on** **ENVIRONMENTAL ISSUES**

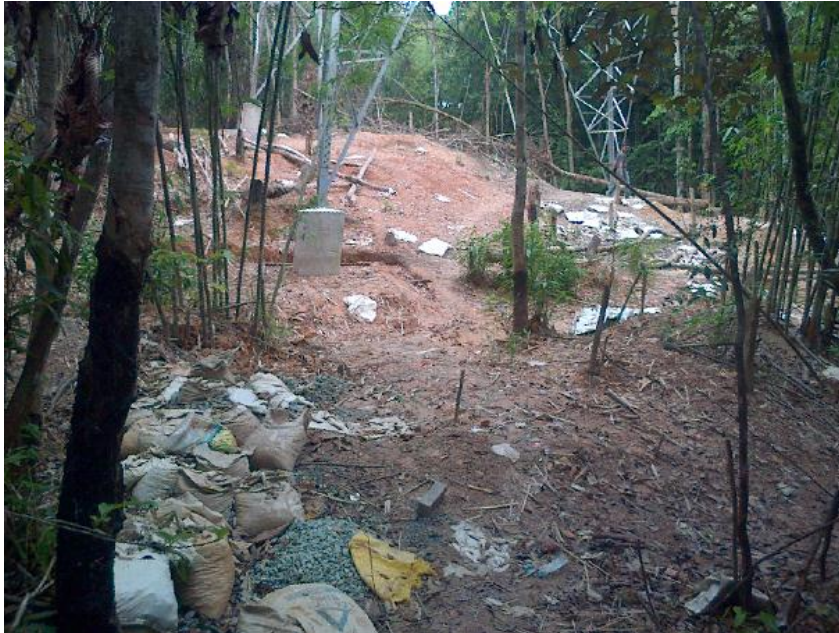
No of Picture: 1
Route: 275 kV Bengkayang-Jagoibabang
No of Tower: 74
Location: Ledo
Status: Tower erection finished
Picture taken: April29, 2014
Problem: Scattered construction waste must be removed

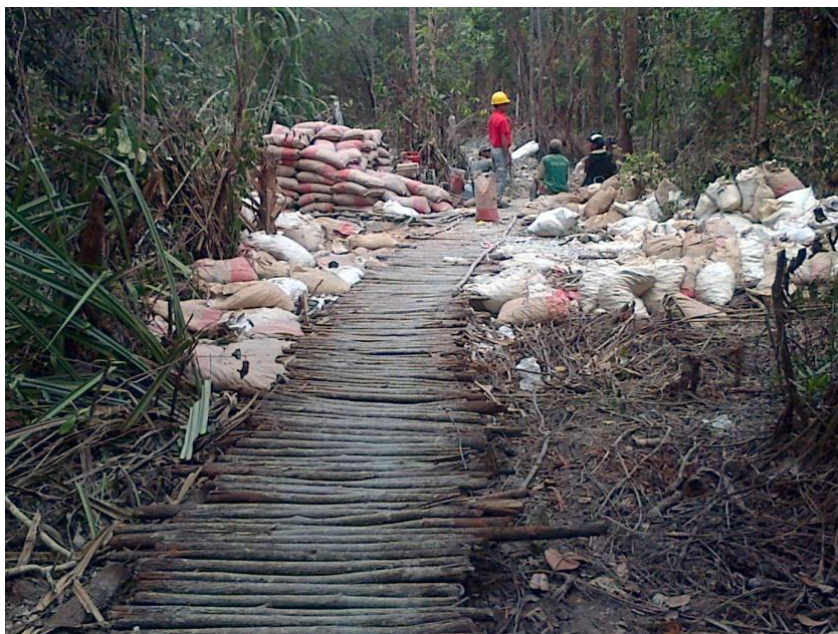
No of Picture: 2
Route: 275 kV Bengkayang-Jagoibabang
No of Tower: 150
Location: Seluas subdistrict
Status: Foundation works
Picture taken: Feb. 24, 2014
Problem: Encroaching community forest, cut trees for building access path.
Note: The pathway access made of cutting trees from community forest. In the background sacks of sand, stones and cement as materials of concrete works.

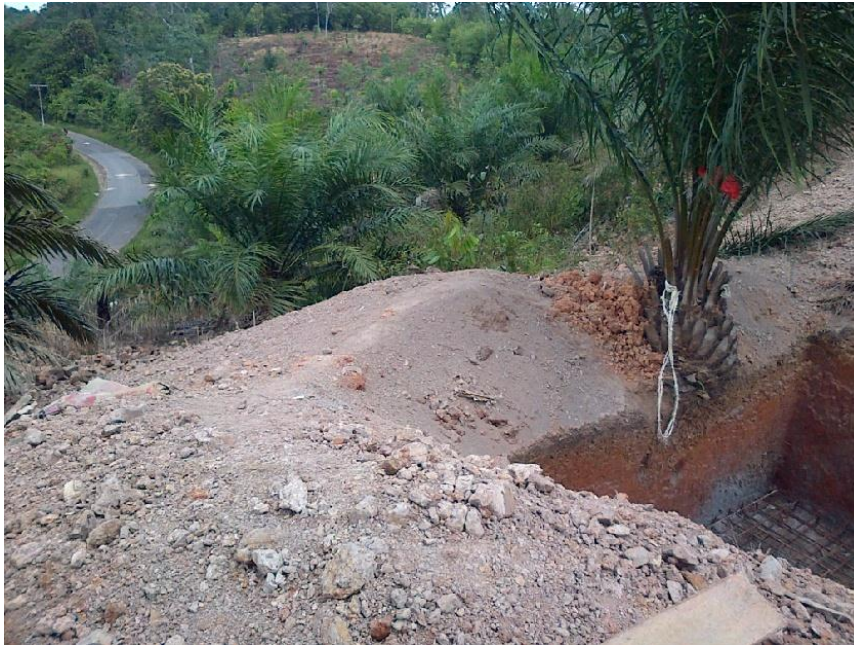
No of Picture: 3
Route: 275 kV Bengkayang-Jagoibabang
No of Tower: 68
Location: Ledo subdistrict
Status: Foundation construction
Picture taken: Feb. 24, 2014
Problem: Tower located in steep slope (see the road below). Note: The picture beneath was the same location but it was taken from different angle

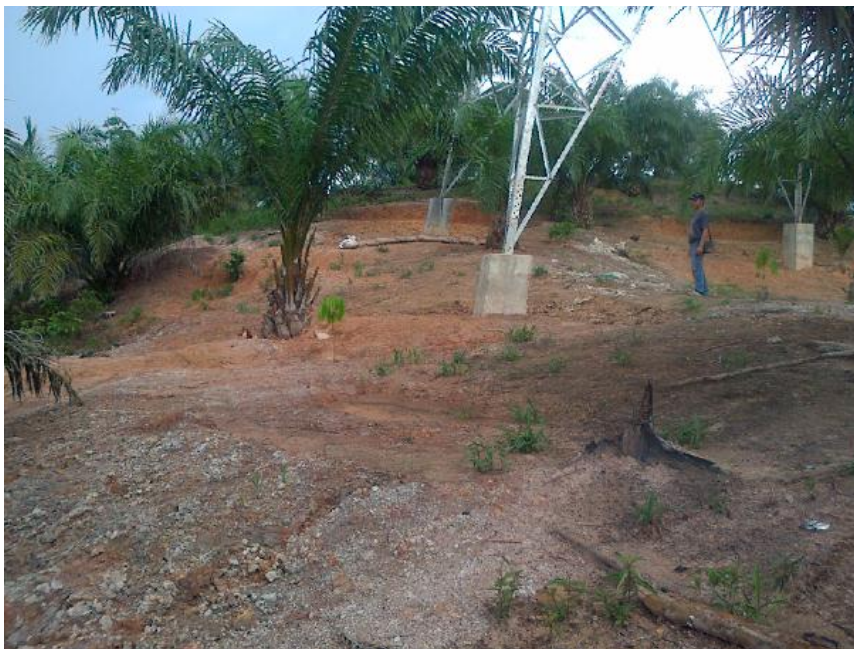
No of Picture: 4
Route: 275 kV Bengkayang-Jagoibabang
No of Tower: 68
Location: Ledo subdistrict
Status: Tower erection finished
Picture taken: April 29, 2014
Problem: Potential for soil erosion of tower located in steep slope Note: The picture above was the same location but it was taken from different angle

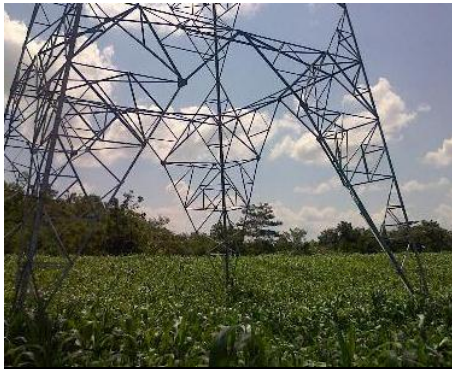
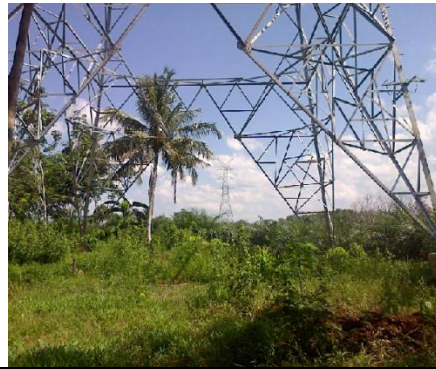
No of Picture: 5
Route: 275 kV Bengkayang-Jagoibabang
Location: see below
Status: Erection tower finished
Picture taken: June 24, 2014

- Left: Tower 94 covered with maize planted by local people.
 - Right: Tower 97 covered with grass.
- For the erosion point of view the vegetation is good for erosion protection

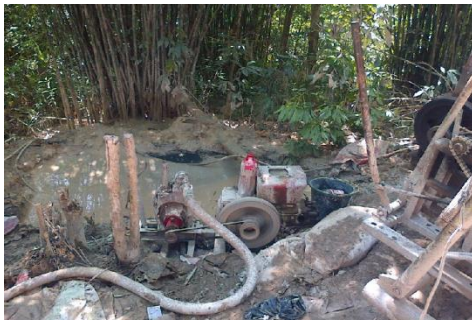
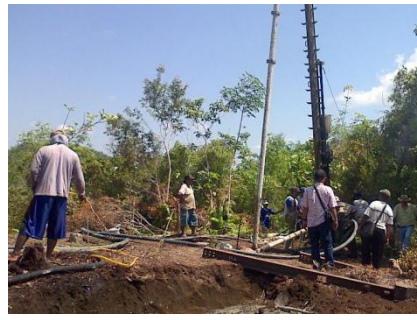
No of Picture: 6 & 7
Route: 275 kV Bengkayang-Jagoibabang
Location: see below
Status: Foundation works
Picture taken: June 24, 2014

- **Left:** T. 67 foundation with bore pile system. Mud pond of tower boring machine was frequently overtopped and it flowed to surrounding wood. Impact was insignificant, it could easily be absorbed by surrounding landscape.
- **Right:** T. 77 foundation with SMCF system, produce intermittently very loud sound, SMCF is abbreviation of steel mortar composite foundation. It was located in mixed garden remote from dwelling area.

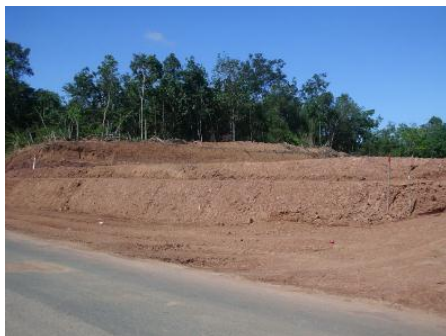
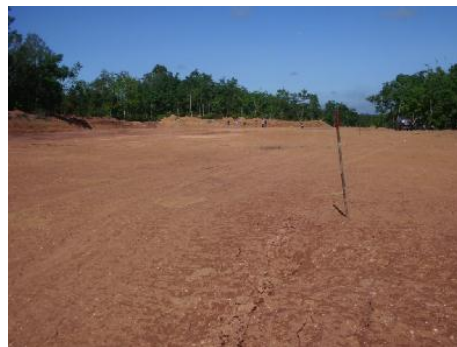
No of Picture: 19
Location: New Ngabang substation
Status: The land and vegetation have been compensated and land preparation has been completed
Picture taken: April. 20, 2014

There is no retaining wall and drainage along the roadside (Pontianak – Tayan – Ngabang main road). This causes the sediment of soil erosion to overflow on the road.

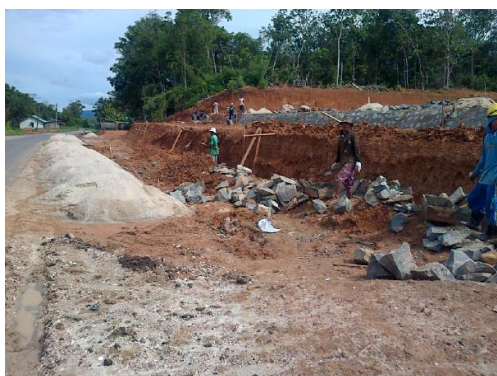
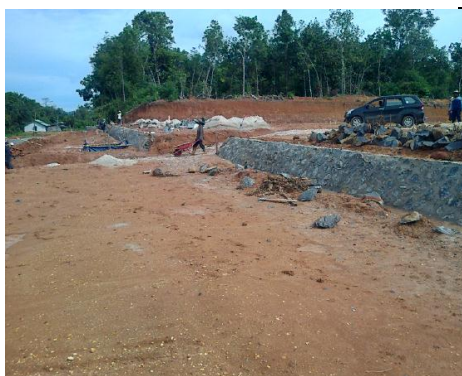
No of Picture: 20
Location: New Ngabang substation
Status: Retaining wall at road side under construction
Picture taken: April. 20, 2014

Retaining wall was being constructed without drainage along the roadside (Pontianak – Tayan – Ngabang main road). This causes the sediment of soil erosion overflow on the road.

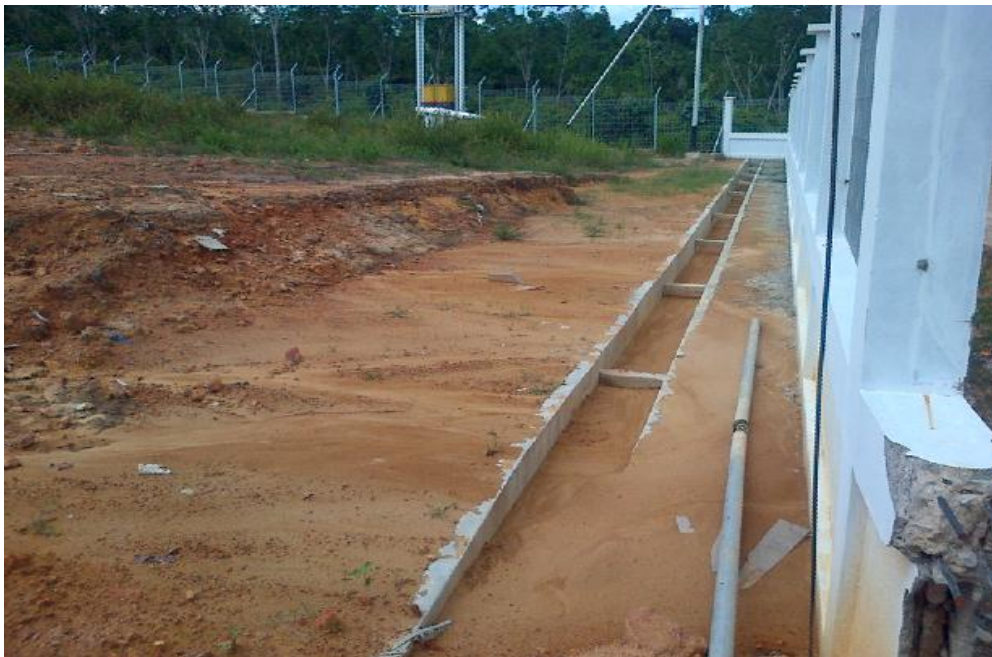
No of Picture: 22

Note:
Suspended soil erosion
in drainage canal

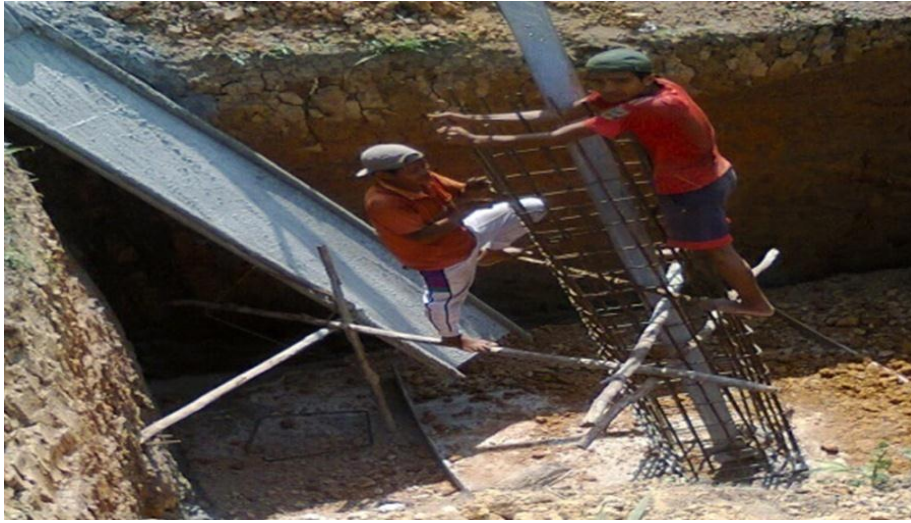
No of Picture: 23

Note: The workers did not wear personnel protection equipment (Helmet, shoes, safety harness)

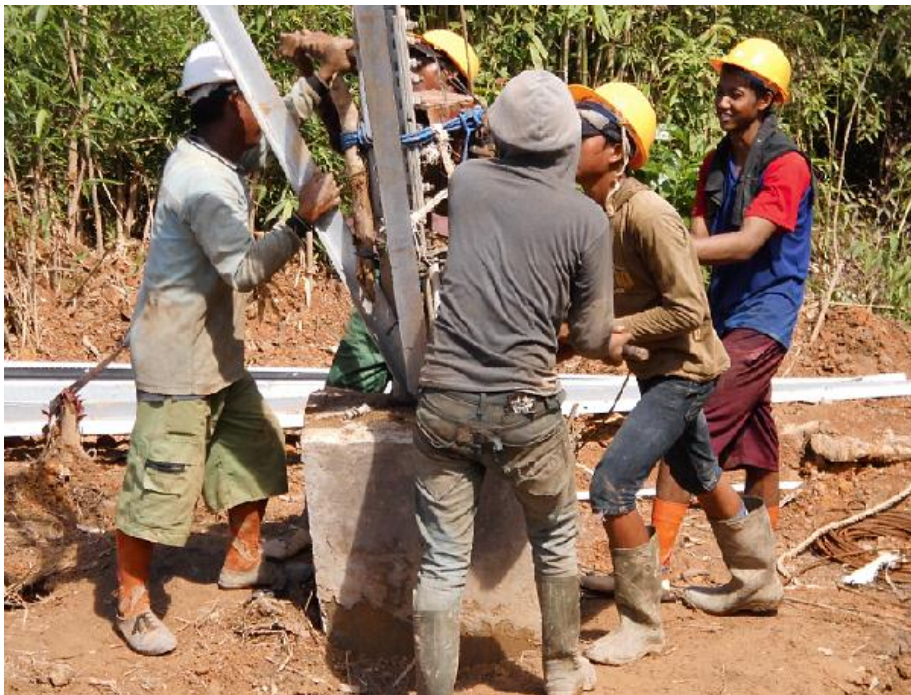
No of Picture: 24

Note:
The workers were manually rotating the pulley for elevating the assembled steel members. They wore safety shoes but some did not wear helmet, and some of them did not wear gloves.

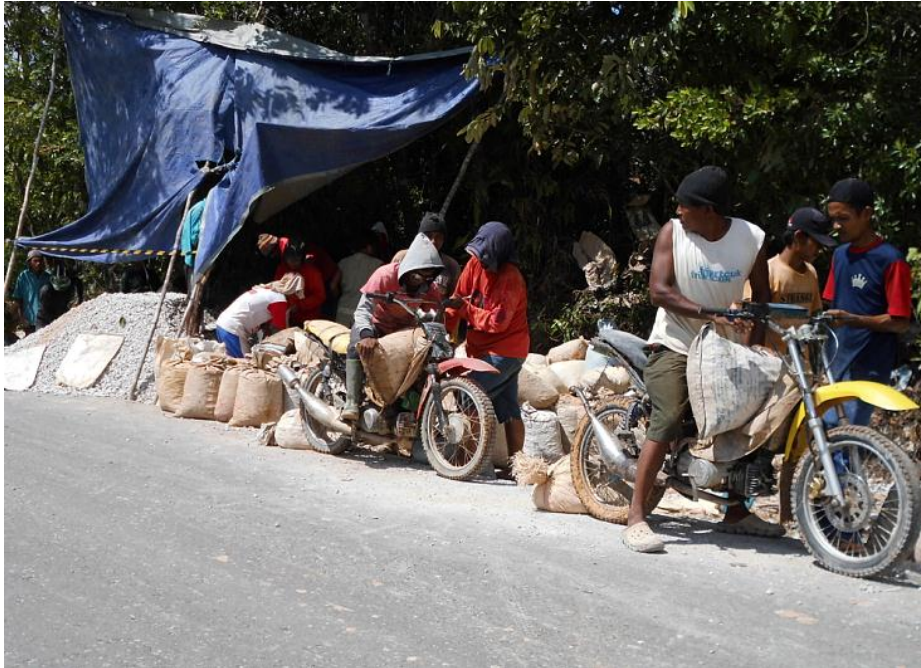
No of Picture: 25

Note: The local people transported the materials for concrete works using motorcycle, they did not wear proper personal protective equipment such as helmet and Safety shoes
