# Environmental Monitoring Report – Part 1

# Semiannual Report  
January – June 2019  
June 2019

## INO: West Kalimantan Power Grid Strengthening Project

**West Kalimantan Power Grid Strengthening Project  
Semi-Annual Environmental Monitoring Report  
January to June 2019**

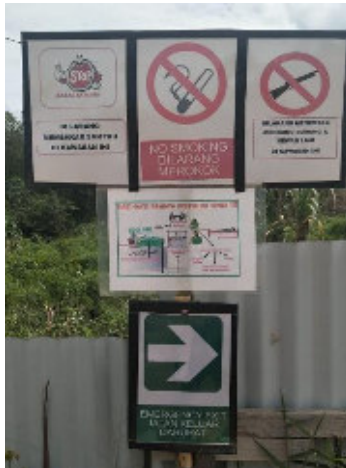
Prohibition of herbicide usage around the Sanggau Substation (April 15, 2019)

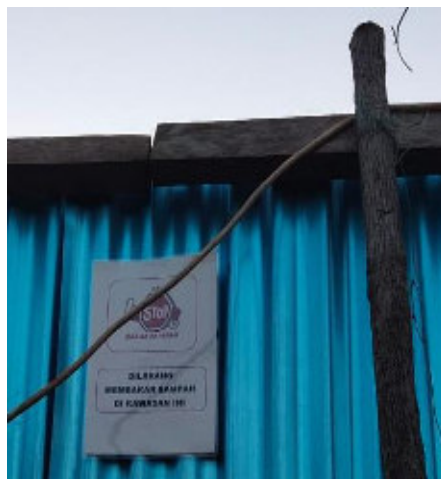
Prohibition of burning waste around the Sekadau Substation (April 16, 2019)

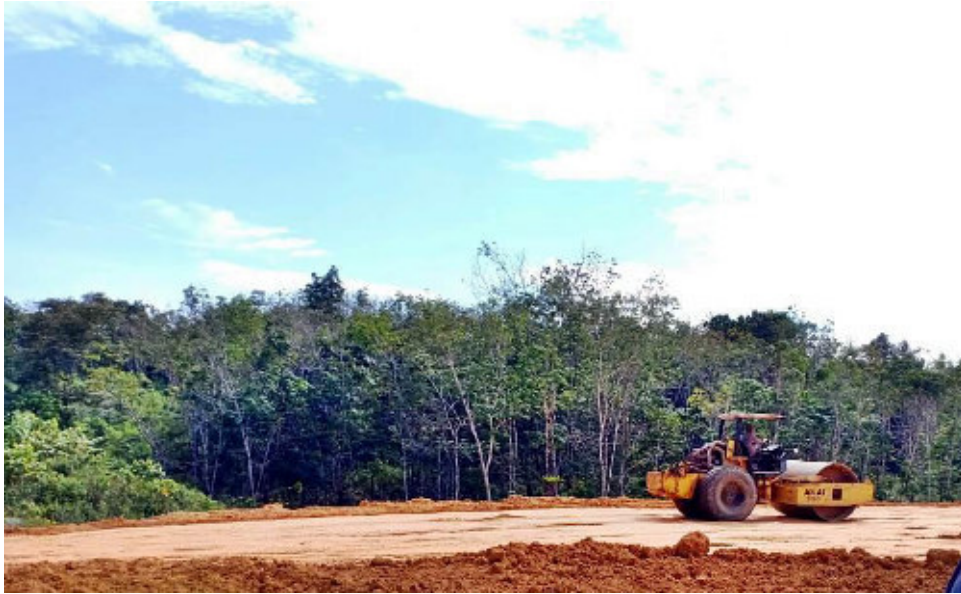
Compacted land in Sanggau Substation (May 7, 2019)

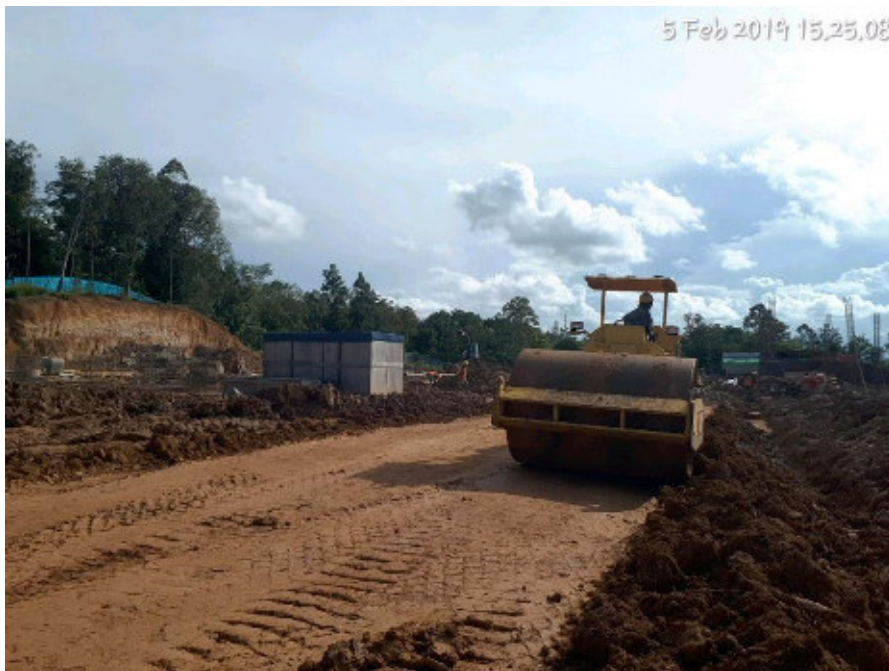
Soil Compaction in Sekadau Substation (February 5, 2019)

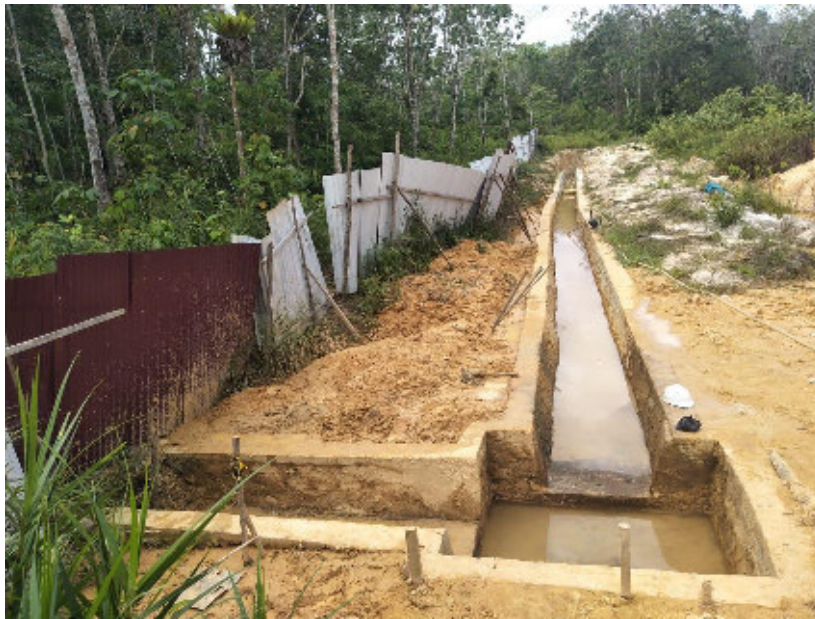
Drainage construction in the Sanggau Substation (June 24, 2019)

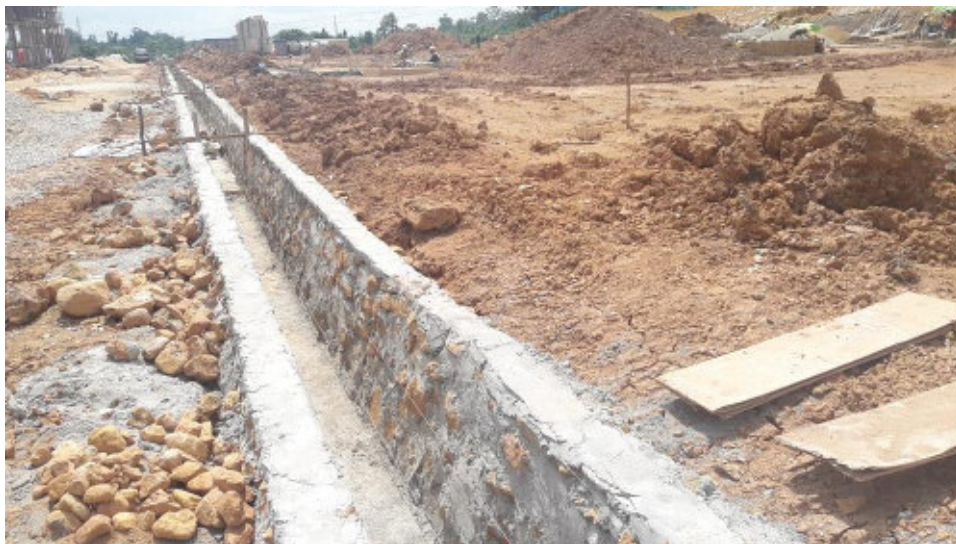
Drainage construction in the Sekadau Substation (May 29, 2019)

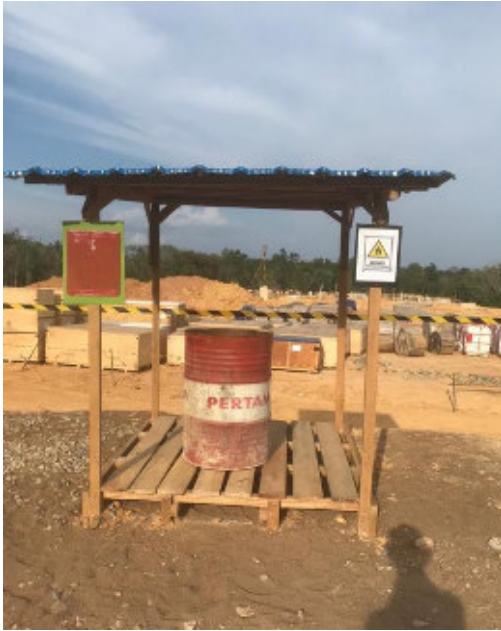
Temporary oil and fuel storage at Sanggau SS (April 12, 2019)

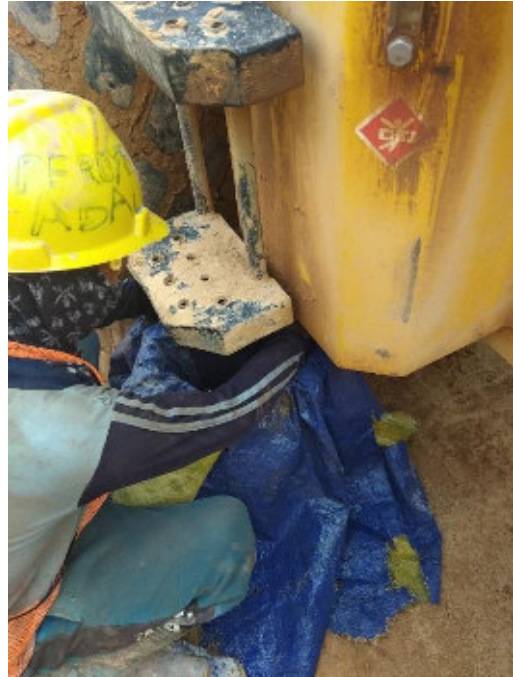
A container wrapped with tarpaulin is used to prevent oil spill during oil changing in Sanggau SS (April 13, 2019)

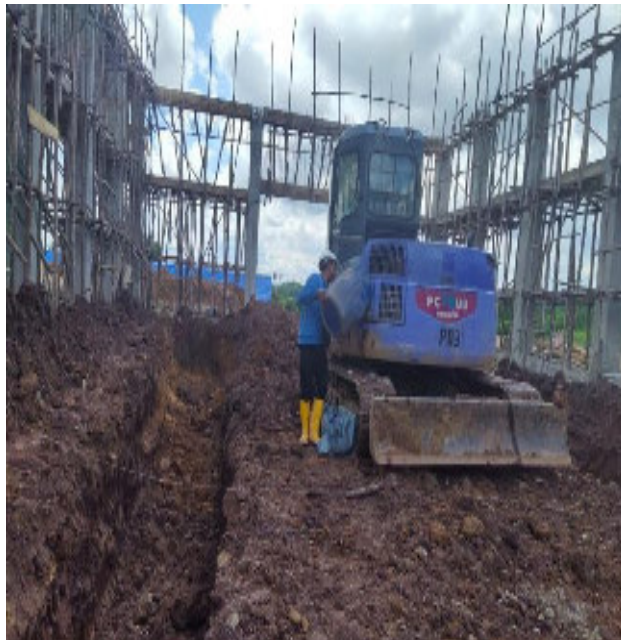
Oil changing using hose in the Sekadau SS, to prevent oil spill using oil secondary containment underneath. (May 12, 2019)

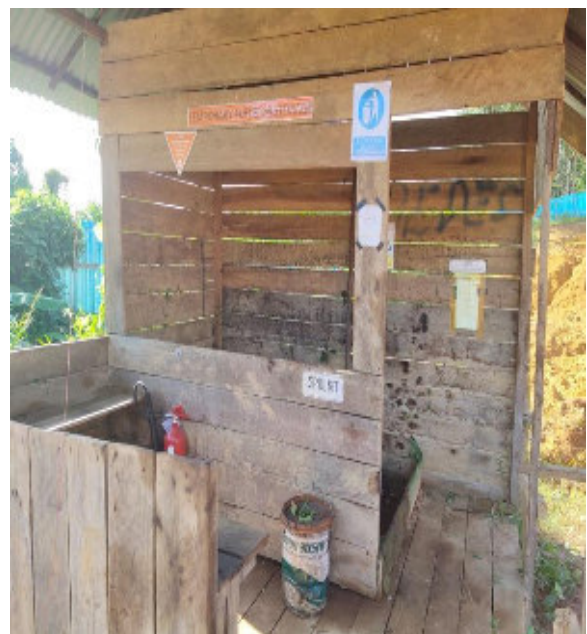
Temporary oil and fuel storage at Sekadau SS equipped with sign, MSDS, spill kit, and fire protection system (Portable Fire Extinguisher type DCP) (April 24, 2019)

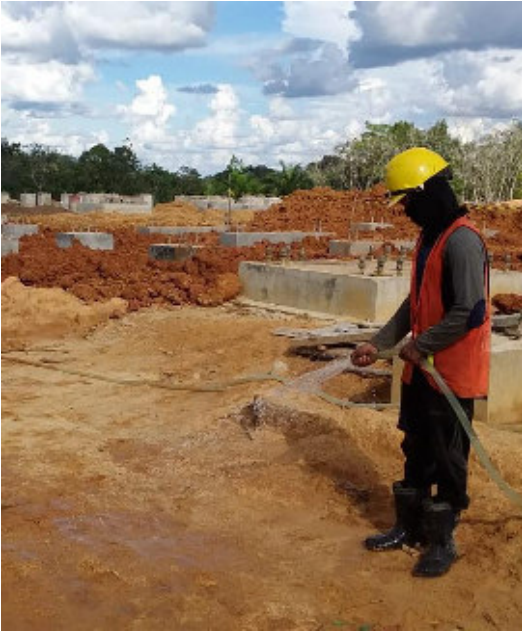
The water spraying was conducted at the Sanggau SS construction site, since dust level is considered high (May 19, 2019)

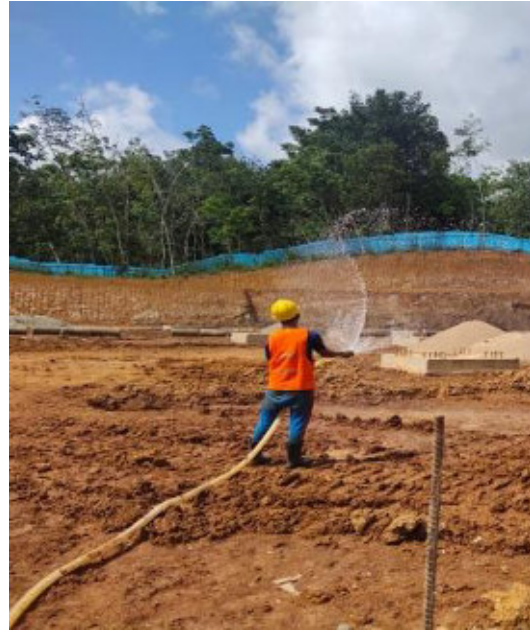
The water spraying was conducted at the Sekadau SS construction site (April 22, 2019)

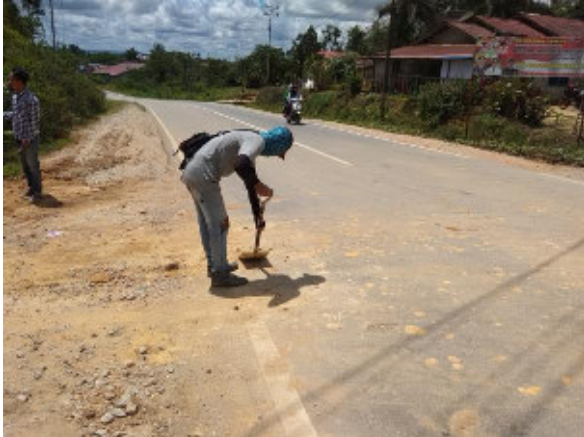
Scraping debris that fell when transporting soil material in Sanggau Substation (June 14, 2019)

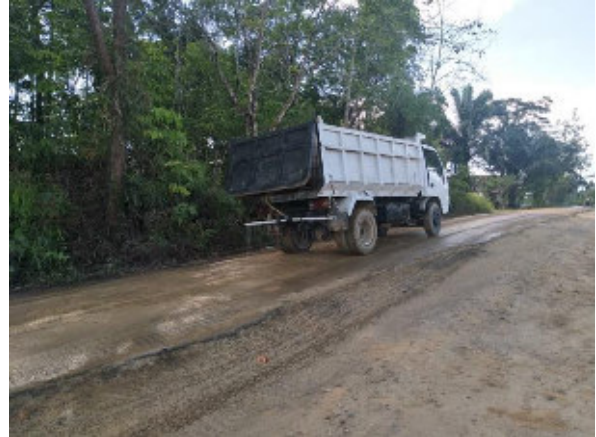
Spraying water on the road to remove the remaining soil in Sanggau Substation (June 14, 2019)

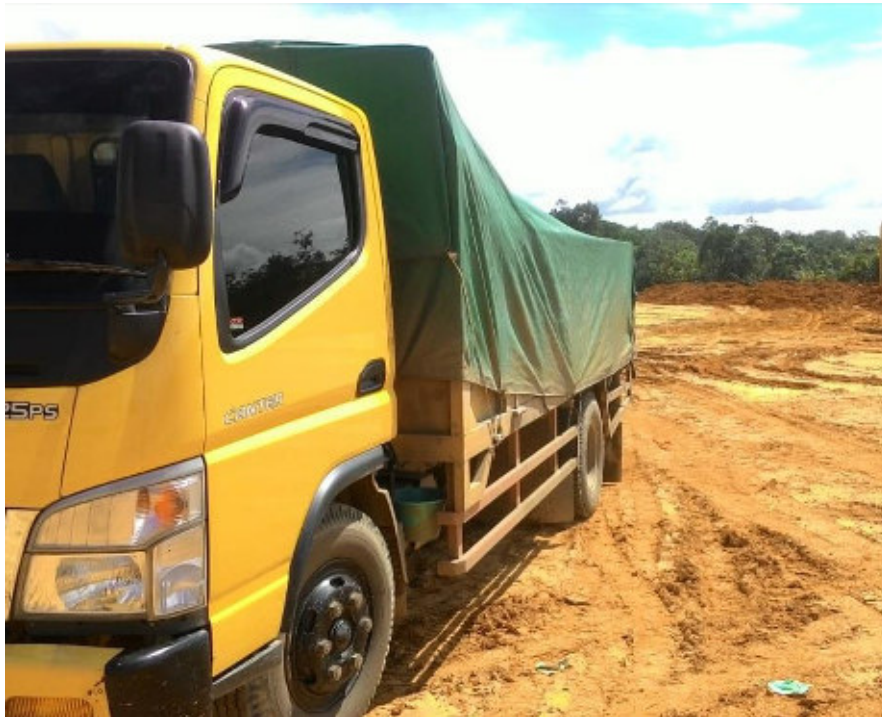
The truck that used as material transport in Sanggau SS was covered to prevent dust pollution (April 16, 2019)

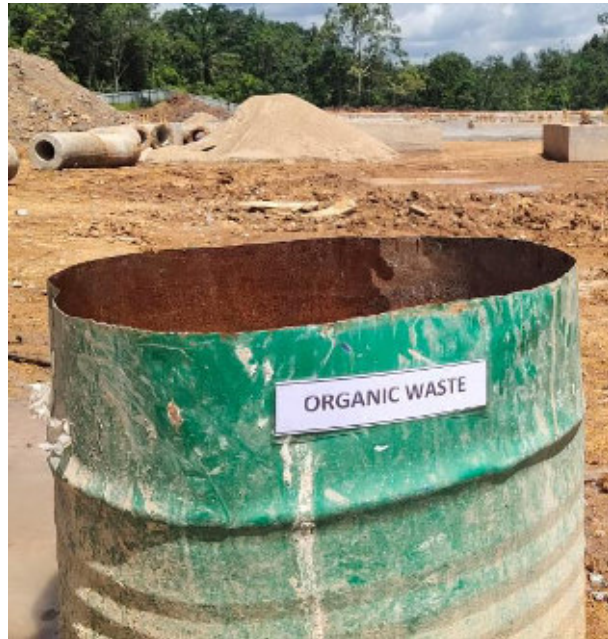
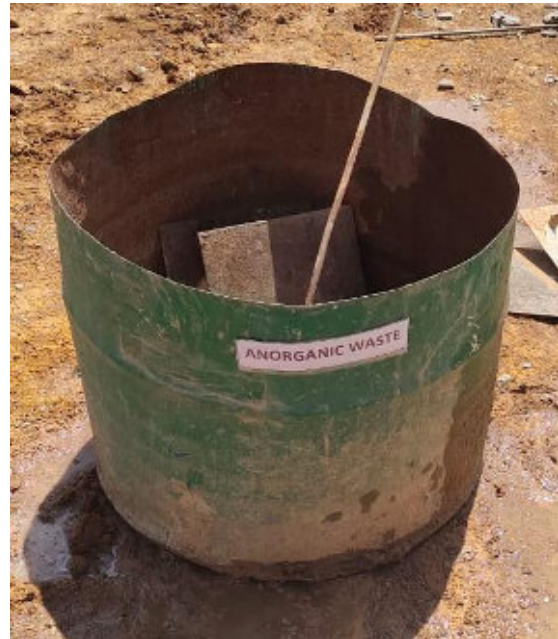
Organic and non-organic waste has already separated in Sekadau SS (March 4, 2019)

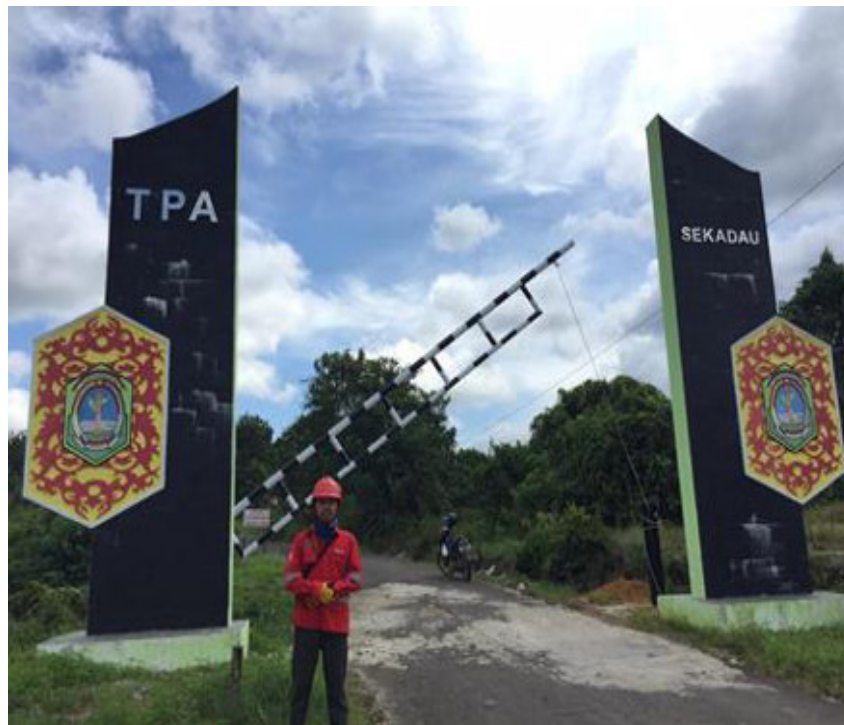
Sekadau Final disposal facilities, in Sekadau-Sanggau street Km. 6, Sekadau Hilir Sub-district (March 4, 2019)

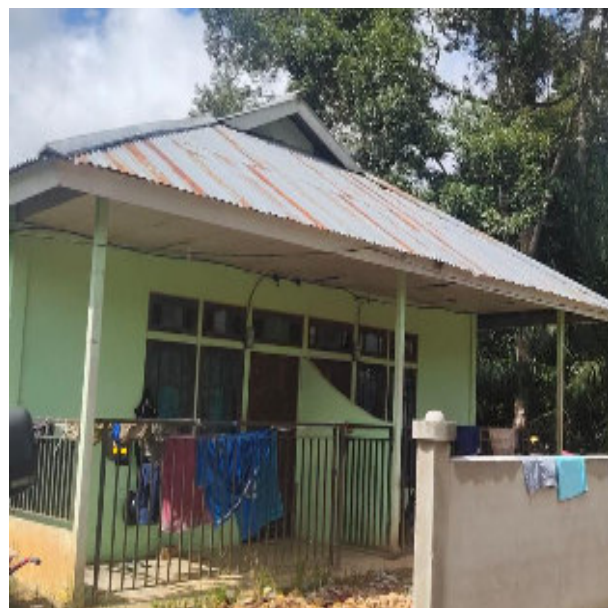
Worker camp in Sekadau (May 23, 2019)

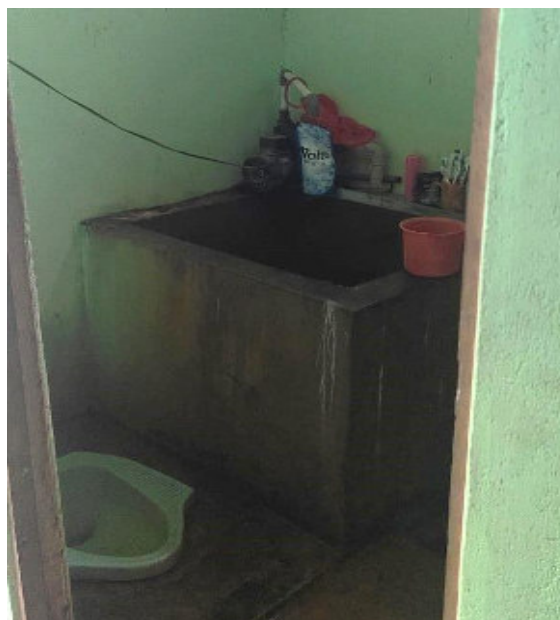
Sanitation facilities in the Sekadau's work camp (May 23, 2019)

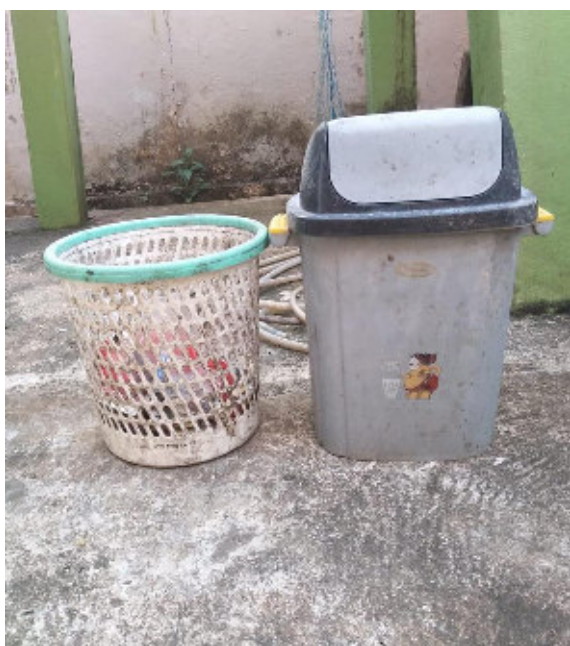
Trash bin in Sanggau's worker camp (May 23, 2019)

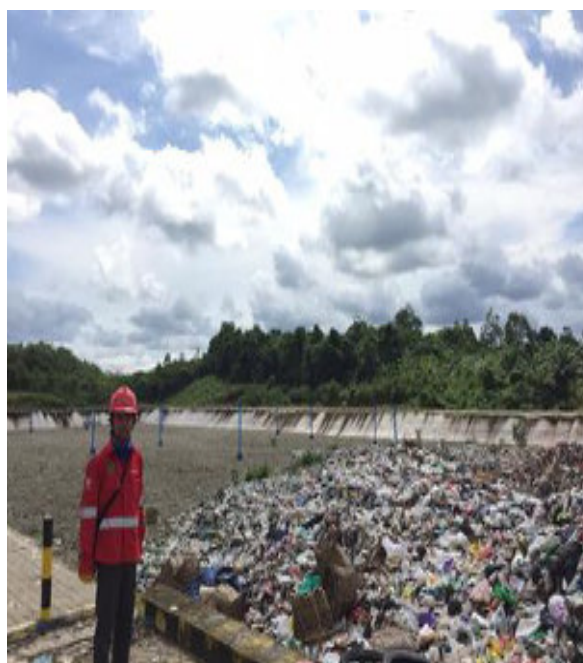
Sekadau Final disposal in Sekadau-Sanggau st. Km. 6, Sekadau Hilir Sub-district (March 4, 2019)

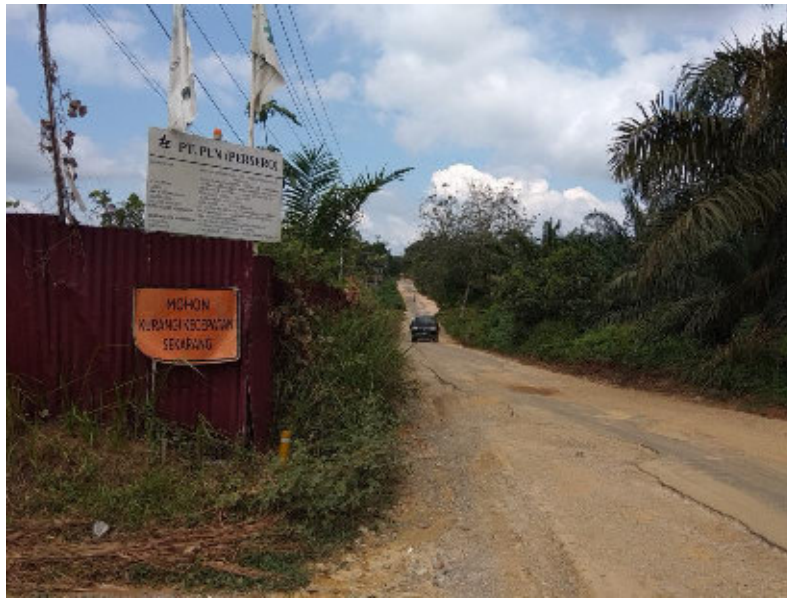
The road access in Sanggau Substation (June 17, 2019)

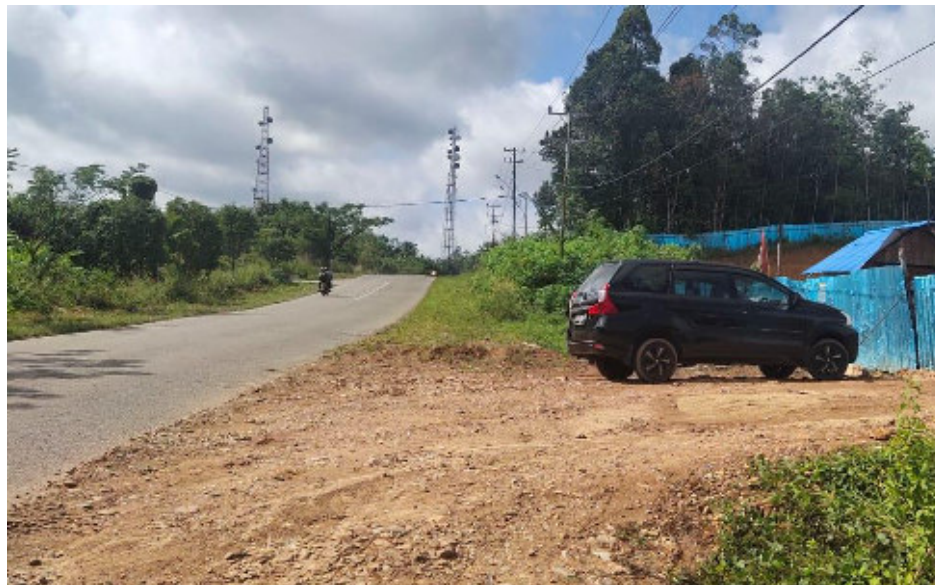
The road access in Sekadau Substation (June 15, 2019)

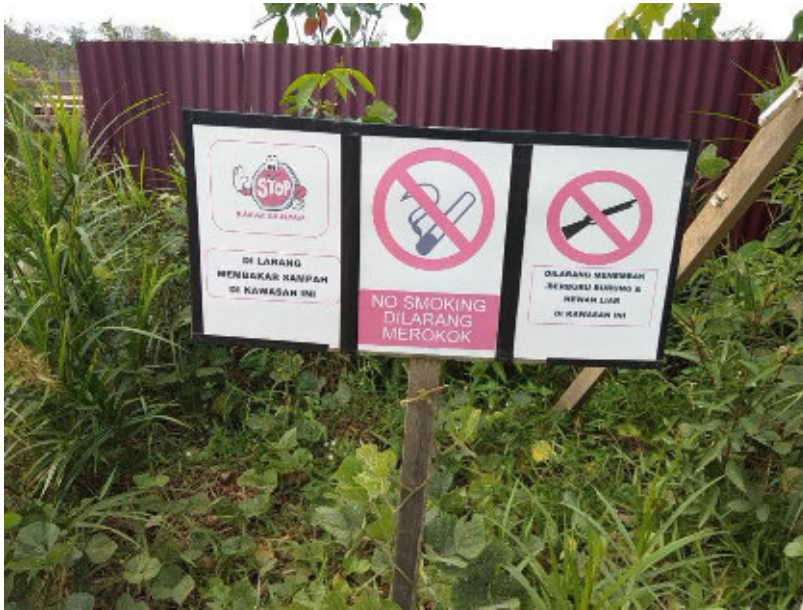
Prohibition of hunting in Sanggau Substation (June 18, 2019)

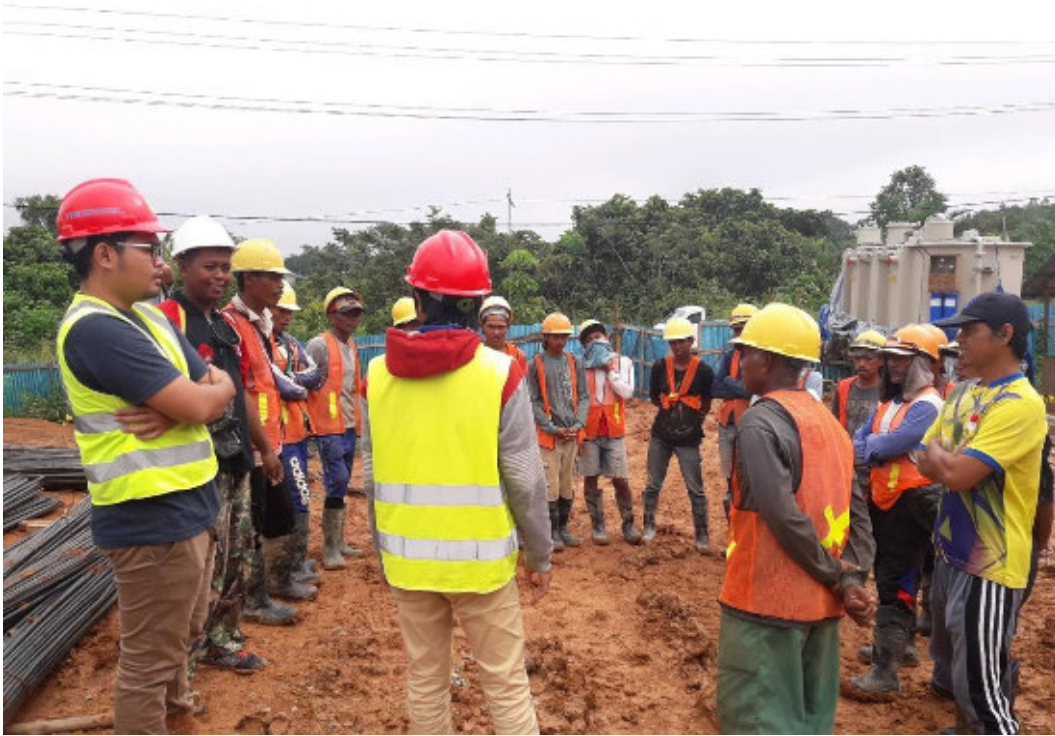
Awareness regarding cultural heritage and resources during toolbox meeting in Sekadau Substation  
(June 22, 2019)

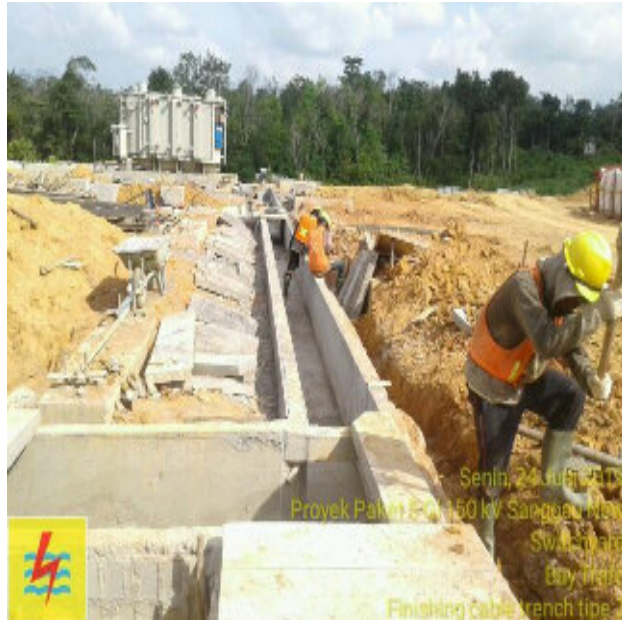
PPE usage for the workers (June 24, 2019)

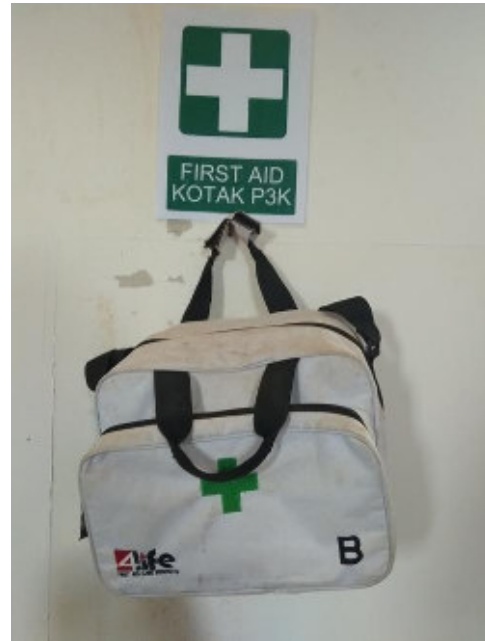
First aid kit (June 10, 2019)

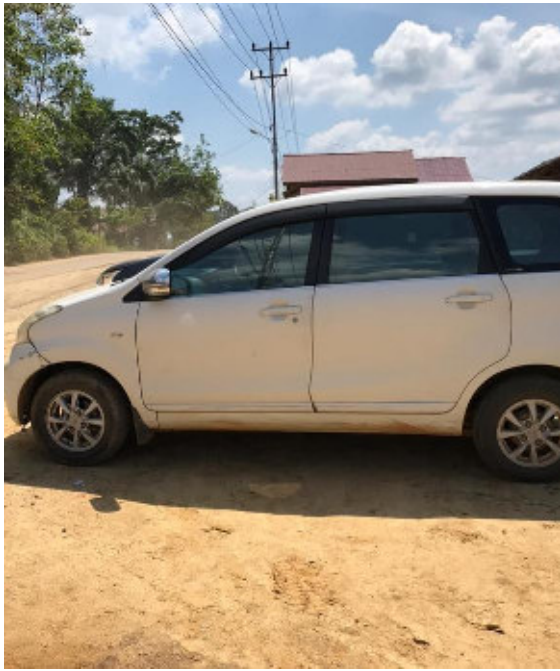
Emergency vehicle services in Sanggau Substation (June 18, 2019)

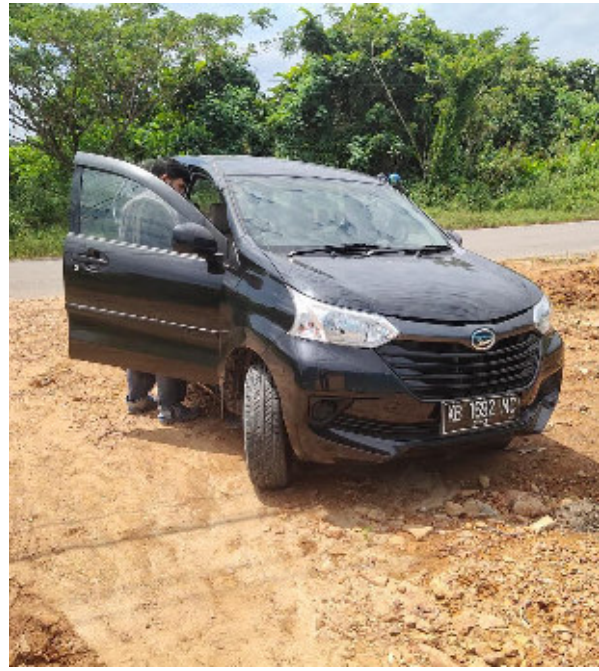
Emergency vehicle services in Sekadau Substation ( June 18, 2019)

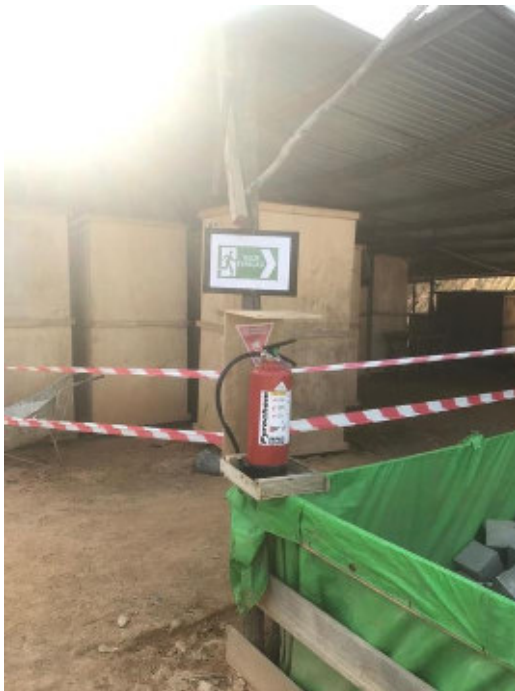
Provide Fire Extinguisher in Sanggau Substation (April 4, 2019)

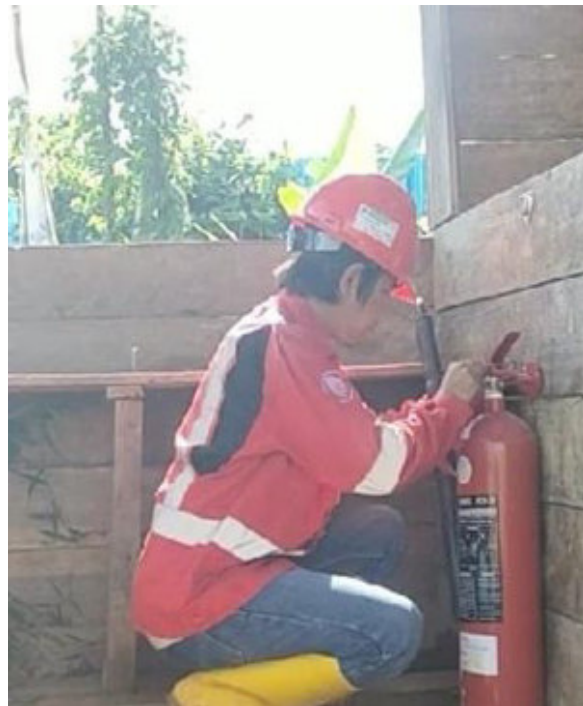
Fire Extinguisher Inspection in Sekadau Substation (May 26, 2019)

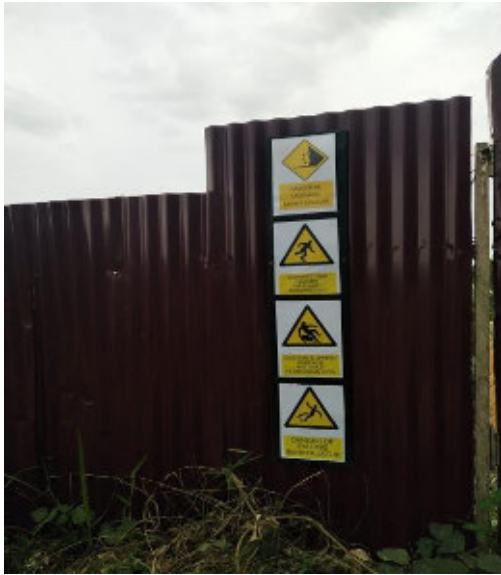
Safety sign around construction site in Sanggau substation (June 25, 2019)

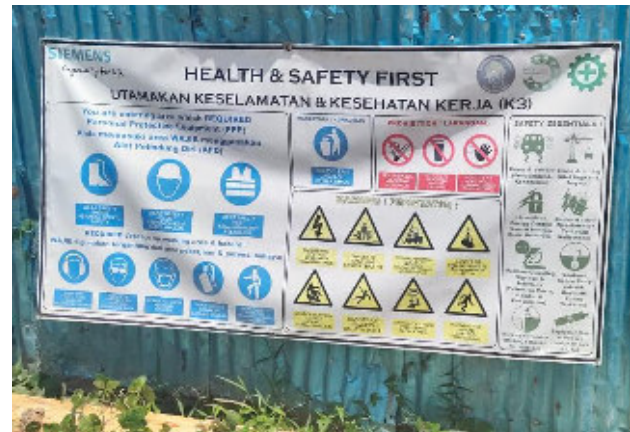
Safety sign around construction site in Sekadau substation (May 10, 2019)

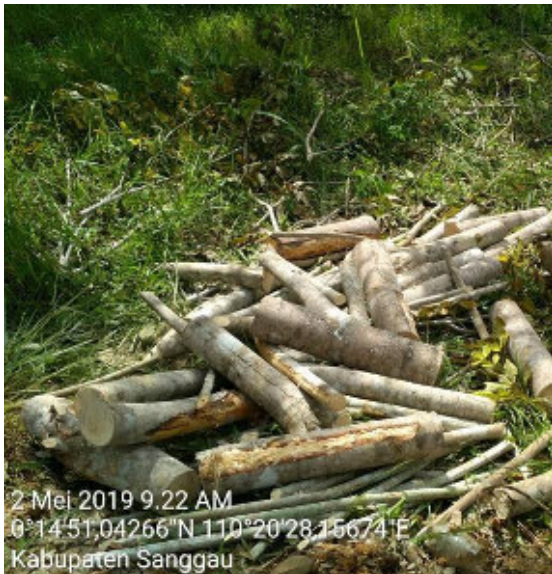
The remaining vegetation removal woods will be used by the people around the project (May 2, 2019)

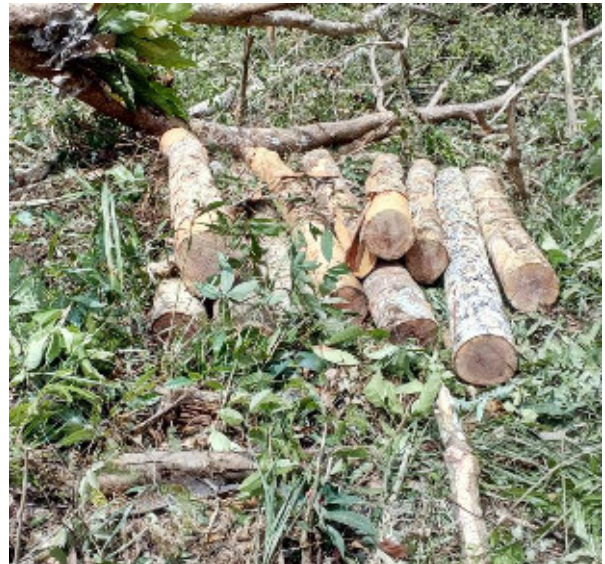
The remaining vegetation removal woods will be used by the people around the project in T. 99 (May 5, 2019)

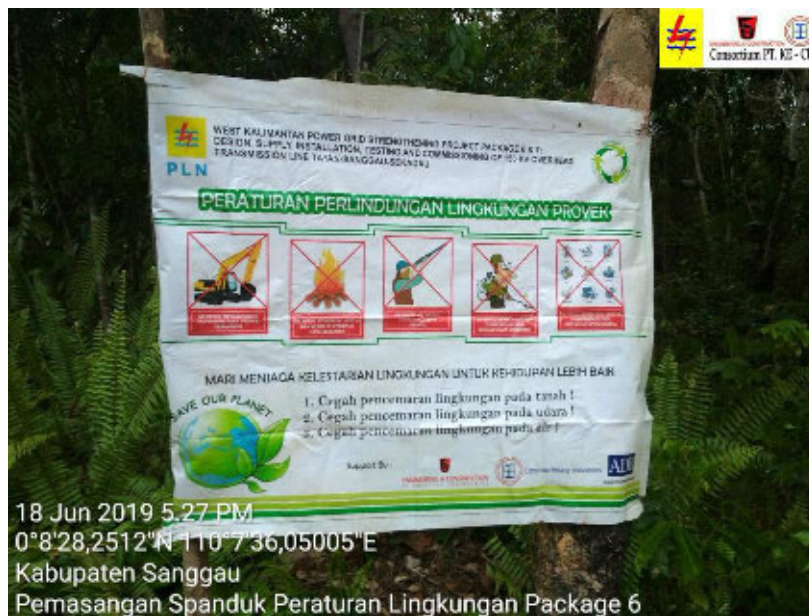
Warning sign related to the prohibition of herbicide and hunting animal in T. 164, Parindu Village (June 18, 2019)

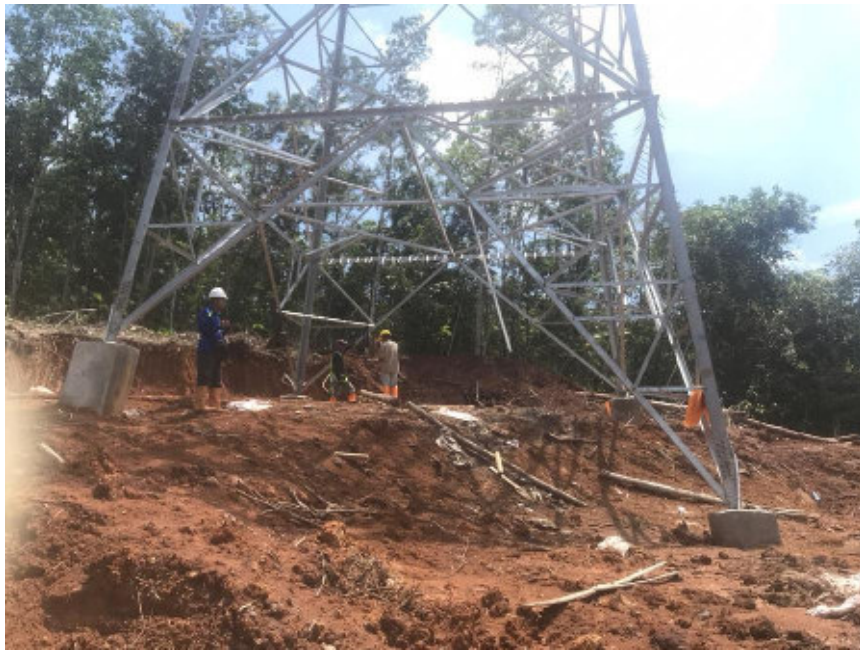
Tower adjusting was done in the location that the land is steep, it located in T.133 Binjai Village  
(April 24, 2019)

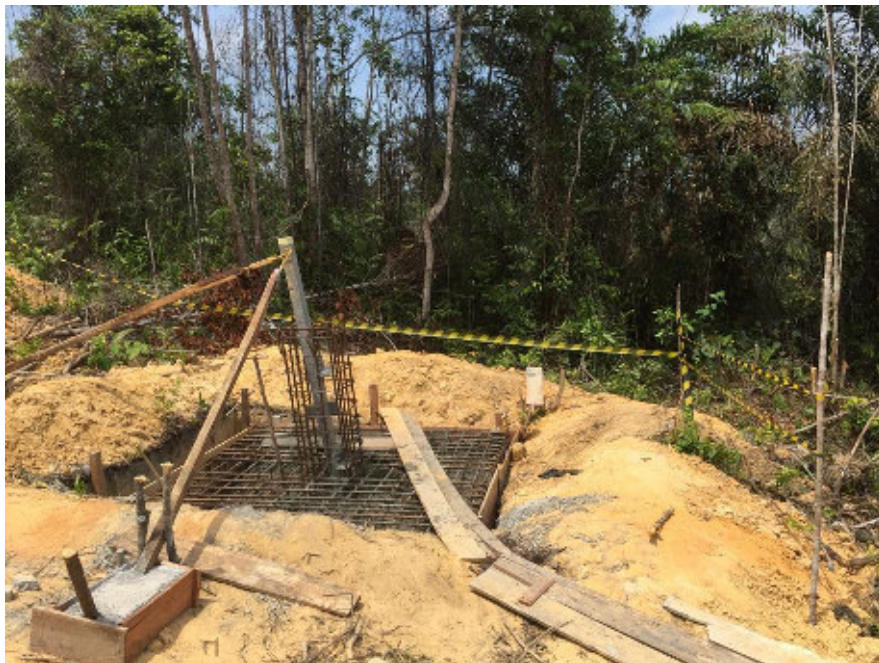
The vegetation cut was used to protect disturbed ground in T. 137R Sei Ringin Village

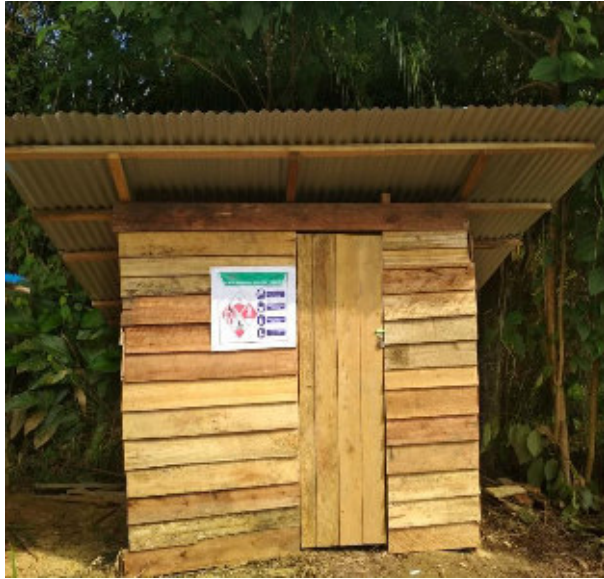
Temporary hazardous waste shelter located in Keadu Village (January 16, 2019)

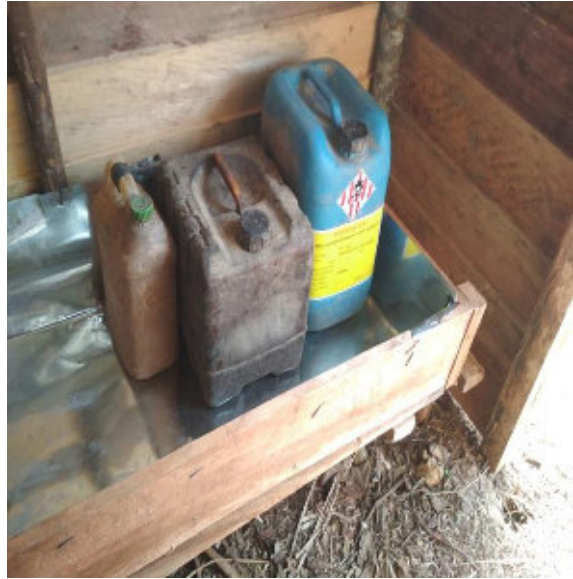
Oil and other hazardous materials was stored with temporary bunds (January 16, 2019)

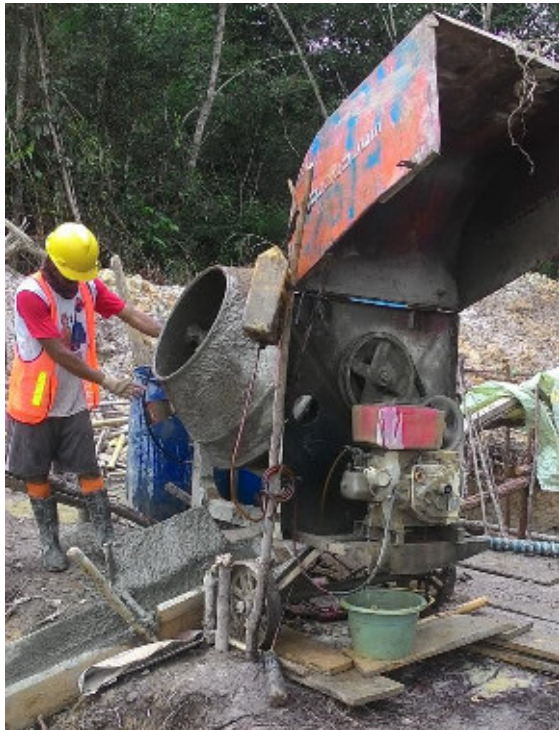
Refueling of machinery using external drum to prevent oil spill contaminate soil in T.203, Sebarra Village (April 29, 2019)

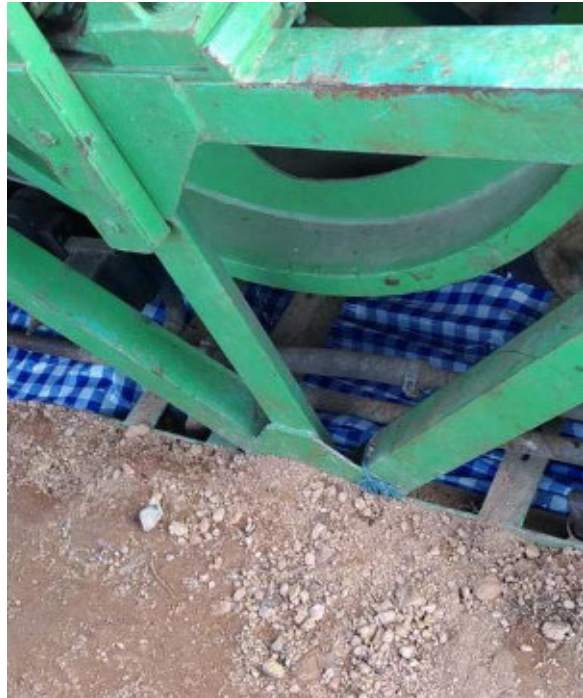
Under the drum engine for stringing work is covered by tarp to prevent oil spill in T.130 (March 24, 2019)

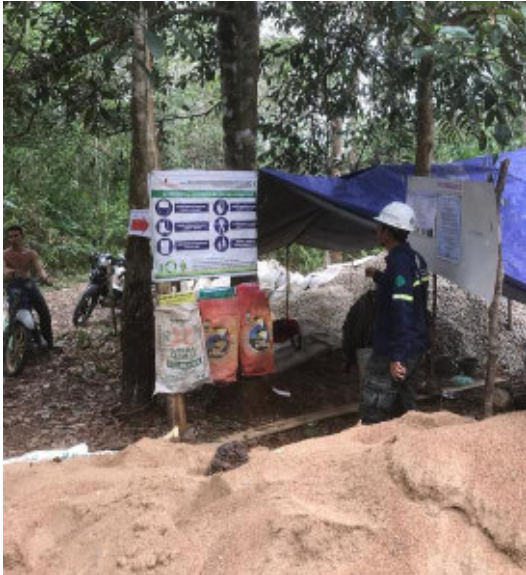
Trash bags that are distinguished based on type of the waste in T. 57 Keadu Village, Sanggau District (June 19, 2019)

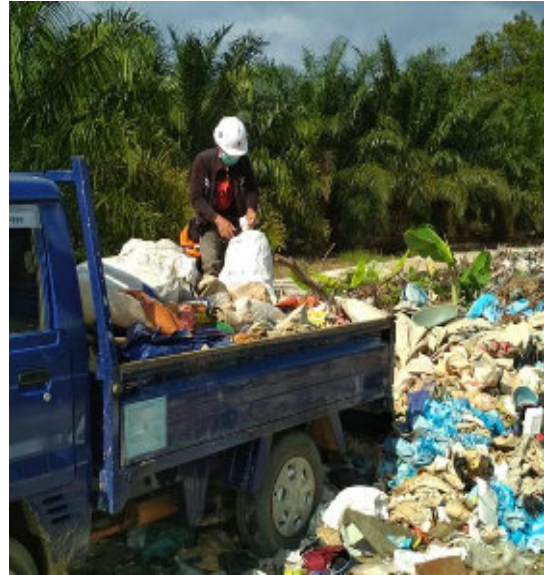
Waste collected, routinely dispose to the nearest final disposal (March 18, 2019)

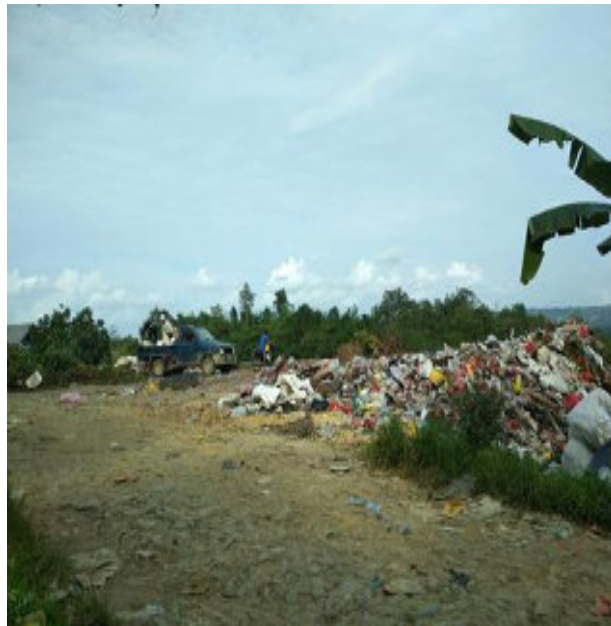
Waste disposal to Sei Kosak disposal in Sanggau District (March 18, 2019)

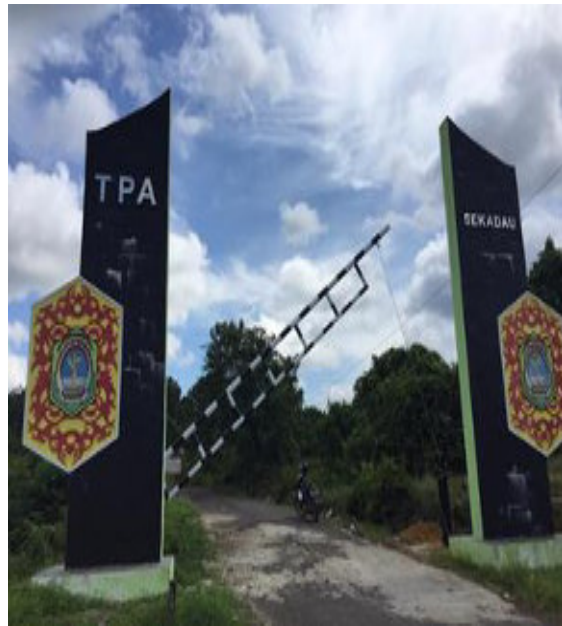
Waste disposal to Sekadau disposal in Sekadau District (March 18, 2019)

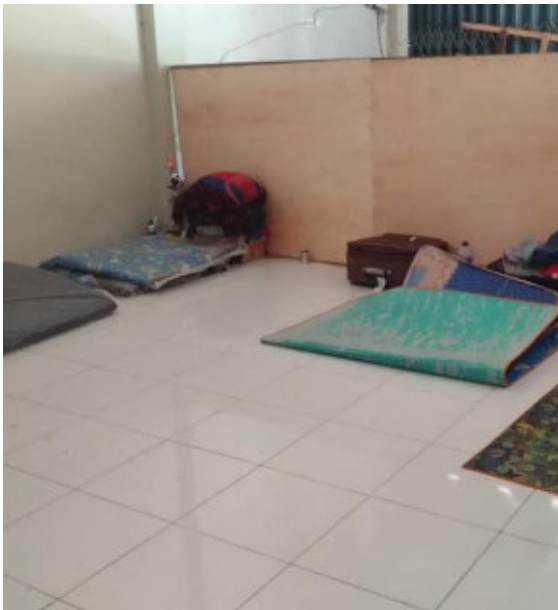
The condition of the stringing worker camp in Binjai Village, Sanggau District (March 25, 2019)

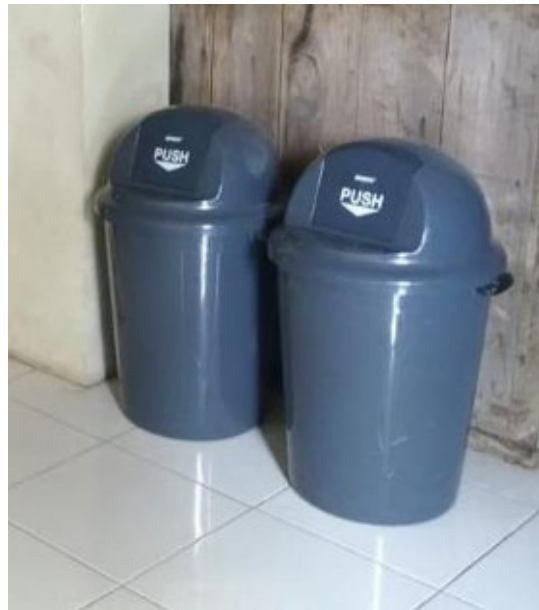
Trash already provided in the worker camp (March 25, 2019)

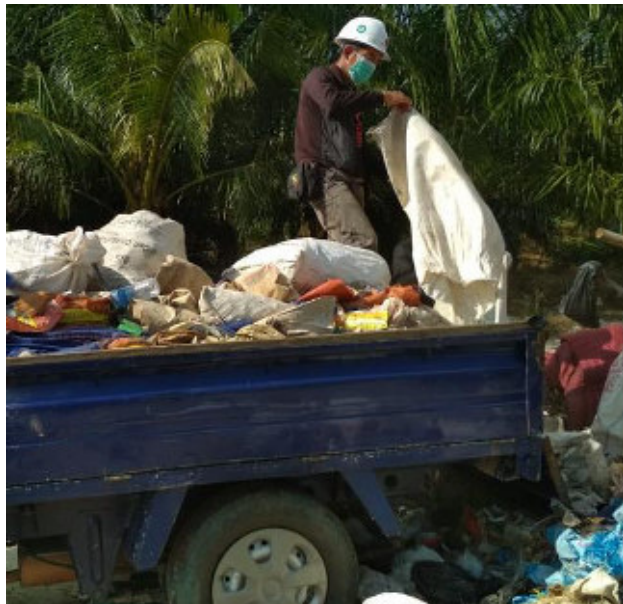
Waste disposal to Sei Kosak final disposal in Sanggau District (March 18, 2019)

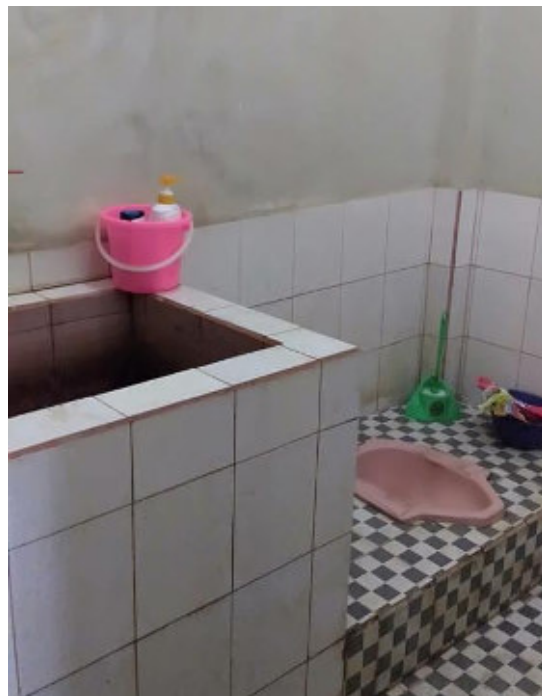
Sanitation conditions in the worker camp that rented from the local community (March 25, 2019)

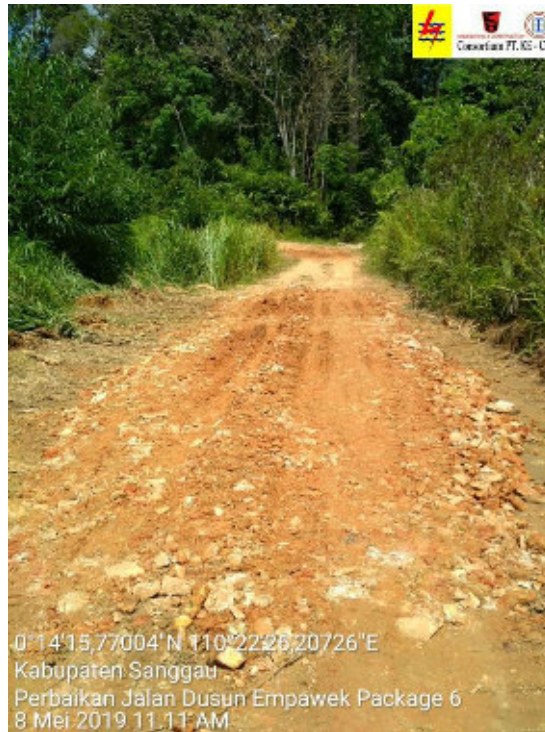
The contractor has been repaired the access road in Empawek Village (May 8, 2019)

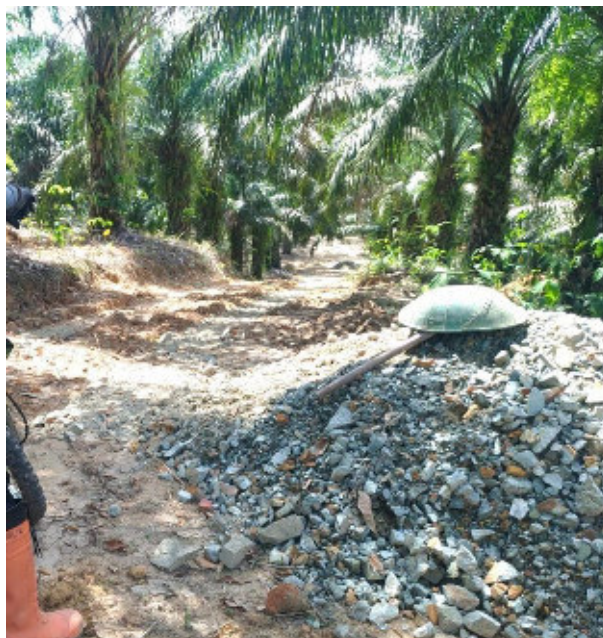
The contractor has been repaired the access road to T. 121 in Peniti Village, Sanggau District (June 19, 2019)

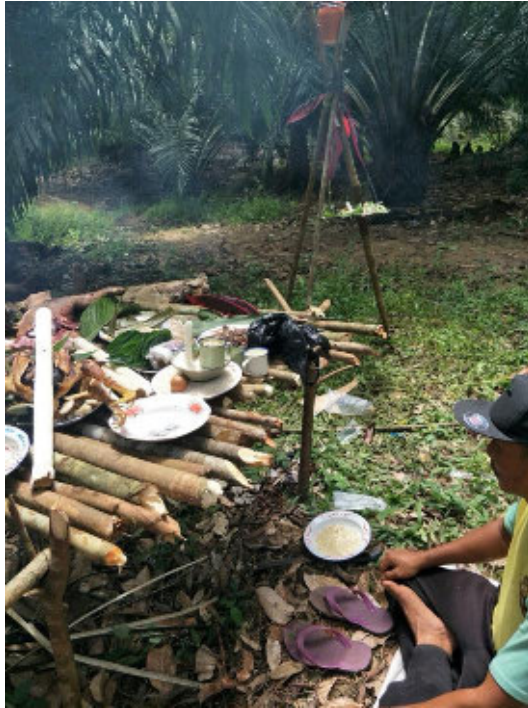
Ngudas ceremony was conducted because the sacred cemetery is located near the tower area in T.158 Palem Jaya Village, Sanggau District (April 2, 2019)
