# Environmental Monitoring Report – Part 1

# Semiannual Report  
January – June 2019  
June 2019

## INO: West Kalimantan Power Grid Strengthening Project

**West Kalimantan Power Grid Strengthening Project  
Semi-Annual Environmental Monitoring Report  
January to June 2019**

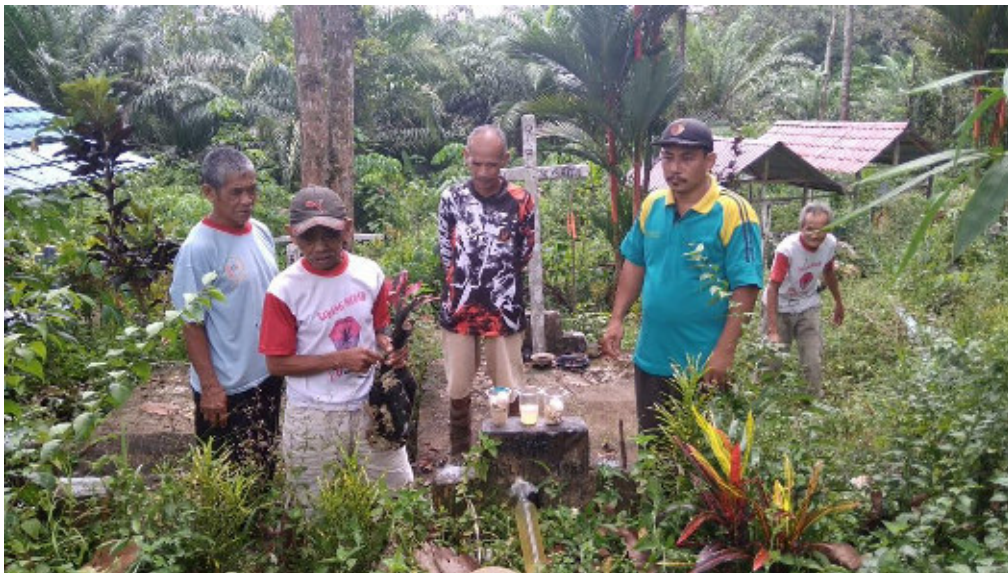
Ngudas ceremony was conducted because the sacred cemetery was found near T.168 Sebarra Village, Sanggau District (April 7, 2019)
