# Environmental Monitoring Report

Project Number: 41193-019  
Semiannual Report  
December 2018

## MON: Western Regional Road Corridor Investment Program, Tranche 2

## ENVIRONMENTAL MONITORING REPORT: AUGUST TO OCTOBER, 2018

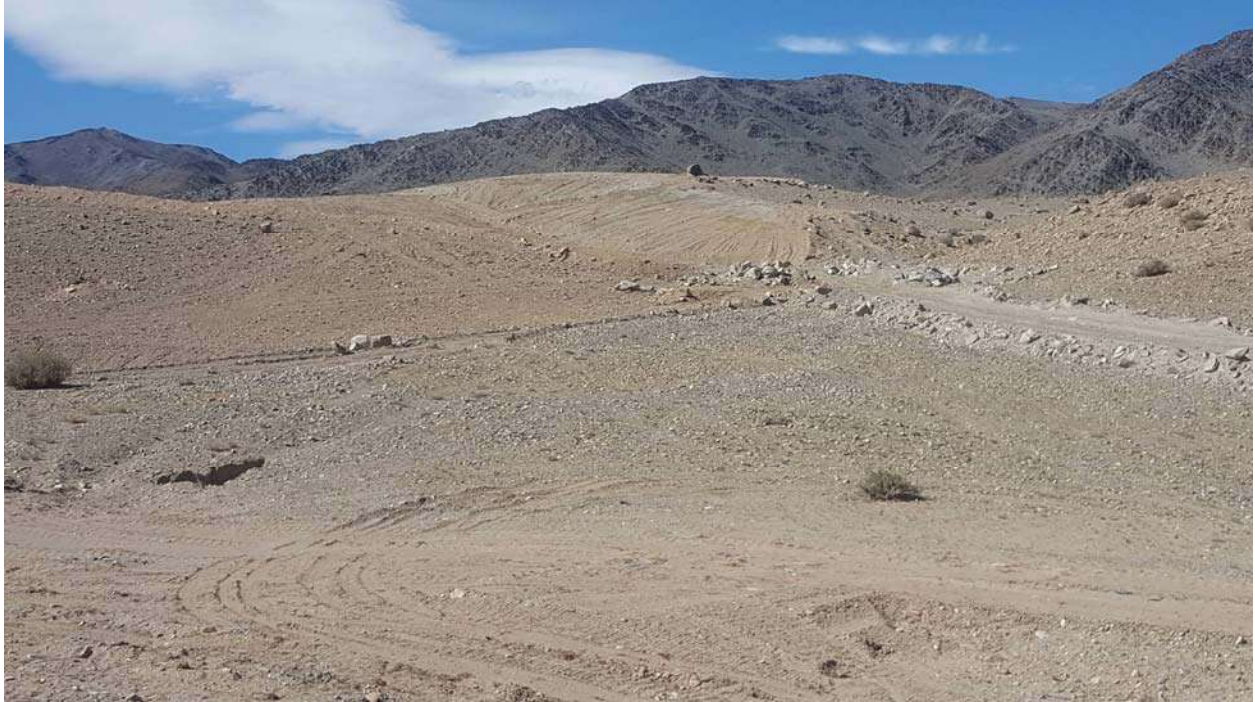
**Restored borrow pit at the lot CW1-1. STA. 49+700. September, 2018.**

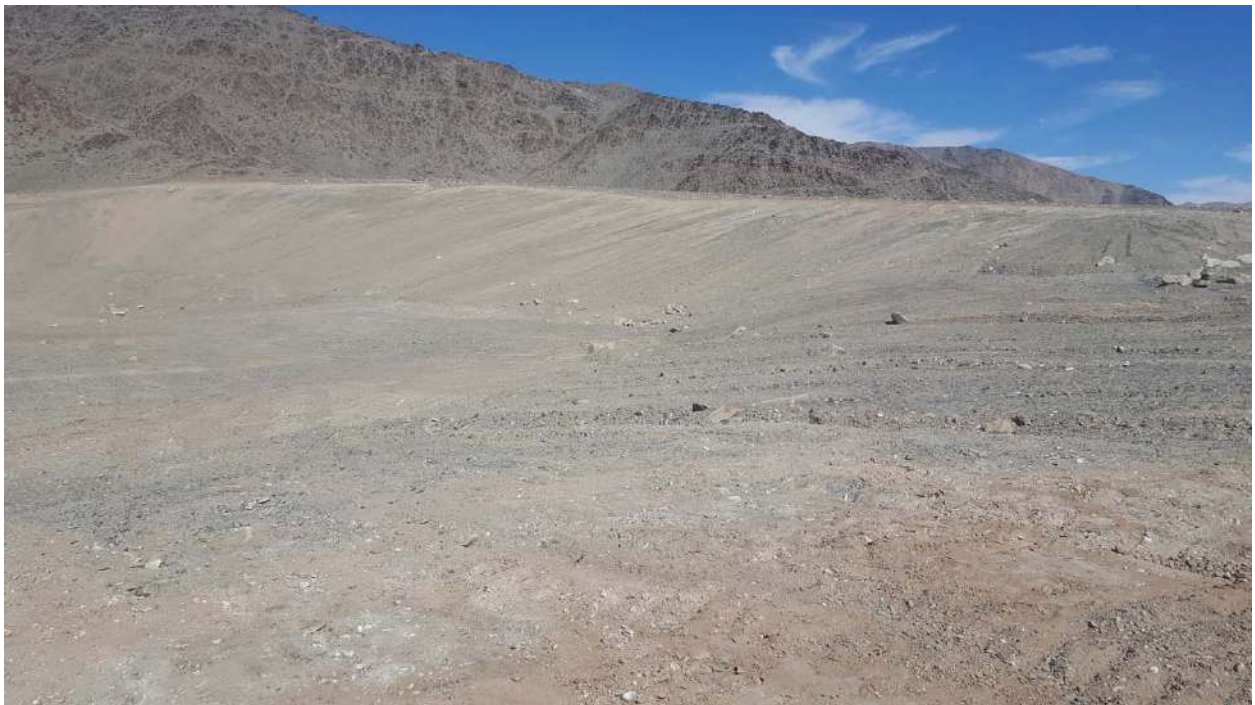
**Restored borrow pit at the lot CW1-1. STA. 38+000. September, 2018.**

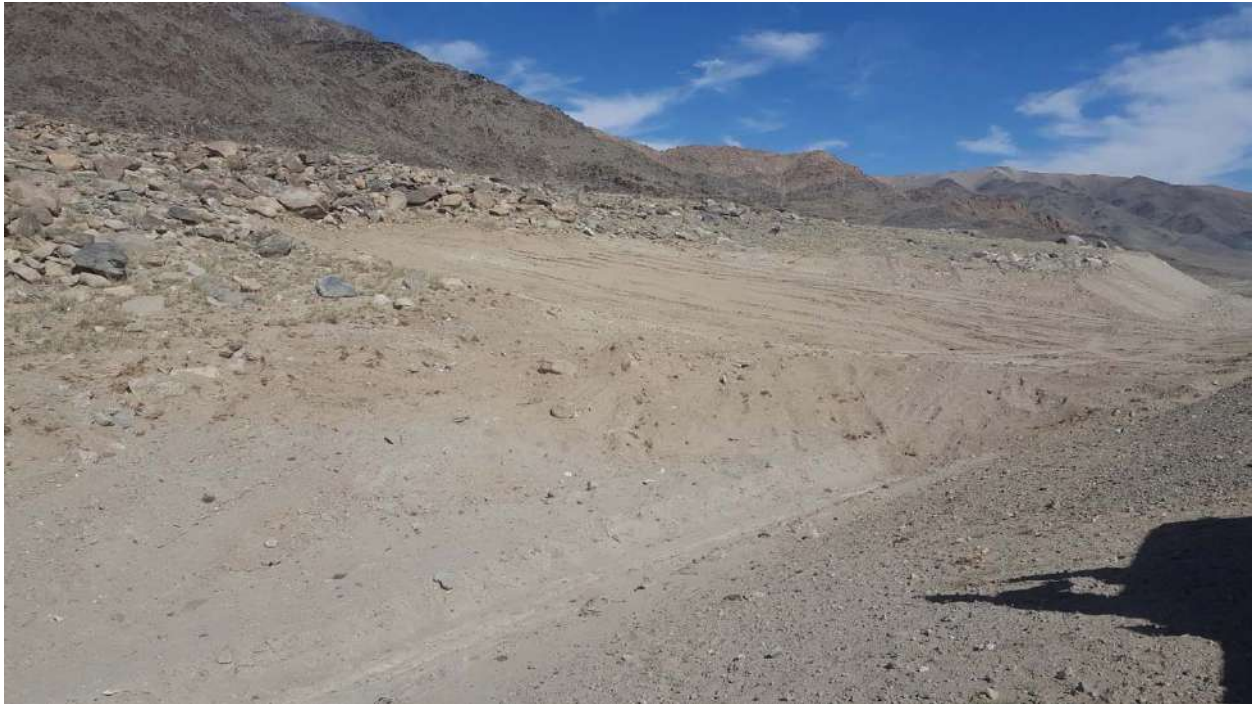
**Restored borrow pit at the lot CW1-1. STA. 29+200. September, 2018.**

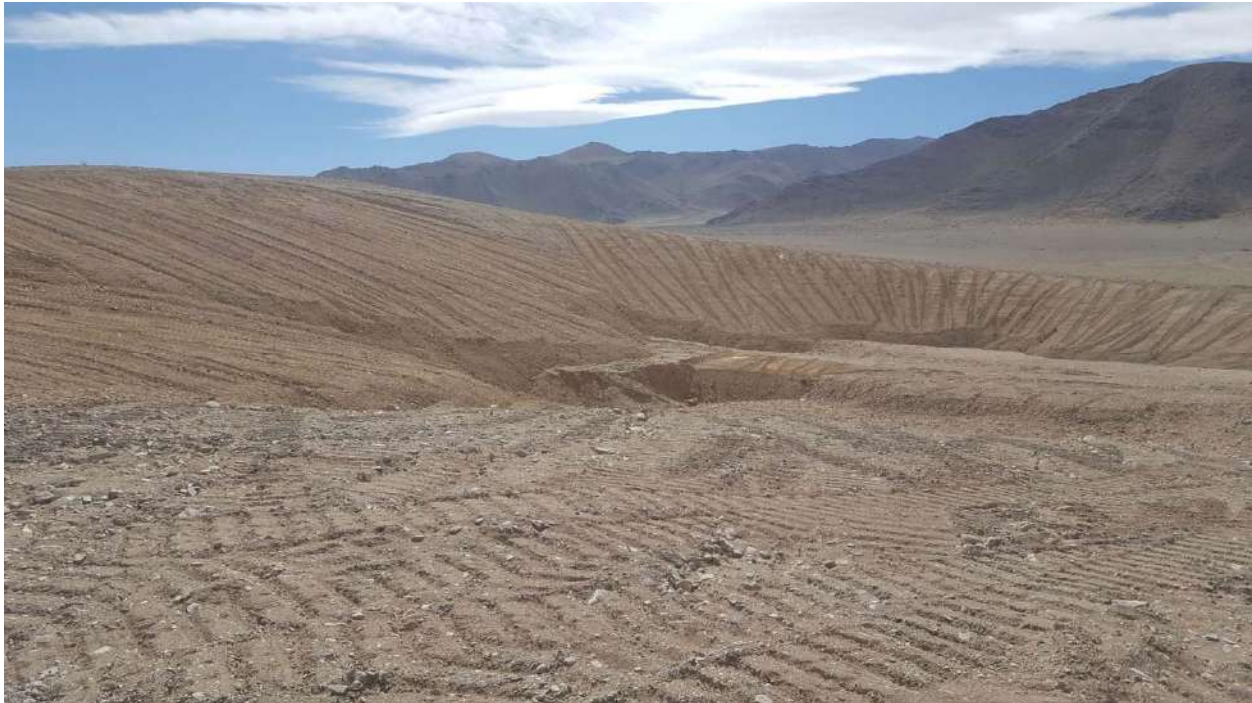
**Restored borrow pit at the lot CW1-1. STA. 19+840. September, 2018.**

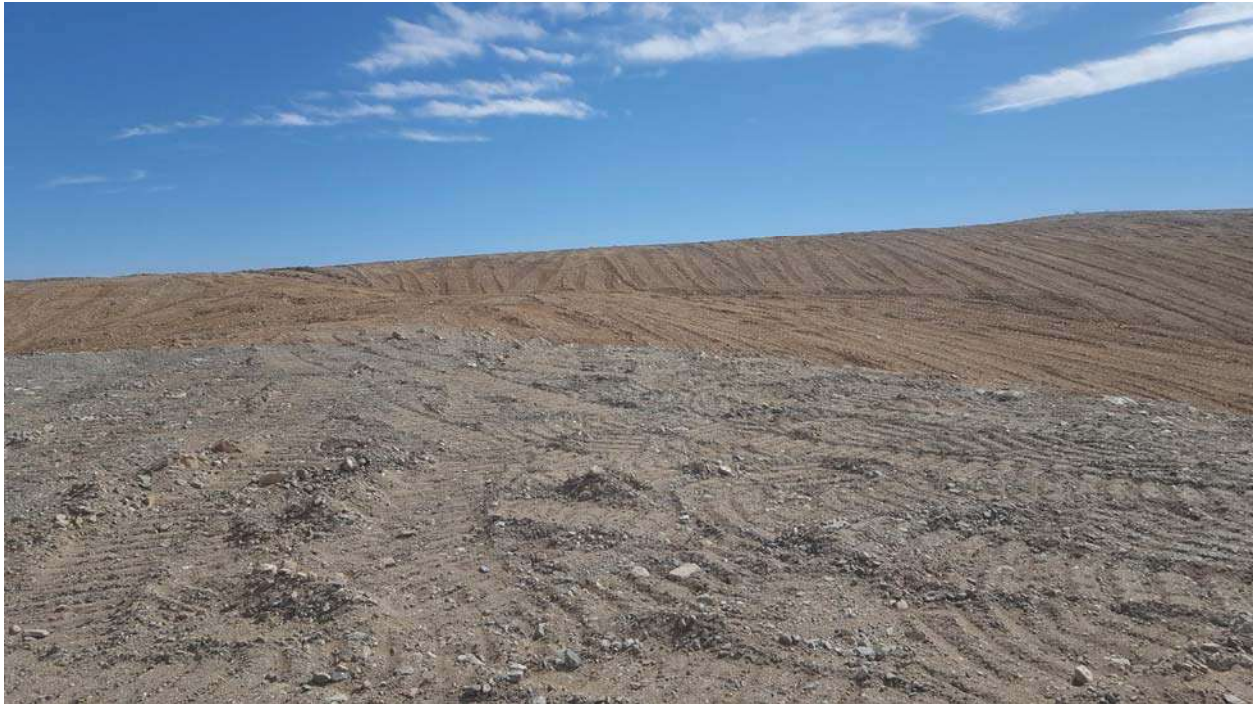
**Restored borrow pit at the lot CW1-1. STA. 24+460. September, 2018.**

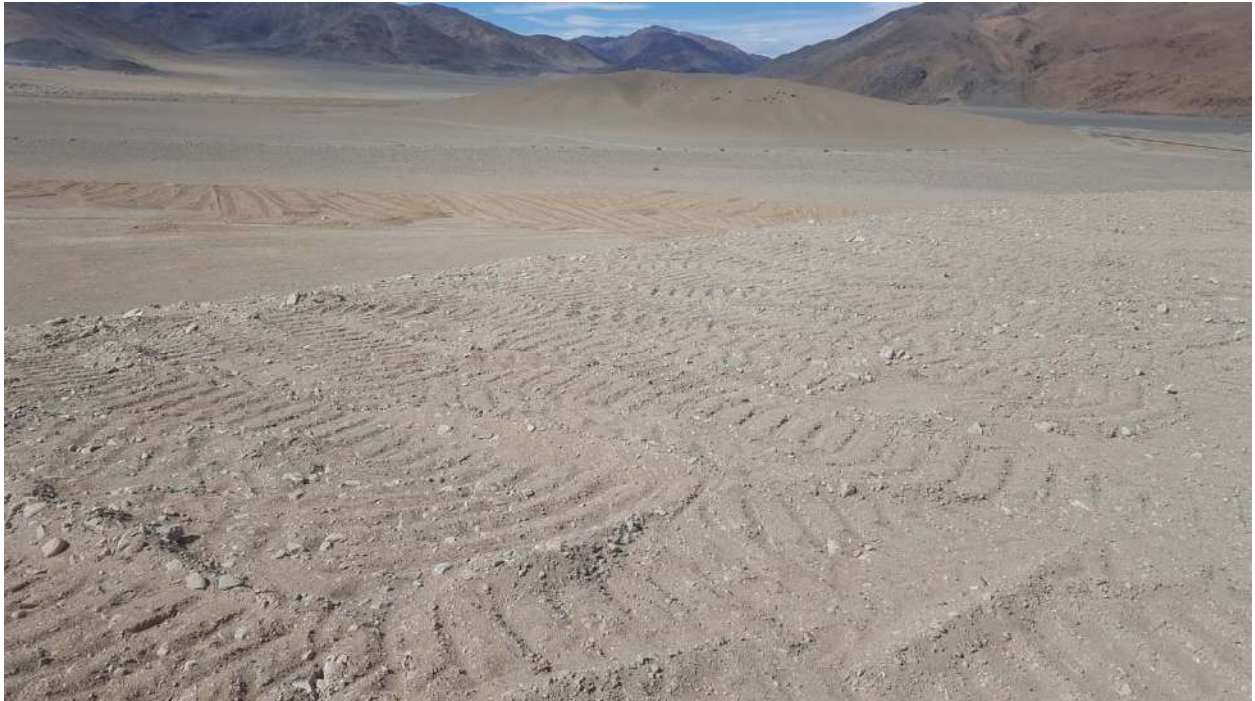
**Restored borrow pit at the lot CW1-1. STA. 12+100. September, 2018.**

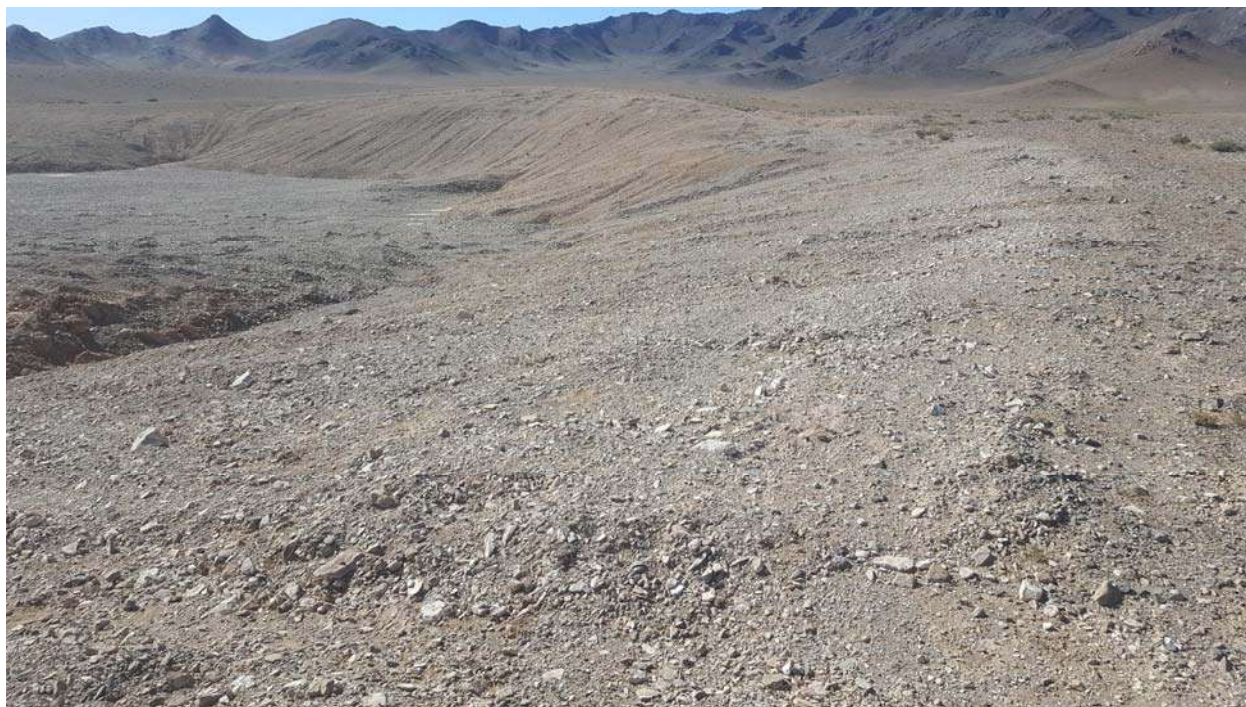
**Restored borrow pit at the lot CW1-1. STA. 2+200. September, 2018.**

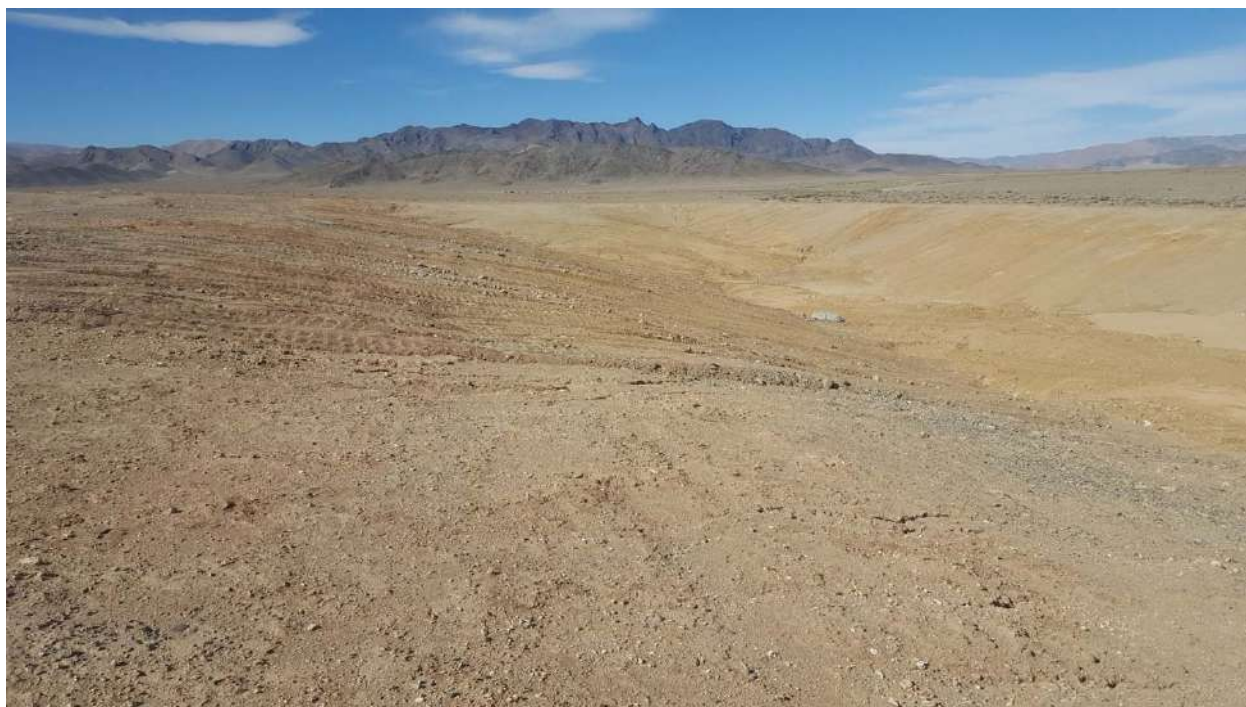
**Restored borrow pit at the lot CW1-1. STA. 35+350. September, 2018.**

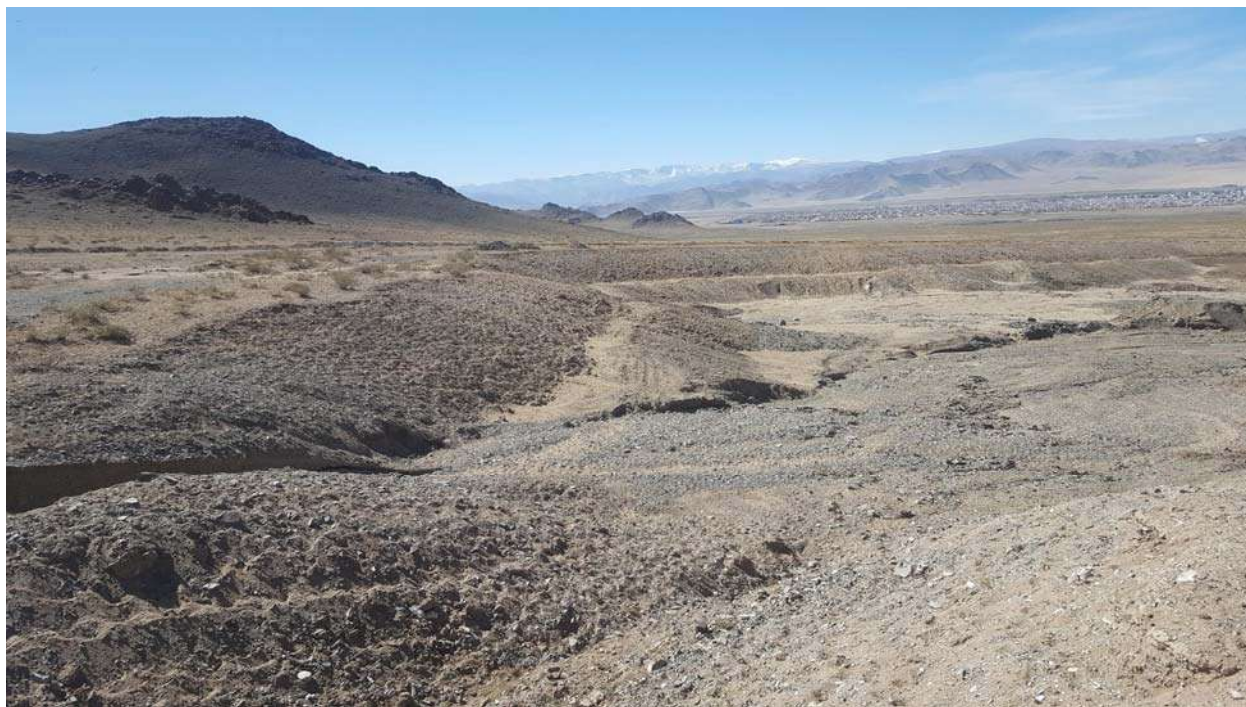
**Photo. Restored borrow pit at the lot CW1-2. STA.103+000 , September, 2018**

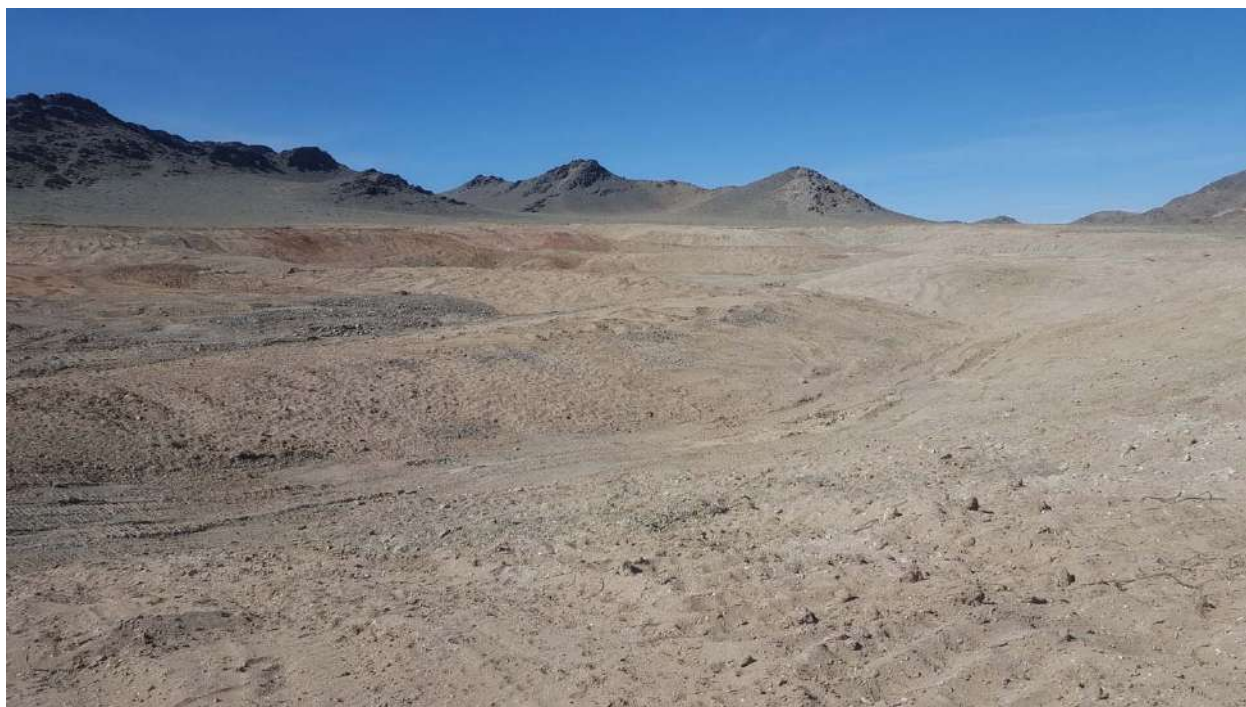
**Photo. Restored borrow pit at the lot CW1-2. STA.57+000, September, 2018**

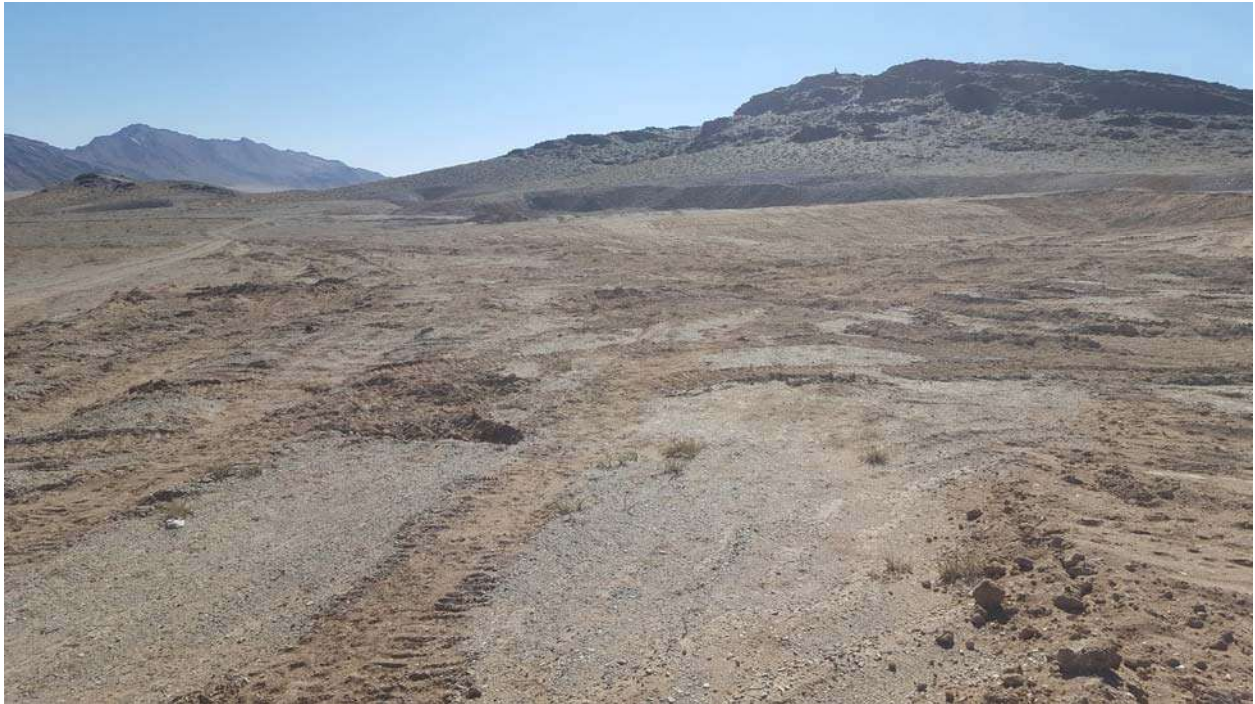
**Photo. Restored borrow pit at the lot CW1-2. STA.65+360, September, 2018**

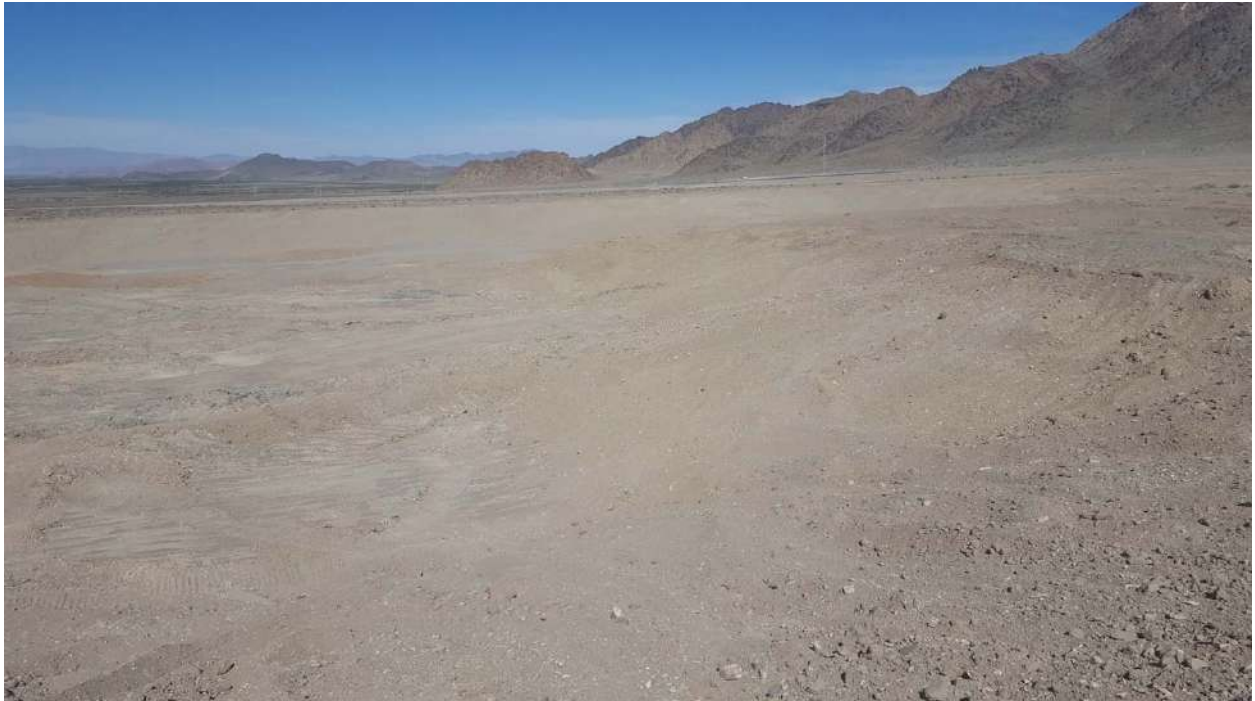
**Photo. Restored borrow pit at the lot CW1-2. STA.68+800, September, 2018**

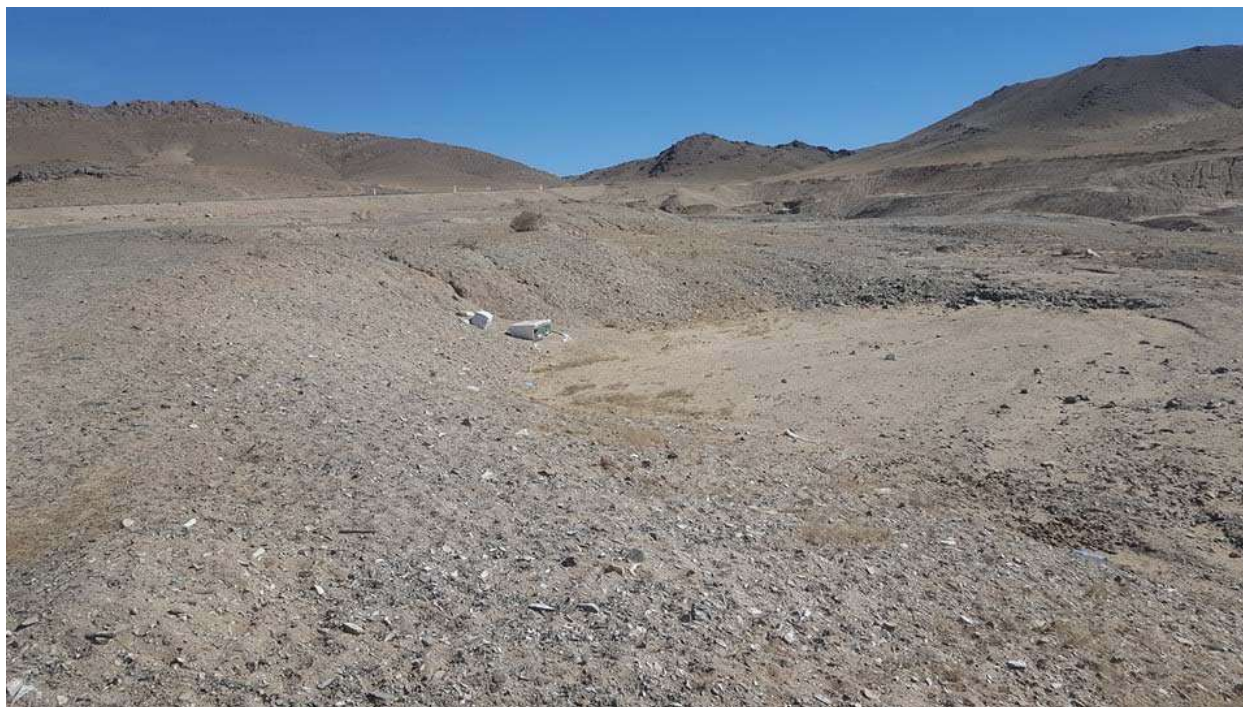
**Photo. Restored borrow pit at the lot CW1-2. STA.52+300, September, 2018**

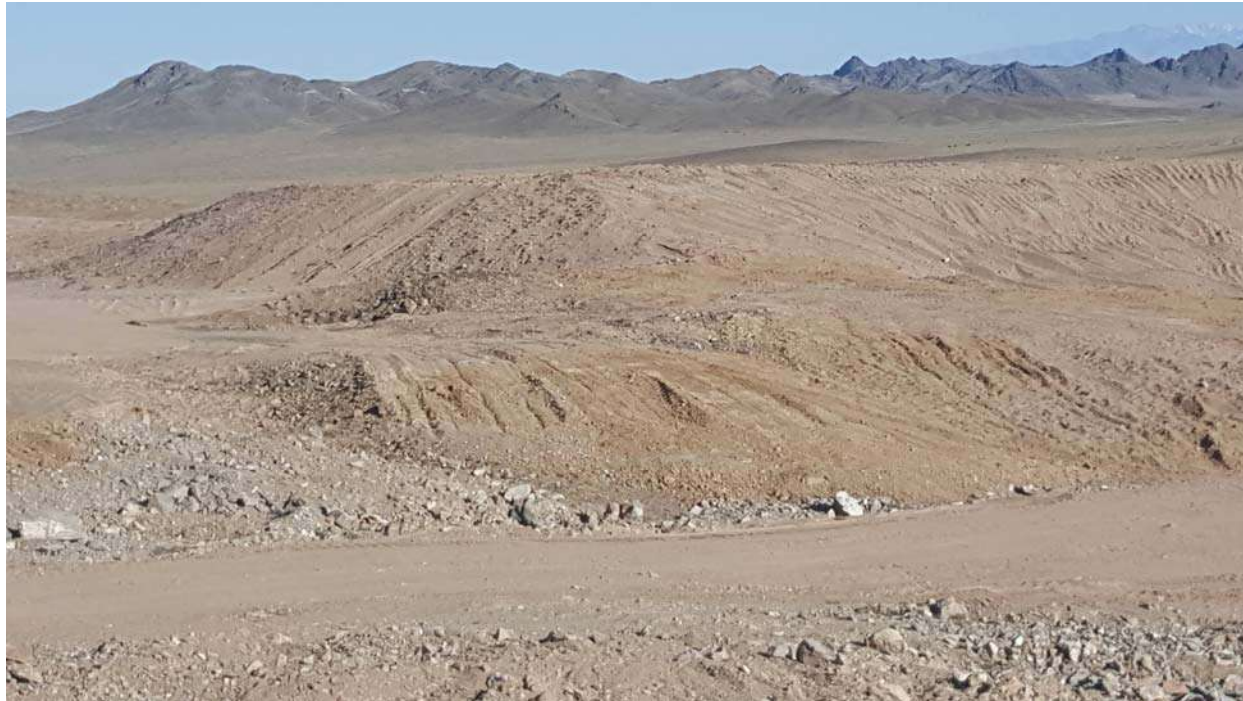
**Photo. Restored borrow pit at the lot CW1-2. STA. 90+500, September, 2018**

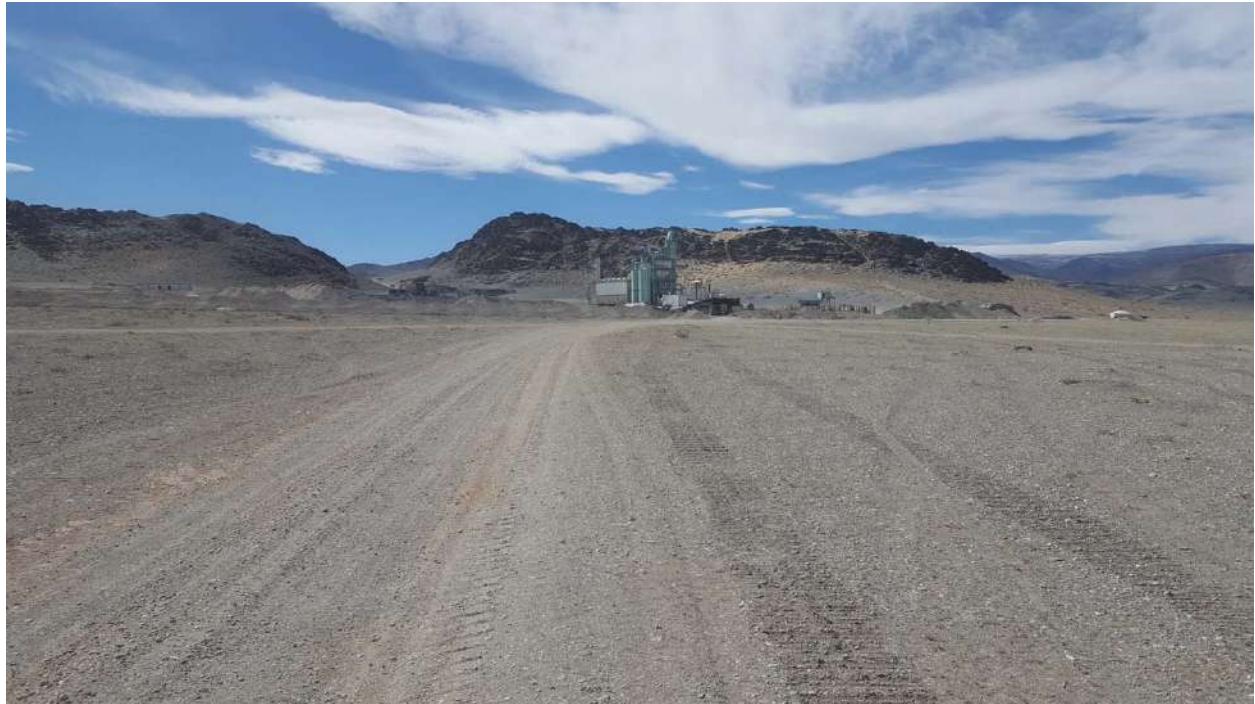
**Photo. Quarry site site and crusher, CW1-1 lot. September, 2018.**

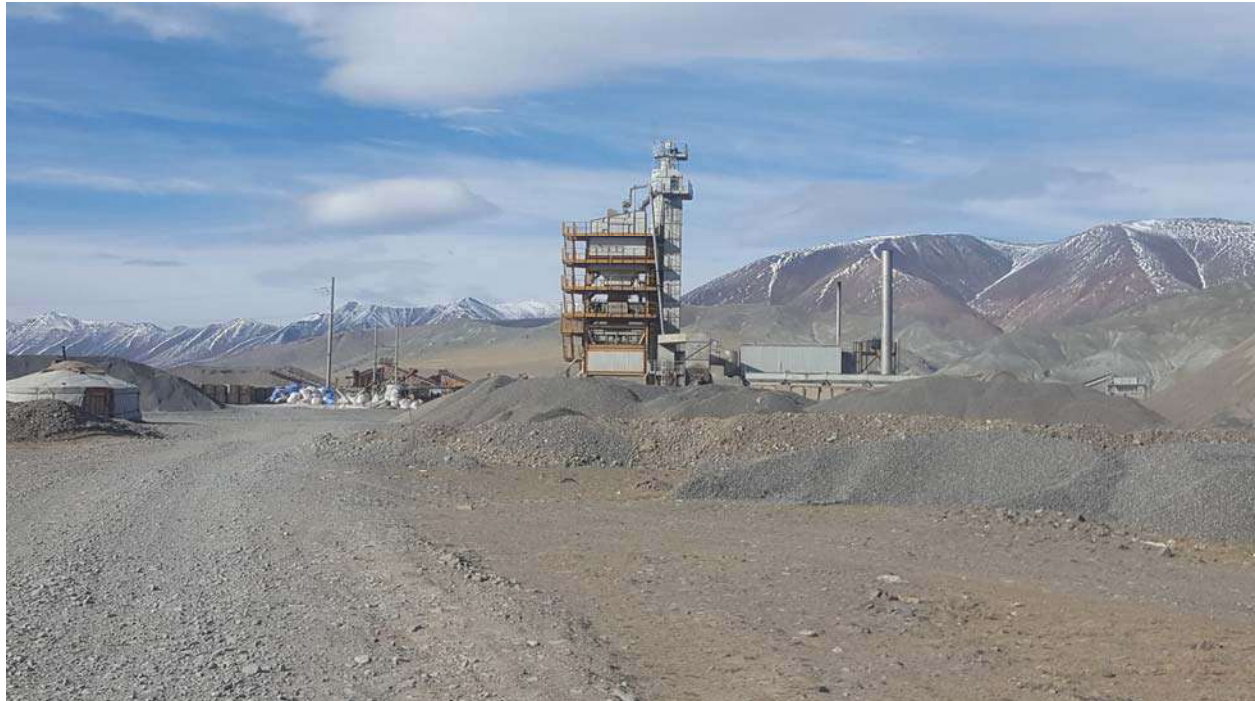
**Photo. Quarry site site and crusher, CW1-3 lot. September, 2018.**

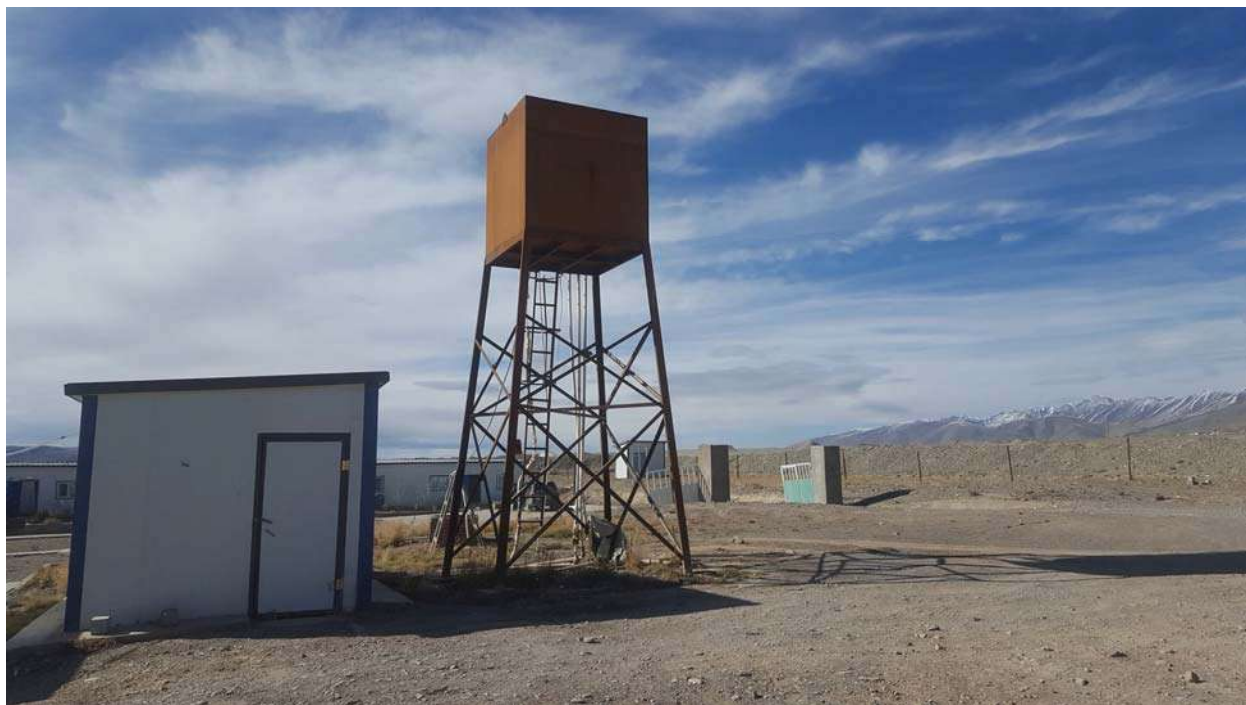
**Photo. Water reservoir, CW1-3 lot. September, 2018.**

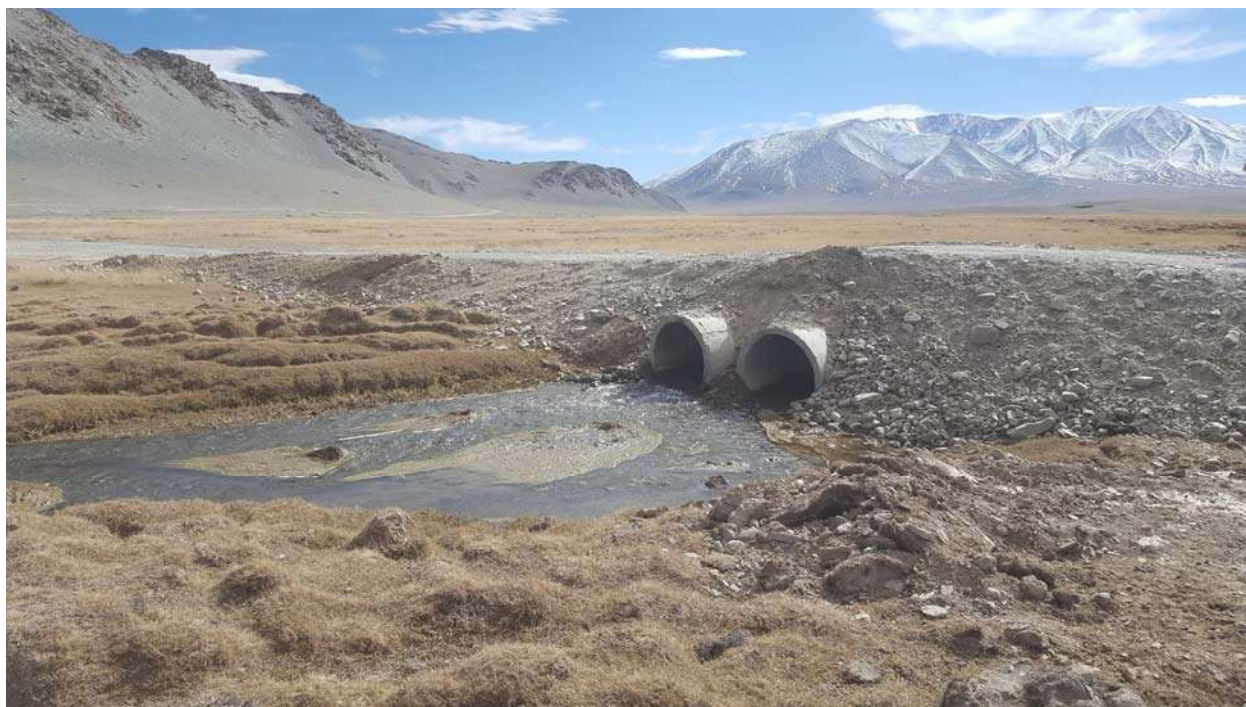
**Photo. Water protection embankment over Hongor Ulun river, CW1-3 lot. September, 2018.**

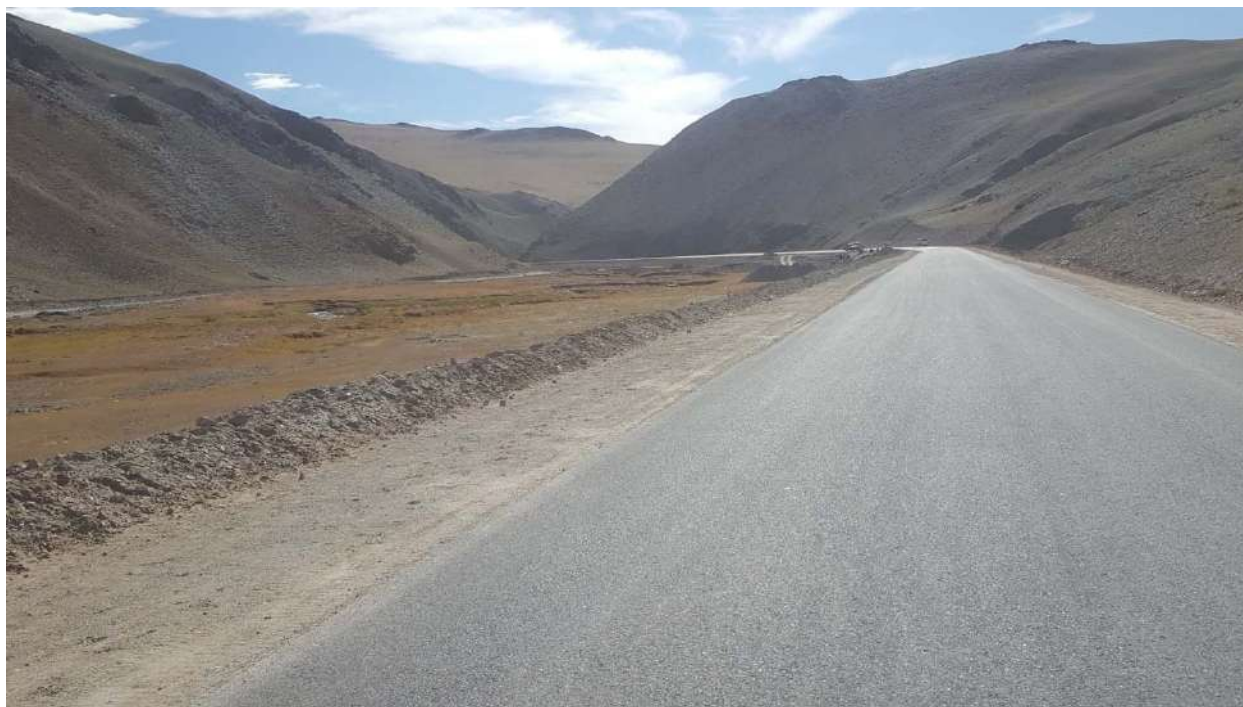
**Photo. Buraat river valley, CW1-3 lot. September, 2018.**

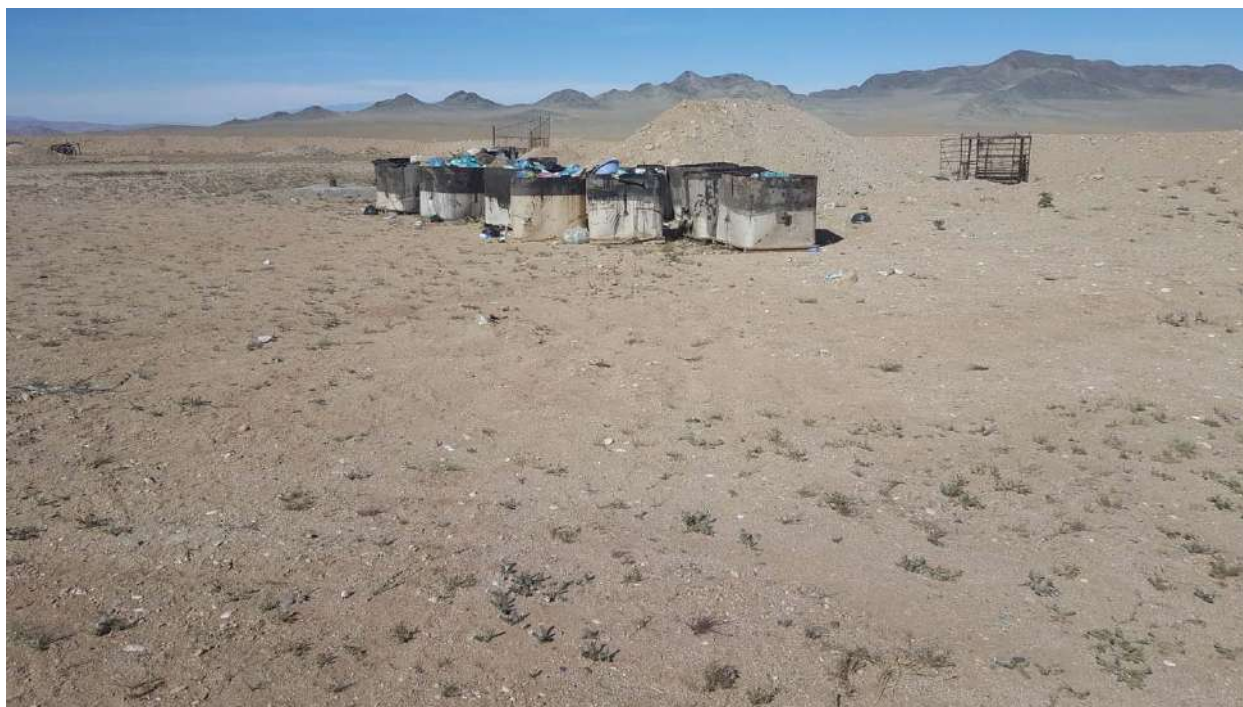
**Photo. Temporary waste collection point at main camp of CW1-2 lot. September, 2018.**

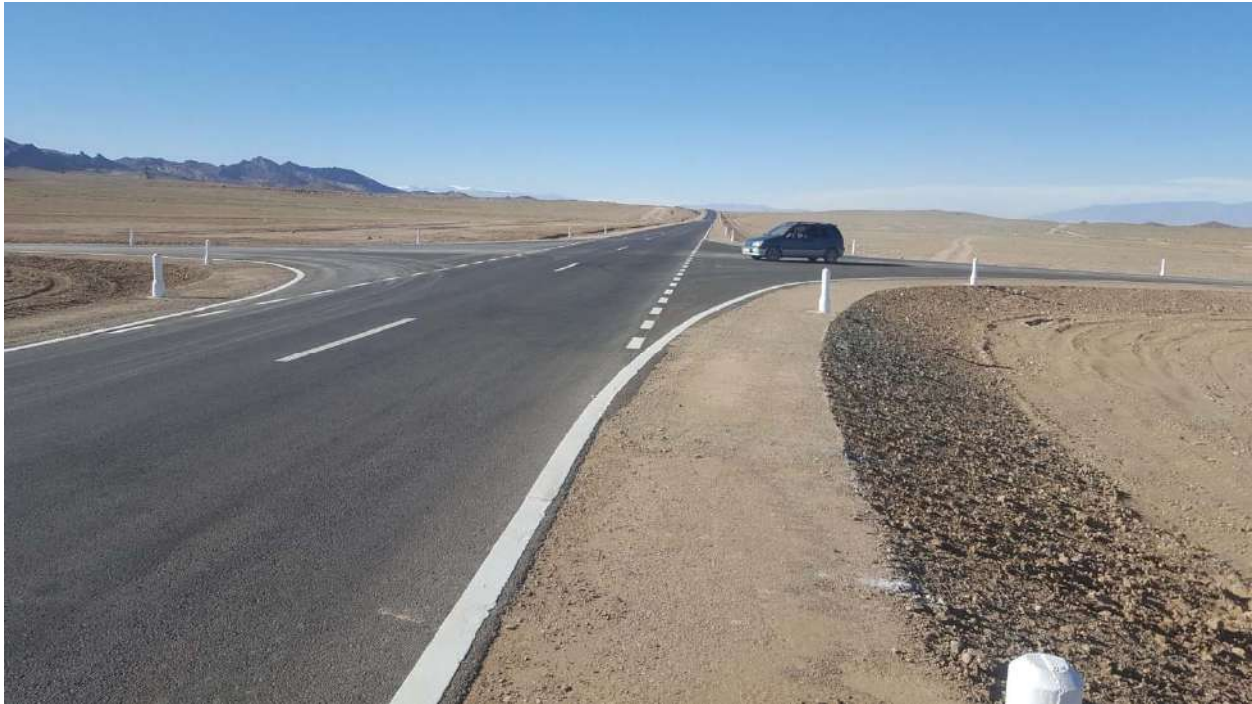
**Photo. Road junction, CW1-2 lot. September, 2018.**

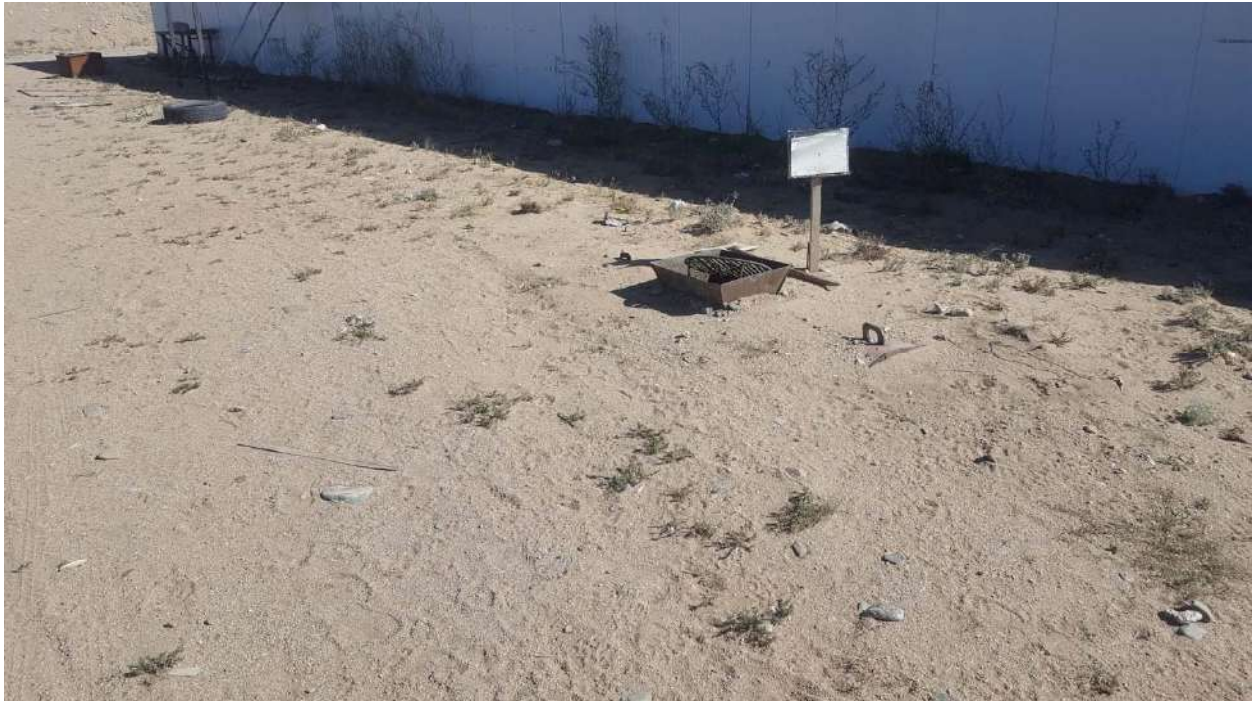
**Photo. Waste water holding tank underneath, CW1-2 lot. September, 2018.**
