Semi-annual Report

TOWN ELECTRIFICATION INVESTMENT PROGRAM – TRANCHE 1

Environment Monitoring Report

Town Electrification Investment Program (TEIP) Tranche 1 Projects

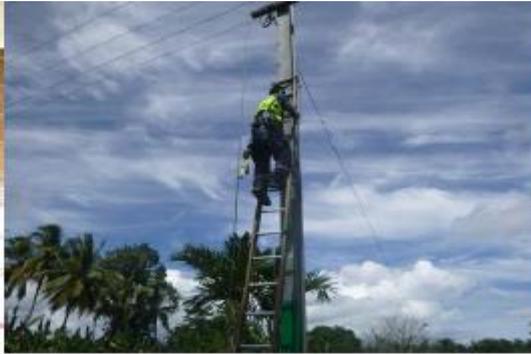
Installation of MSK.
