# Environmental Monitoring Report

Bi-annual Report  
July–December 2018  
April 2019

## Armenia: North-South Road Corridor Investment Program, Tranche 3

Project Number: 42145  
July- December 2018

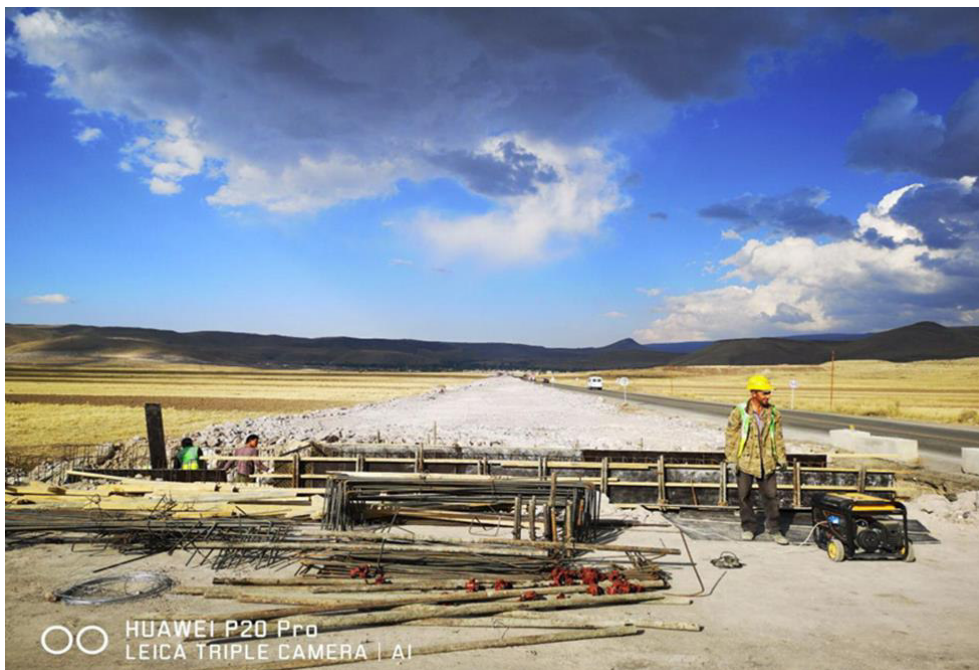
Figure 1: Culvert work at Km76 + 000

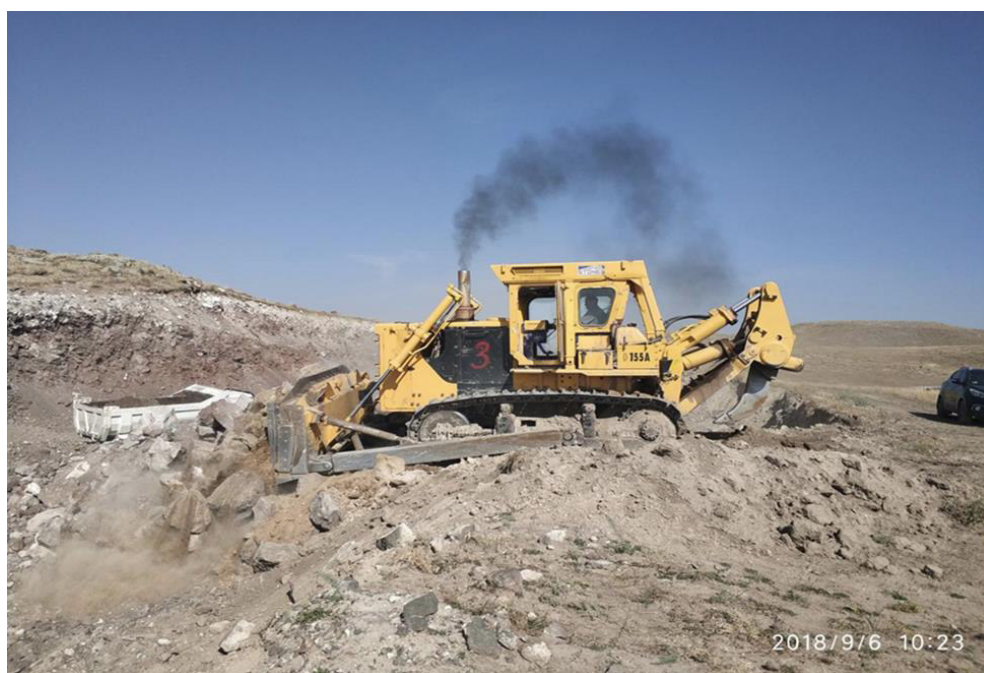
Figure 1: Excavation at Km80+700 to Km 80+900

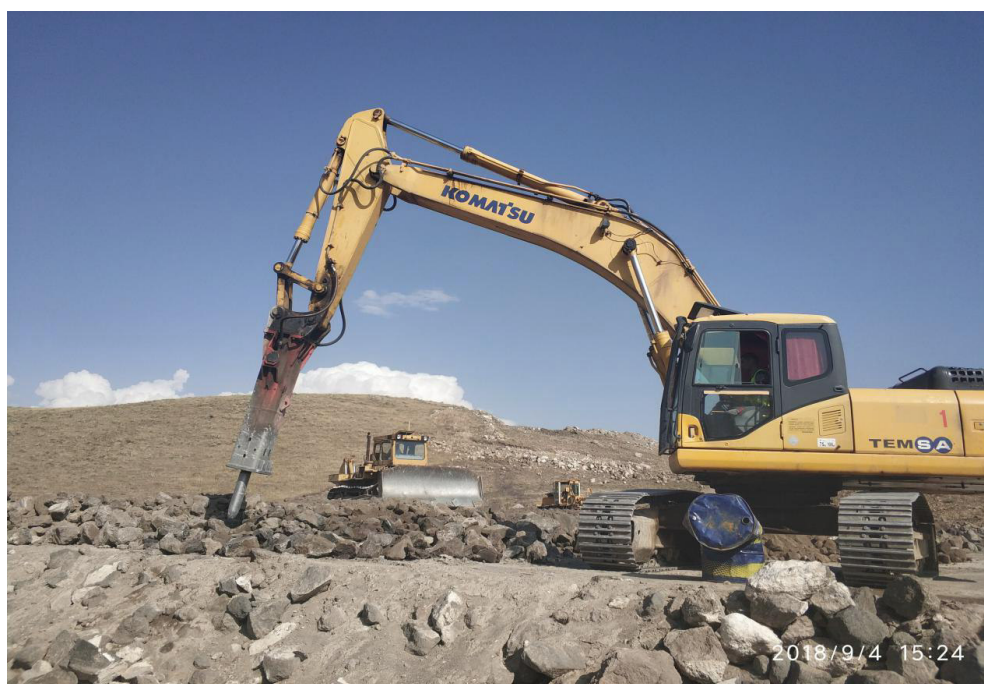
Figure 2: Km81+95 to Km81+100 Embankment
