Bi-annual Environmental Monitoring Report

Project Number: 42145-043

ARM: North–South Road Corridor Investment Program – Tranche 3)

Armenia: North-South Road Corridor Investment Program, Tranche 3
(Financed by the ADB)

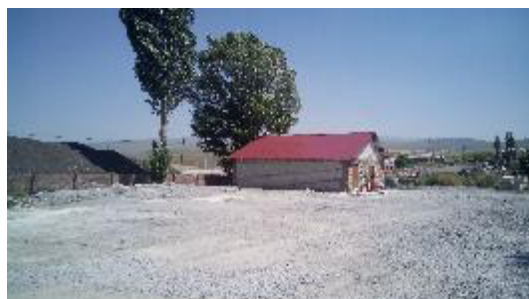
Area for treatment of contaminated soil

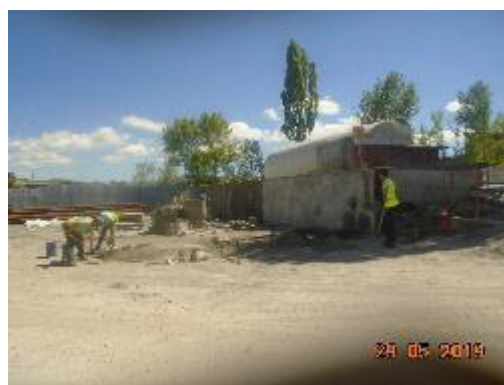
Contaminated soils is cleaned to remediation area

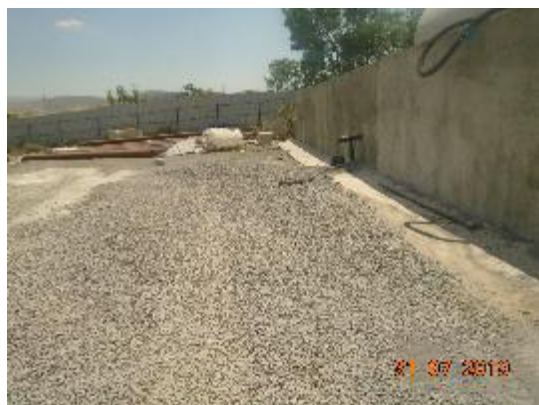
Contaminated soil removed to temporary treatment site

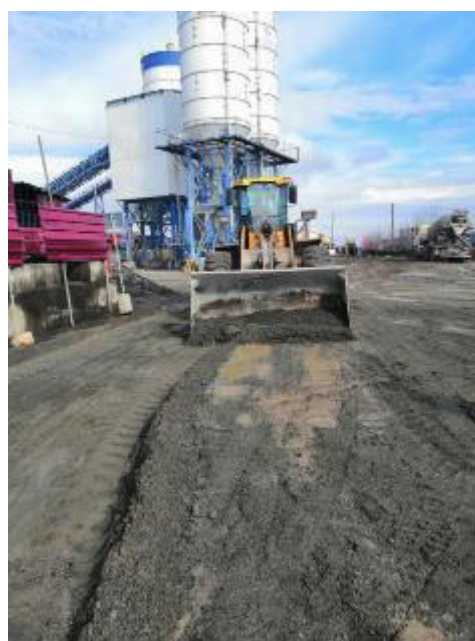
Contaminated soil treated

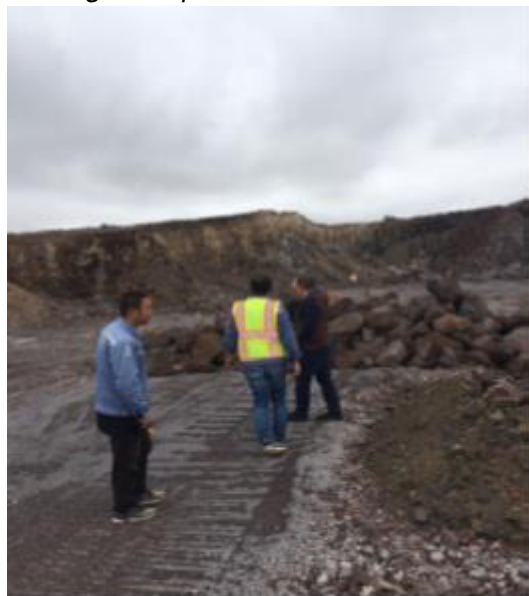
Damage compensated

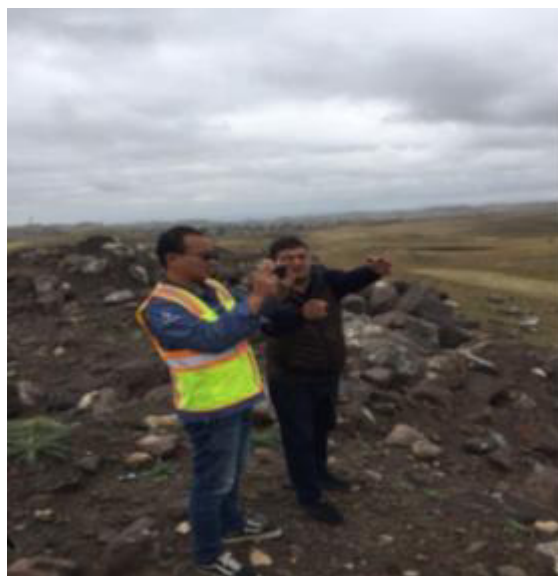
Damage compensated

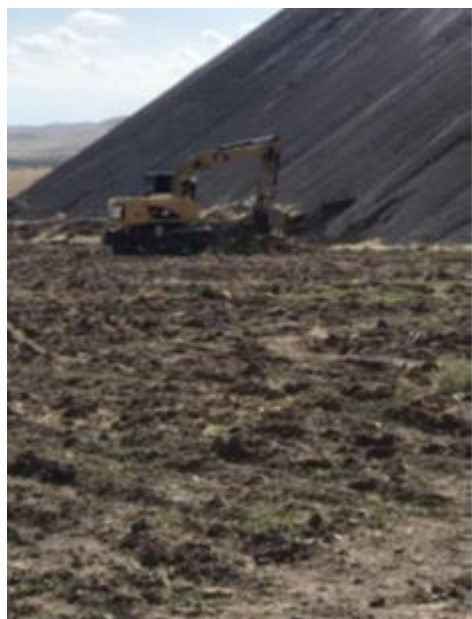
Topsoil removal

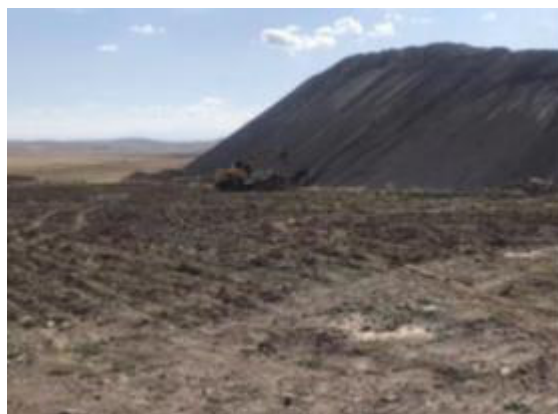
Topsoil removal
