# Environmental Monitoring Report

## KGZ: CAREC Transport Corridor 1 (Bishkek-Torugart Road) Project 2

Reporting Period: July-October 2012

Kyrgyz Republic  
CAREC Transport Corridor -1  
(Bishkek – Torugart road) Project 2  
Section 1, km 365+500 – 400+600  
Section 2, km 439+000 – 479+000

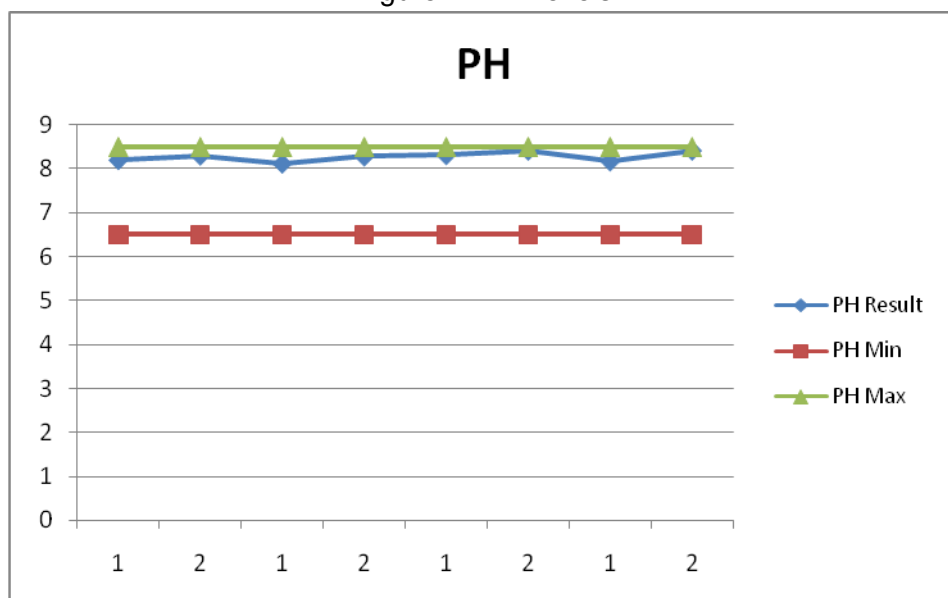
Figure 1: PH Levels

8. Test results for water quality in the Kara Koyun River at the camp at km 450. . The tests for PH (Figure 1), nitrates (Figure 2), sulfates (Figure 3) and oil products (Figure 4) all show levels within the permissible levels. Consistent with tests from 2011 and the earlier half of 2012, the the sulfates tests results for the sites above the camp indicate that there are high levels of sulfates in the water to begin with and the project activities including the plant and camp have had limited or no impact on sulfate levels.

PH				
Date	Points	Result	Min	Max
7/18/2012	1	8.2	6.5	8.5
	2	8.3	6.5	8.5
8/16/2012	1	8.12	6.5	8.5
	2	8.28	6.5	8.5
9/6/2012	1	8.31	6.5	8.5
	2	8.41	6.5	8.5
10/9/2012	1	8.17	6.5	8.5
	2	8.41	6.5	8.5

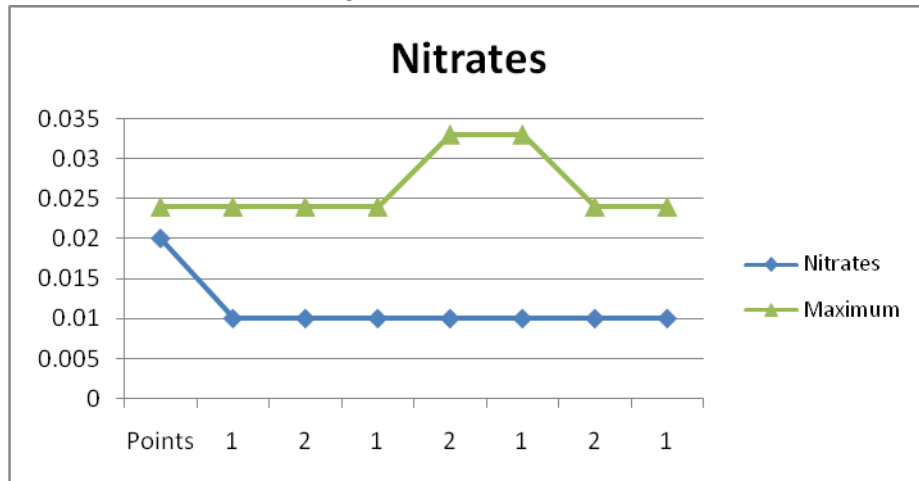
Figure 2: Nitrate Levels

Nitrates			
Date	Points	Result	Max
7/18/2012	1	0.02	0.024
	2	0.01	0.024
8/16/2012	1	0.01	0.024
	2	0.01	0.024
9/6/2012	1	0.01	0.033
	2	0.01	0.033
10/9/2012	1	0.01	0.024
	2	0.01	0.024

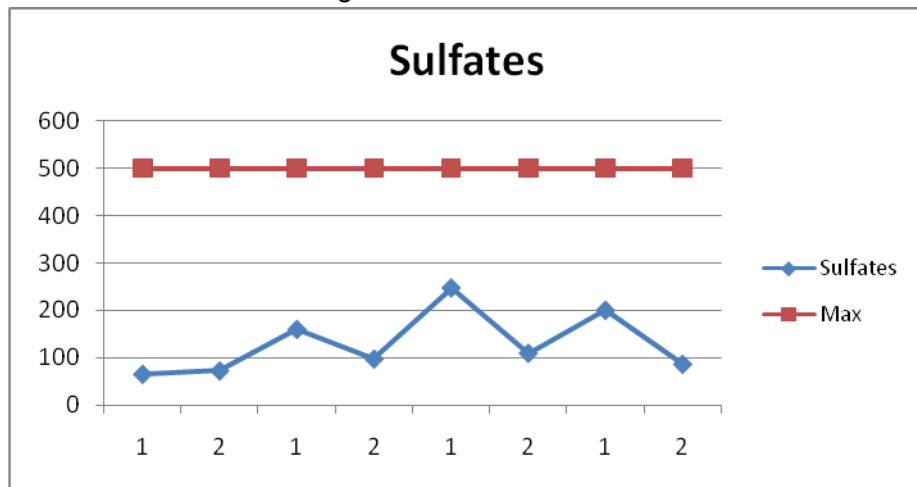
Figure 3: Sulfate Levels

Sulfates			
Date	Points	Result	Max
7/18/2012	1	66	500
	2	73	500
8/16/2012	1	160	500
	2	98	500
9/6/2012	1	247	500
	2	110	500
10/9/2012	1	200	500
	2	87	500

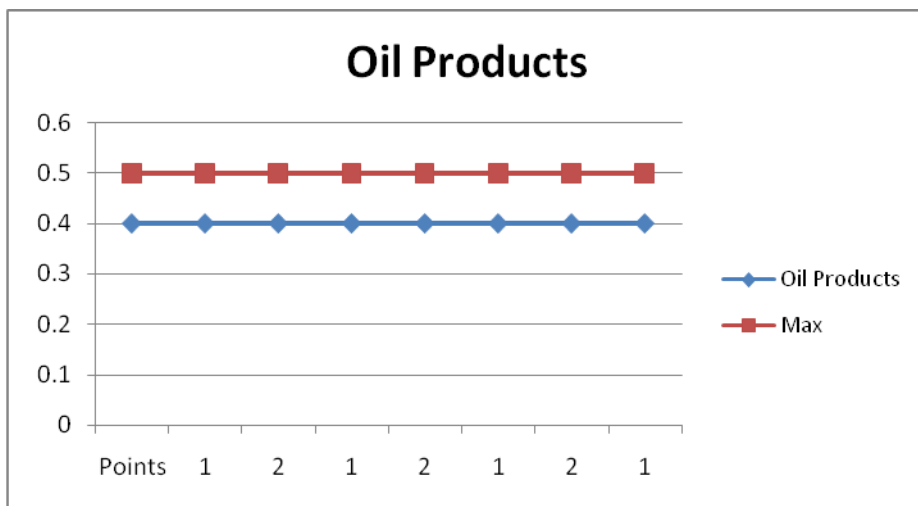
Figure 4: Levels of Oil Products

Oil Products			
Date	Points	Result	Max
7/18/2012	1	0.4	0.5
	2	0.4	0.5
8/16/2012	1	0.4	0.5
	2	0.4	0.5
9/6/2012	1	0.4	0.5
	2	0.4	0.5
10/9/2012	1	0.4	0.5
	2	0.4	0.5

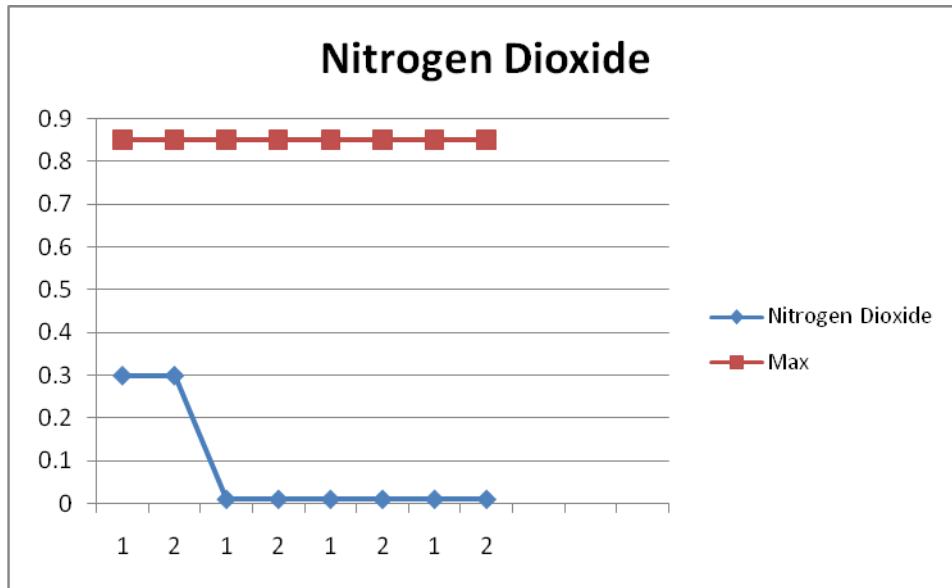
Figure 5: Nitrogen Dioxide Levels

9. For air quality, test results for nitrogen dioxide (Figure 5), suspended particles (Figure 6), sulfur dioxide (Figure 7), and carbon monoxide (Figure 8) were all within permissible levels. However, tests for sulfur dioxide and carbon monoxide continue to show results that are at or near permissible levels. Air quality at the Tash Rabat asphalt/coating plant has been closely monitored because previous test results for carbon monoxide and sulfur dioxide had exceeded permissible levels in June 2012.

Nitrogen Dioxide			
Date	Points	Result	Max
7/18/2012	1	0.3	0.85
	2	0.3	0.85
8/16/2012	1	0.01	0.85
	2	0.01	0.85
9/6/2012	1	0.01	0.85
	2	0.01	0.85
10/9/2012	1	0.01	0.85
	2	0.01	0.85

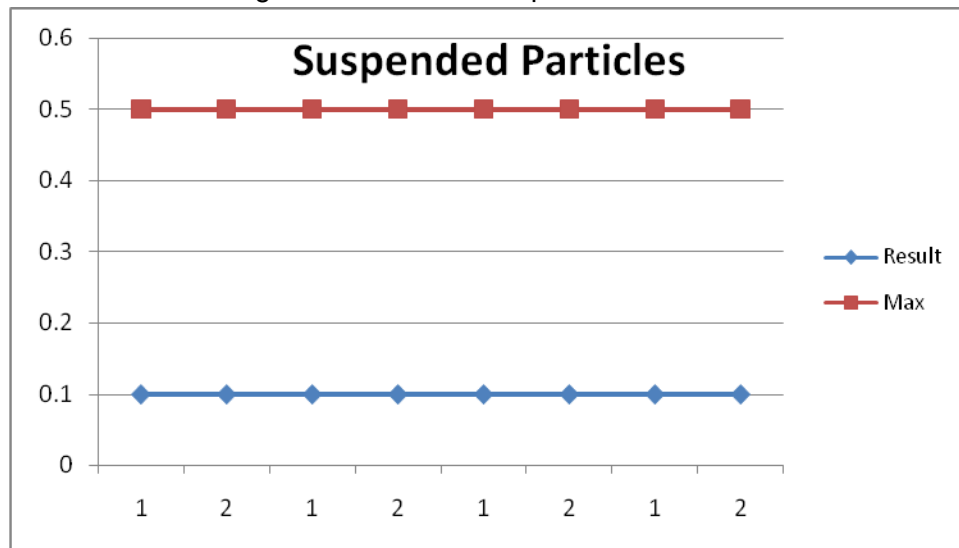
Figure 6: Levels of Suspended Particles

Suspended Particles			
Date	Points	Result	Max
7/18/2012	1	0.1	0.5
	2	0.1	0.5
8/16/2012	1	0.1	0.5
	2	0.1	0.5
9/6/2012	1	0.1	0.5
	2	0.1	0.5
10/9/2012	1	0.1	0.5
	2	0.1	0.5

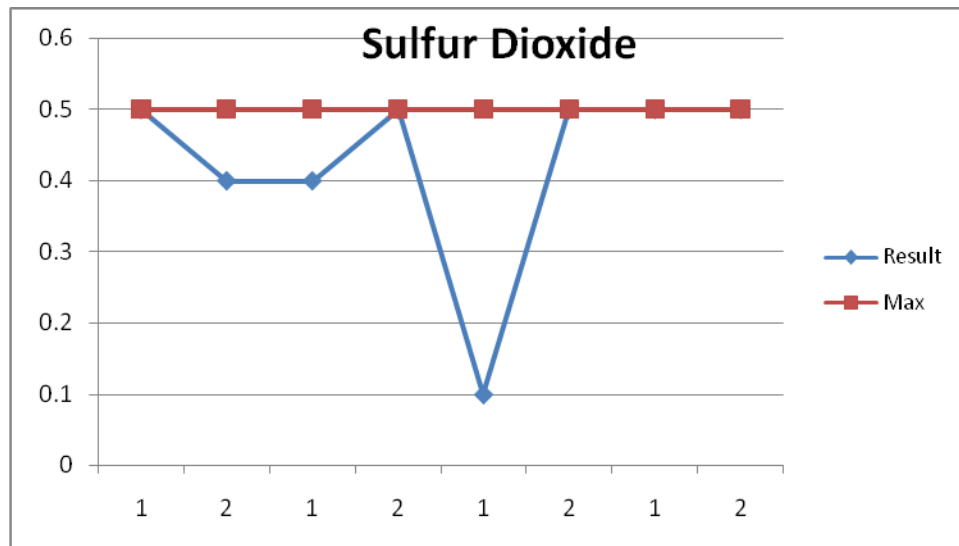
Figure 7: Levels of Sulfur Dioxide

Sulphur Dioxide			
Date	Points	Resultt	Max
7/18/2012	1	0.5	0.5
	2	0.4	0.5
8/16/2012	1	0.4	0.5
	2	0.5	0.5
9/6/2012	1	0.1	0.5
	2	0.5	0.5
10/9/2012	1	0.5	0.5
	2	0.5	0.5

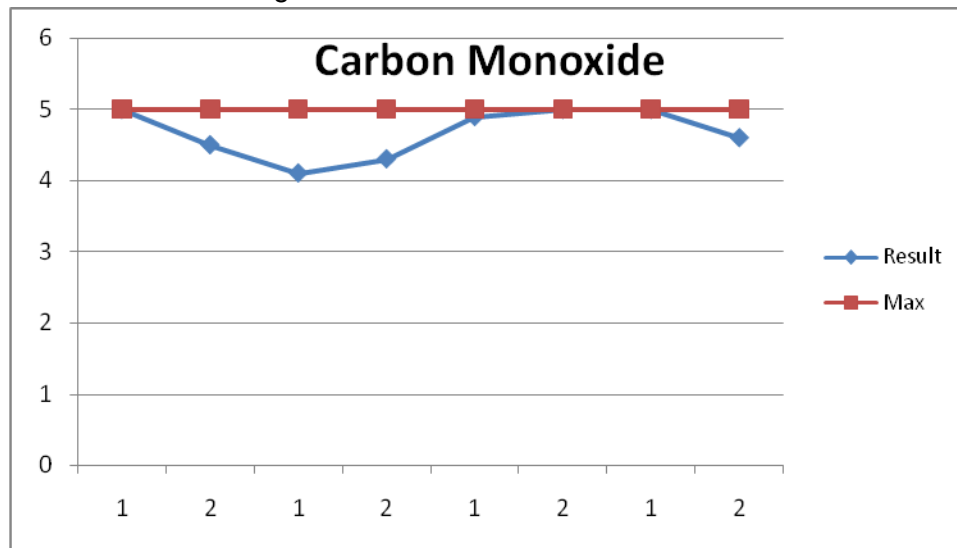
Figure 8: Levels of Carbon Monoxide

Carbon Monoxide			
Date	Points	Result	Max
7/18/2012	1	5	5
	2	4.5	5
8/16/2012	1	4.1	5
	2	4.3	5
9/6/2012	1	4.9	5
	2	5	5
10/9/2012	1	5	5
	2	4.6	5

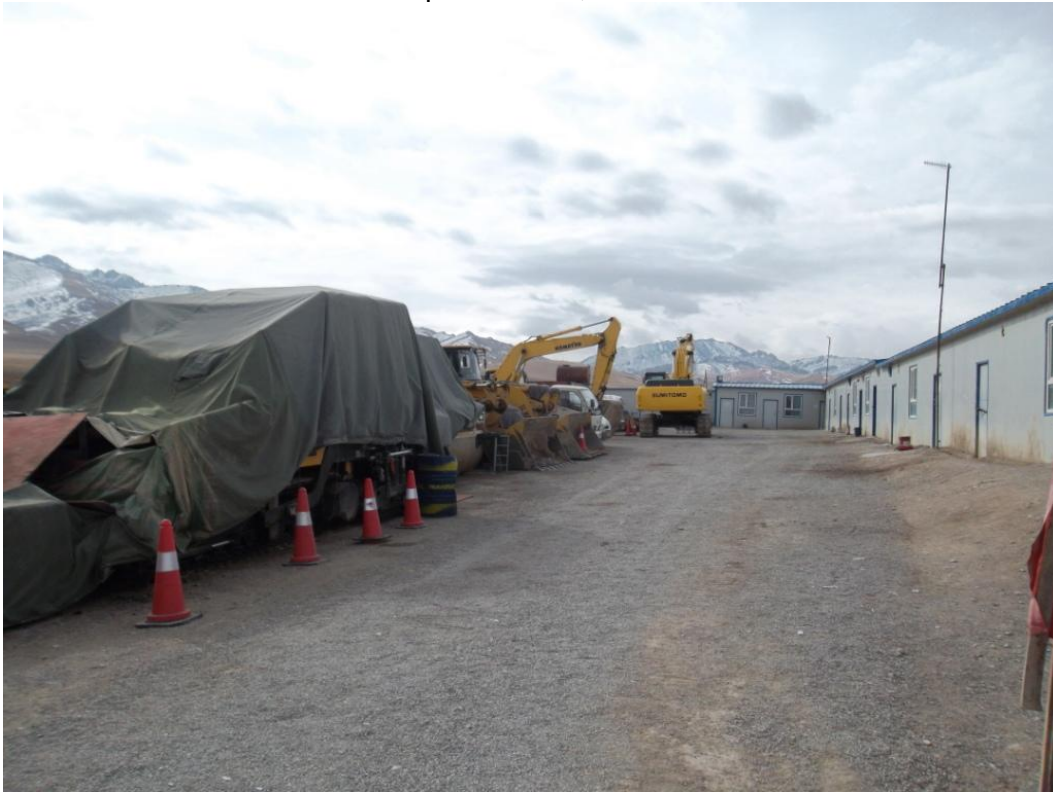
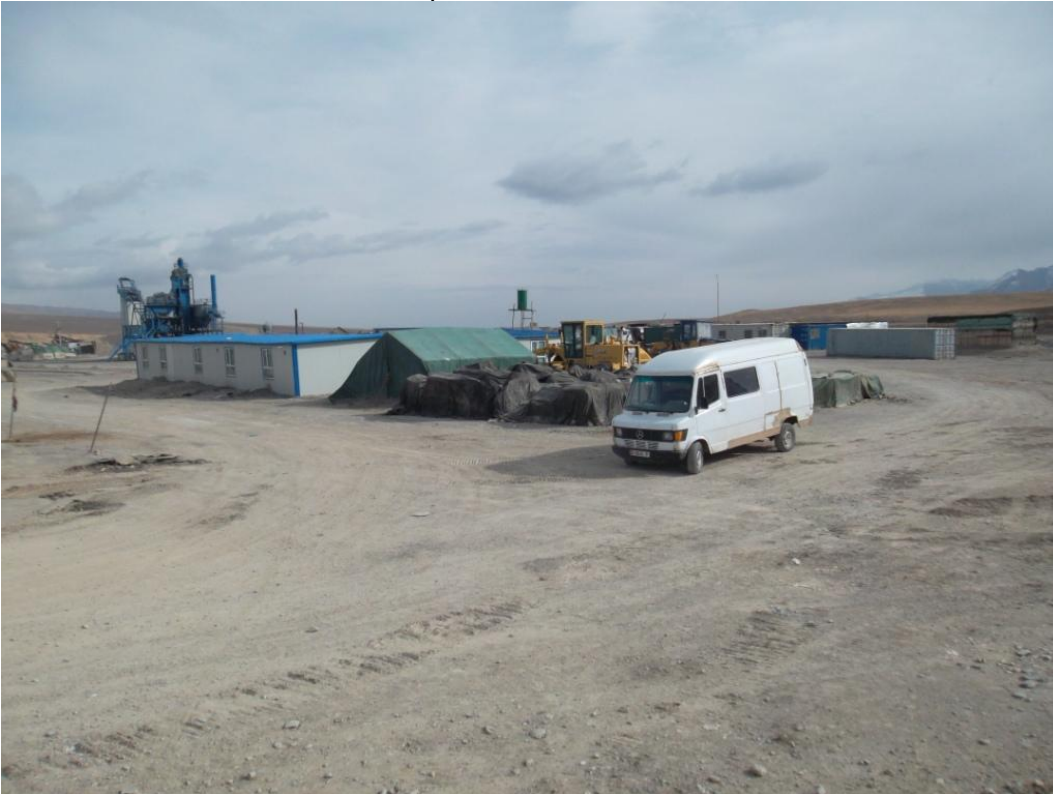
Camp at km 450, October

10. Construction camps	<ul style="list-style-type: none"> <li>• Proper construction camp management in compliance with health and safety plan</li> </ul>	Problems identified with camp cleanliness and some safety violations and these have been corrected	Regular and frequent monitoring

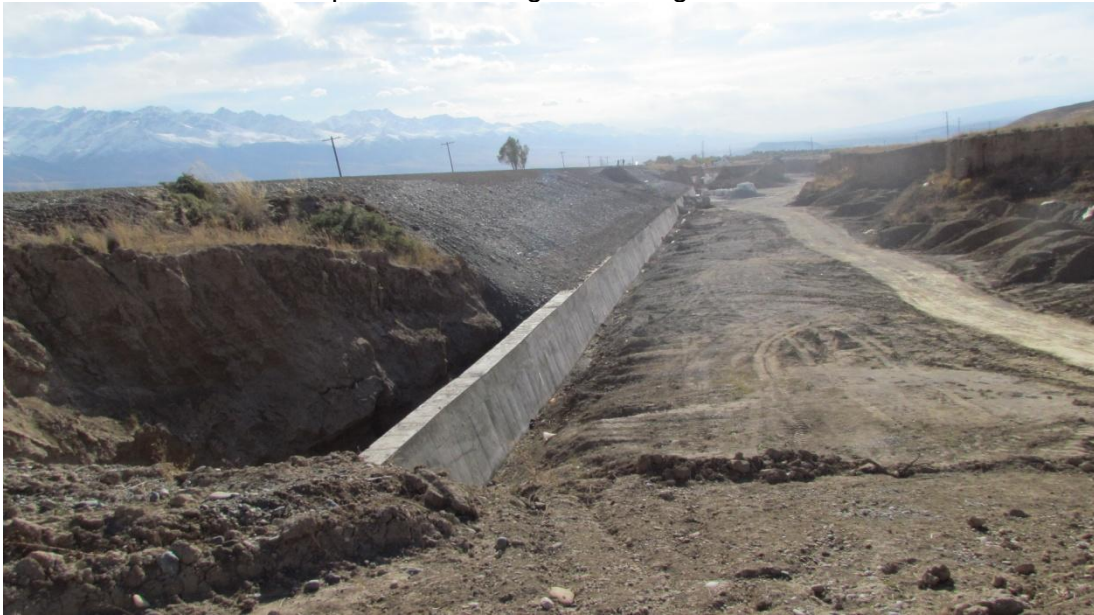
Completed Retaining Wall being Back-filled

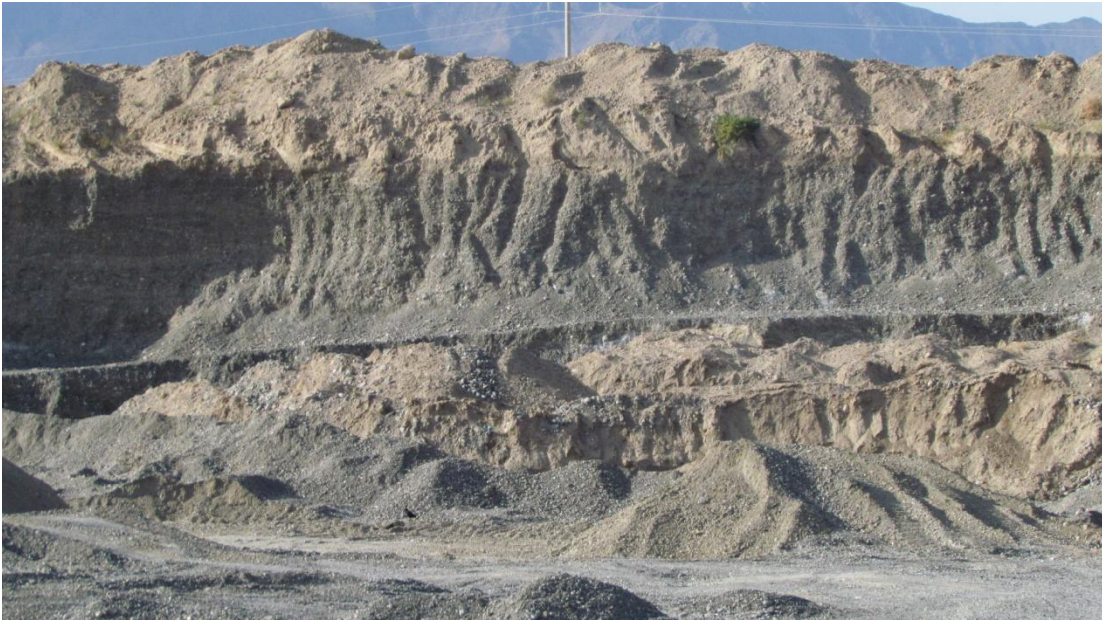
Borrow Pit that will have to be restored, October

9. Reinstatement of borrow pits and quarries	<ul style="list-style-type: none"> <li>Topsoil strip (where necessary) and re-topsoil</li> <li>Grassing the area</li> </ul>	<p>Restoration plan requested</p> <p>There are 9 borrow pit on both sections. All to be restored.</p>	<p>Approval and implementation of restoration plan. Contractor intends to restore following end of works, which is non-compliant. Consultant is withholding payments to ensure that restoration will be completed.</p> <p>Despite agreement in May 2012, the Contractor has yet to propose to the Engineer the methodology for restoration of borrow pits.</p> <p>Late in 2012, Contractor indicated that he does not have to get the Engineer's agreement as his license and approval of borrow pits, including final restoration, had already been approved by Ministry of the Environment.</p> <p>Based on the state of similar restoration works by the Contractor on project BNT-1, Engineer has observed that:</p> <p>1. Borrow areas are generally pits</p>

<p>and the side slopes generally are too steep for safety, either of people or animals.</p> <p>2. Bottom levels of pits are too low to be drained, with consequent high risk of creating mosquito vectors.</p> <p>3. No attempt has been made so far to soil or grass the side slopes, some of which, completed in 2012 are already exhibiting rain-cuts.</p> <p>Contractor will be requested to provide a restoration plan during the kick-off meeting for the 2013 construction season in March 2013.</p>

22. Although the contract requires the Contractor to rehabilitate a borrow pit before another is opened, the Contractor has stated that he will restore all the borrow pits and spoils areas at the end of construction because he is simultaneously working different sections at different stages of road upgrading. While this is logical from one perspective, the Consultant has proposed to withhold a higher level of funds than indicated in the Defects Liabilities Period payment schedule in order to ensure that all borrow pits are properly restored. The issue here is that by the end of the Project, nearly all equipment would have been removed from the Project site, meaning that any restoration activities would then become considerably more expensive than the budget indicates. Withholding a higher level of funds will ensure full restoration of all borrow pits and spoils areas. There are 4 borrow pits on Section 1 and 5 on Section 2 for a total of 9 borrow pits, none of which have been restored. The contractor will be requested to provide a restoration plan during the kick-off meeting for the 2013 construction season in March 2013.

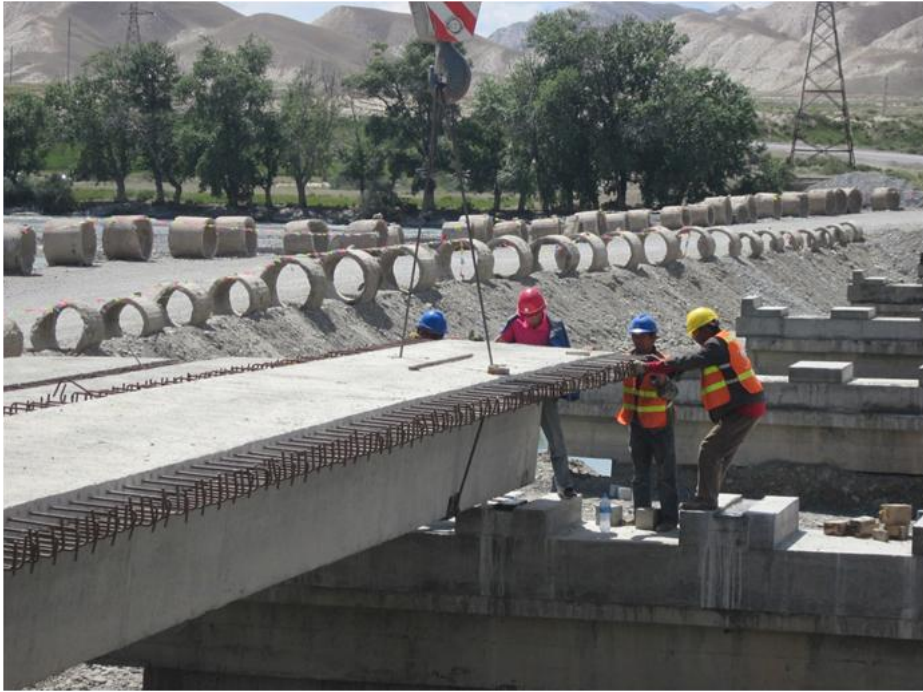
Workers calibrating T-beam, wearing Helmets and Reflective vests

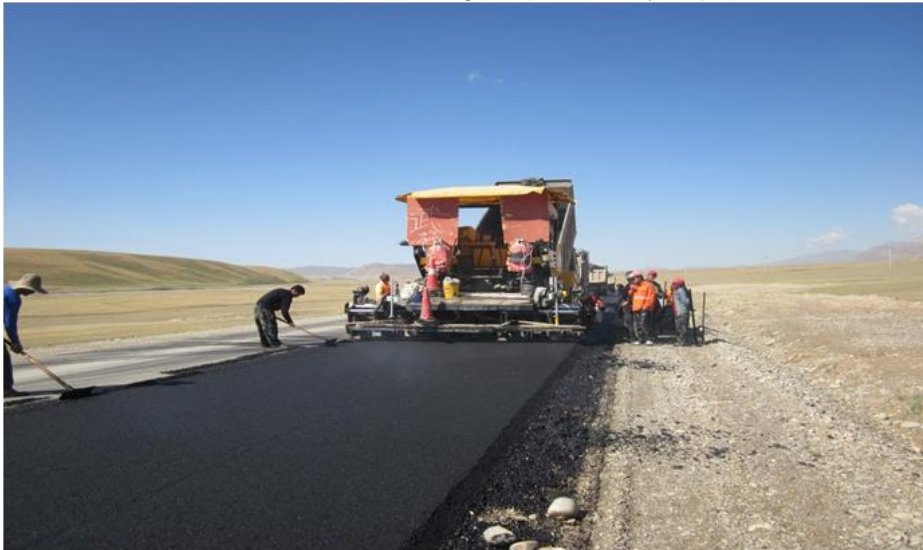
Not all workers are wearing proper Safety Equipment

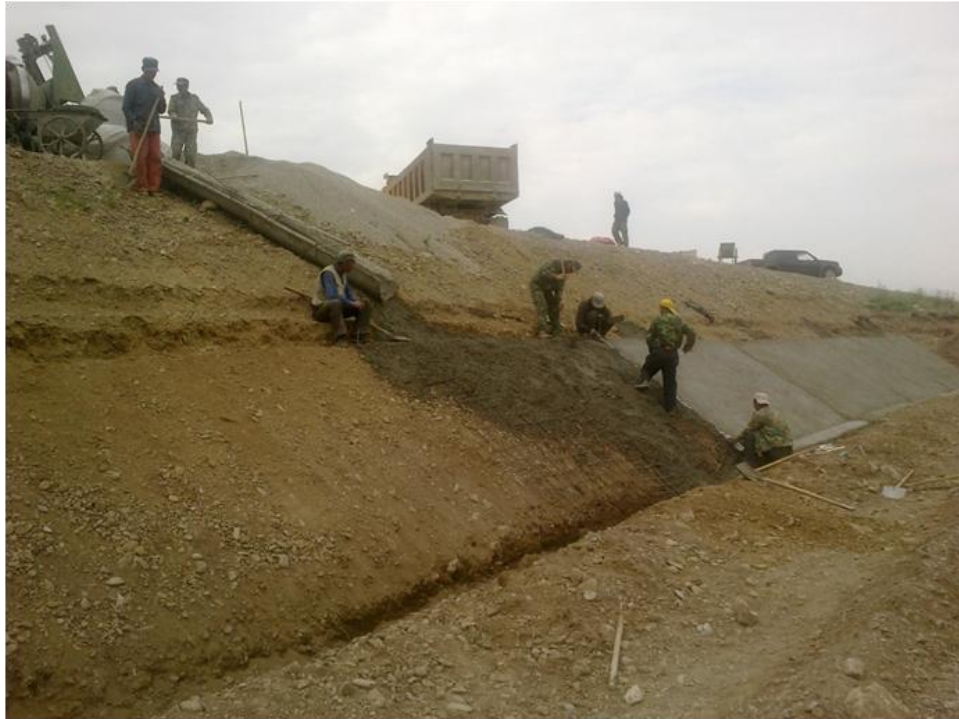
Cast-in concrete Slope Protection

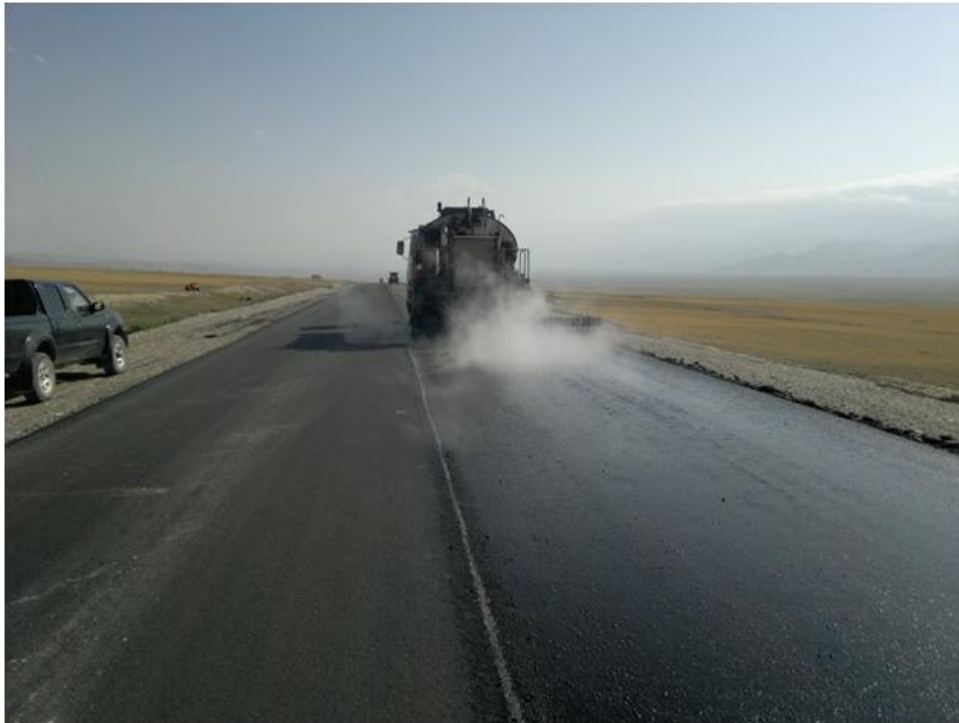
21. Dust has become much less of a safety issue with the paving nearly completed.

Final layer (tack coat) at km 444=no more dust
