Environmental and Social Monitoring Report

July - December, 2016

Kiribati: South Tarawa Sanitation Improvement Sector Project

Prepared by Ministry of Public Works and Utilities, Government of Kiribati for the Asian Development Bank

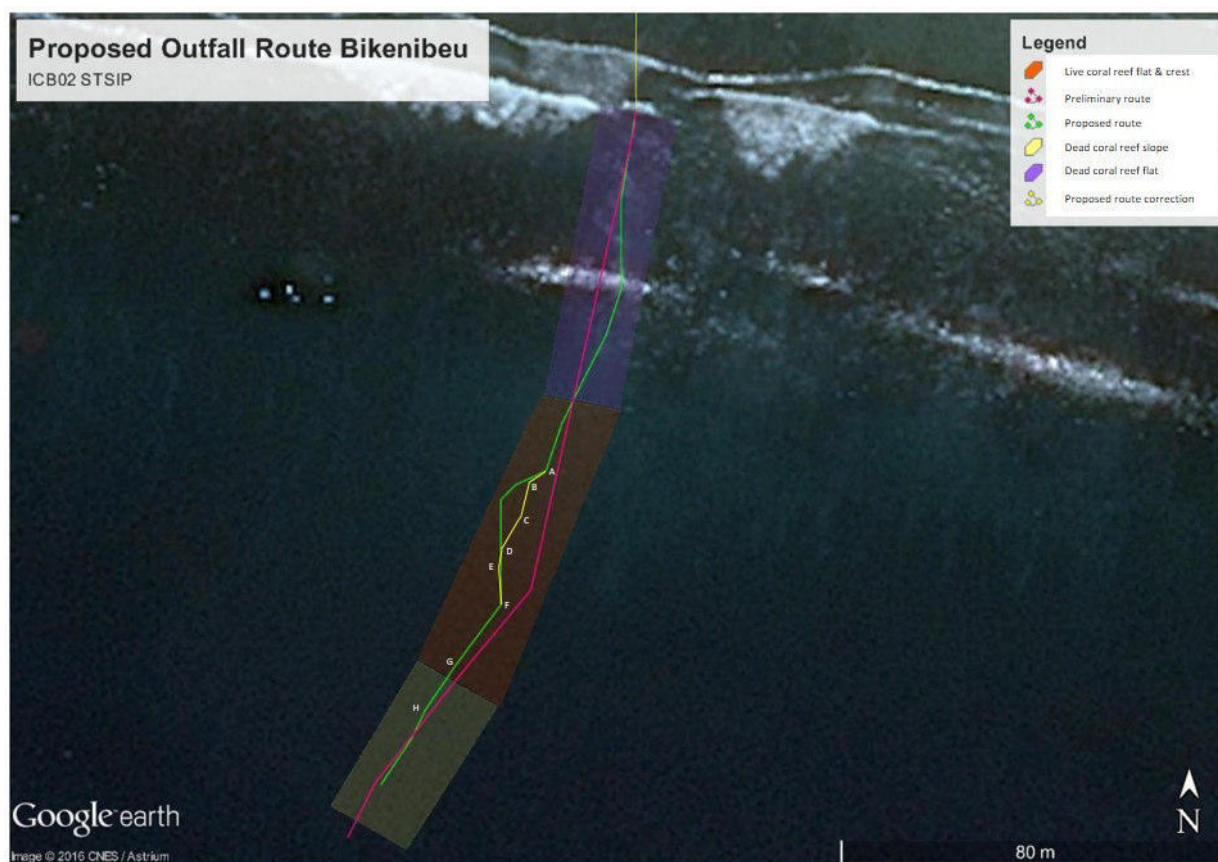
Figure 1: Preliminary and Proposed Pipe routes [Adapted from Anderson Dec 2016 by Fellenius]

The proposed change in route shown in figure 1 is an optimisation of the outfall route at Bikenibeu due to changed seabed conditions since the initial survey was undertaken in 2015.

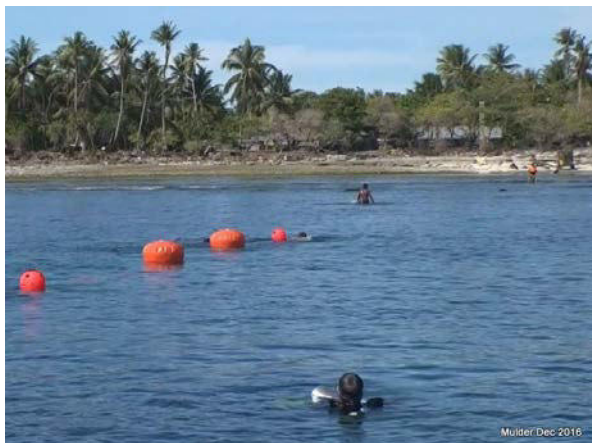
Four lengths of broken pipe were separated at their flanges using bolt cutters and floated via lift bags to an excavator for removal to shore (figs. 2 and 3).

Figure 2: Broken pipe removal via lift bags

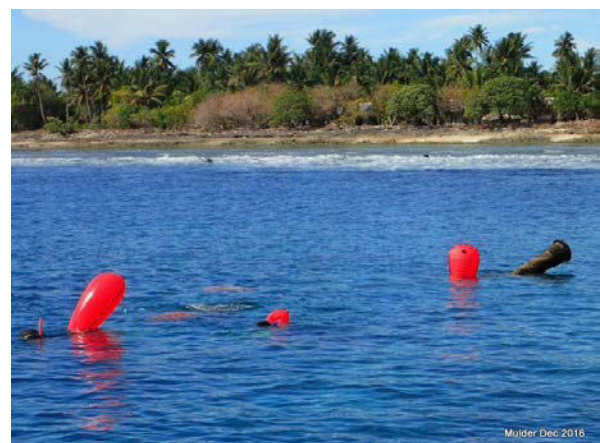
Figure 3: Broken pipe removal via excavator

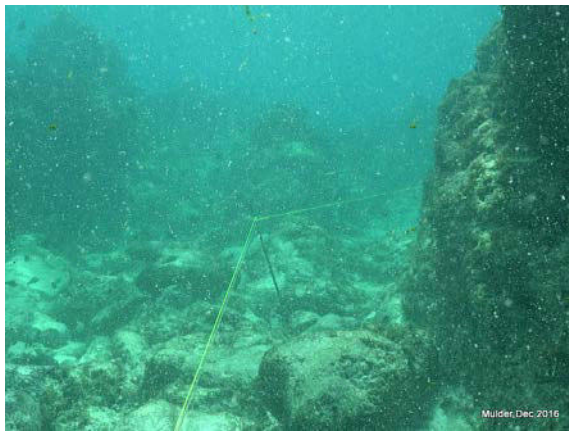
The shallow reef flat is devoid of live coral, like it was during the initial 2015 survey. The route follows a straight line for one-quarter of the way and then goes to the east of a large coral rock spur inside the groove for the remaining length. At point A it bends slightly west (figs. 4 and 5).

Figure 4: Point A bend, pre-obstruction removal

Obstructions within the straight line segment were a dozen 0.3-1.5m diameter rocks. Obstructions within the groove were of similar size, although there were many more large rocks to remove. A dozen old concrete anchor blocks were also moved.

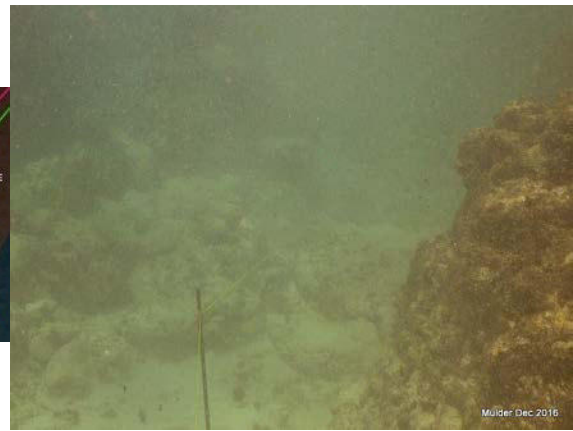
Figure 5: Point A bend, post-obstruction removal

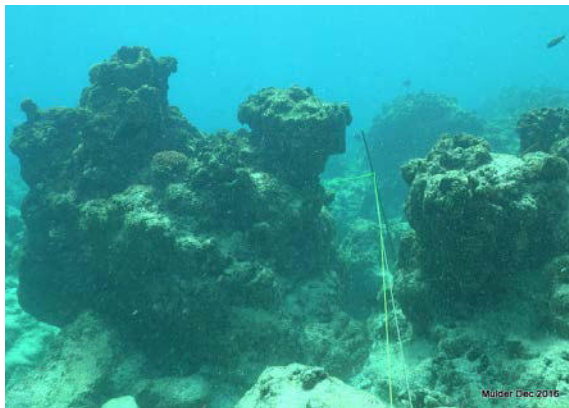
The rock spur adjacent to point A terminates at a large rock outcrop at point B. To the east is the 1m high bedrock rise and to the west is a narrow gap and a smaller rock outcrop (figs. 6 and 7).

Figure 6: Point B bend, pre-obstruction removal

This gap was widened by the removal of the smaller obstruction, and shaving of the side of the larger one. This was a very significant obstruction due to the density of the coral rock, and had to be removed using a car jack. The remaining large rock outcrop is very strong, and can easily facilitate pipe tension.

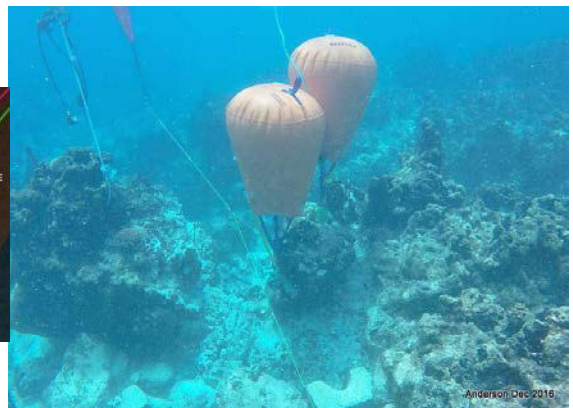
Figure 7: Point B bend, during obstruction removal

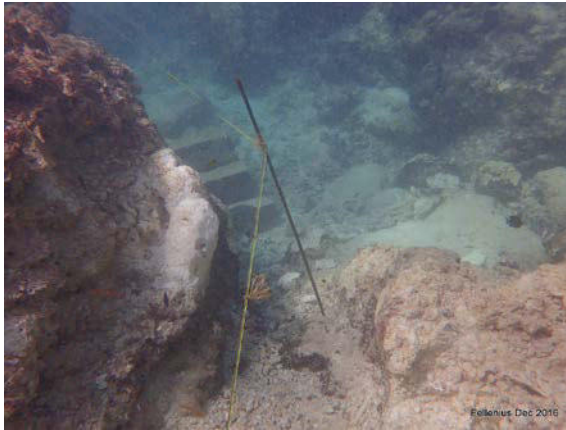
Figure 8: Point B bend, post-obstruction removal

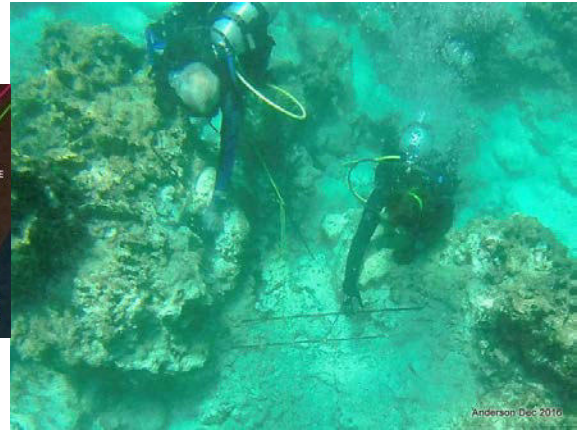
Figure 9: Point B bend, post-obstruction verification

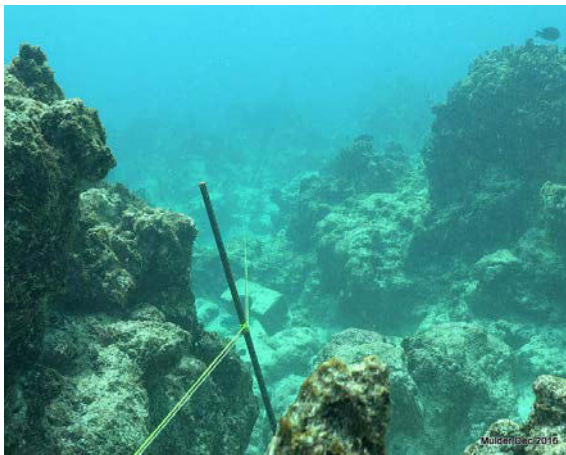
Once past the large rock outcrop, the groove at point A continues between point B and C. It is not precisely straight and makes a very slight angle, but minimal compared with points A and B (figs. 10-13). The segment from points B to C was filled with 0.5-2.0m diameter rocks. Once removed, the depression had to be raised using numerous old concrete anchor blocks to avoid downstream high points in the pipe (fig. 12).

Figure 10: Point B-C depression, pre-obstruction removal

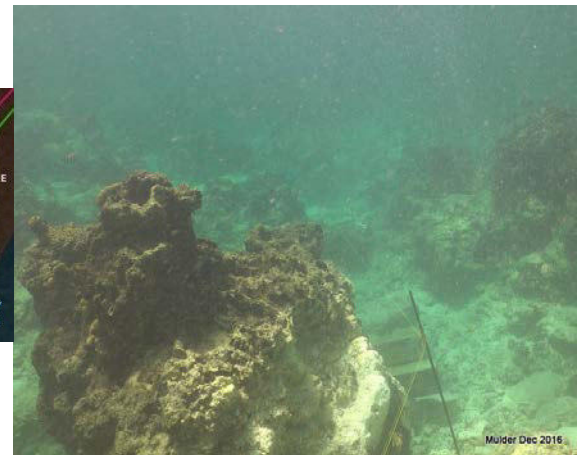
Figure 11: Point B-C depression, post-obstruction removal

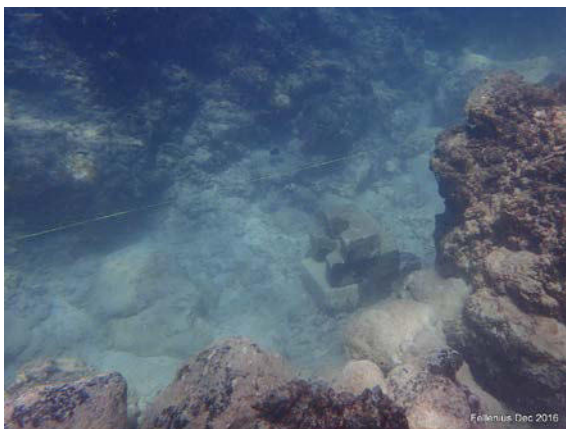
Figure 12: Point B-C depression, post-obstruction removal

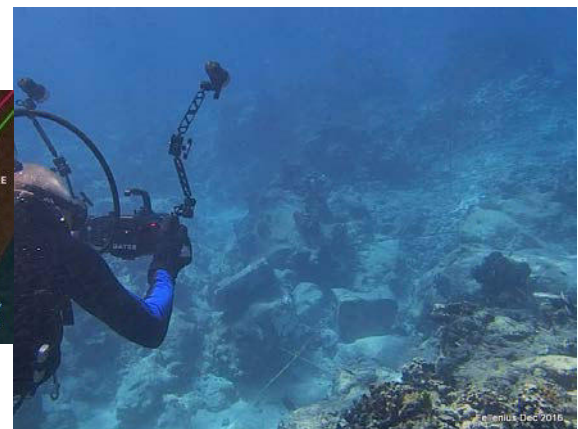
Figure 13: Point C bend, post-obstruction removal

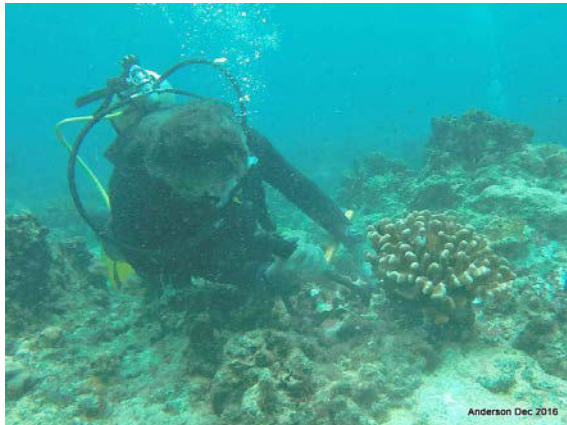
Significant *Pocillopora* sp. and some *Heliopora* sp. coral colonies had to be relocated from the continued groove between points C and D (figs. 14 to 16).

Figure 14: Point C-D, *Pocillopora* sp. colony removal

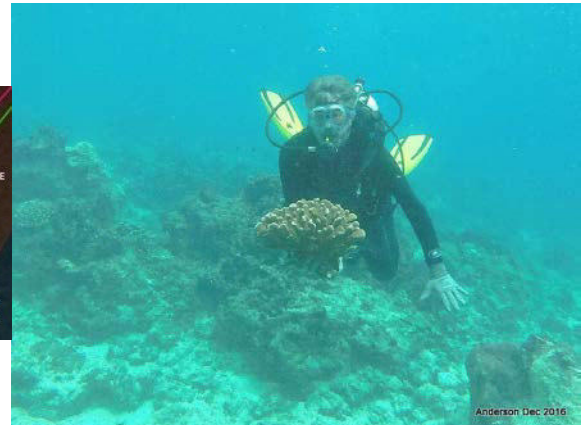
Figure 15: Point C-D, *Pocillopora* sp. colony transport

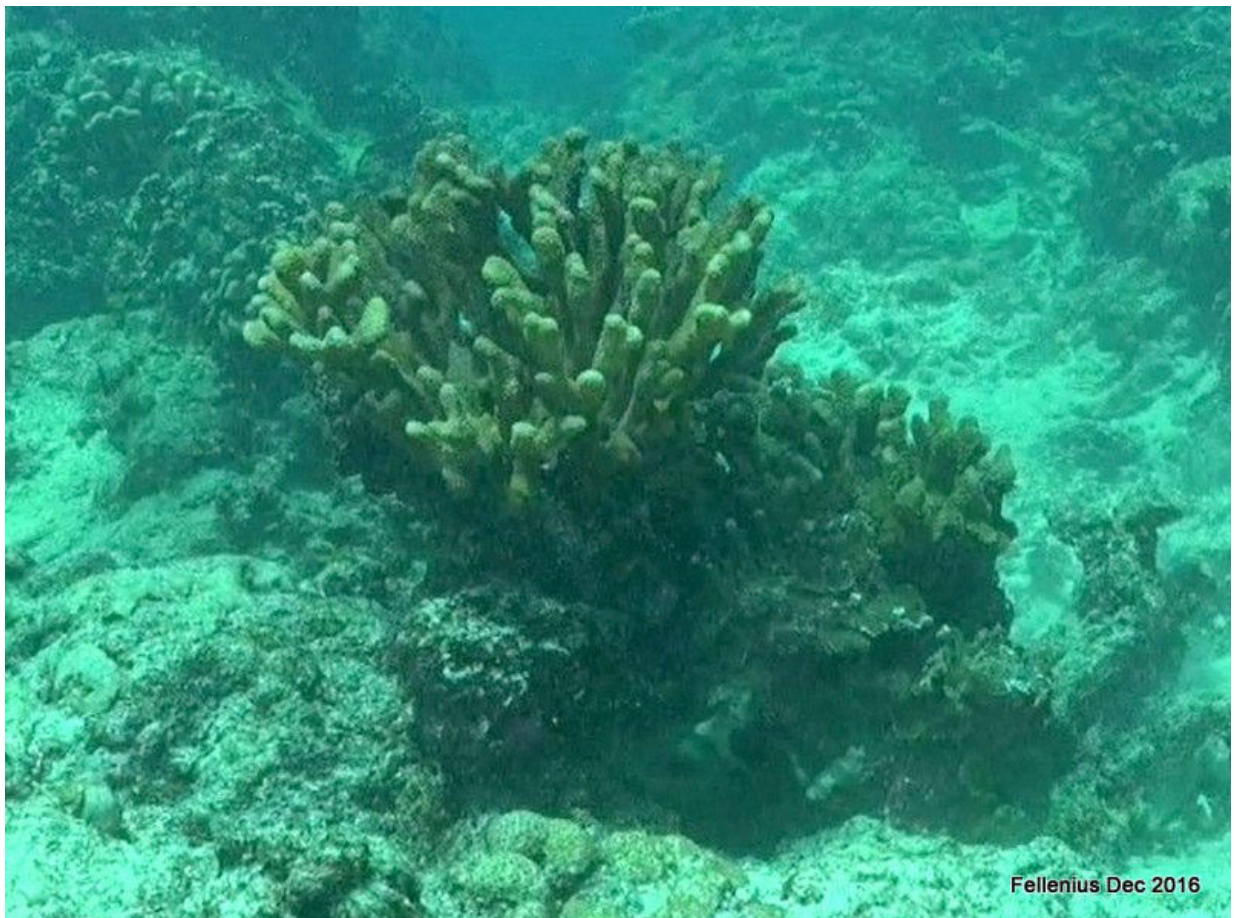
All relocated coral is placed next to coral of the same type outside of the route at the same depth (fig. 16). The colony is stabilized by digging a hole for the base and placing rock around the sides. Where possible, stability and re-growth is enhanced by having physical contact with the branches of the other colony so that tissues grow together more quickly. On average this can take 2 weeks to 2 months.

Figure 16: Point C-D, *Pocillopora* sp. colony relocation – smaller colony on right.

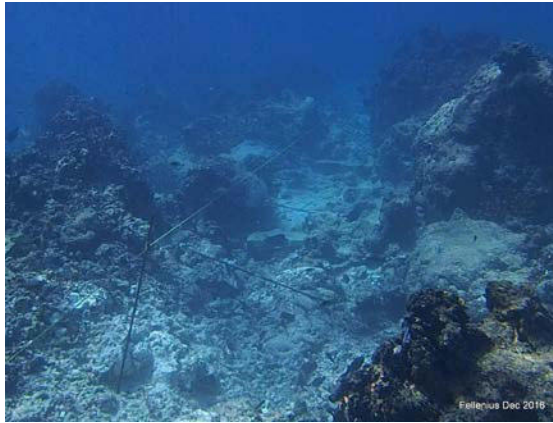
There were also a few significant bedrock rises and rock outcrops that were removed along this segment of the route (bottom left of fig. 17 and centre of fig. 18, post-obstruction removal only).

Figure 17: Point C-D centre, post-obstruction removal

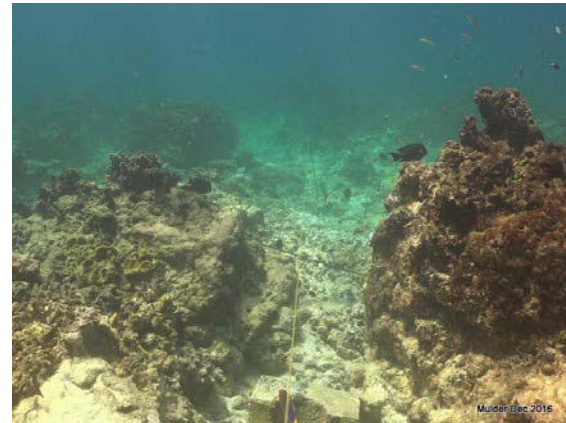
Figure 18: Point C-D south, post-obstruction removal

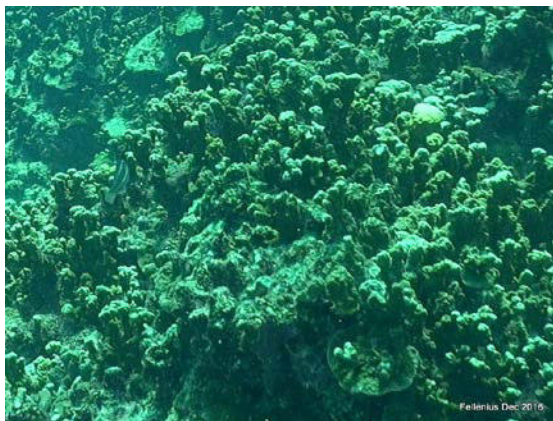
Just south of point D the adjacent coral assemblage changed from compact colonies of limited variety to single-species cover of the common submassive *Porites rus* (fig. 19). This variety of coral grows quickly, resulting in very weak rock. Thus the side of the trench line at point D will not support significant bending of the pipe (fig. 20).

Figure 19: Point D, common *Porites rus* colony

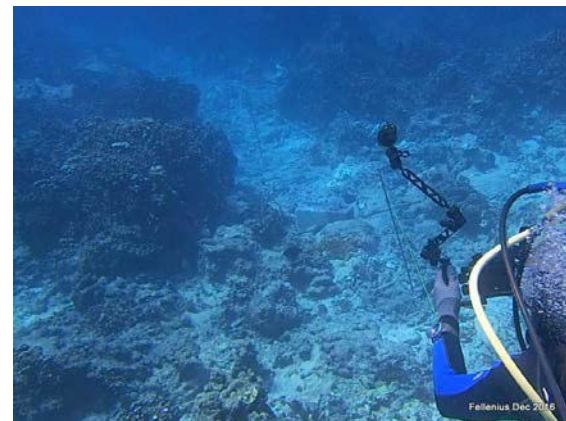
Figure 20: Point D south, post-obstruction removal

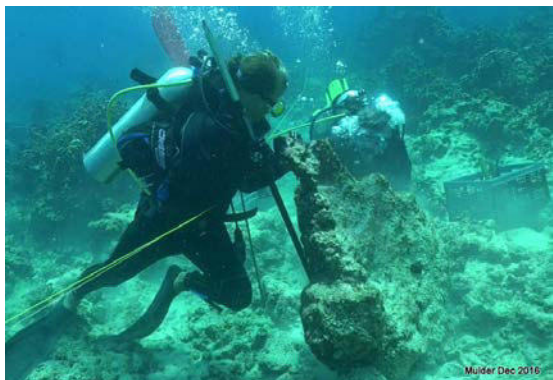
One 2m diameter rock and half a dozen 0.3m-0.7m diameter rock obstructions were removed from the groove between points D and E (figs. 21 and 22). There is a good bedrock base to support bending of the pipe at point E.

Figure 21: Point E seaward, during obstruction removal

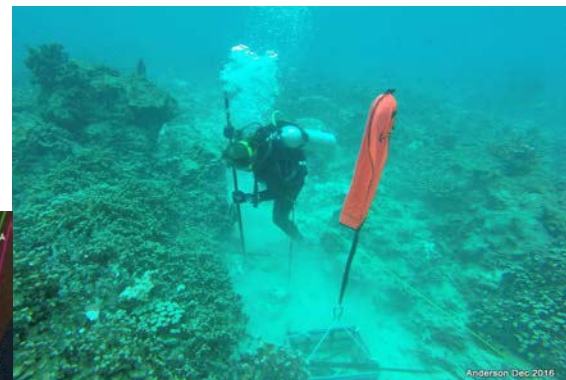
Figure 22: Point E shoreward, during obstruction removal

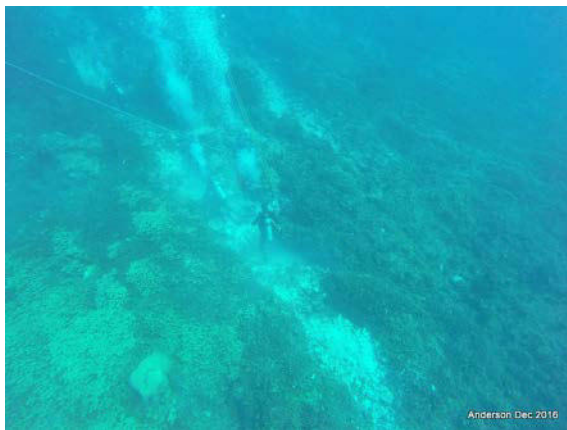
This segment along the back-side of the reef crest rests within a groove, allowing for a straight route with no bends (figs. 23 and 24).

Figure 23: Point F-E shoreward, during obstruction removal

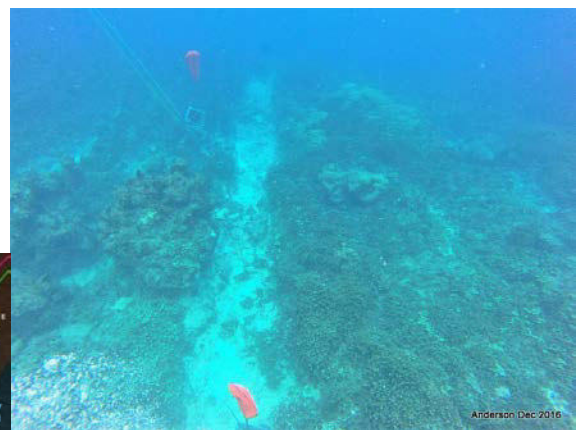
Figure 24: Point E-F seaward, post-obstruction removal

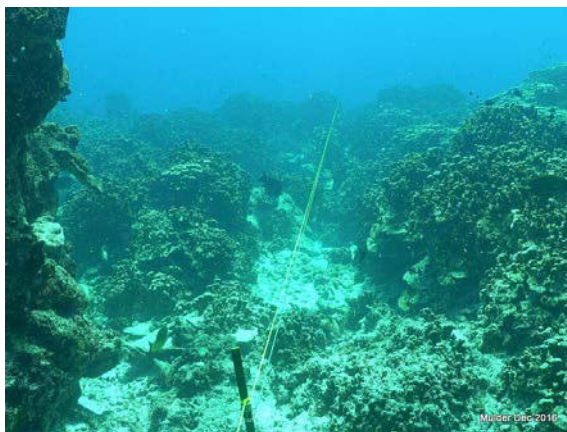
Just south of point E is a large rock outcrop on the east side of the route. This location marks the end of the reef flat and the beginning of the back-reef crest. The presence of a groove through this often elevated area of abundant coral cover is fortunate for the optimised route. The preliminary route also had a groove, although it was not as ideal as this one (figs. 25 and 26).

Figure 25: Point E-F, pre-obstruction removal

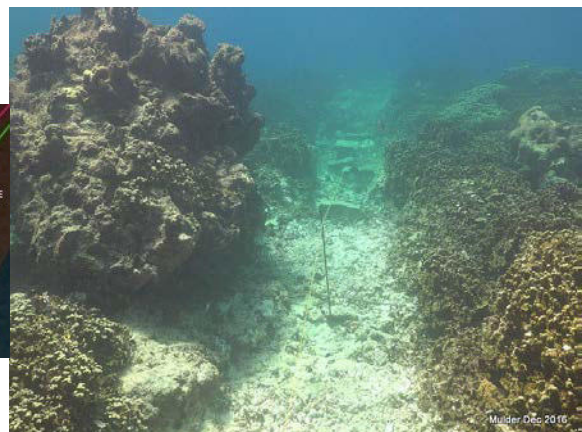
Figure 26: Point E-F, post-obstruction removal

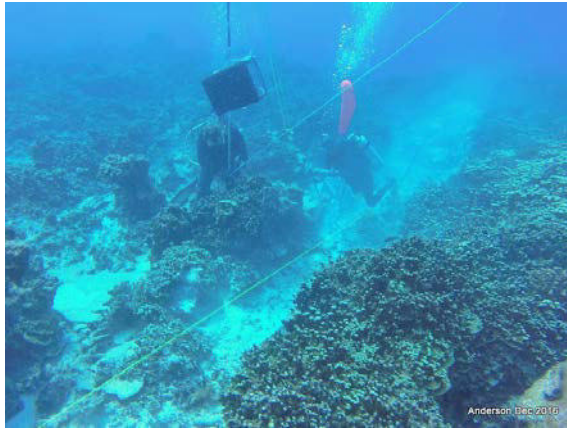
Significant *Porites rus* had to be relocated from within the trench line, with some pieces being 1.5-2.5m in diameter. The colonies grew from a coral rubble and sand base, and broke off intact and relatively easily. The low density of the coral and coral rock enabled the use of lift bags to relocate to adjacent depressions in the reef (figs. 27 and 28).

Figure 27: Point E-F, during obstruction removal

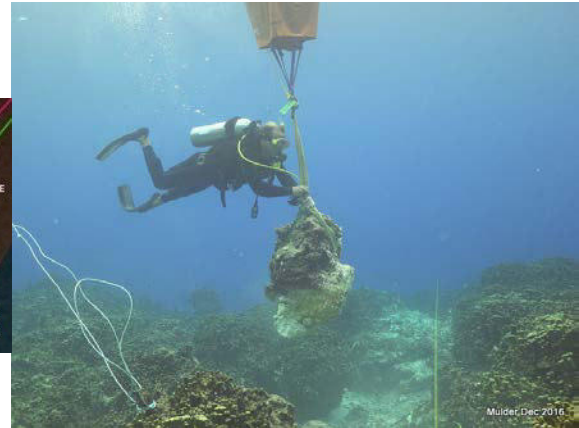
Figure 28: Point E-F, during obstruction removal

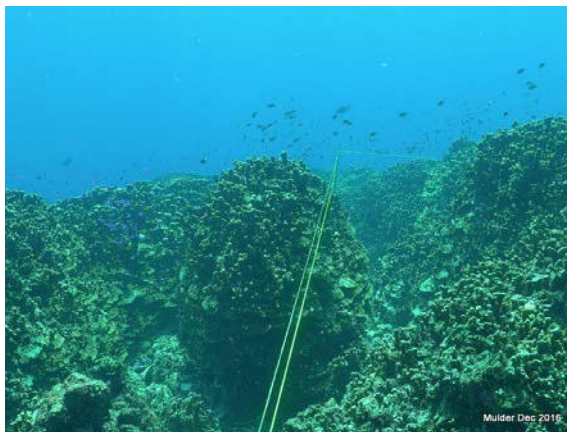
This point has a moderate bend in the route for two reasons (figs. 29 and 30). The segment between points E and F was defined based on the partial sand and rubble base and ease of removal of coral in an existing groove. If a line to the west had been used, it would have tripled the amount of coral to be removed and would have resulted in significant rises in the route due to the lack of a pre-existing groove. Moreover, the segment going west to point G from a route further west would have impacted more diverse coral colonies on the crest than occurred with the optimised route chosen.

Figure 29: north of Point F, pre-obstruction removal

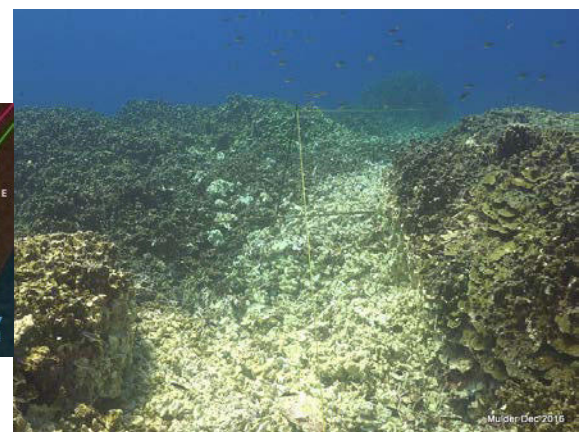
Figure 30: Point F, post-obstruction removal

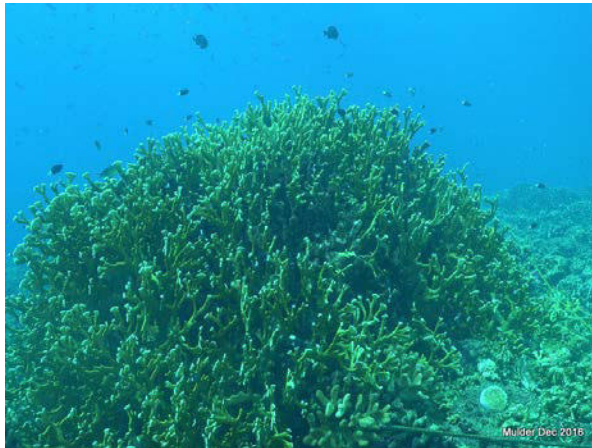
There is a 3m diameter *Millepora dichotoma* (common name, net fire coral) colony at this point on the reef crest. It is the only one in the vicinity (fig. 31). Its western edge fell within the route for 0.6m and was relocated (fig. 32).

Figure 31: Point G looking south, Fire coral pre-obstruction removal

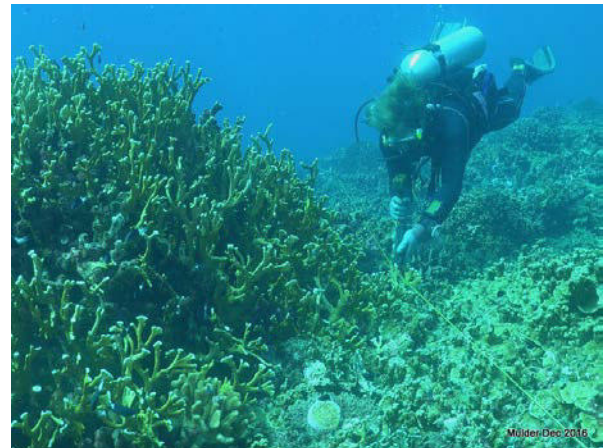
Figure 32: Point G looking south, Fire coral during obstruction removal

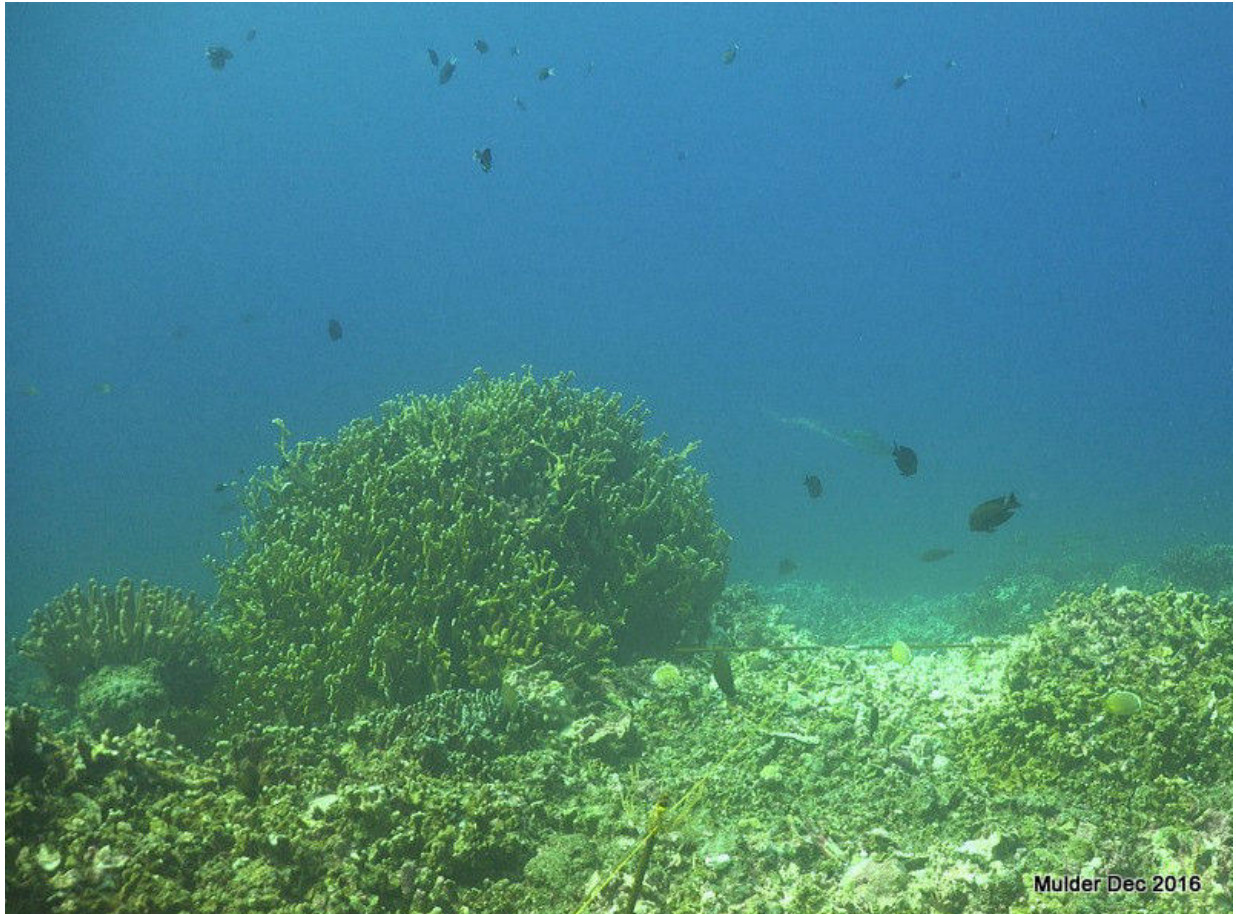
Pipe laying adjacent to the fire coral does not allow for deviation from the route in either direction, and especially to the east due to the need to avoid contacting the fragile colony (fig. 33).

Figure 33: Point G looking south, Fire coral post-obstruction removal

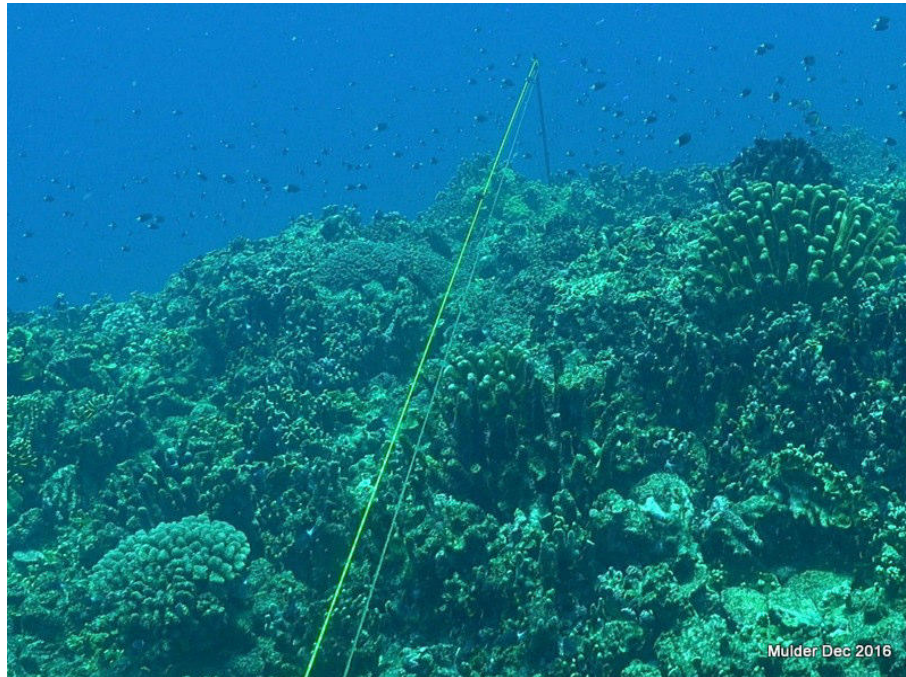
The first half of the segment from point G to H has a high variety of coral types, but similar to segments seaward of point D it has about half the coral cover in non-*Porites rus* species than it did during the initial survey in 2015 (fig. 34).

Figure 34: South of Point G looking south, pre-obstruction removal

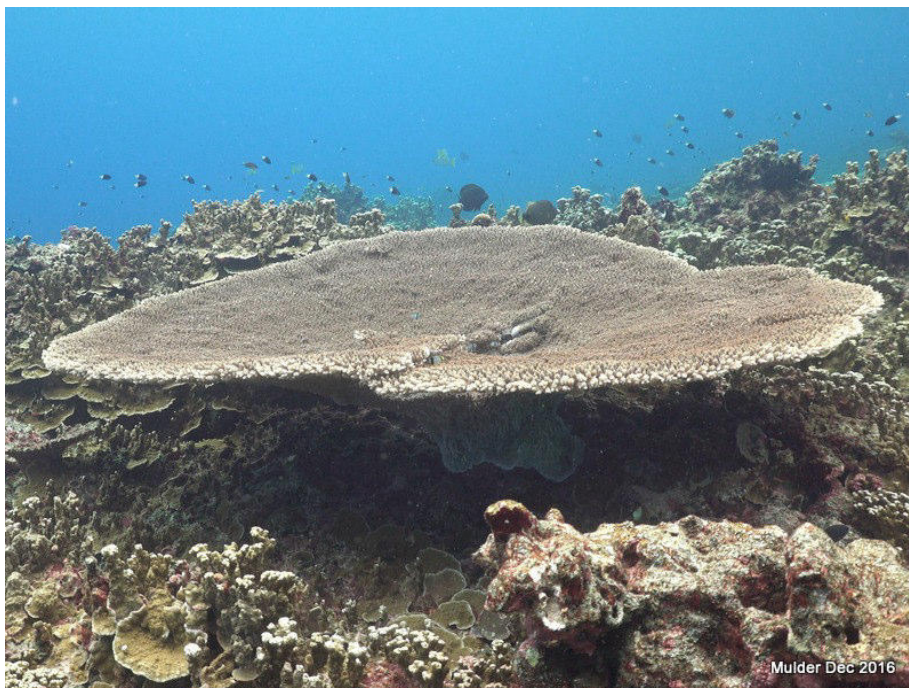
Figure 35: East of Point G looking south, 20m outside of optimised route

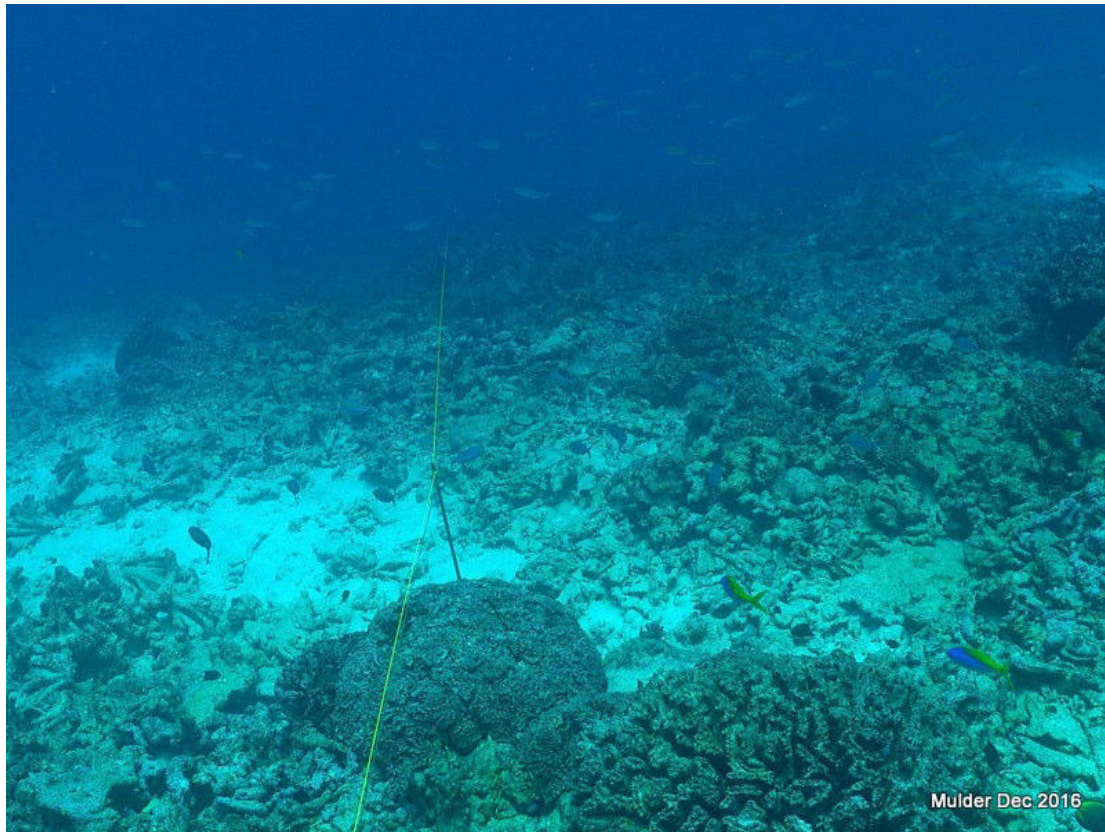
Just east (upslope) of point H was a 1.5m diameter dead massive coral colony that was removed from the route (fig. 36). This point on the central reef slope also defines the start of the exclusively *Plerogyra sinuosa* (common name bubble coral) rubble and debris field, which extends well below the proposed end of pipe.

Figure 36: Point H looking south, pre-obstruction removal

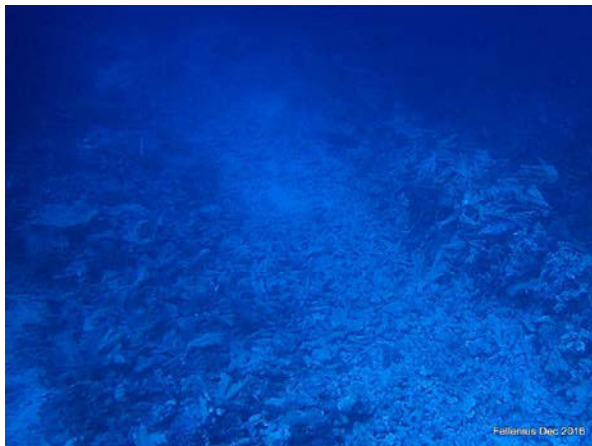
The initial 2015 survey reported significant live coral of this species along the entire surveyed slope, but also noted extensive Crown-of-Thorns seastar feeding scars and ongoing loss of cover. It appears that the seastars have run out of their food supply and moved on. The rubble and debris that remain is very light, and is stacked in layers up to 1m thick. The pieces range from 0.1-1.0m in diameter, and blanket the entire reef slope. All pieces greater than 0.3m were removed, with hundreds of pieces piled up as ridges on either side of the route (figs. 37 and 38).

Figure 37: Point H looking south, post-obstruction removal

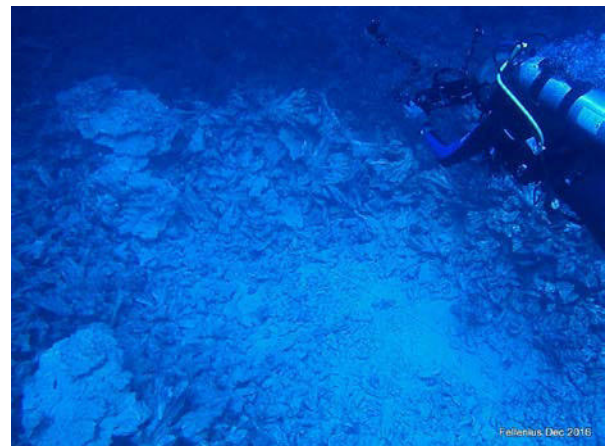
Figure 38: South of Point H looking at proposed end of pipe location, post-obstruction removal

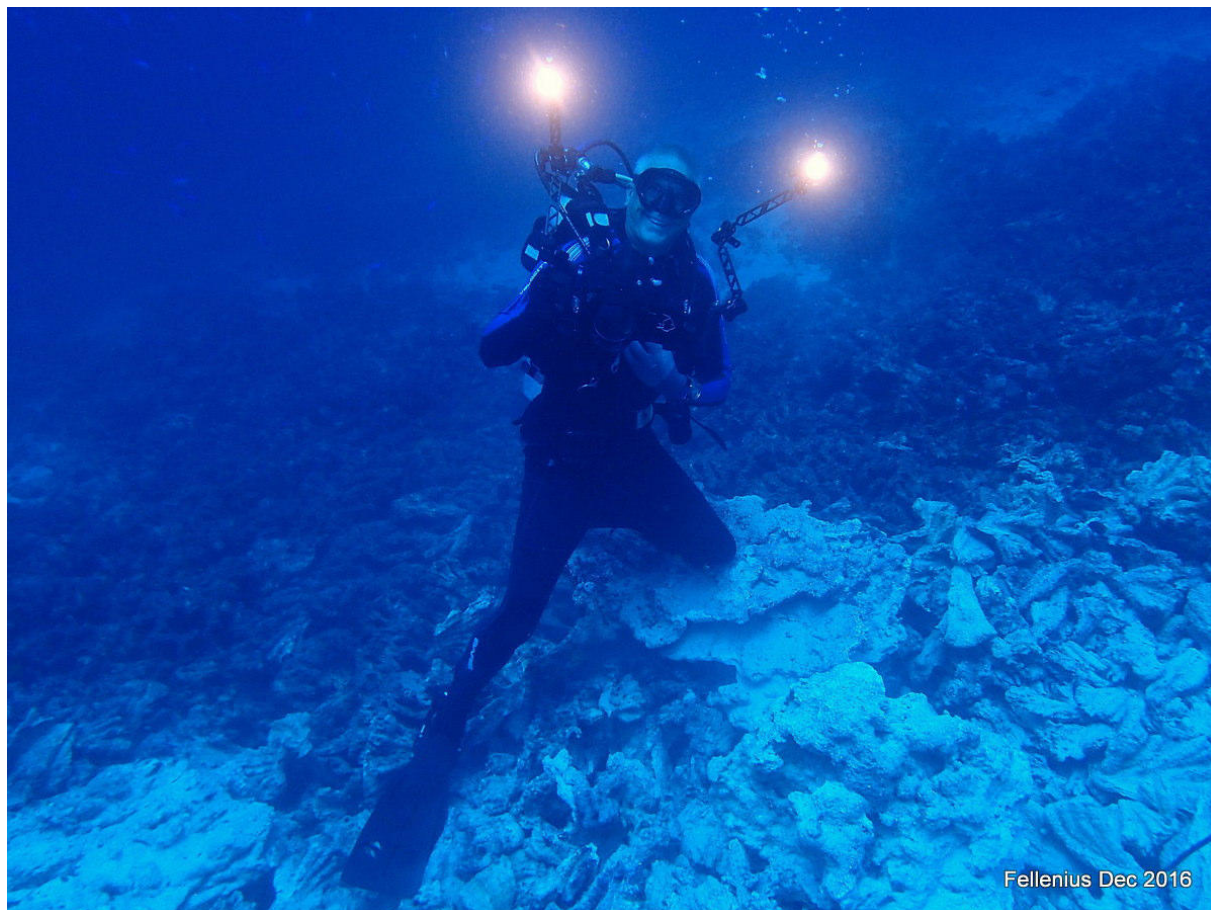
Figure 39: Between Point H and proposed end of pipe looking west, post-obstruction removal (Roy Mulder, Videographer)
