# Environmental and Social Monitoring Report

January - June, 2018

## Kiribati: South Tarawa Sanitation Improvement Sector Project

South Tarawa Sanitation Improvement Sector Project

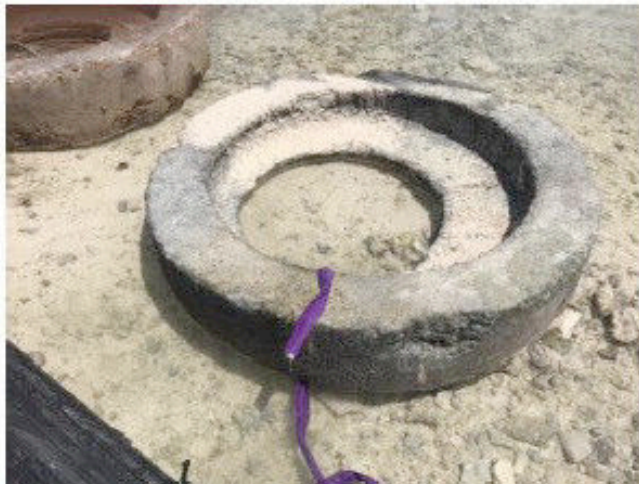
- 1)

- Mr Simmons is a responsible, safe and diligent long term staff member of CCB with an excellent safety record.
- On Wednesday Mr Simmons had moved a 400m string of 355OD HDPE pipe onto the reef flat during low tide in Betio in preparation for installation the following day.
- The pipe was tethered with rope and strapping at to temporary anchor weights at a number of locations along the pipe – the standard practice used to secure strings of pipe effectively on the reef flat to date.
- Between 6pm & 11pm by third party reports unidentified locals walked out onto the reef, cut and removed the rope and strapping from each of the temporary anchor weights.
- See below photos showing at least 3 cut tethers.

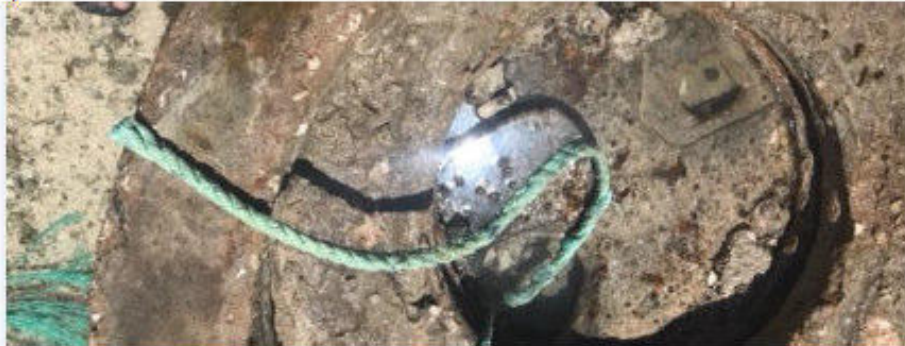
- 3)

- This left the pipe string untethered on a rising tide and able to float away.
