ENVIRONMENTAL MONITORING REPORT

Final Bi-annual
January – June 2014

Georgia: Urban Services Improvement Investment Program (Tranche 1)

Prepared by “United Water Supply Company of Georgia”, LLC Tbilisi, Georgia for the Ministry of Regional Development and Infrastructure of Georgia and the Asian Development Bank

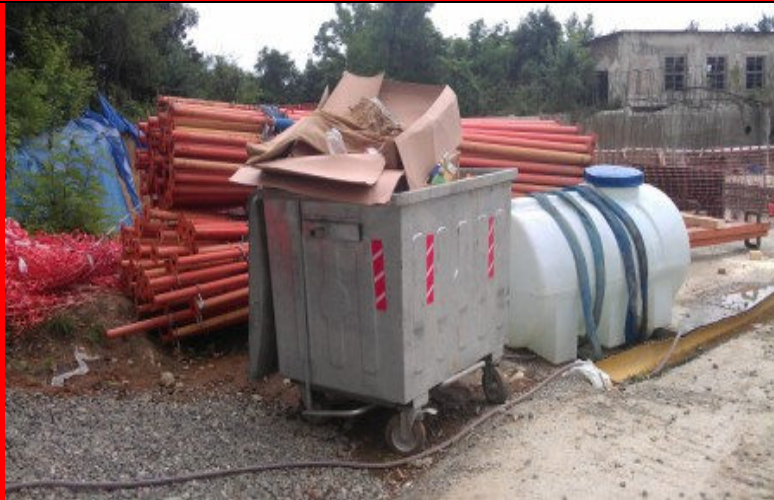
Kutaisi/Vazha Pshavela

Environmental Issues

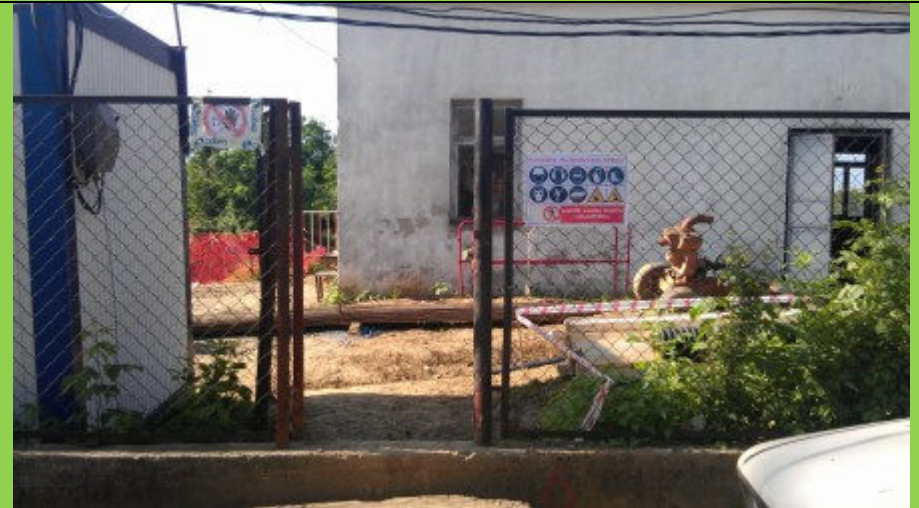
Environmental Issues Mitigated

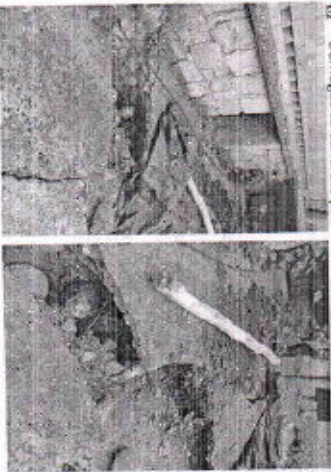
<p>(i) Damages to concrete path around foundation of House No.1</p>

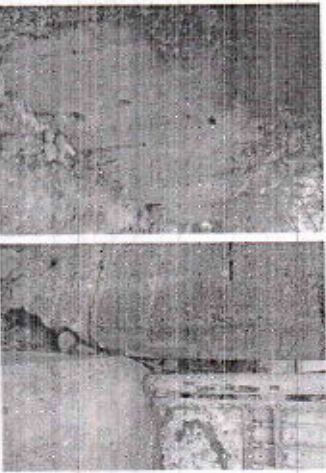
<p>built a two-floor warehouse with superficial foundation on the environs of the wall that transmits additional loads to it. Moreover, in the vicinity of this wall, a septic tank has been constructed and which discharges are probably done directly to the backfill sustained by the wall. It remains to be evaluated if a valid construction permit was delivered by the City Hall for such a two-floor building considering geotechnical and soil conditions.</p>	
<p>Corner of House, left</p> <p>(ii) Dislocation of retention wall at House no 1</p> <p>Corner of House, right</p>

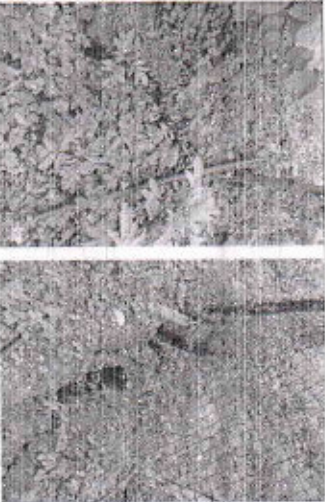
<p>At the bottom of the wall, it has been installed by others Contractors, in an unknown date, a steel pipe in a trench that has modified the instable balance of the sec. Through several landslides in the aforementioned trench during the works carried out in the current trench it has been tested the deficient compaction of the former trench, that has probably caused its collapse before the outset of Cobra's works.</p>

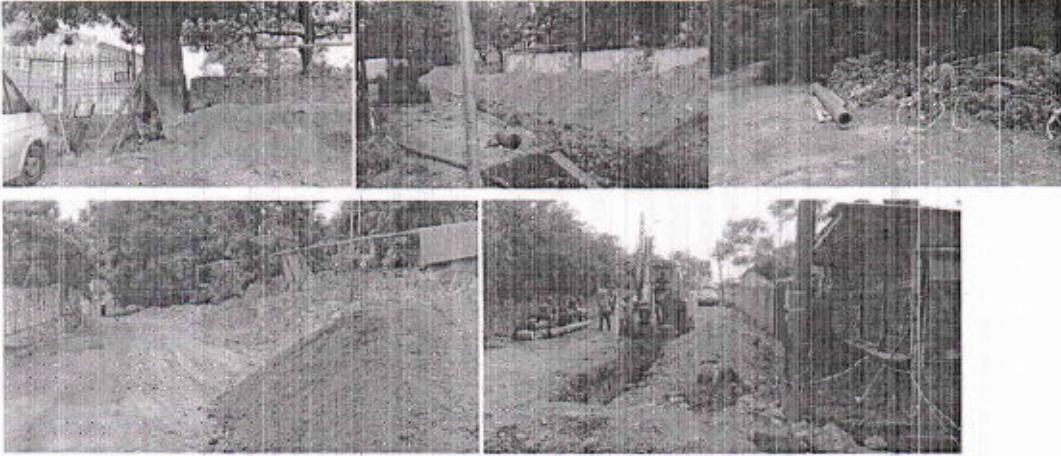
Project: USIIP	Non-compliance Notice KUTAISI
Contract No: REG-01	
Contractor: COBRA	
Reference: Kutaisi: network – Kldiashvili, Gelati, Kupradze, Erevani streets and Vazha Pshavela site	
This notice is to advice you, the prime Contractor, on the referenced Contract, of the following notice on health, safety and environmental measures to be implemented urgently	
Non-Compliance in Kutaisi	
Kldiashvili street :	
<ul style="list-style-type: none">– Trees located at the construction area should be fenced– The surplus/waste soil should be stored separately for further use at the dedicated place to avoid disturbance of the population, if trenches are left open more than 24 hours– All workers should wear complete PPE during operation– Construction area should be organized properly according to given instructions and cleaned regularly– The standard fixing should be used for warning signs or safety tapes. At the roads blinking signs should be installed

These conditions have to be remedied within five (5) days by the prime Contractor (Cobra).

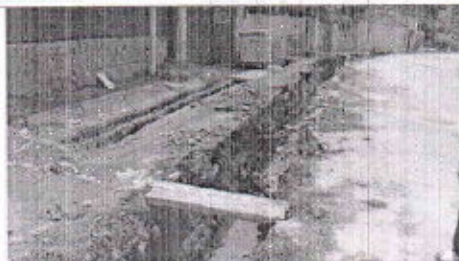
Gelati street:	
<ul style="list-style-type: none">– The standard fixing should be used for warning signs or safety tapes. At the roads blinking signs should be installed if street central lightening is not operating– The relevant wooden/metal walkways/planks should be installed across open tranches when passing settlement area– Construction area should be organized properly according to given instructions and cleaned regularly

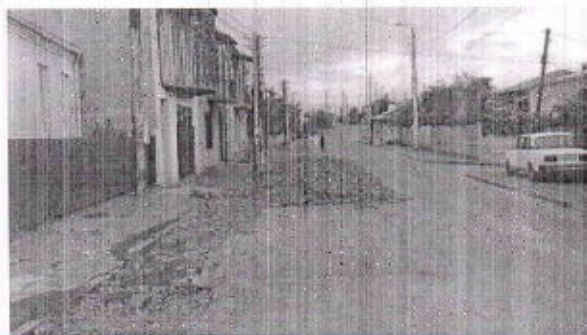
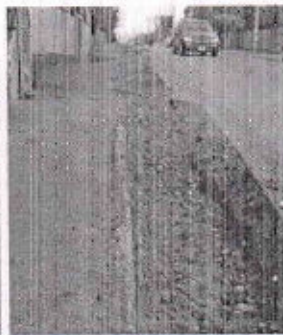
Kupradze street :

- The surplus/waste soil pile should be stored separately for further use at the dedicated place
- Refilling/compaction and reinstatement process should bring site at the same condition as it was before construction

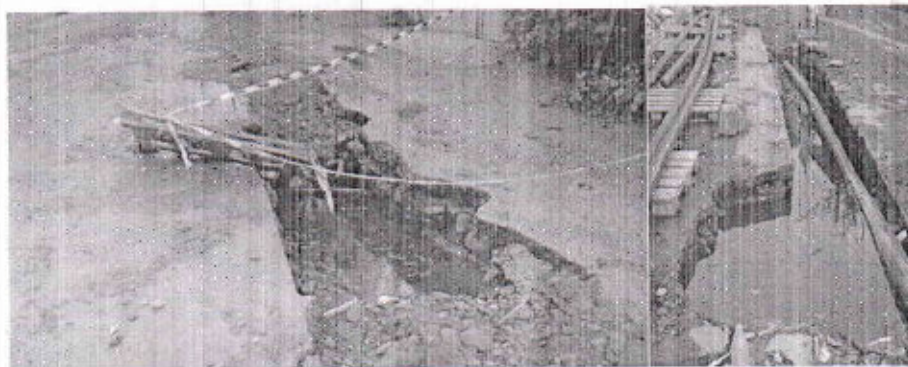
Erevani street

- All openly left trenches should be fenced properly with standard warning signs and safety tapes
- If street central lightening is not operating the openly left trenches should be lightened or blinking signs should be installed

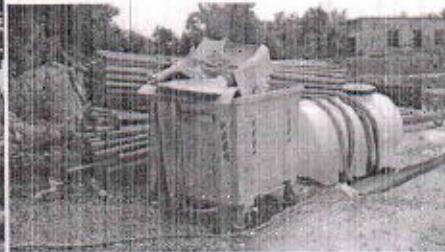
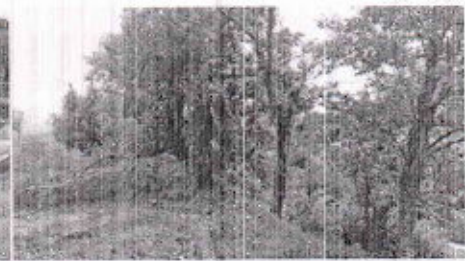
Vazha Pshavela site:

- Trees located at the construction site should be fenced
- Should be arranged special place for fuel/oil spill response
- Household Waste container should have clear sticker mentioned "Household Waste" and regularly collected by the waste collection service
- Hazardous Waste container should be installed in proper place
- To avoid soil spreading to public roads from construction site it is necessary to apply truck wheels washing
