Environmental Monitoring Report

Semestral Report
February 2015

GEO: Urban Services Improvement Investment Program – Project 1

Project Number: 43405-023

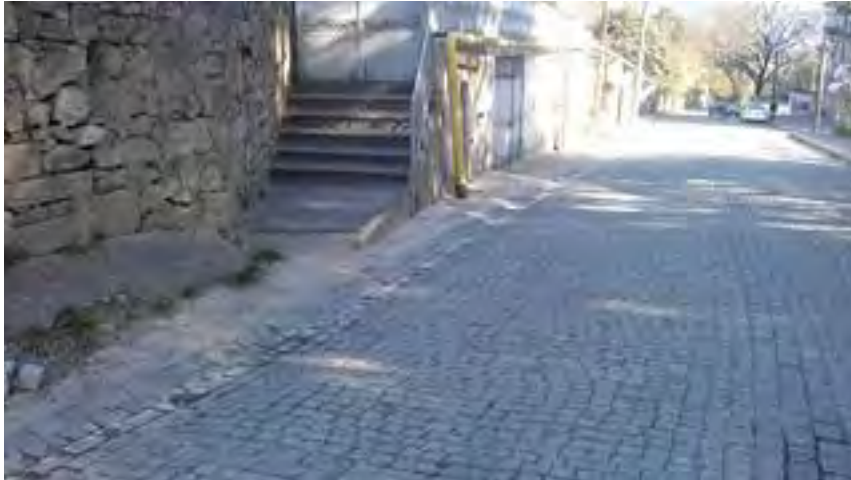
Kutaisi network after reinstatement

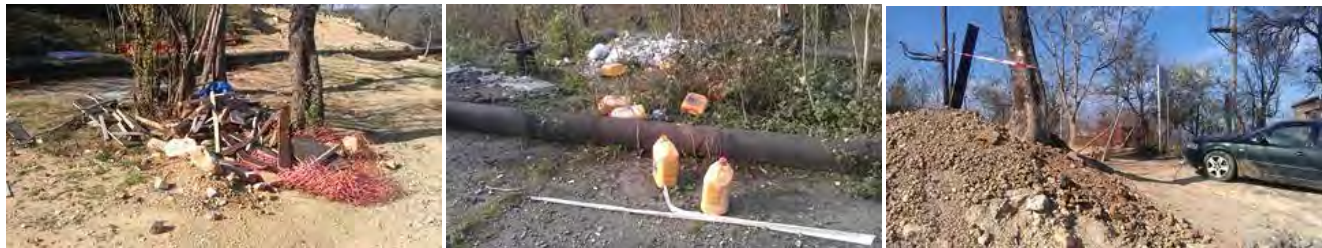
Kldiashvili site

- Accumulated waste soil and construction waste should be taken out of the site immediately!
- All trees located at the construction site should be fenced properly!
- Household and Hazardous Waste containers should be installed in proper place with relevant signs!
- Site internally should be arranged properly and cleaned regularly. All construction materials should be properly segregated and stored adequately!
- Proper site fencing needs to be arranged

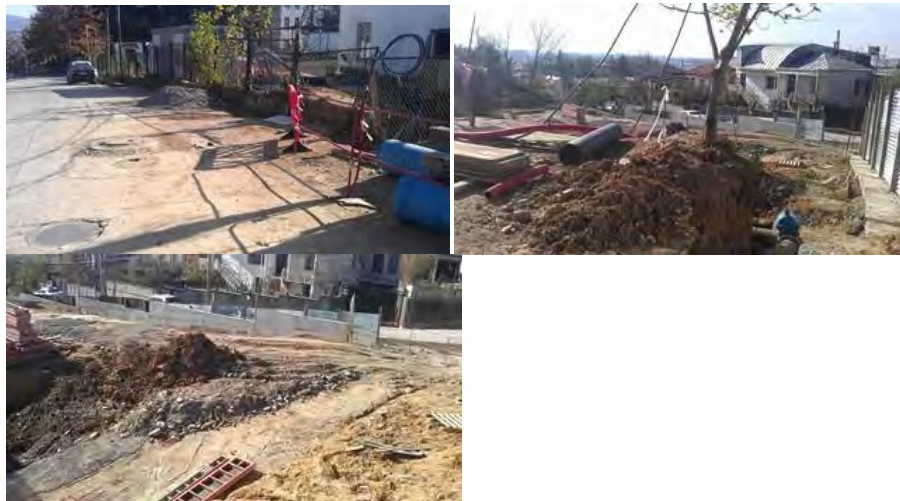
Vaja Pshavela site

- Proper fuel/oil spill response items should be available at the site as per SEMP, however it was noted that oil spill absorbent was available at the site
- Trees located at the construction site should be fenced and preserved properly!

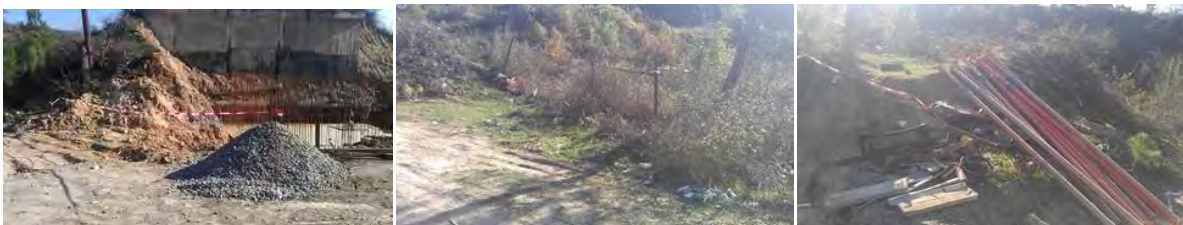
TV Tower site

- Construction site should be defined and fenced properly with relevant material (avoid fencing with safety tapes)!

- Relevant warning signs should be installed
- Site area should be arranged properly and organized in accordance with given instructions, including internal access roads (at least graveled to avoid mud roads)!
- Household and Hazardous Waste containers should be installed in proper place with relevant signs!
- **Bio Toilet should be installed**

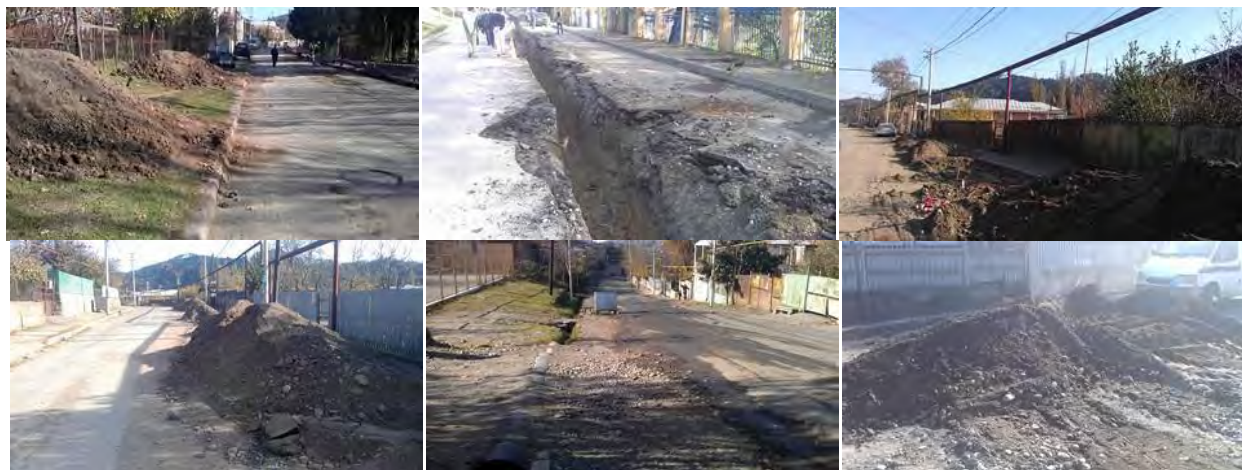
Network

- All accumulated waste soil and construction waste at the road sides should be taken away for its final disposal immediately!
- Enough wooden/metal walkways/planks should be installed across open trenches when passing settlement area!
- Refilling/compaction and reinstatement process should bring site at the same condition as it was before construction (there are some sites observed with no final reinstatement, like, Gelati, Solomon and Kldiashvili streets)

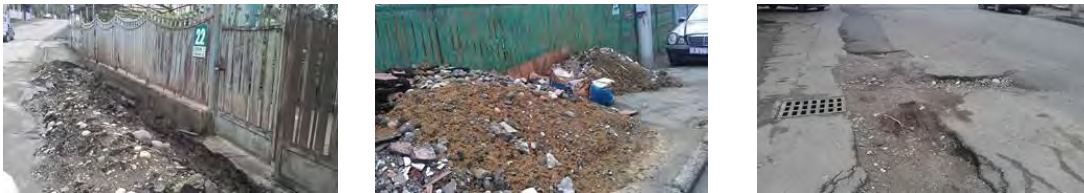
Network

- The adequate lightening of tranches should be provided with relevant signal lights;
- All accumulated waste soil and construction waste at the road sides should be taken away for its final disposal immediately;
- Enough wooden/metal walkways/planks should be installed across open tranches when passing settlement area;
- Refilling/compaction and reinstatement process should bring site at the same condition as it was before construction

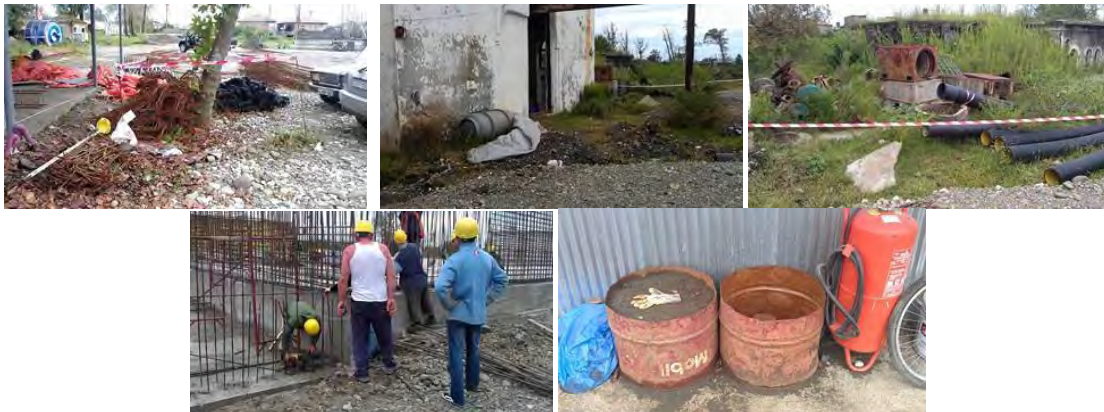
Non-Compliance in Poti Nabada site

- All trees located at the construction site should be fenced with proper fencing material. The construction waste should be removed from fenced trees urgently;
- Provide adequate fencing of construction area from all side. Front part of site is done but behind of site some parts still needs urgent fencing;
- The chlorine container should be disposed in safe place urgently;
- Fuel and lubricants spill elimination items have no special indication sign and sawdust container is empty;
- All workers (even personnel of subcontractor) should be equipped with complete PPE;
- Overall site should be clean and organized properly

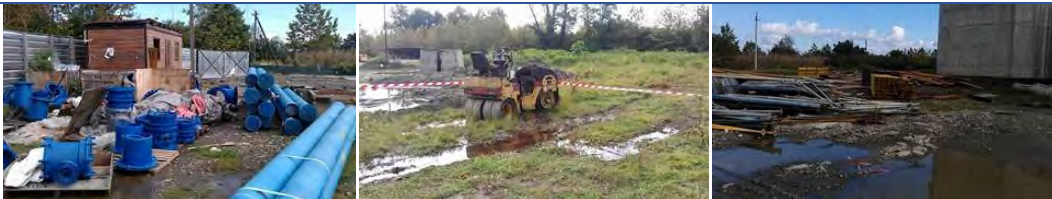
Non-Compliance in Anaklia Darcheli site

- Parking area is arranged but there is NO parking special sign "Parking Area" that was available before;
- On site, construction equipment and vehicles should be kept in safe environment and in proper place;
- All construction materials should be stored properly within site facilities.

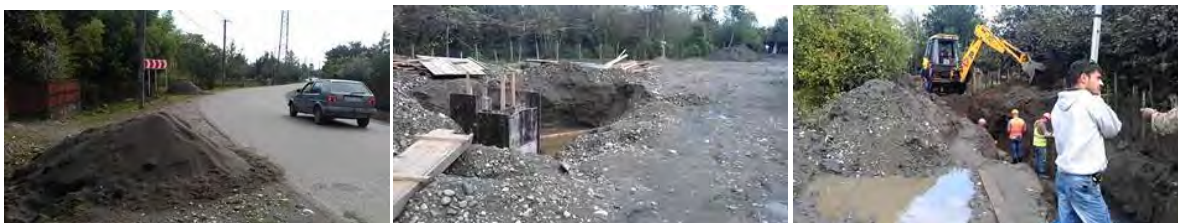
Network

- The adequate lightening of tranches should be provided with relevant signal lights. At the roads blinking signs should be installed;
- The surplus/waste soil along to tranches should be stored at specially allocated place for further use;
- Workers should wear complete PPE;
- Materials for refilling of tranches should be brought to the site when refilling is to start. To leave refilling materials nearby to tranches is NOT acceptable;
