# Environmental Monitoring Report

## GEO: Urban Services Improvement Investment Program – Project 1

## BI-ANNUAL ENVIRONMENTAL MONITORING REPORT

### **GEORGIA: URBAN SERVICES IMPROVEMENT INVESTMENT PROGRAM (TRANCHE 1) (FINANCED BY THE ASIAN DEVELOPMENT BANK)**

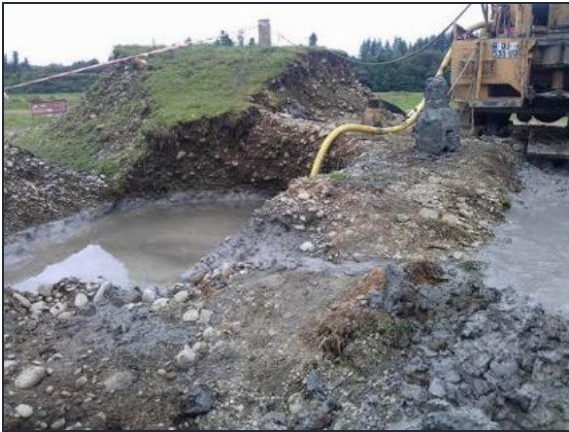
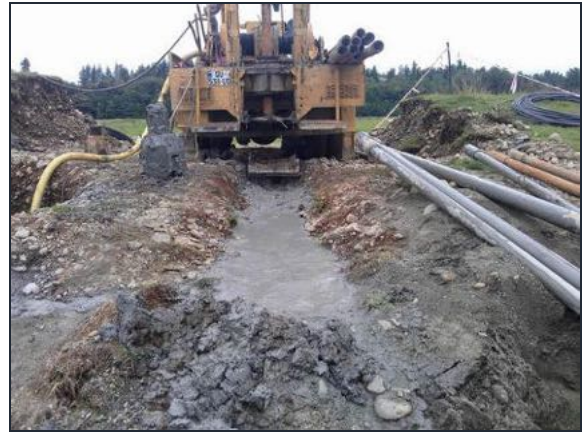
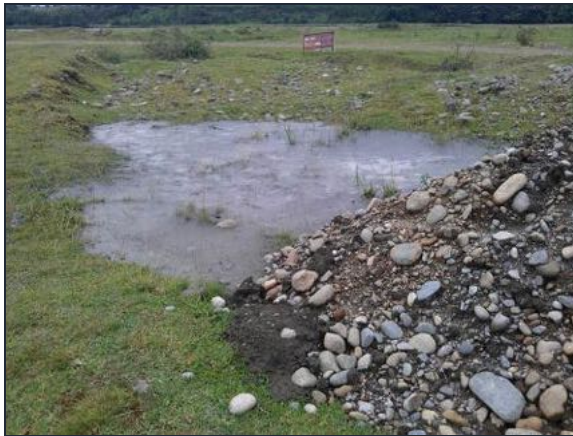
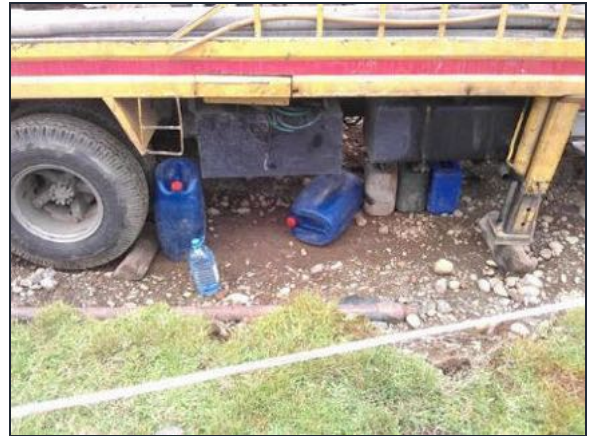
### **WELLFIELD**

- Fuel/oil spill response items (sand, sawdust, special containers) should available
- Fencing of the site is to be established
- Topsoil should be managed according to the SSEMP
- Machinery and equipment should be in standard technical condition (no leakage of fuel and lubricants)
- All containers of fuel and lubricants should be placed in a special place with roofing
- Bentonite waste should be managed according to SSEMP

All these conditions have to be remedied within five days (by the 25 September 2016) by the prime Contractor (Peri).

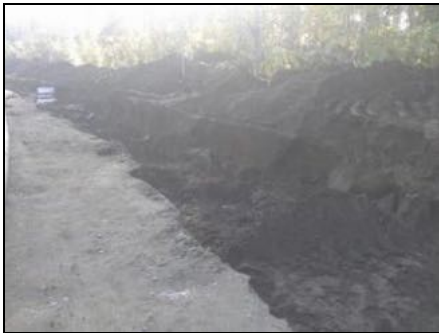
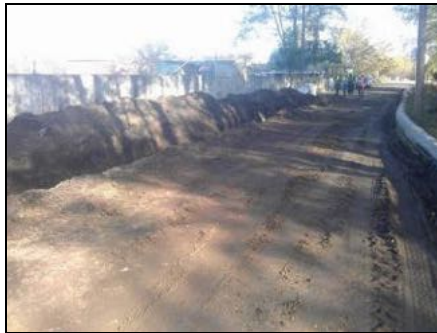
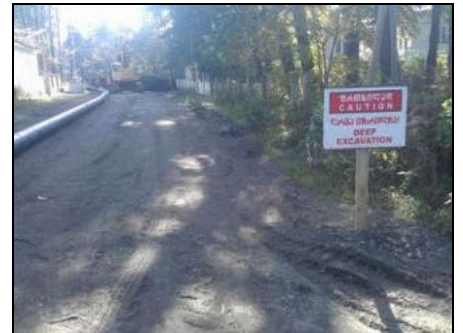
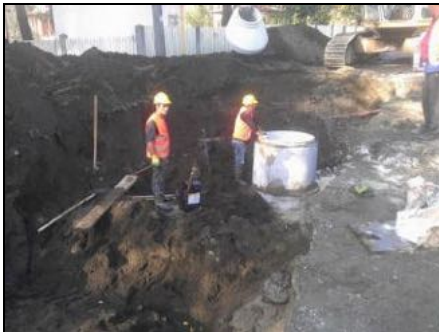
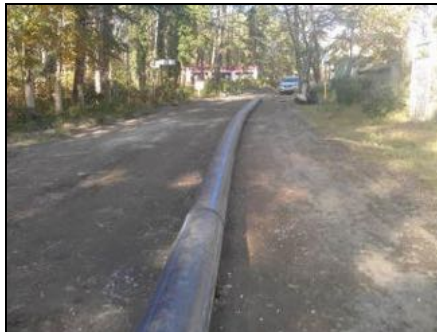
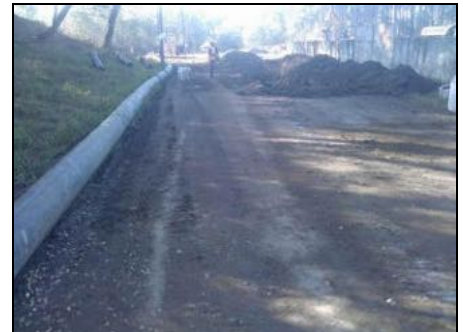
### NETWORK

- Protect trees to avoid its damage during transmission line construction
- Enough and high visible safety signs/tapes and trench side barriers around of deep open trenches should be installed to avoid accident of population
- Walls of the deep trenches (>1.5m) should be strengthened by boards to avoid landfall of the soil and accidents
- Accumulated waste soil should be removed from construction area and disposed in a proper place
- Use tarpaulins to cover during materials transportation
- Workers always should use complete PPE

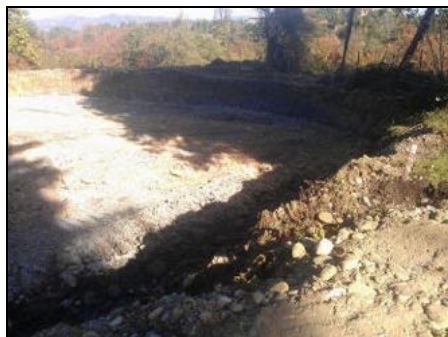
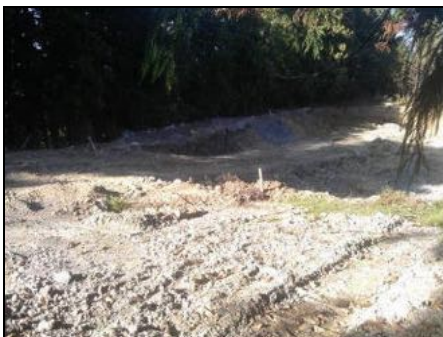
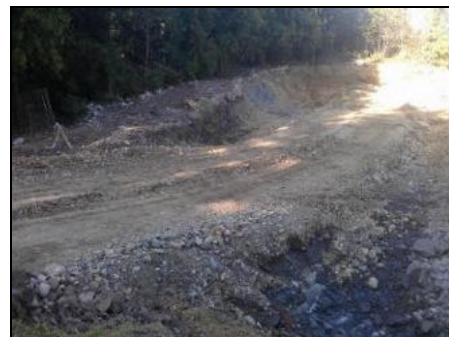
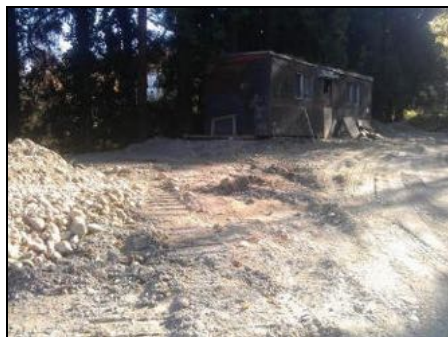
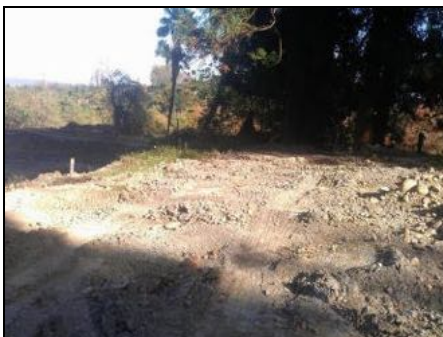
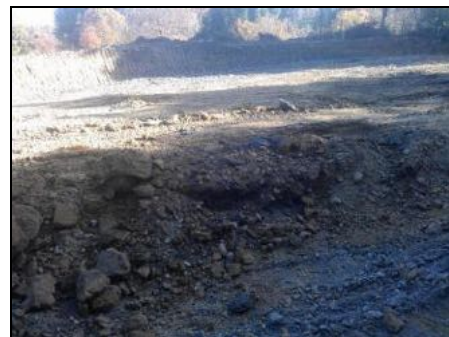
### RESERVOIR

- Trees at the construction site should be protect to avoid its damage
- Site should be fenced from all sides and equipped with lockable gate with proper warning and information signs
- Proper warning and information signs should be arranged at the entrance, perimeter and inside of construction site
- Safety signs/tapes and trench side barriers should be installed around of excavation of reservoir
- Household Waste containers with relevant sign should be installed in proper place
- Hazardous Waste containers with relevant sign should be installed in proper place
- Workers always should use complete PPE
- Site internally should be arranged properly and cleaned regularly

All these conditions have to be remedied within five days (by the 20 November 2016) by the prime Contractor (Peri).

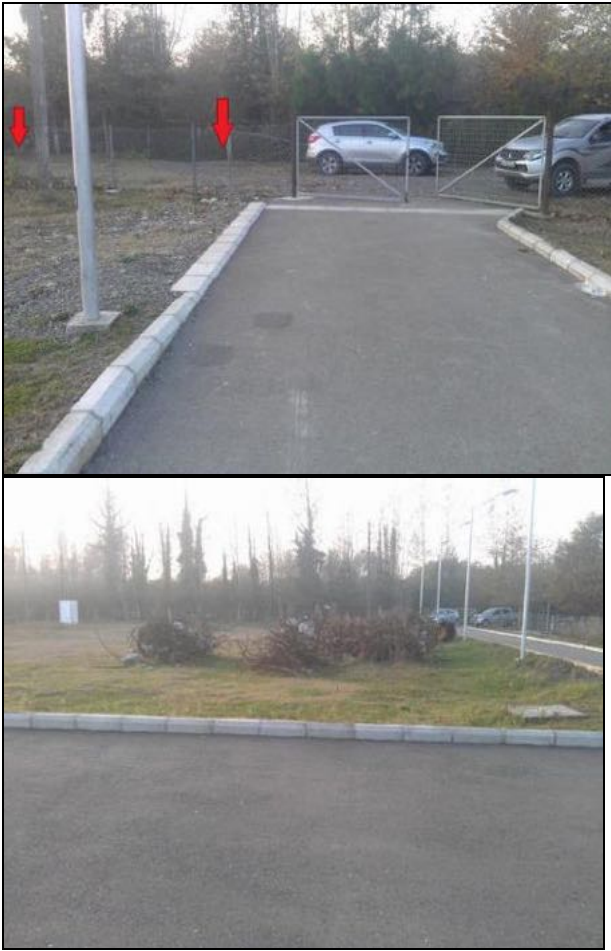
**Figures 31 and 32: Darcheli reservoir fencing with gates**

74. Darcheli reservoir is fenced with metal fence and has gates (Figures 31 and 32). Post-construction territory and access road are reinstated and is satisfactory (Figures 33 and 34).

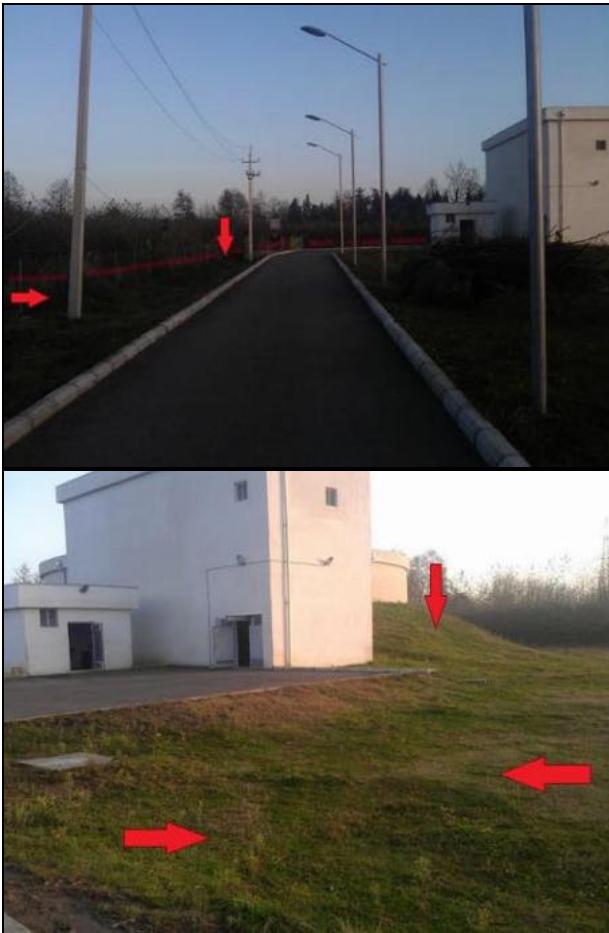
75. The construction waste is removed from the reservoir site. The local roads are faced with concrete and the rehabilitation works in the area are accomplished satisfactorily (Figures 33 and 34).

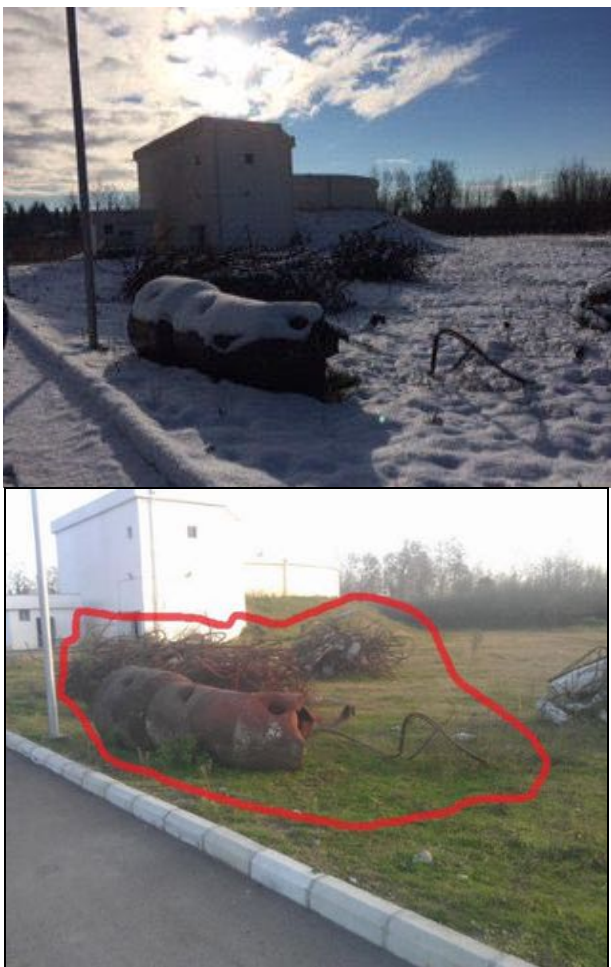
**Fig. 35 and 36: Scrap metal and wooden waste at the Darcheli reservoir territory**

**76. Non-compliance 1:** Scrap metal and wooden waste is scattered in an uncontrolled manner on the site of Darcheli reservoir (Figures 35 and 36).

**77. Corrective action:** The scrap metal and wooden waste scattered in an uncontrolled manner on the site of Darcheli sub-station must be removed from the site by the Contractor. The deadline of this work is 1 month.

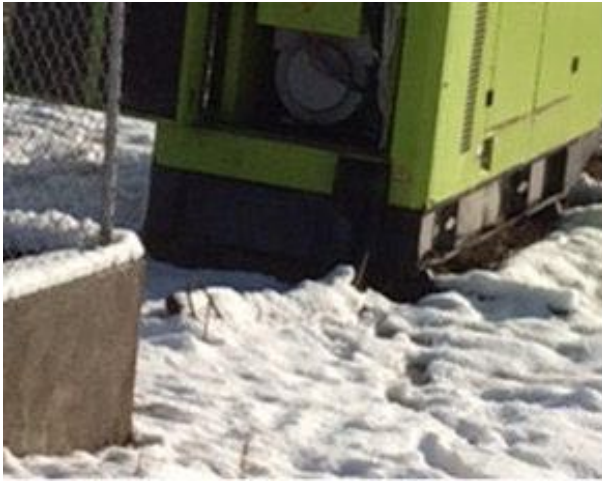
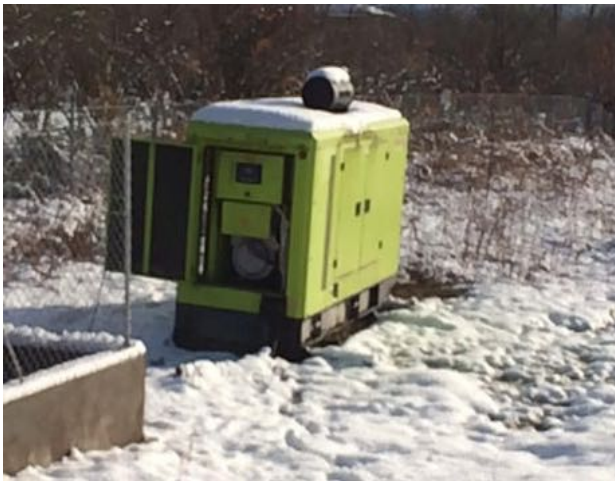
**Figures 37 and 38: The generator on the site**

**78. Non-compliance 2:** The generator unit on the territory of Darcheli sub-station running on diesel is not placed on a secondary tank. In case of diesel spill, there is a danger of the soil and underground waters pollution (Figures 37 and 38).

**79. Corrective action:** The generator must be placed on the secondary tank. The volume of the secondary tank must be at least 110% of the generator diesel capacity.

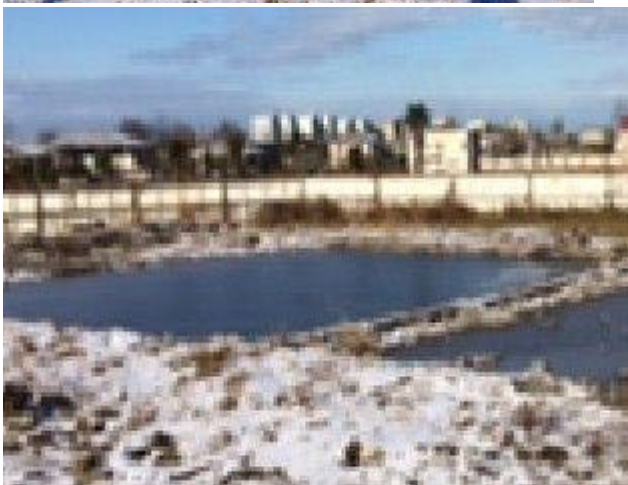
**Figures 43 and 44: Water-flooded site of the existing reservoirs**

**99. Non-compliance 2:** The project envisaged the disassembly of the existing reservoir on the territory of Nabada and removal of the construction waste from the area. At present, only the upper ground layer of the existing reservoirs is removed, while the underground part of the reservoir is untouched. As it rains, the rainwater is accumulated on the site resulting in two basin-like units on the site of the reservoir (Figures 43 and 44).

**100. Corrective action:** The old reservoirs on the territory must be totally disassembled and the construction materials must be removed and disposed as per the legislative requirements.

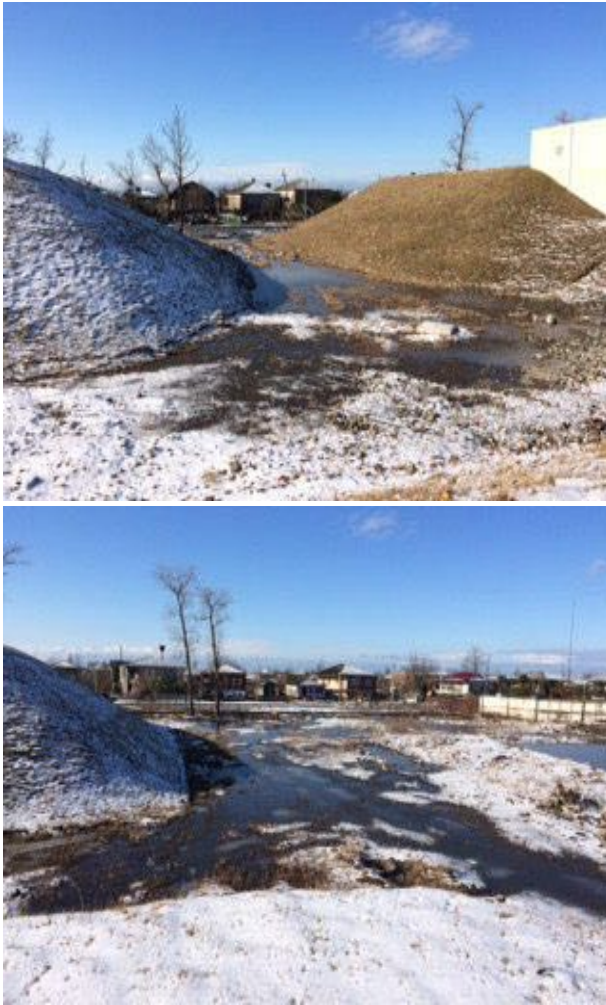
**Figures 45 and 46: Water-flooded site of the reservoirs**

**101. Non-compliance 3:** The site of the reservoir is not leveled and in case of abundant precipitations, large part of the reservoir area is flooded increasing the risk of pollution of the underground waters (Figures 45 and 45).

**102. Corrective action:** The site of the reservoir is to be leveled.

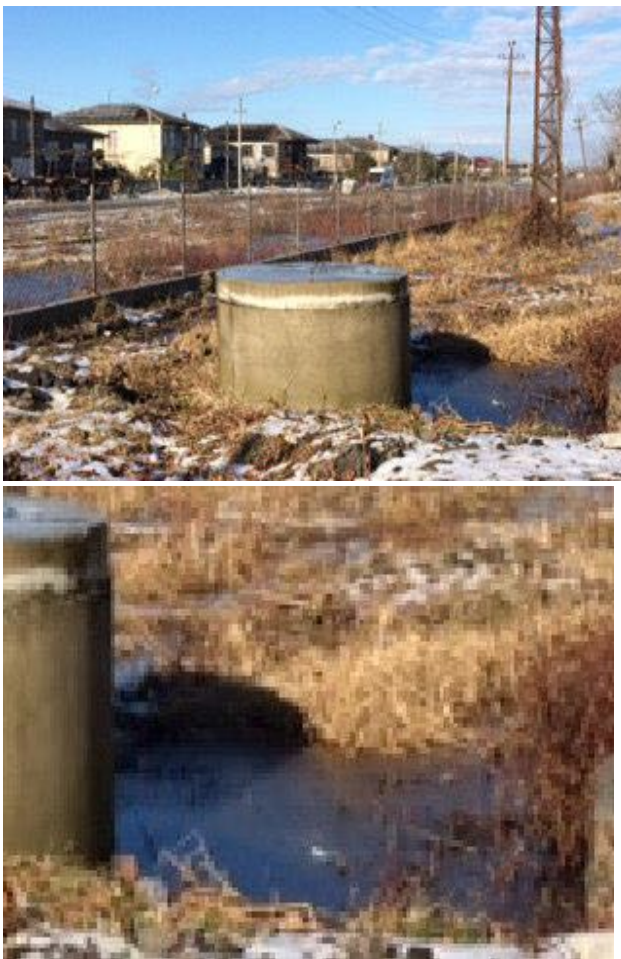
**Figures 47 and 48: The sewage pump on the site of Nabada reservoir**

**103. Non-compliance 4:** The sewage pumping system on the site of Nabada reservoir is not complete contributing to the increased risk of pollution of underground waters (Figures 47 and 48).

**104. Corrective action:** The installation and exploitation of the sewage pumping unit is to be accomplished.
