Social Safeguards Monitoring Report

TIM L-2857/2858: Road Network Upgrading Project

Dili – Tibar - Liquica Road

Social Safeguards Monitoring Report (Report No. 2)

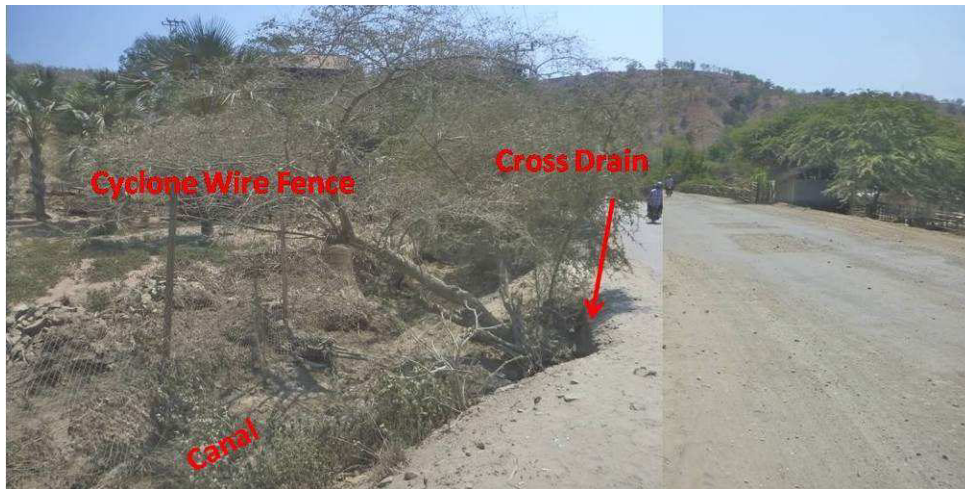
5.2 The planned improvement of the cross drain near Sta. 16+864 and 16+877 will disturb the adjacent cyclone wire fence. The owner of the fence is still out of the country thus, negotiation activities will have to wait until the return of the owner.

Section of the 3 meter long cyclone wire that will be disturbed by the planned improvement on the cross drain near Sta. 16+864 and 16+877.

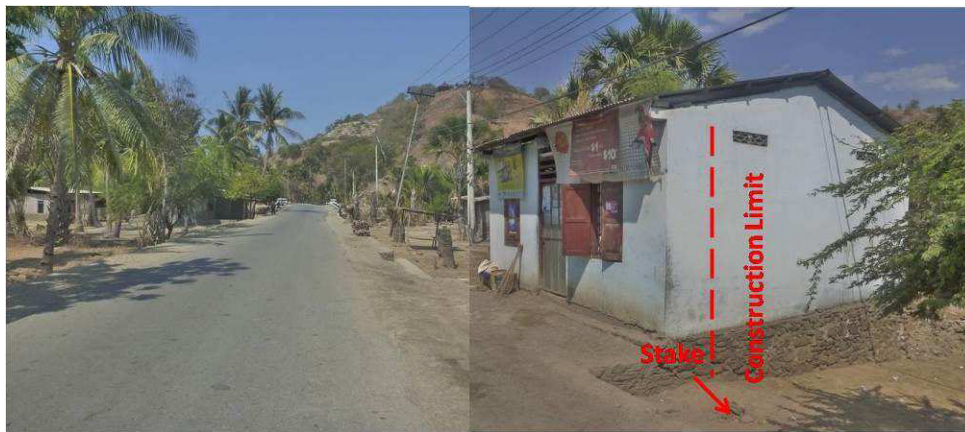
5.4 The owner of the permanent kiosk in Sta. 18+380 is requesting compensation 2.25 times the amount offered by the project.

Concrete kiosk in Sta. 18+380 that need further negotiation to reduce the amount requested by the owner.

Action Taken: Further negotiation will be made to reduce the amount requested by the owner of the affected kiosk.

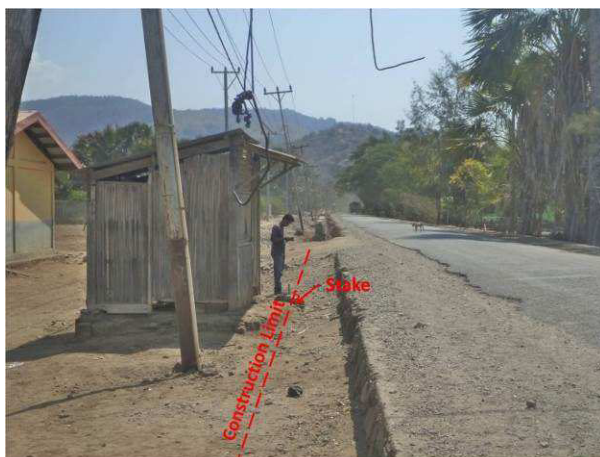
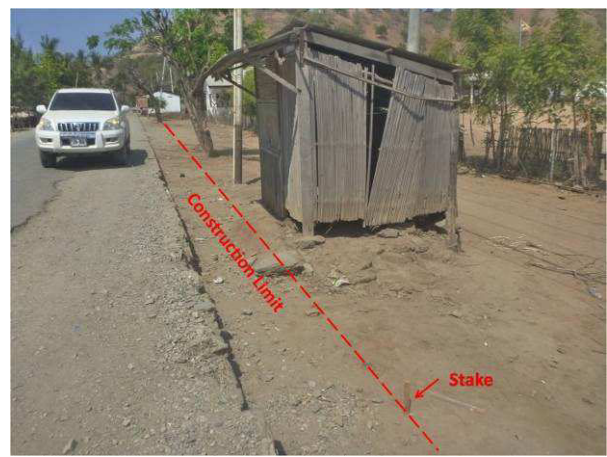
5.5 The owner of the dilapidated temporary kiosk in Sta. 18+500 is requesting compensation nearly 2.25 times the amount offered by the project. Aside from its condition, the owner had not been using the structure for some time. For safety reason, the project deemed it fit to have the structure removed.

A delapidated temporary kiosk in Sta. 18+500 considered affected structure by the project for safety consideration. Negotiation is on going to reduce the compensation cost requested by the owner.

Action Taken: Negotiation is on going to reduce the compensation cost requested by the owner.

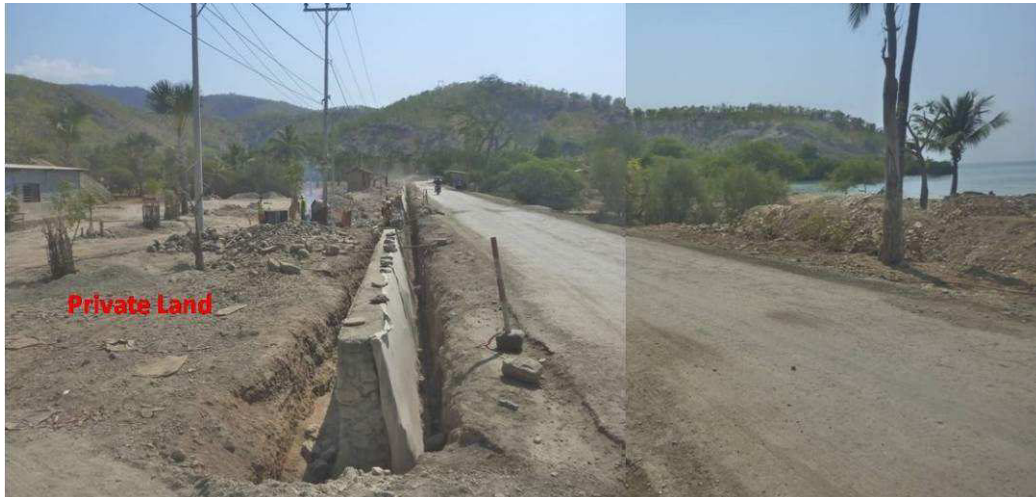
5.3 Five private land owners claim that the road widening between Sta. 20+300 to Sta. 20 + 600 will encroach their land (see Figure 3). These land owners have land certificates as follows:

On-going construction between Sta. 20+360 to Sta. 20 +580 L/S after the five private land owners were convinced by the project that the construction is outside their claimed land boundary.

- Request the Directorate the Land and Property through the PMU to authenticate the land certificate and verify the location of the land boundary of the concerned private land owners.
- Conduct a dialog with the concerned land owners showing them the limit of construction on the ground.

The concerned land owners were eventually convinced and the construction is now proceeding on site.

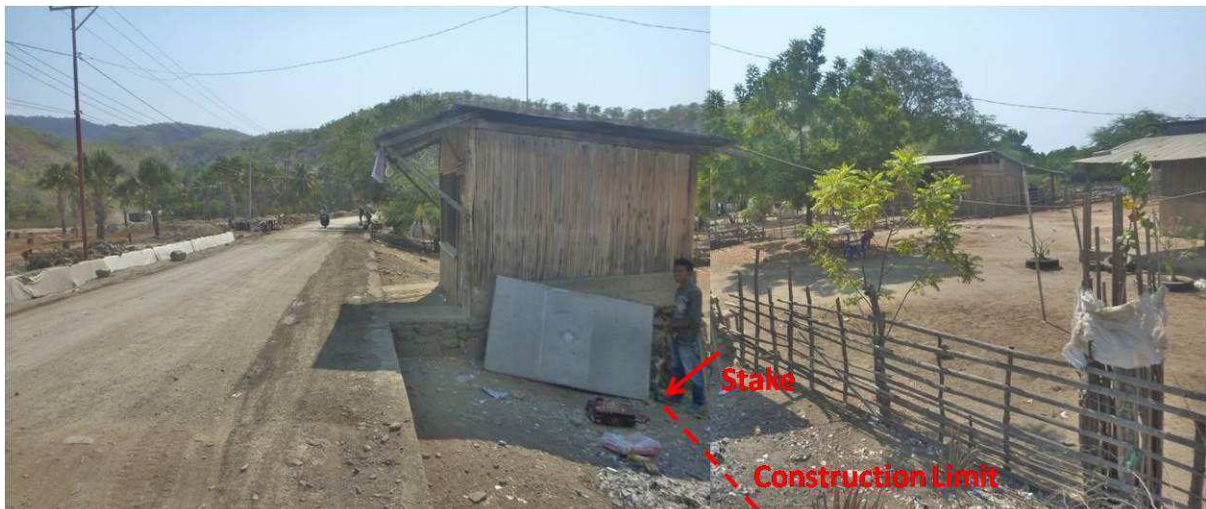
5.6 The owner of the semi-permanent kiosk in Sta. 20+480 is requesting compensation nearly 3.3 times the amount offered by the project.

On-going negotiation for the semi-permanent kiosk in Sta. 20+480 R/S to reduce compensation cost requested by the owner.

Action Taken: Negotiation is on going to reduce the compensation cost requested by the owner. If ever practical or when necessity arise, the other option that might considered by the project is to construct a new replacement kiosk in the adjacent area since the owner raised said option in one of the negotiation meeting. The compensation cost offered by the project will be used in the construction. The only obstacle for this option is the availability of people with construction knowhow in the area.

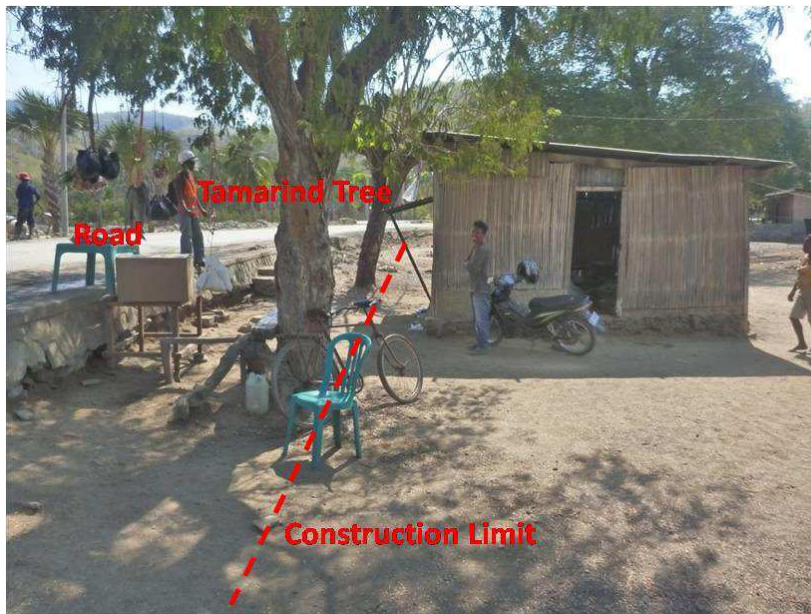
On-going negotiation for the tamarind tree in front of the kiosk in Sta. 20+520 to reduce the requested compensation cost.

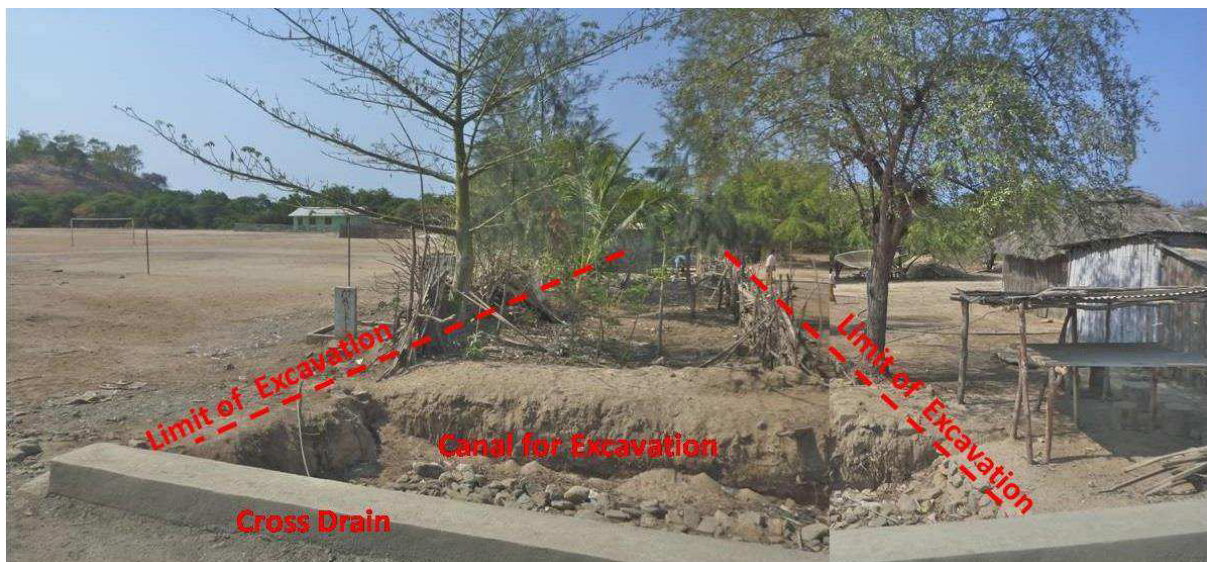
Portion of the canal for excavation near Sta. 24+008. Canal excavation is needed to convey surface water flow to the sea. Negotiation for the affected trees and structures has been completed.

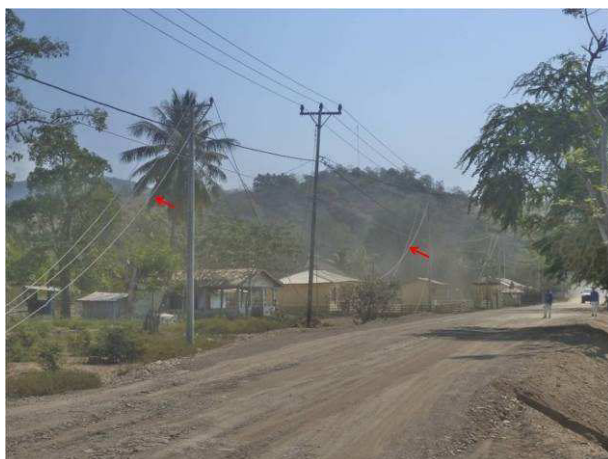
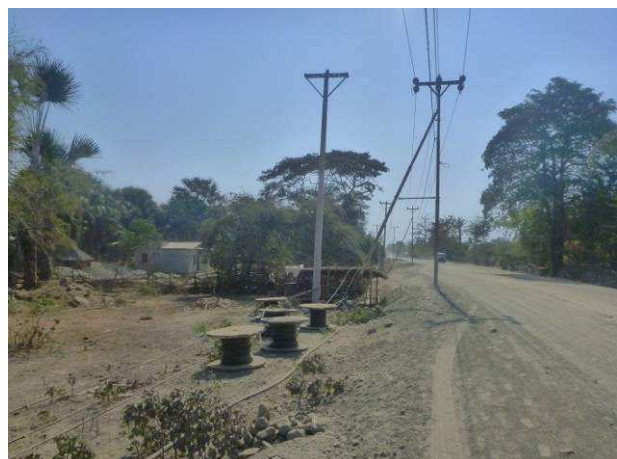
5.7 Issue : *Some electrical posts of EDTL are within the construction limit*

On-going relocation by EDTL of electric post outside the construction limit in various road section of the project.

Action Taken: Consultant requested EDTL copy furnished PMU MPW to relocate the electrical posts outside the construction limit. Relocation of electrical posts are on-going.

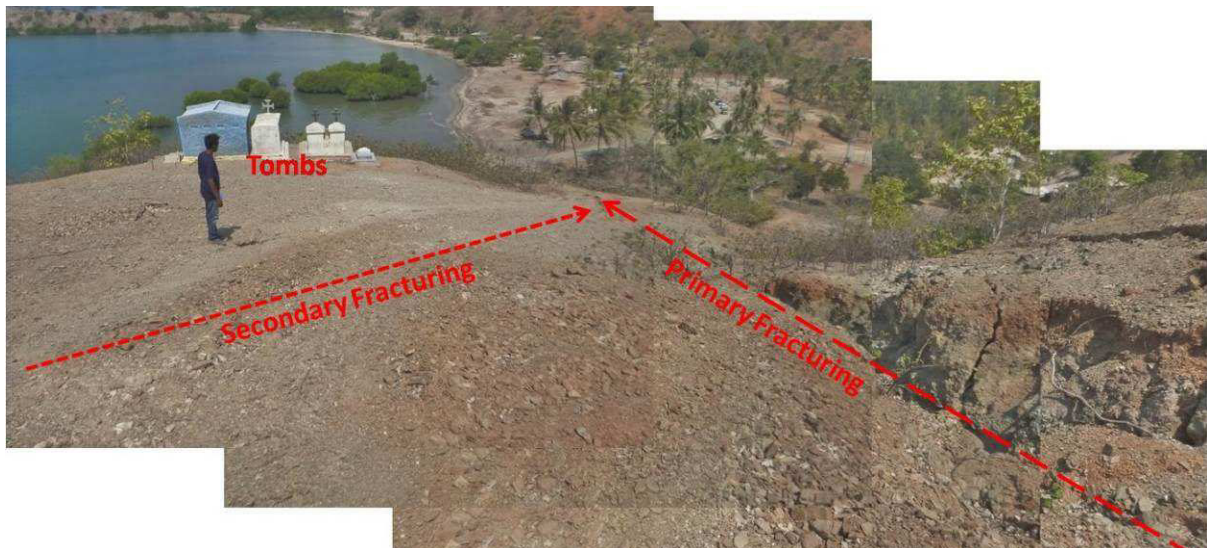
- A. A primary fracture is present at the upper slope section above the cemetery, near the crest of the ridge. This fracture may extend towards the general location of Sta. 20+940.

- B. Displacement were noted in the primary fracture by as much as 1.0 meter in some section. Direction of dip of displacement is towards the general direction of the road.

Fracturing of slope section above the cemetery at the vicinity of Sta.20+800 to Sta. 20+840. Top photo is looking down slope towards the direction of the road. Bottom photo is looking upslope from the tombs. Note the displacement of about 1 meter in some section of the fracture.

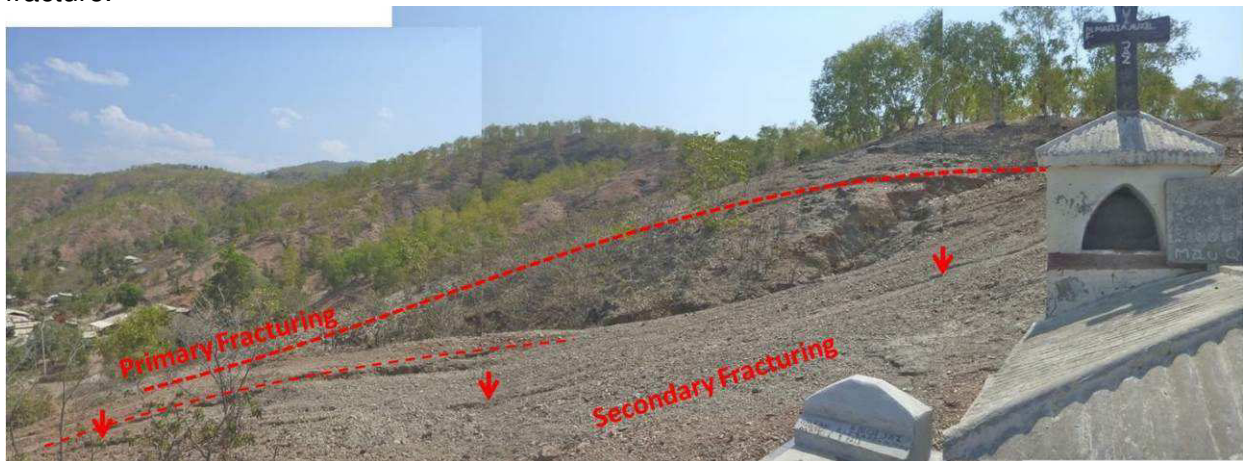
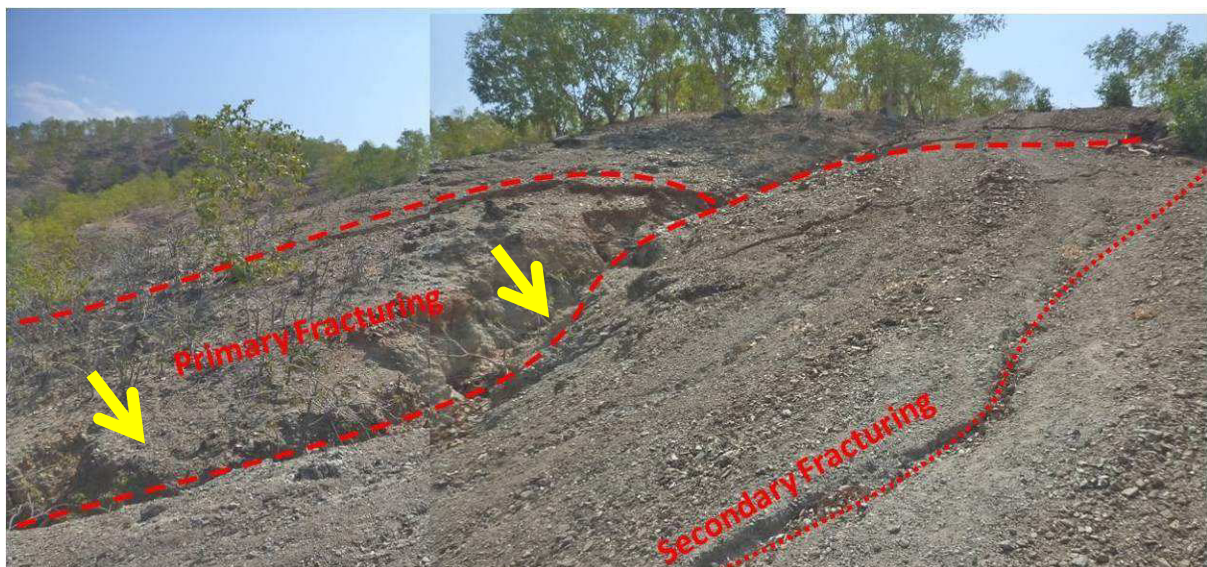
- C. Aside from the major fracture, a number of secondary fractures also propagate from and runs parallel to the primary fracture. Displacement is common some by as much as +/- 20 cm and also dips towards the road.

Detail of fracturing near the crest of the slope above the cemetery. Displacement of about 1 meter and direction of movement shown by yellow arrow. Secondary fractures propagating from and running roughly parallel to the primary fracture.

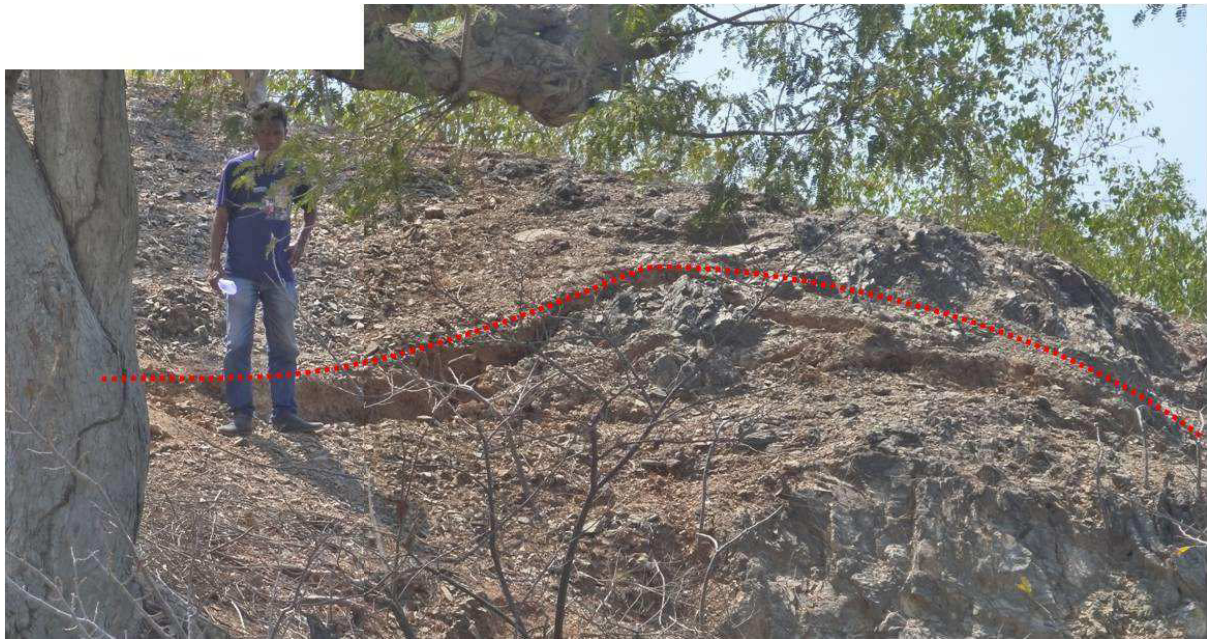
Primary fracture near the crest of the slope in the vicinity of Sta. 20+880, the extension of fracture from Sta. 20+840 (top photo). Red arrows in the bottom photo show the trace of secondary fracture propagating from the primary fracture with direction of dip generally trending towards the road.

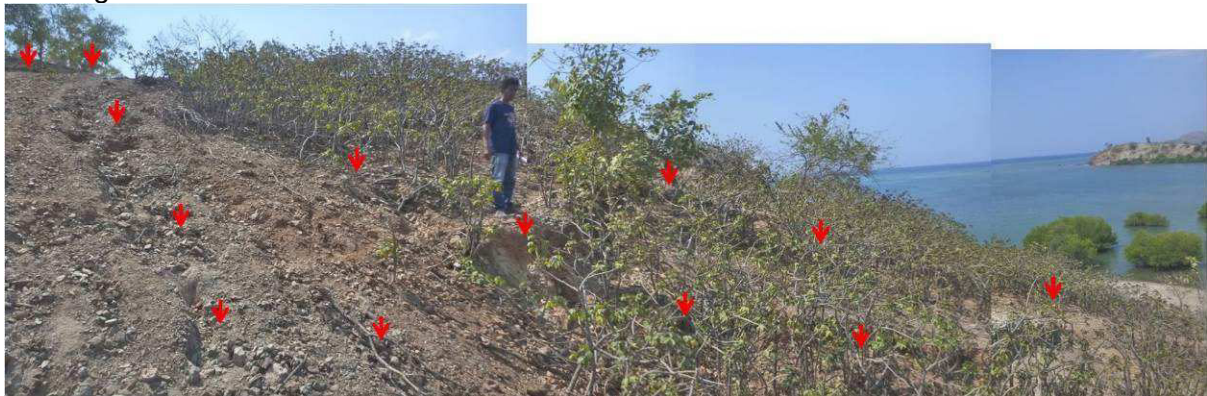
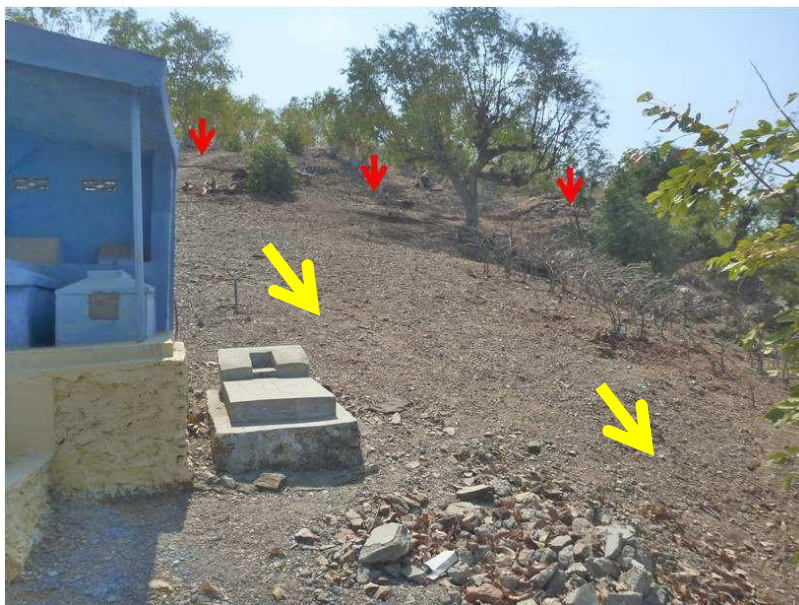
- D** Although the slope movement in the area is a natural process, caution must still be taken. The possibility that slope failure that might affect the cemetery may be blamed by the relatives of the deceased to the road widening activities of the project. At present, the cemetery have 7 tombs. The slope where the cemetery is located may eventually fail as a result of the movement coming from the crest (catastrophic).

Left photo show the position of the above two photos relative to the cemetery.

Yellow arrow shows possible slide direction in case of slope failure.

7 tombs are on site

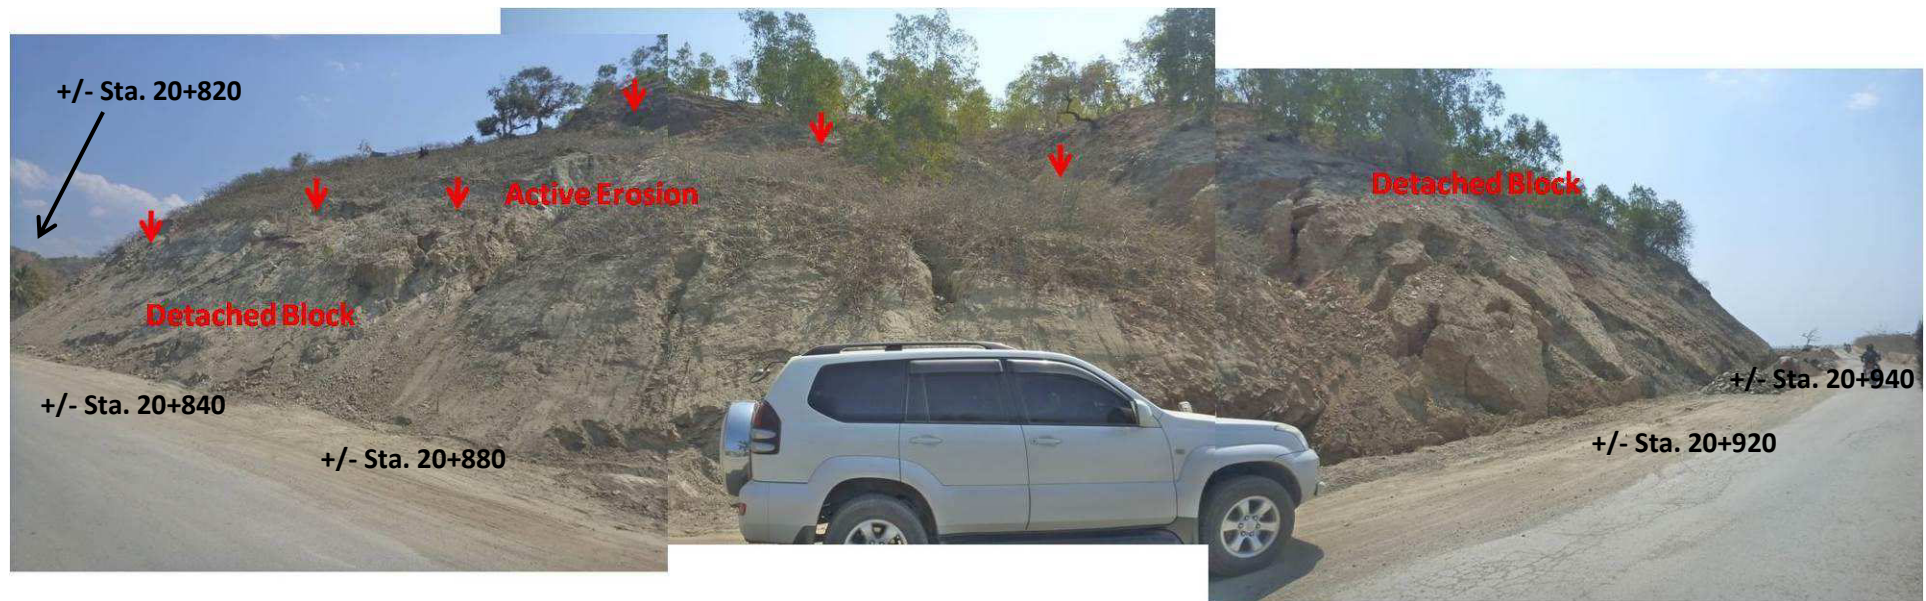
- D. Observed at the road section between Sta. 20+800 to Sta. 20+940 are failed slopes with detached block between +/- Sta. 20+840 to Sta. 20+860 (slope below the cemetery) and Sta. 20+900 to Sta. 20+940 (below the extension of the fracture in the slope crest). Potential future scenarios with the advent of rainy season in this road section are:

- massive erosion of slope resulting to heavy siltation on the canal and road carriageway,
 - movement of the detached block further down slope which may cause damage to the road section and drainage due to impact

- movement of adjacent slope section left hanging when the detached block fails may follow, the scale of which will be dictated by the pattern and scale of the fractures in the upper slope section

- slope section where the cemetery rest may also move downslope due to the presence of fractures on slope above the cemetery in the long term or induced by the movement of adjacent failed slope section in the short term

- A** From what has been observed and unless proven otherwise by a detailed study, the detached blocks and disturbed slope section along the road (Sta. 20+800 to Sta. 20+940) is a consequence of the slope movement starting near the crest of the slope as manifested by the major fracture.

- B** Aside from the above mentioned progressive slope failure, a catastrophic slope failure may also occur given the right condition such as intense rainfall, continues slide plain formed partly by interconnected rock discontinuity, and increase in hydrostatic/pore pressure. In a catastrophic scenario, the whole slope from Sta. 20+800 to Sta. 20+940 starting from the crest to the slope toe will move as a whole.

- C** Movement of varying scale is a common feature of the slope of the mountainous terrain of the project area. The bedrock being metamorphic in nature has a high degree of rock discontinuity such as faulting layering and foliation among others making them highly susceptible to slope movement and eventually failure resulting to rock fall and land slide.

Slope condition in road section approximately between Sta. 20+800 to Sta. 20+940. Present are failed slopes with detached block between +/- Sta. 20+840 to Sta. 20+860 (slope below the cemetery) and Sta. 20+900 to Sta. 20+940. Potential future scenarios with the advent of rainy season are:

- massive erosion of slope resulting to heavy siltation on the canal and road carriageway,
- movement of the detached block further down slope which may cause damage to the road section and drainage due to impact
- movement of adjacent slope section left hanging when the detached block fails may follow, the scale of which will be dictated by the pattern and scale of the fractures in the upper slope section
- the slope section where the cemetery rest may also move downslope due to the presence of fractures on slope above the cemetery in the long term or induced by the movement of adjacent failed slope section in the short term.

The possibility that the slope failure might be blamed to the road construction by the relatives of the buried in the cemetery should be considered by the project.

- a) Inform the authorities (Ministry of Public Works, PMU etc) given the seriousness of the of the slope condition on site.
- b) Inform the Suco Chief and the relatives of the 7 deceased buried in the area about the existing slope condition and possible consequences

- c) To formulate a cost effective slope remediation program, a detailed slope investigation will be needed which will involve but not limited to the following activities;

- i. Topo survey of the affected slope covering the area from the ridge crest to the shore line. A topo map of the site is needed in plotting the data gathered in the detailed investigation and an essential element of a slope investigation

- ii. Conduct a detailed geological mapping to determine the character and distribution of geological features (e.g. rock types, soil, weather zones geological structures etc.) on site

- iii. Conduct a detailed discontinuity mapping noting the types of rock discontinuity in the area (e.g. faulting, fracturing, layering, foliations, jointing etc.)

- iv. Conduct a slope analysis using appropriate software. Among others, an essential component of an effective slope analysis is the result of a statistical analysis of data from the detailed discontinuity mapping.

- v. A geophysical survey using geo-resistivity method should be considered primarily to determine the slide plane of the slide. In addition, the geophysical survey may also help determine the presence of multiple slide (as manifested by the number of slide plane), and depth of the slide plane (essential in determining and designing appropriate counter measure). Since the bedrock is exposed, sampling by drilling is no longer a major consideration in the usual geotechnical investigation to reduce cost.
