Environmental Monitoring Report

#3 Bi-Annual Report (July to December 2014)
Loan No. 2824-KAZ
January 2015

KAZ: Central Asia Regional Economic Cooperation Corridor 1 (Taraz Bypass) Project

BI-ANNUAL ENVIRONMENTAL MONITORING REPORT - January 2015

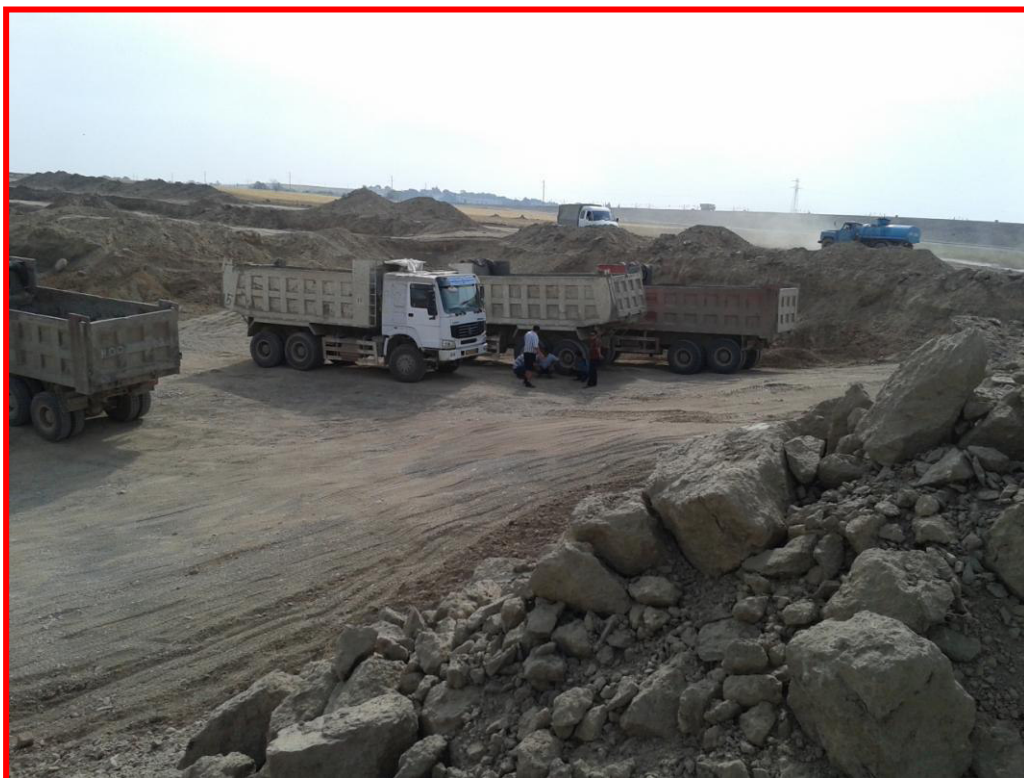
Photo No. 1: Borrow Pits should have Reinstatement Plan

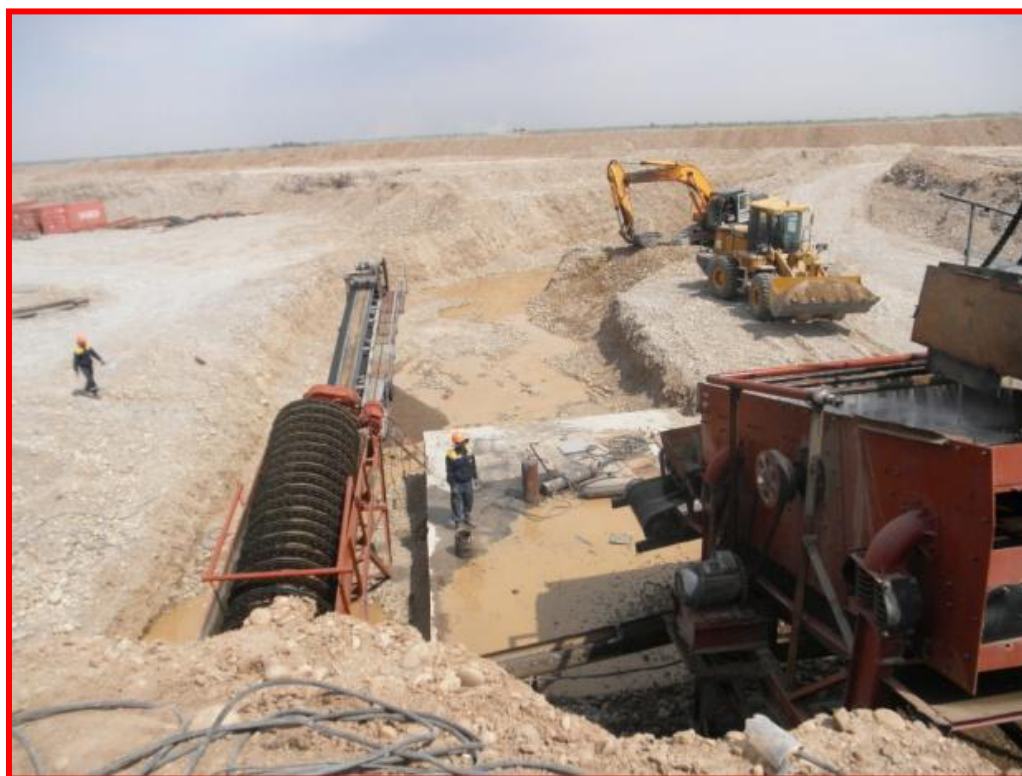
Photo No. 2: Quarry Sites should be reinstated (Pk 400+60)

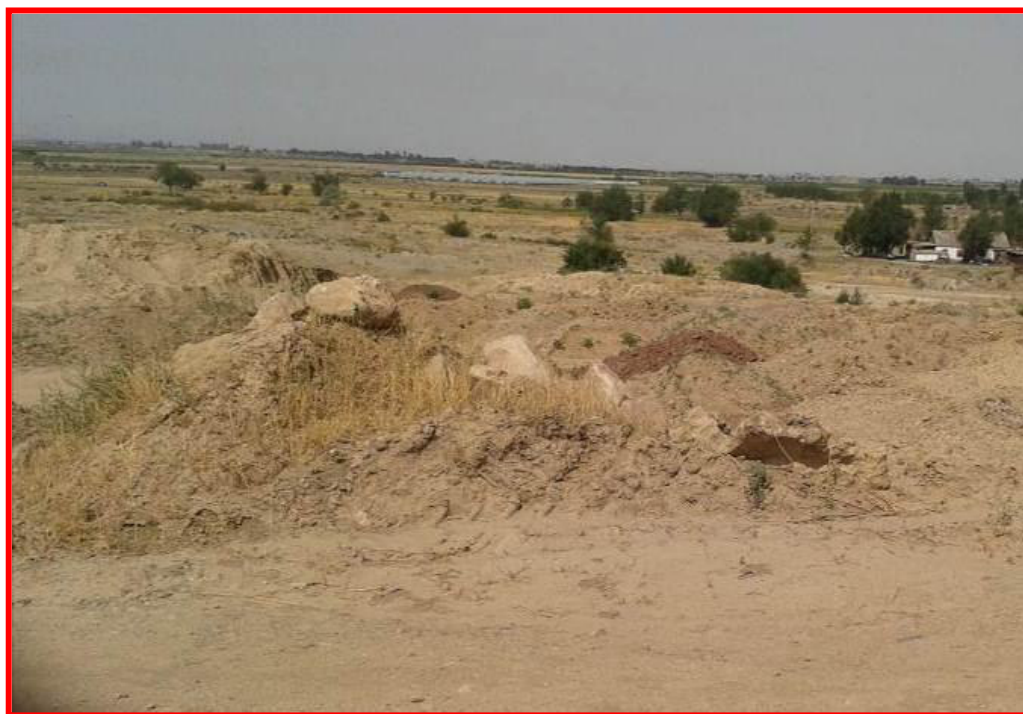
Photo No. 3: Borrow Pits should be reinstated to allow natural re-vegetation

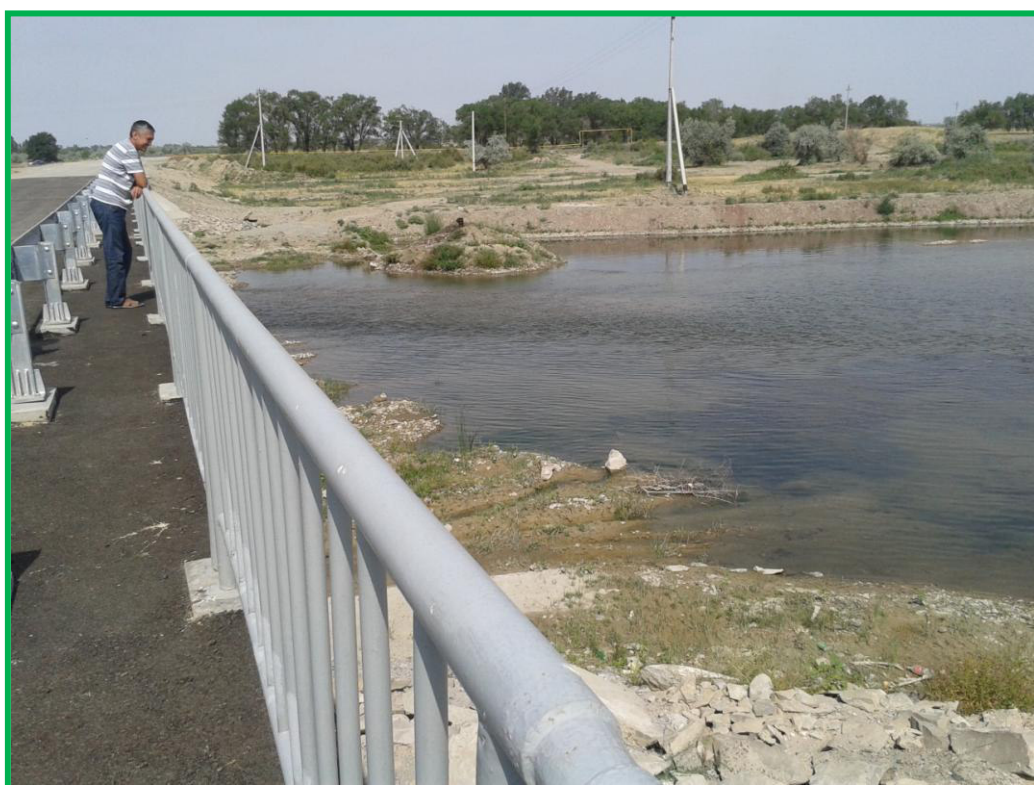
Photo No. 4: Waterways already free of contamination

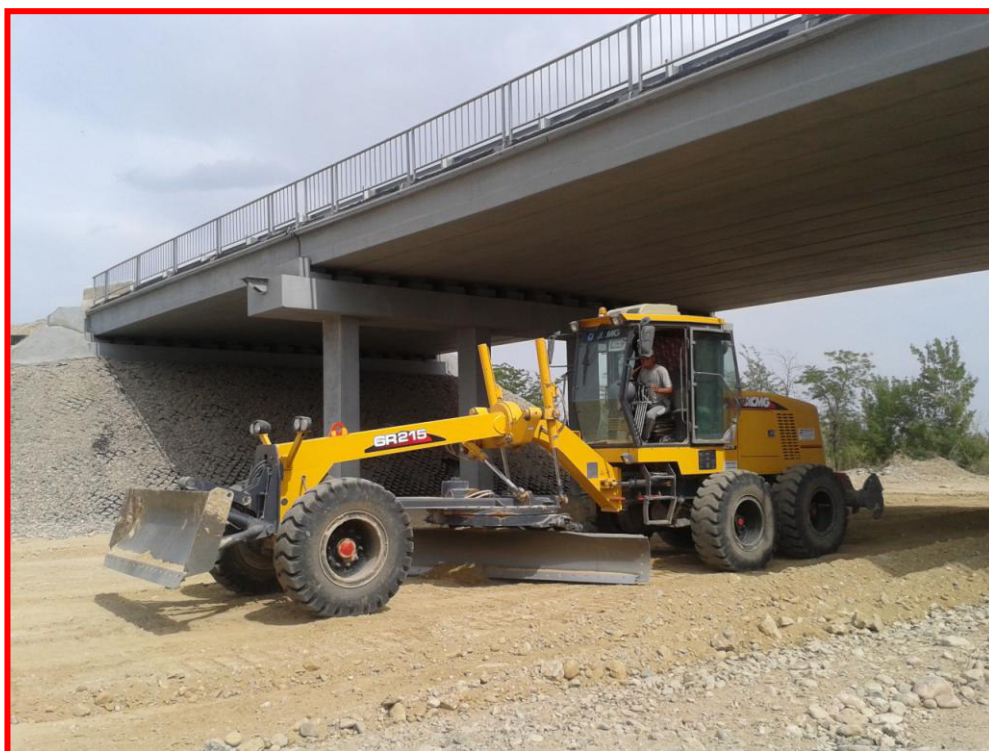
| No. | Description of EHS Issue | Description of Proposed Measures |
|---|--|--|
| | <u>Equipment operator not wearing proper Personnel Protective Equipment (PPE)</u> – All operators should wear reflectorized vest and ear protection. (Photo No. 5) | The Contractor should instruct his subcontractors that PPE should be worn at all times at the work place by equipment operators for safety purposes. |

Photo No. 5: Equipment operator without proper Personnel Protective Equipment (PPE)

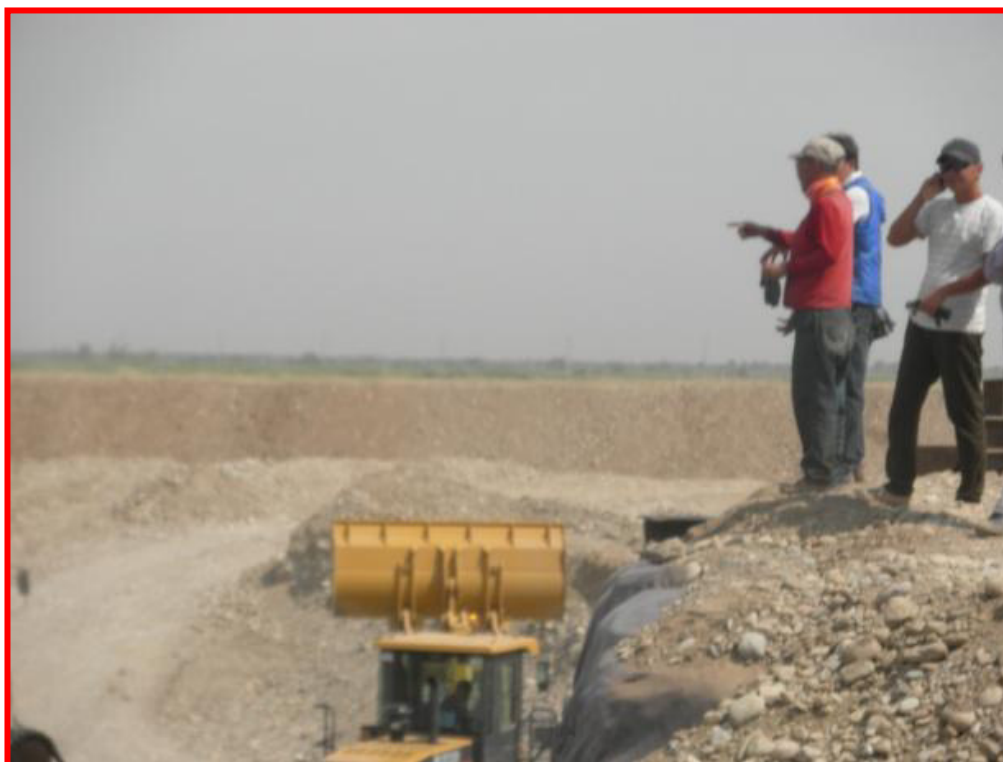
| No. | Description of EHS Issue | Description of Proposed Measures |
|---|--|--|
| | <u>Workers without proper Personnel Protective Equipment (PPE)</u> – Workers were not wearing helmets and work boots. (Photo No. 6) | The Contractor should instruct his subcontractors that PPE should be worn at all times at the work place to minimize accident and health hazards. |

Photo No. 6: Workers not using proper PPE

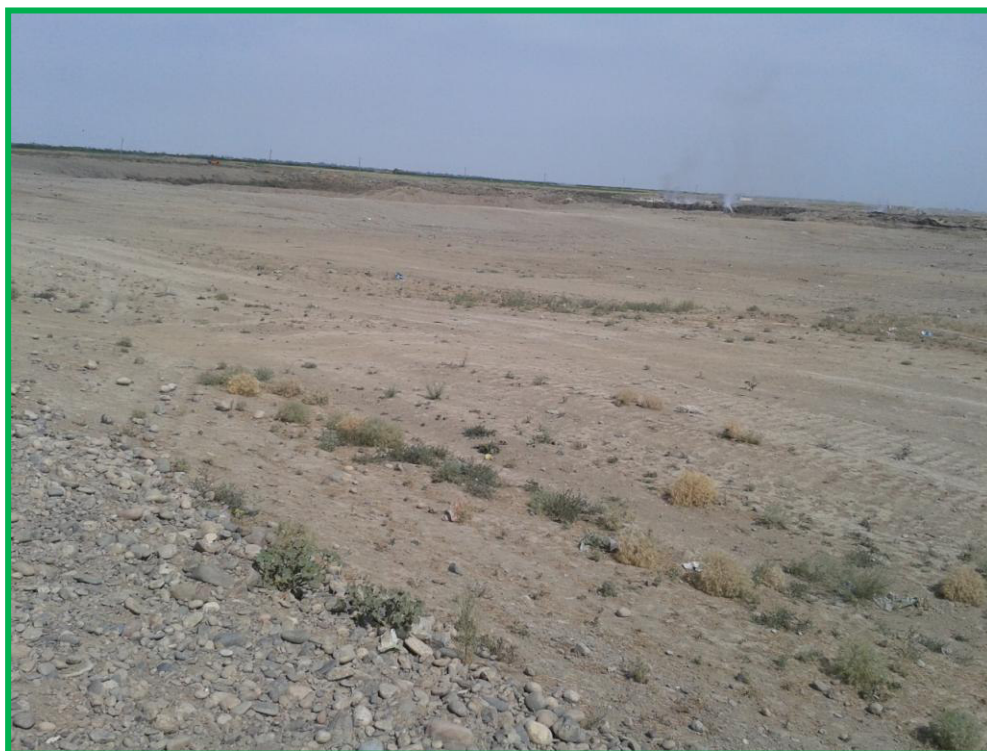
Photo No. 7: Rehabilitated Dumpsite at PK110

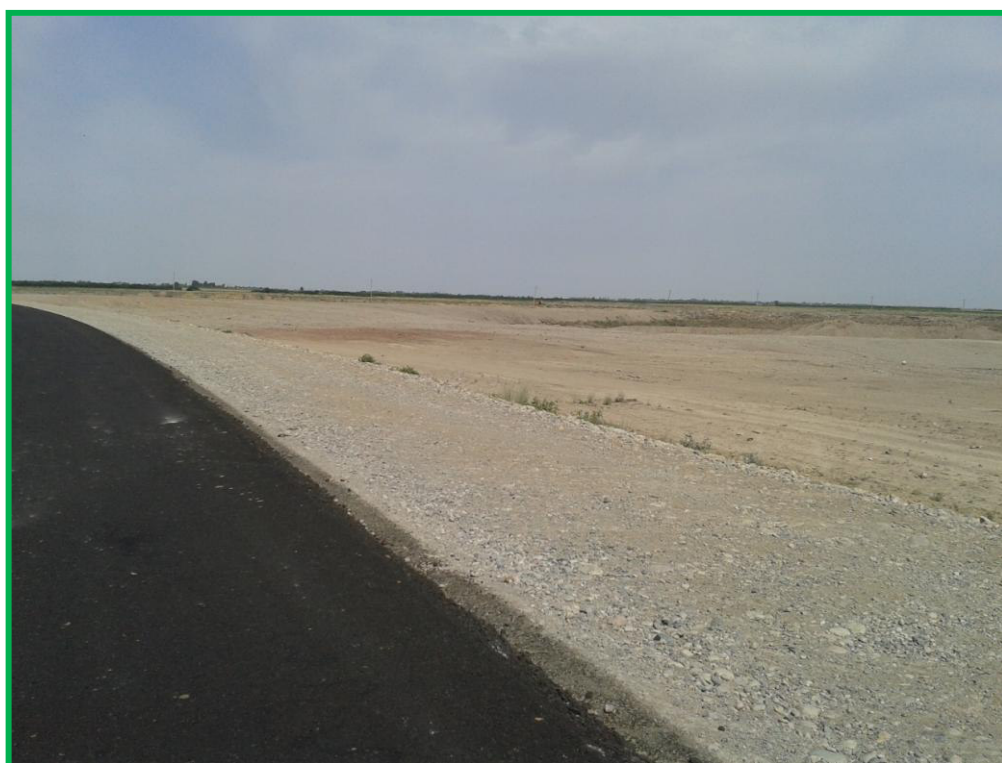
Photo No. 8: Garbage materials removed from the roadside (PK110)
