# Environmental Monitoring Report

Semestral Report  
June 2016

## BAN: Financing Brick Kiln Efficiency Improvement Project – Bricks 2010 Limited

**Post Implementation Environmental Monitoring Report**  
**Bricks 2010 Limited**  
**Polastoli, Chiteshwari, Mirzapur, Tangail**

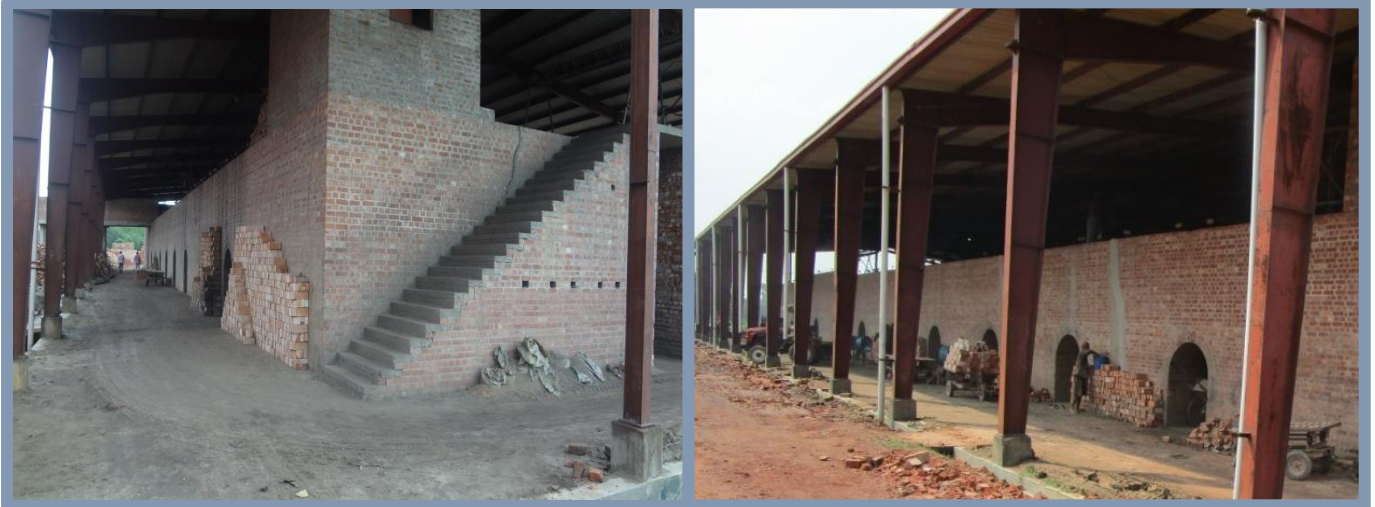
Sides of the Brick kiln (HHK)

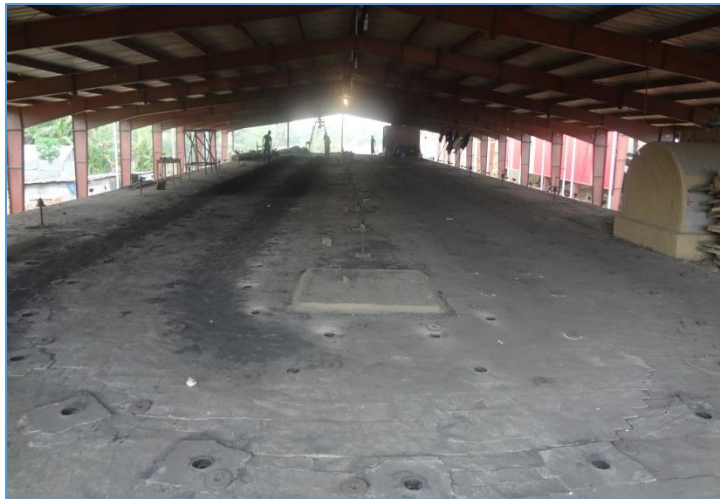
Top of the Brick Kiln showing holes for coal feeding

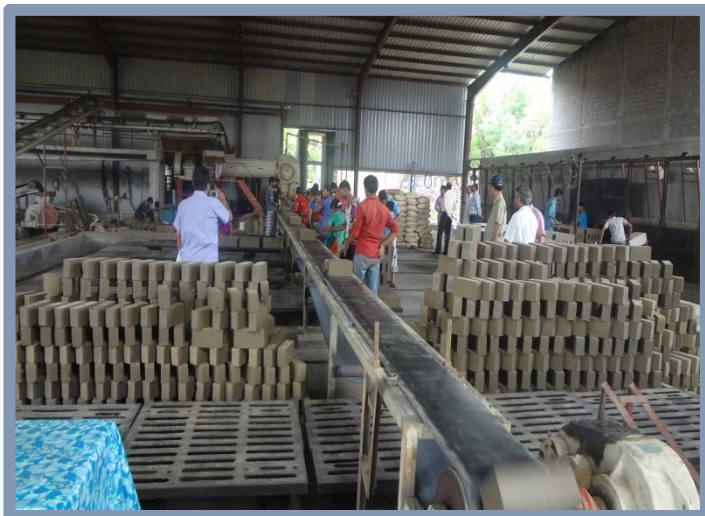
Green Brick Stacking

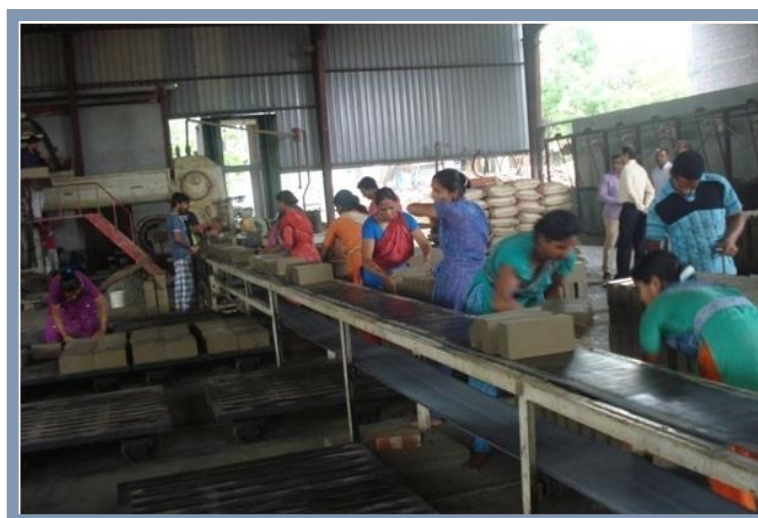
Female workers in the Green bricks making section

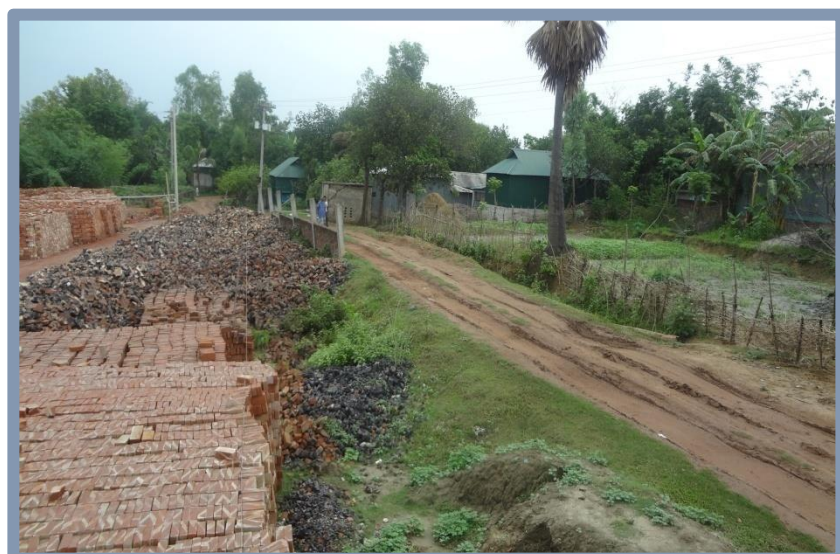
c) Landscaping & greening	Create buffer zone and planting trees.	Not Complied	No boundary, no beautification plan
<b>D. Occupational</b>	a) Supply & use of PPE	Protective clothing, goggles, helmets,	Partially complied	There are supplies of

Unprotected boundary

d) Landscaping b& greening	Create buffer zone and planting trees.	No boundary, no beautification plan	Erection boundary wall surrounding the subproject and plant trees	30 June 2017

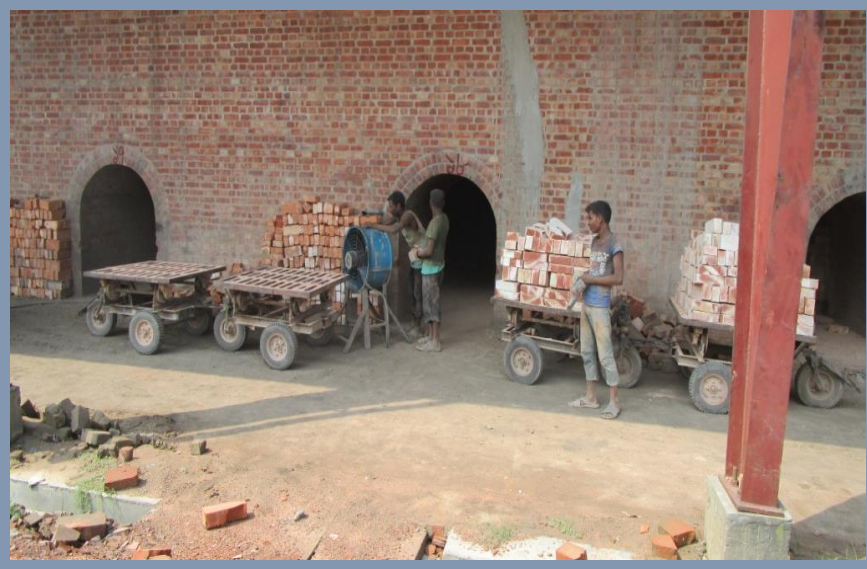
Workers for finish  
product transporting

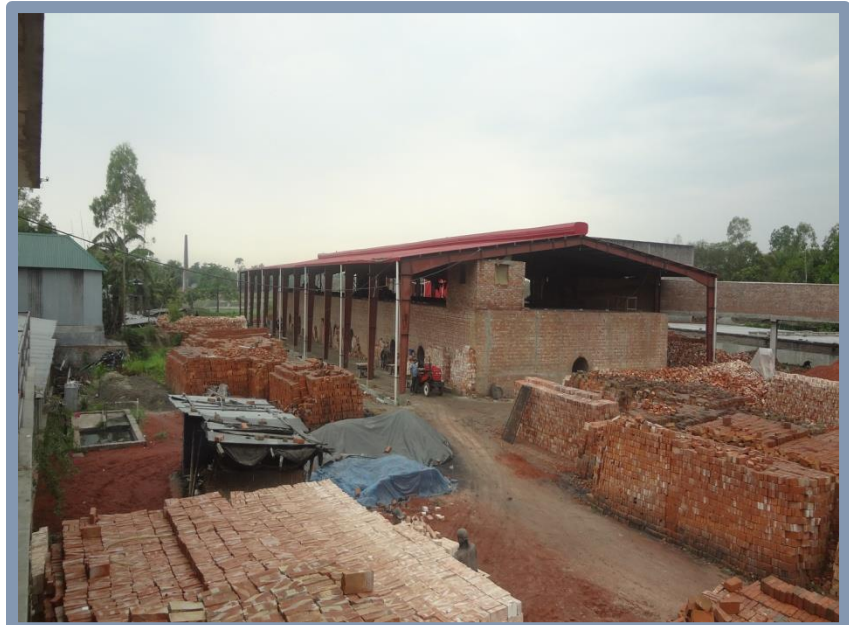
Final Brick Product  
stacking yard
