# Environmental Monitoring Report

## BAN: Financing Brick Kiln Efficiency Improvement Project – Tradexcel Auto Bricks Limited

## Post Implementation Environmental Monitoring Report

### Tradexcel Auto Bricks Limited

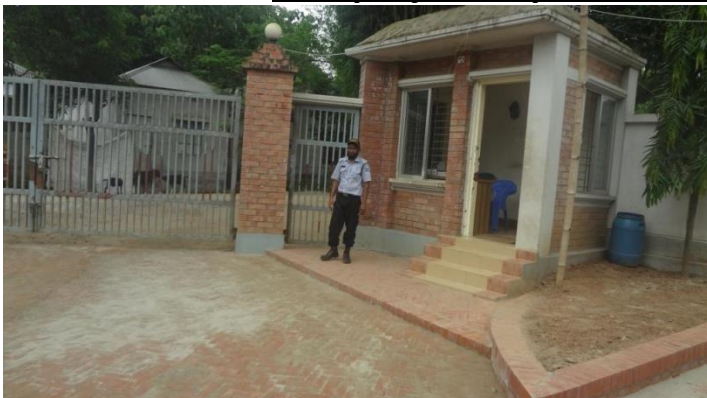
← Security Guard at the front gate

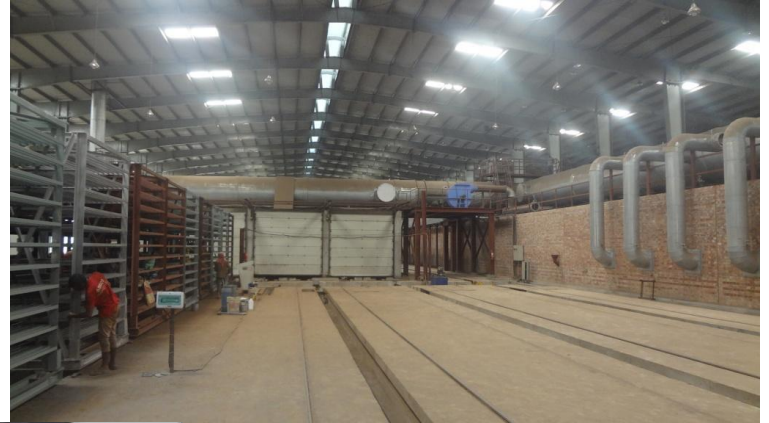
Dryer for the green bricks

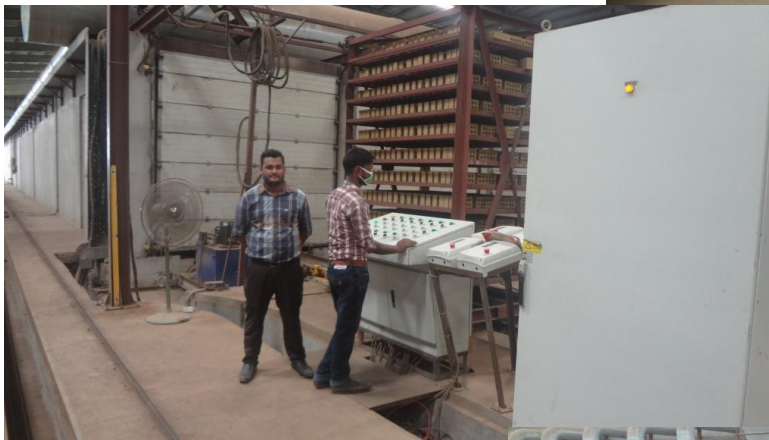
Green Bricks entrance and exit  
in Dryer by mechanical control  
panel

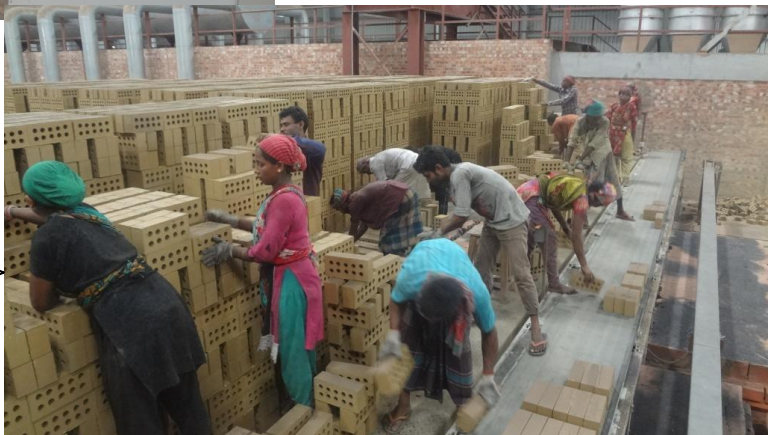
Manual Stacking of Dried  
Bricks for firing

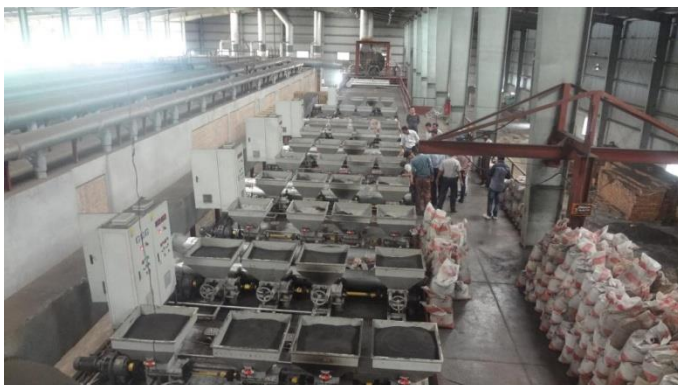
Automatic coal feeding in the  
Kiln

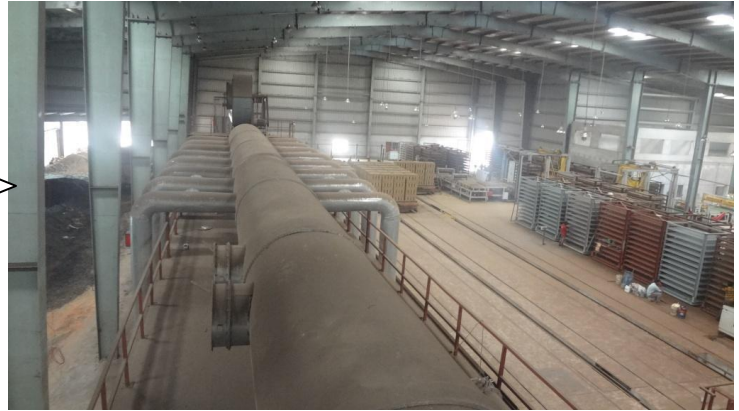
Top of Tunnel Kiln (Brick Firing)

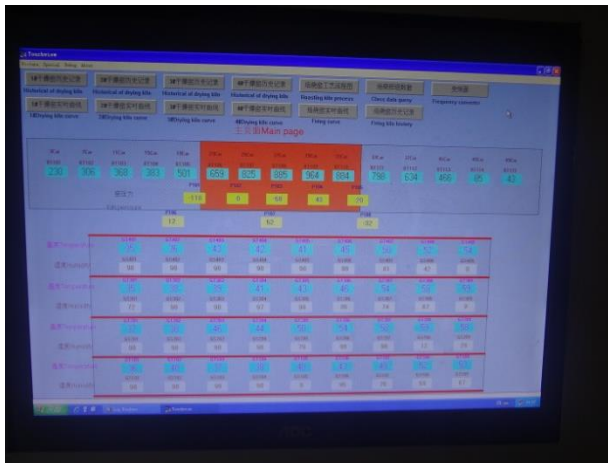
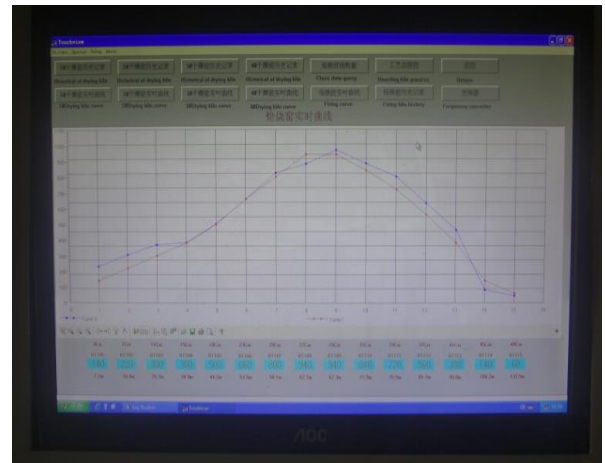
Snap shot of table and curve of tunnel kiln temperature (firing tunnel) from the control room

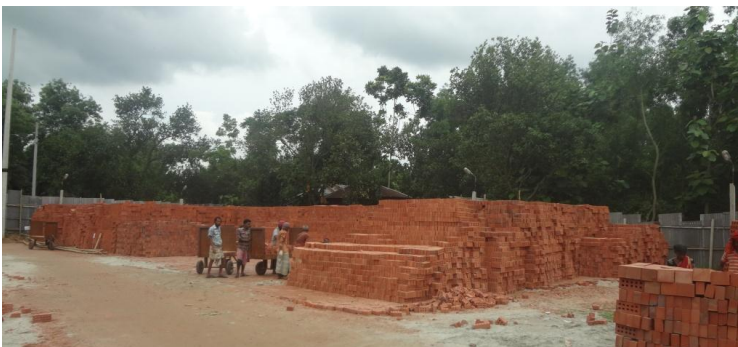
Finished Brick stack yard

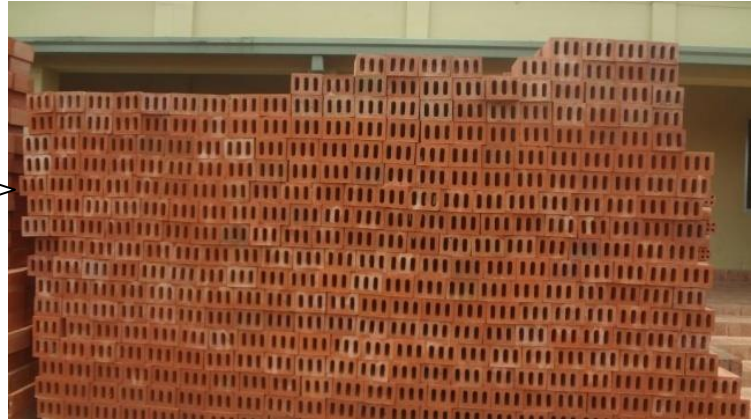
Hollow Brick stack

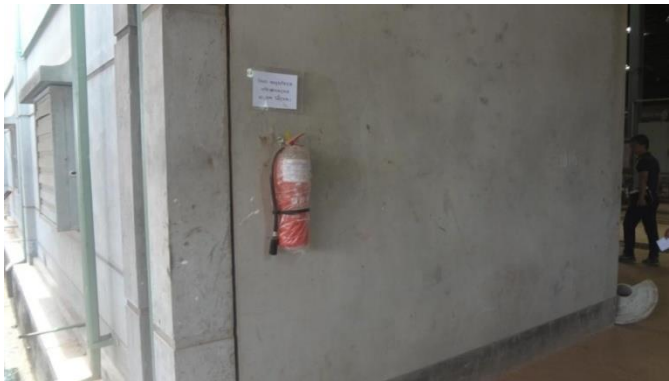
Fire extinguisher mounted on the wall

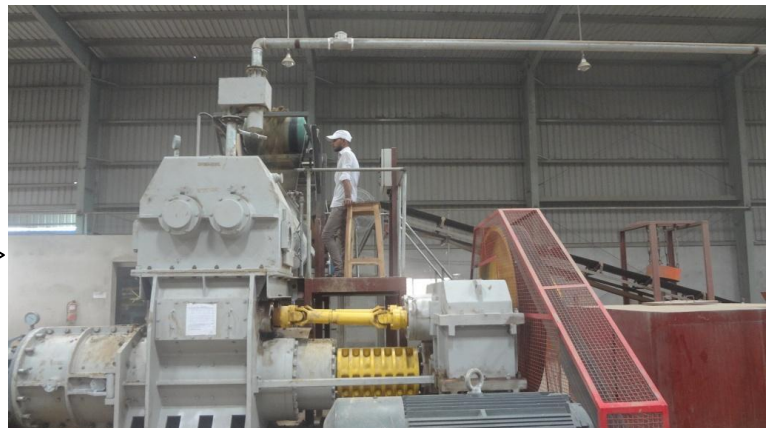
Proper guard rail for the operator working at height

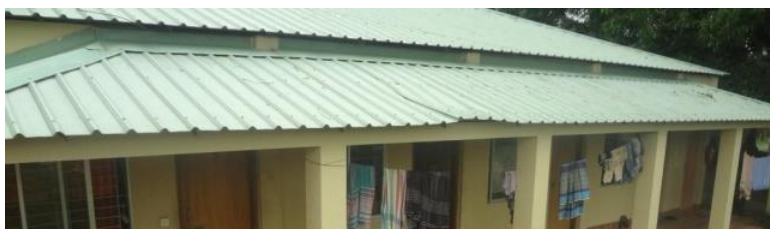
← Accommodation for the employees in the factory premises

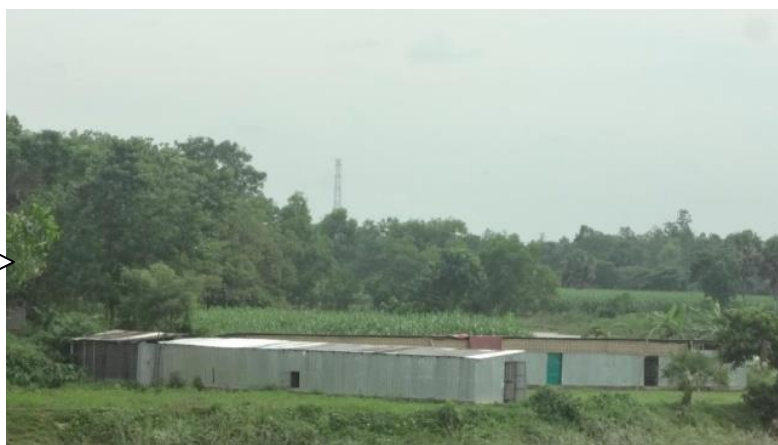
Accommodation arrangement for the workers at rented houses

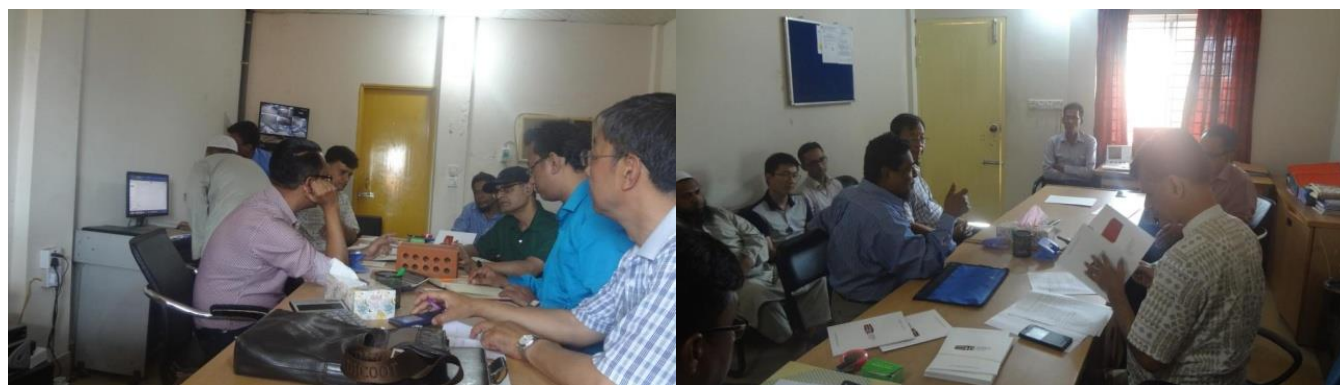
Discussion with the entrepreneur during the site visit
