Environmental Monitoring Report

Bi-annual Report
December 2015

AZE: Second Road Network Development Investment Program – Project 1

Republic of Azerbaijan:
Second Road Network Programme, Tranche 1:
Construction Supervision for the Alat-Astara Motorway –
Masalli to Jalilabad Intersection

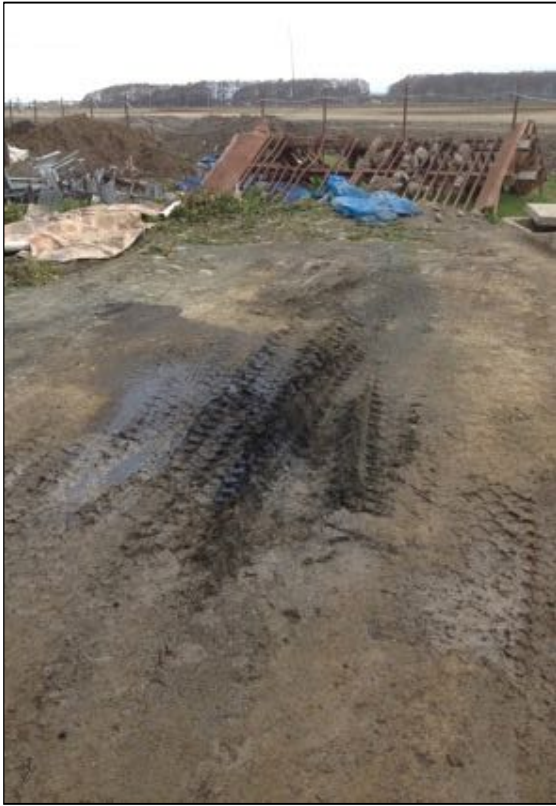
42. Oil Spills/Leaks – Several small spills and leaks of oils were noted across the site (see **Figure 1**). There are several reasons for the spills/leaks; firstly, undertaking vehicle maintenance in the wrong areas, i.e. not in the maintenance yard. Secondly, leaking of oil from old, and poorly maintained vehicles. And thirdly, lack of awareness of workers regarding the handling and management of hazardous liquids. All of these issues have simple remedies, however the Contractor and his HSE staff seem to be unwilling, or unable to manage these issues. The third issue, lack of worker awareness, should really be dealt with by improving staff training. It appears that many staff have either a very basic, or no understanding at all, of issues such as management of hazardous waste. This results in situations where staff in the maintenance yard are pouring, and spilling, large quantities of oil directly onto bare soils (see **Figure 2**). The simple way to deal with this issue is tool-box training by the Contractors HSE team. During two weeks on site in December the Engineers International Environmental Specialist did not, even once, see any kind of tool-box training by the Contractors HSE team, in fact they were never spotted around the site except when requested by the Engineer. This is completely unacceptable and the Contractor has been warned regarding this matter. The Contractor did send the Engineer some limited documentation as proof that some toolbox training had been undertaken in the last week of December, 2015. The Engineers EHSM will continue to monitor the Engineers HSE team to see if these trainings continue into the next reporting period, or if they were just a passing fad to placate the Engineer.

Figure 1: Oil leaks from old, poorly maintained vehicles

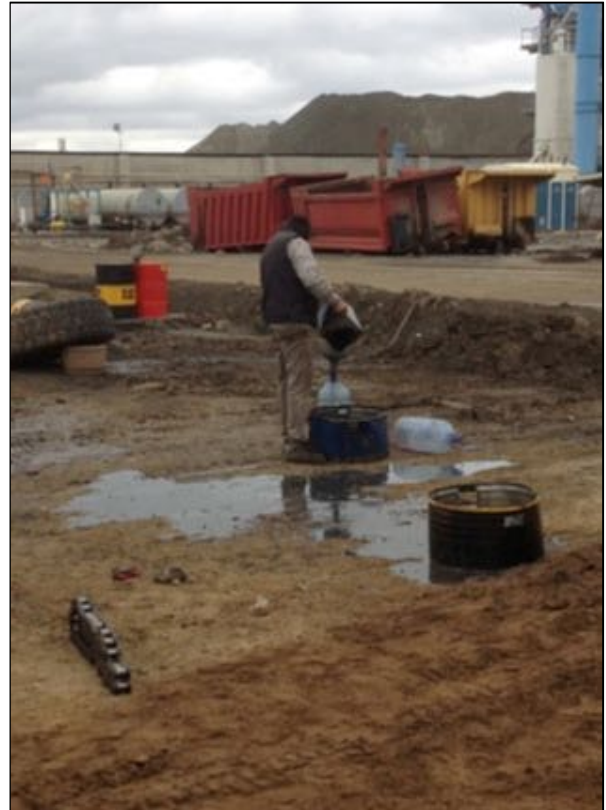
Figure 2: Worker, without any PPE, spilling oil around the maintenance yard, adjacent to a drainage ditch.

44. Maintenance Yard – Again, despite requests in September to improve the conditions in the maintenance yard, the conditions were still not acceptable in December. Waste management was poor, no spill kits had been installed, the gravel around the yard had not been laid (as specifically requested by the ADB), there was a lack of fire extinguishers and there were no sand in sand-boxes. All of these issues were discussed with the Contractor in December's visit, after which he has placed an order for new waste containers, fuel storage containers and spill kits. He also agreed to make sure gravel was laid around the yard by 21/12/15. In addition, two new maintenance areas have been constructed next to the existing maintenance yard. The Contractor has been informed that both of these areas should have suitable drainage and bunding to collect and spills and leaks of hazardous liquids. By the end of December, only sand had been placed in the sand boxes and none of the other tasks had been completed and none of the ordered items received.

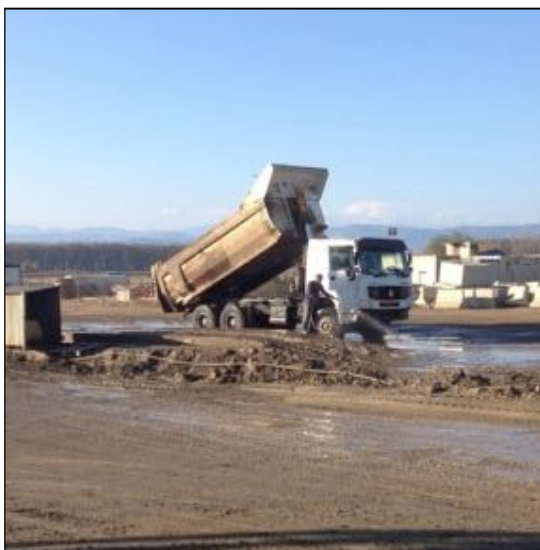
6. Vehicle Washing Area	a. Waste water is not running off into the wash pit.	Concrete lips should be provided around the whole wash bay to ensure that run-off enters the wash pit, not areas adjacent to the wash pit.	Kolin HSE Team	09/10/15	No improvements to the wash pit have been made. Recommendations have been provided by IRD to Kolin to improve this area to an acceptable	IN-PROGRESS 1. Kolin have laid more concrete with bunding, but monitoring of the area is still required by the Engineer to ensure it functions correctly.

Figure 3: Truck unable to fit on the vehicle washing bay.

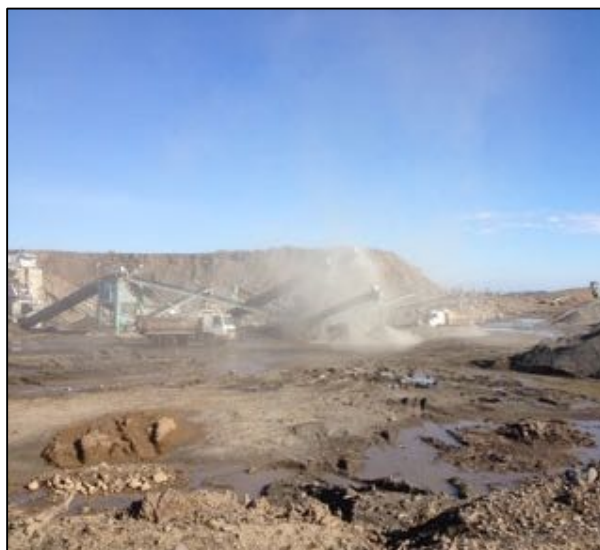
47. Rock Crushing Plant – Water spraying is occurring at the crushing plant, but only where the main loading area to the crusher. Observations of the plant identified multiple areas where dust is being created as the rock is gradually ground down into smaller pieces (see **Figure 4**). The Contractors camp is located more than two kilometres from any settlement, or house, and as such dust impacts from the plant to residents is not a factor. However, the dust does blow over the camp when the wind is blowing in a westerly direction. Accordingly, it was recommended to the Contractor that watering additional portions of the plant would be beneficial for the health of his staff who live and work at the camp.

Figure 4: Dust from rock-crushing plant
