Environmental Monitoring Report

Bi-Annual Report
June 2016

AZE: Second Road Network Development Investment Program – Project 1

Republic of Azerbaijan:
Second Road Network Programme, Tranche 1:
Construction Supervision for the Alat-Astara Motorway –
Masalli to Jalilabad Intersection

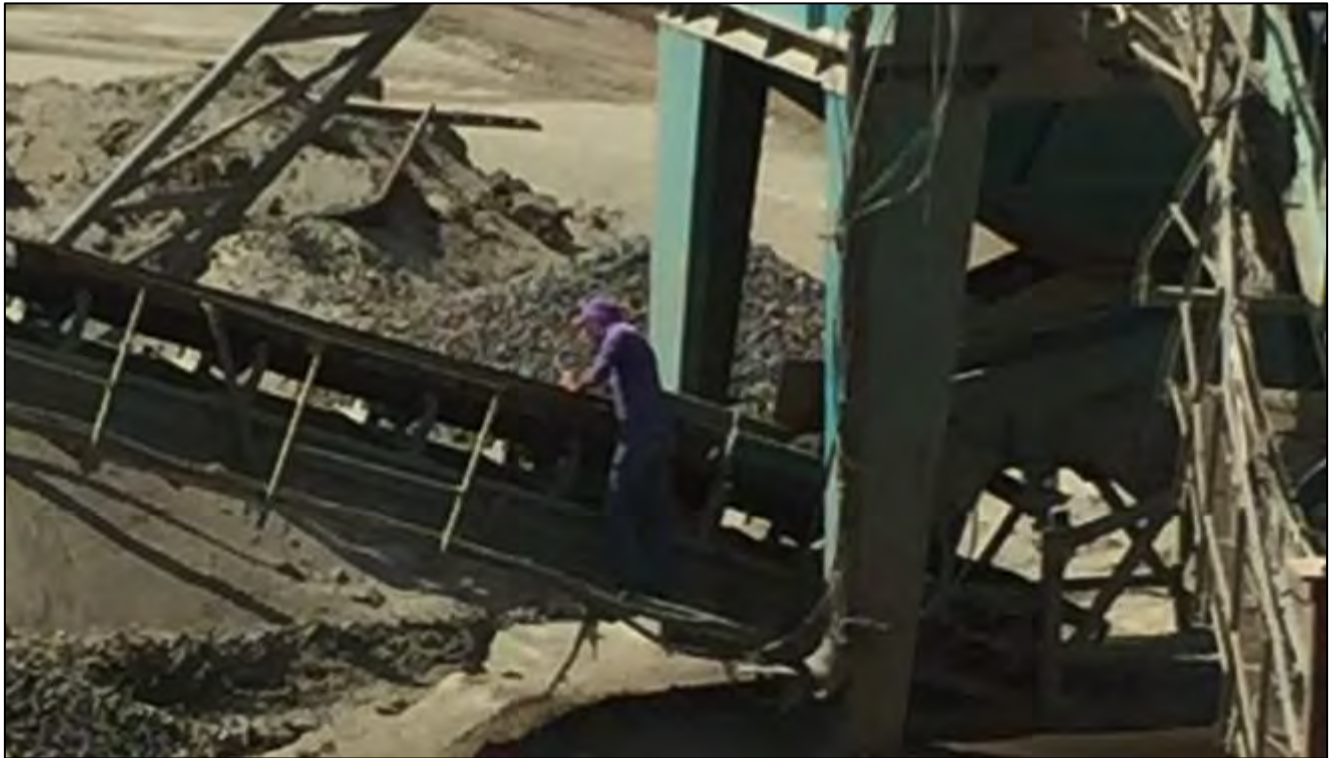
Figure I-1: Worker in the rock crushing conveyor belt.

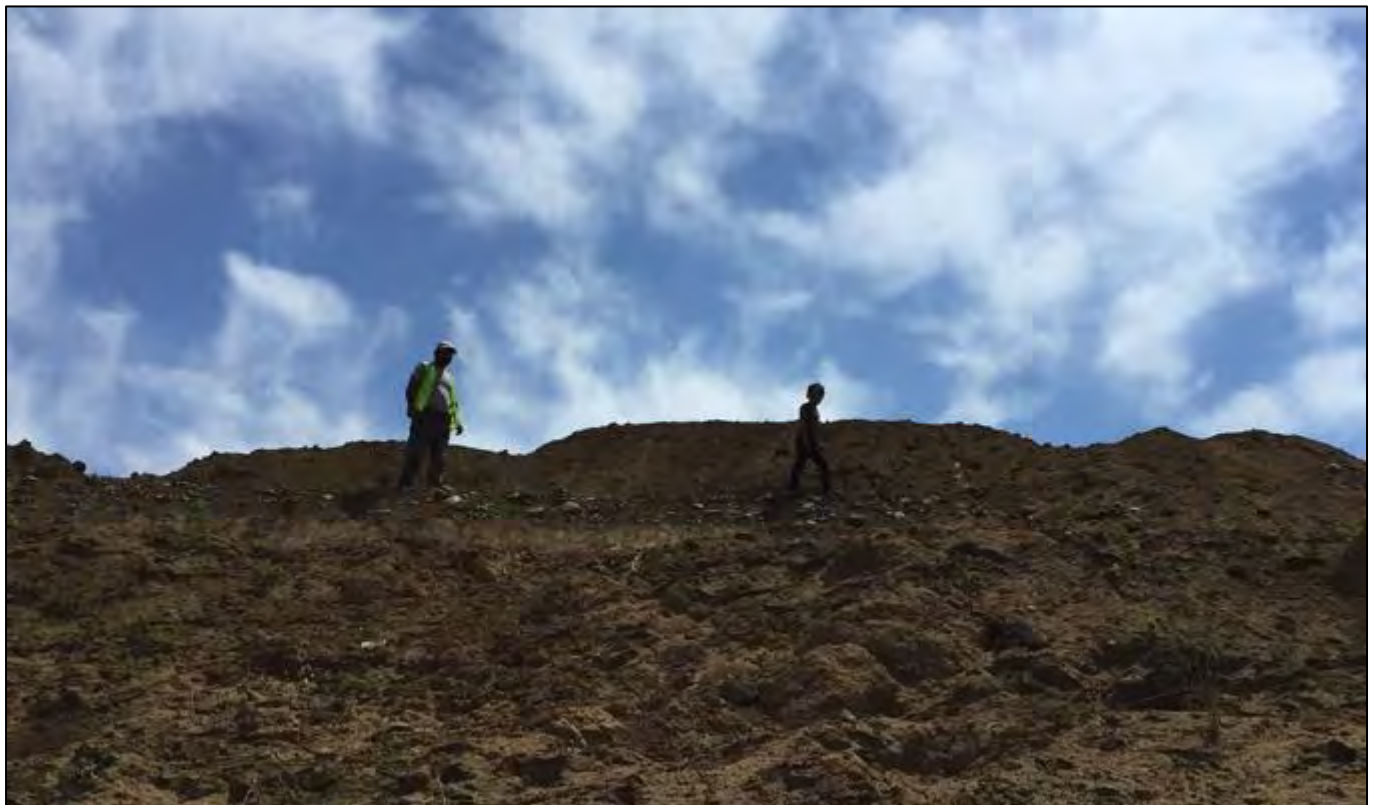
or around weigh hoppers (see Appendix I).			
9. Health and Safety	Health and safety continues to be a great concern around the camp and work site. Children were noted on road embankments close to work sites. At the camp workers were noted in conveyor belts at the rock crusher and in weigh hoppers for the asphalt plant. Hardly any of the workers at the construction camp wear any form of PPE. In addition, fire fighting equipment is non-existent in some locations, including accommodation blocks and the maintenance yard.	<p>1. The Contractors HSE team should continuously monitor the construction sites to ensure that there are no children in these areas.</p> <p>2. Suitable fire-fighting equipment, in working order, needs to be provided across the camp.</p>	Item 1-2: Kolin HSE Team	<p>Item 1: from 01/07/16</p> <p>Item 2: 08/07/16</p>

Figure I-2: Small children on road embankments

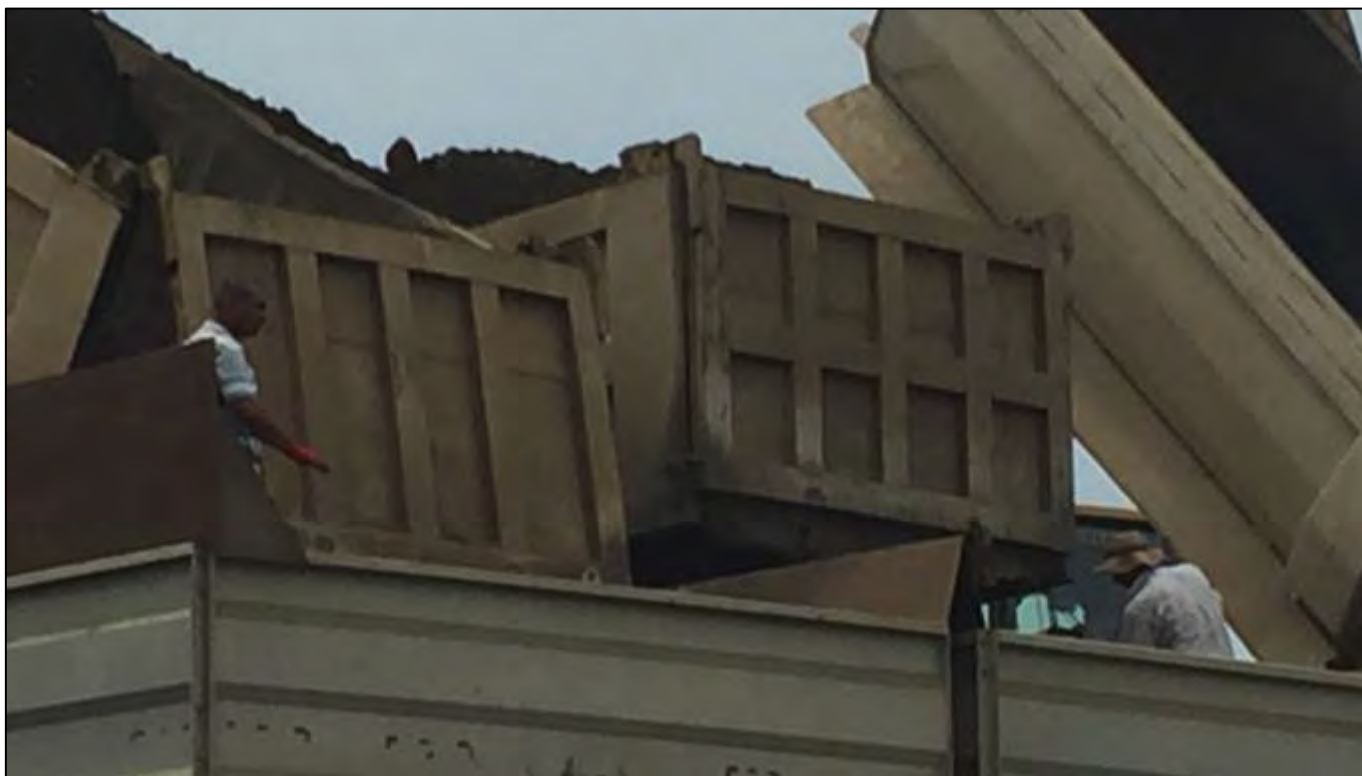
Figure I-3: Workers in weigh hoppers

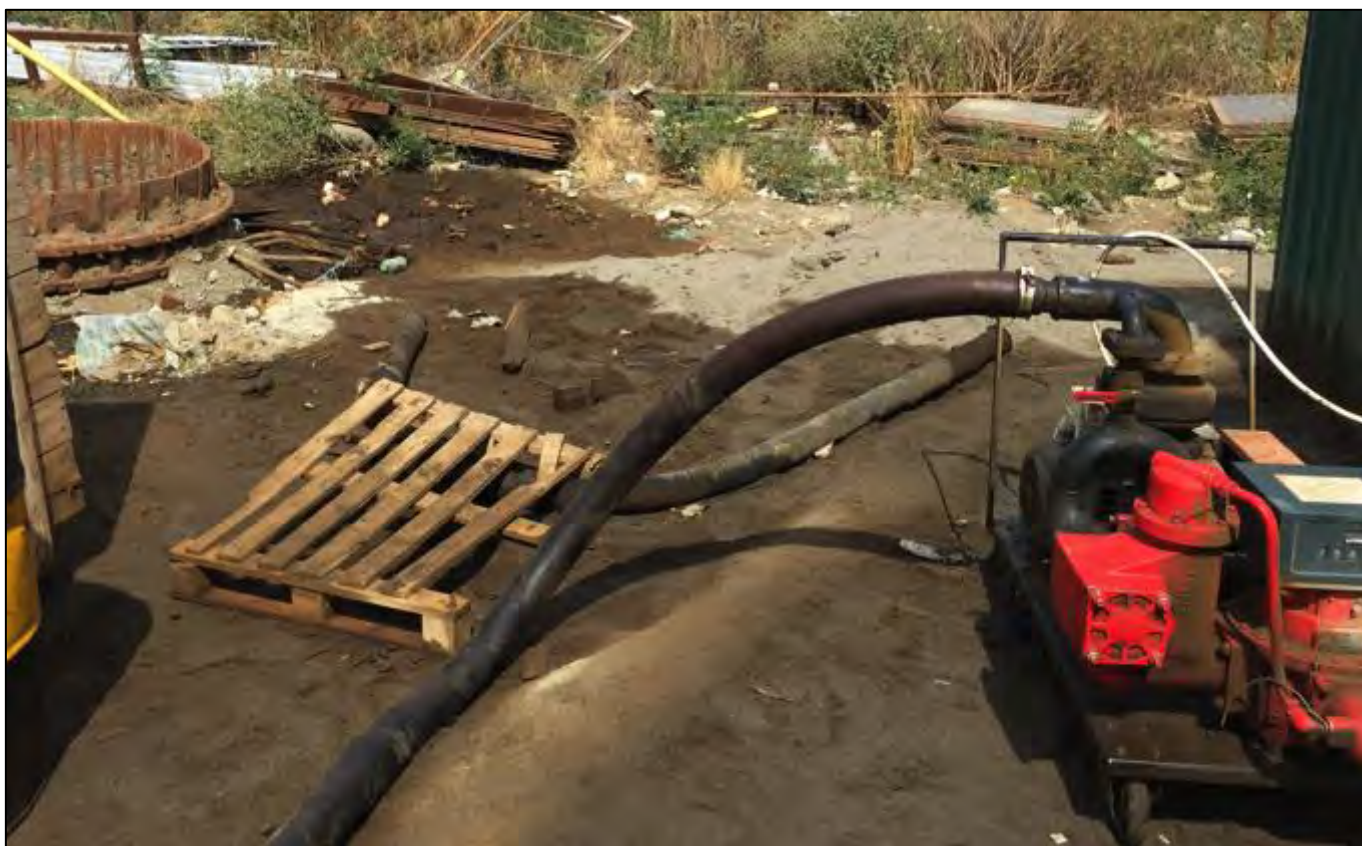
Figure I-4: Fuelling pipe outside of bund. Note the clear signs of soil contamination.

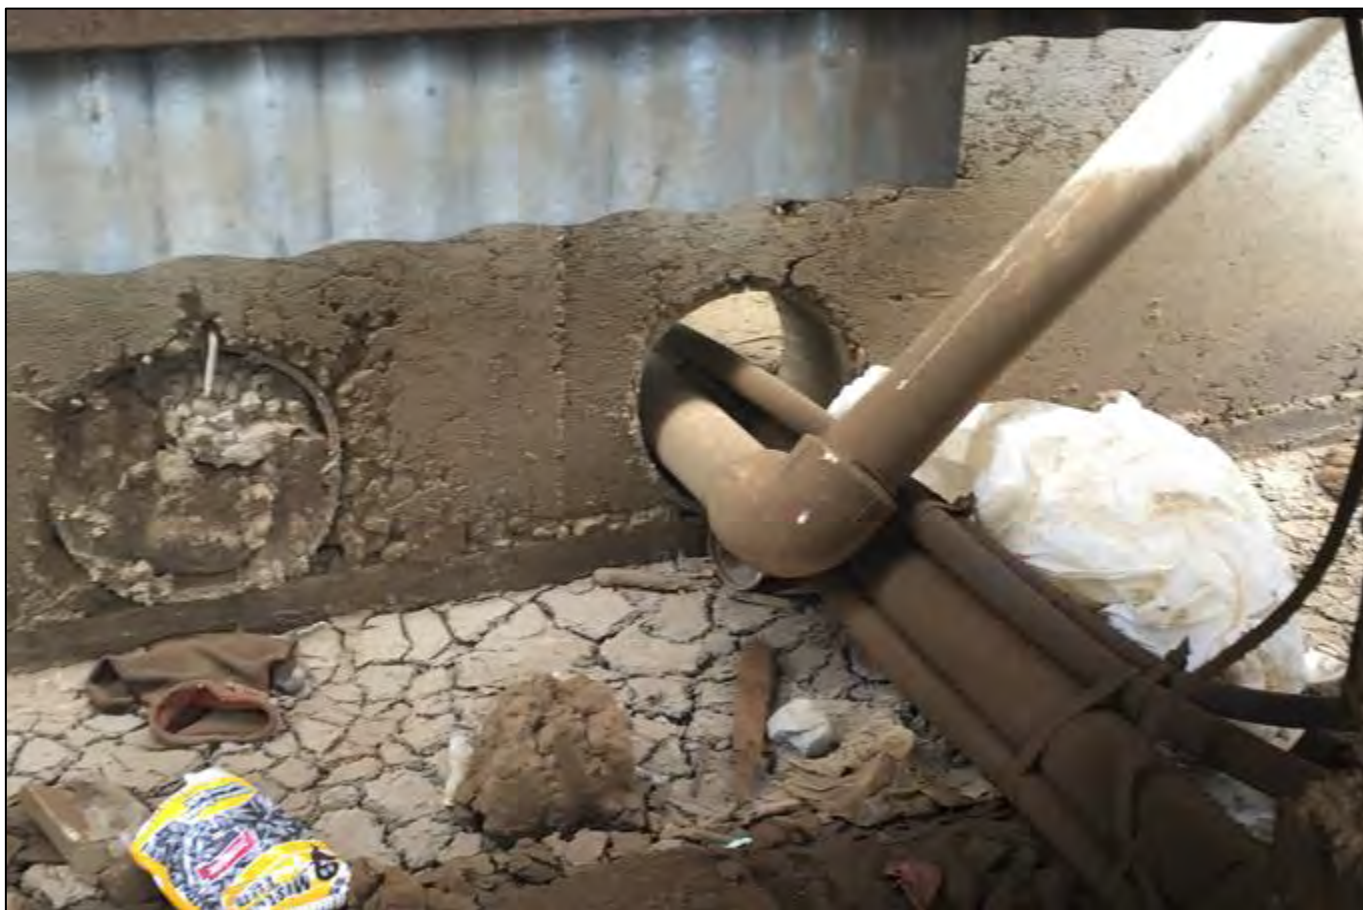
Item	Comment	Action	Responsibility	Schedule
1. Bunding	Cracks have started to appear in some older bunds. In addition bunds also now appear to have holes in them (see Appendix I for photos). New un-bunded fuel storage tanks have appeared in some location. In addition, bunding has started around the asphalt plant, but it is incomplete. Finally, the bunding at the concrete batching plant needs to be made suitable for the size of drums it contains.	<p>1. Cracks should be sealed.</p> <p>2. All fuel storage tanks should be bunded.</p> <p>3. Suitable bunds shall be constructed for plasticisers at the concrete batching yard.</p> <p>4. Bunding at the asphalt plant should be completed in all relevant locations.</p>	Items 1-4: Kolin HSE Team	15/07/16

Figure I-5: New hole in the fuel storage bund.

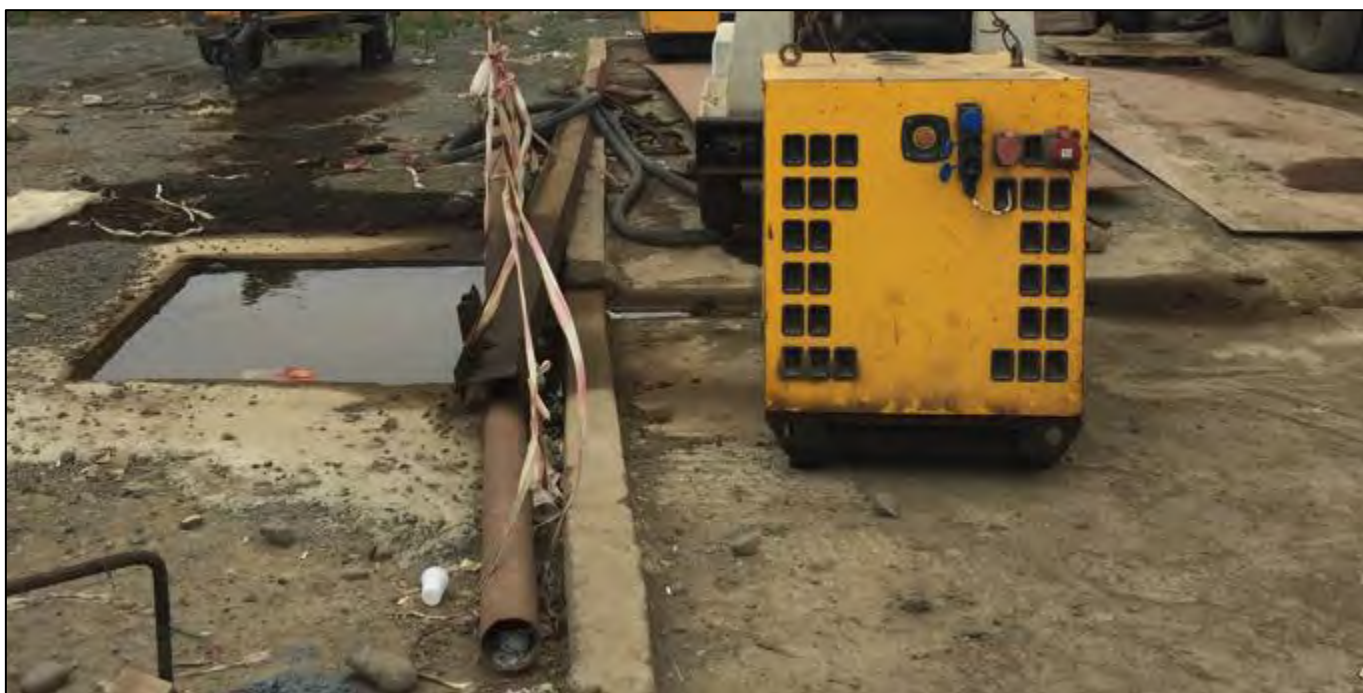
2. Vehicle Refueling	As noted in the previous bi-annual report, rehabilitation of this area had occurred. However, it was noted that the sump which collects the run-off from the fuelling area was full during the site visit (see Appendix I for photos) – any additional rainfall will result in the sump overflowing and contaminating the soils and groundwater around this area. A hole in the bund of the fuelling area has again appeared. This needs to be filled. In addition, training needs to be provided to staff who use this area in the methods to keep this area clean and tidy.	<p>1. Regular emptying of the sump to ensure it does not overflow.</p> <p>2. Fill bund holes.</p> <p>3. Training for staff in the use and management of the vehicle fuelling area.</p>	Items 1-3: Kolin HSE Team	<p>Item 1: As and when required</p> <p>Item 2: 08/07/16</p> <p>Item 3: 15/07/16</p>

Figure I-6: Full vehicle fuelling area sump

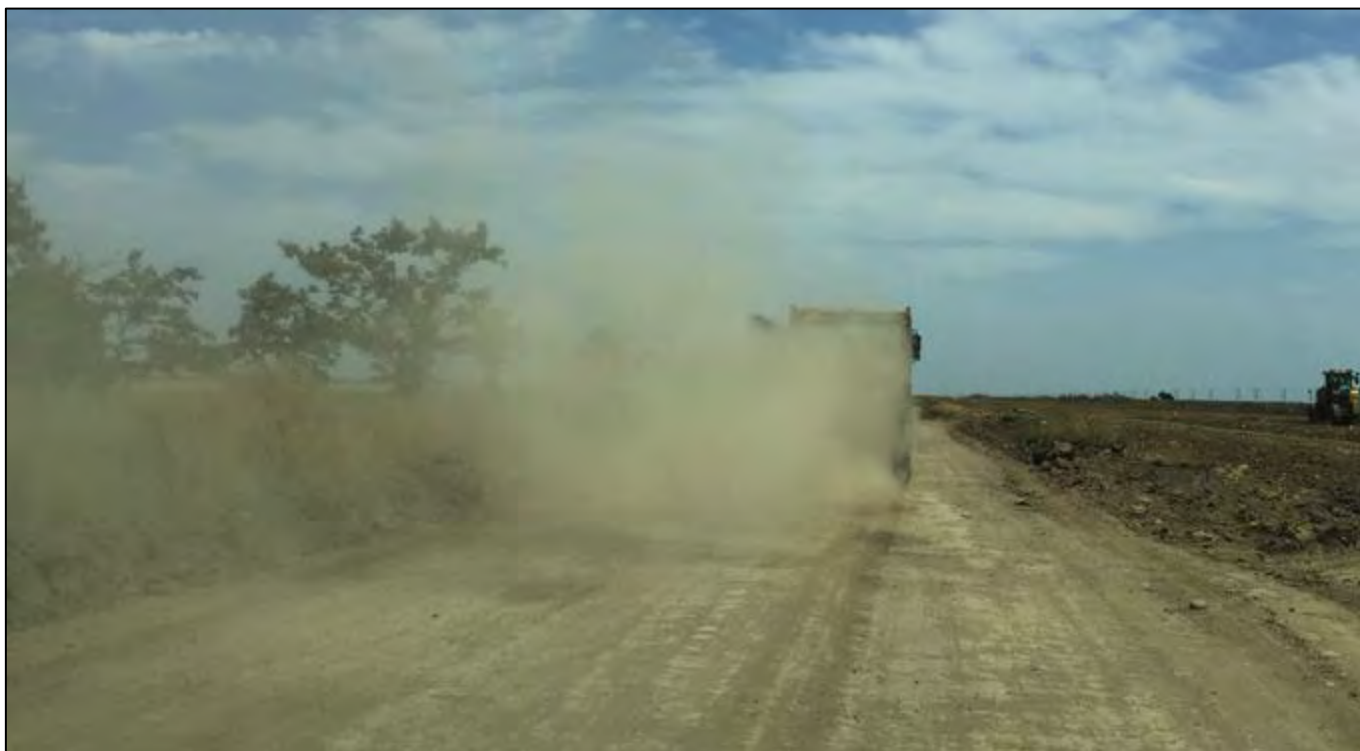
on the road. Appendix I illustrates the levels of dust being created on access roads by Contractors vehicles. In addition, it is noted that some of the Contractors vehicles avoid driving in newly dampened areas to avoid their vehicles getting dirty.	operating in all construction zones on a regular basis 2. Tool-box training from drivers on the need to drive in the areas recently sprayed.	Kolin HSE Team	01/07/16 Item 2: 08/07/16

Figure I-7: Dust on access road from construction traffic

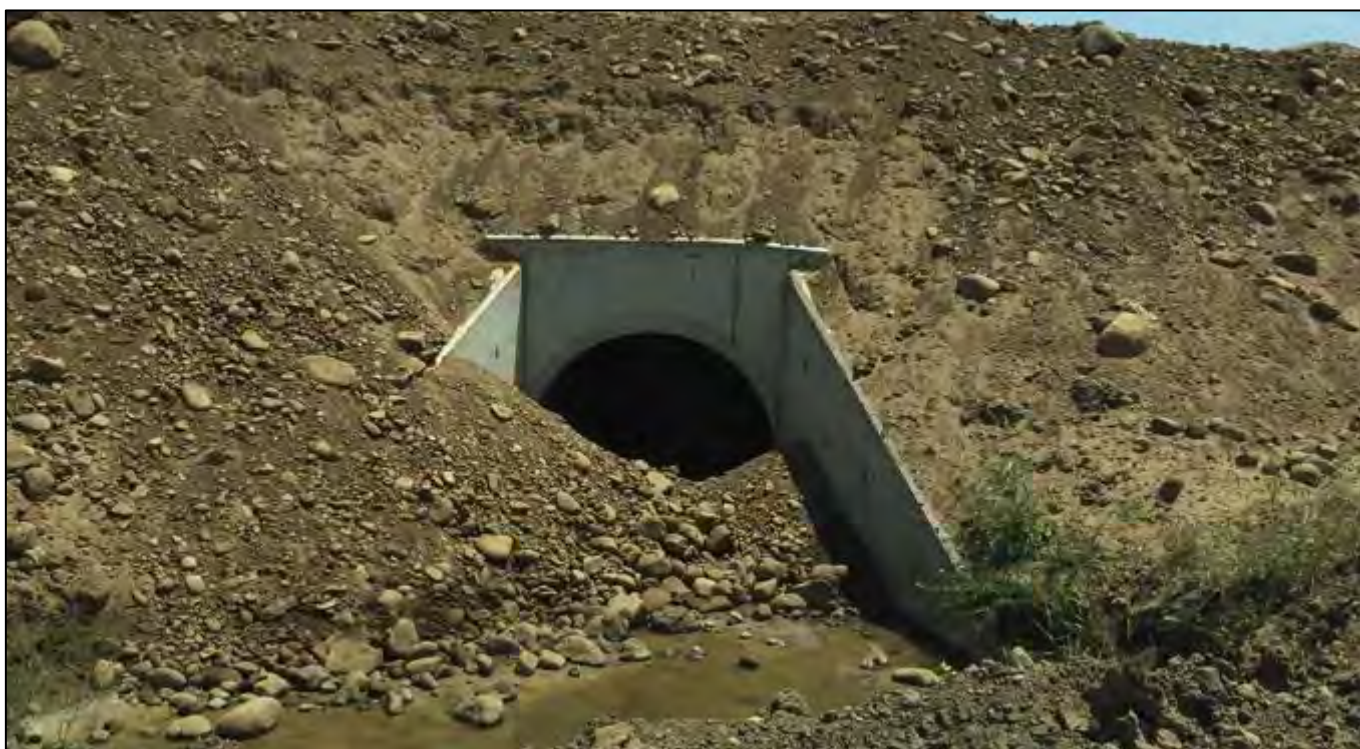
44. An item to keep an eye on as construction progresses is the status of culverts, specifically the suitability of the wing-walls, which in some locations appear to be too small to prevent embankment material overtopping them (see **Appendix I**) and silting up the culverts which over time may reduce their capacity and lead to localised flooding. In addition, it was noted at km113 that an electricity transmission line is quite close to the top of the road embankment (see **Appendix I**). According to the Engineer, the design SNIP the minimum height for transmission lines above a road is 8 meters and the current height between the road and the transmission lines is 8.6 meters. It is recommended that the Engineer double check the actual heights once the pavement construction is completed.

Figure I-8: Poorly sized culverts and wingwalls

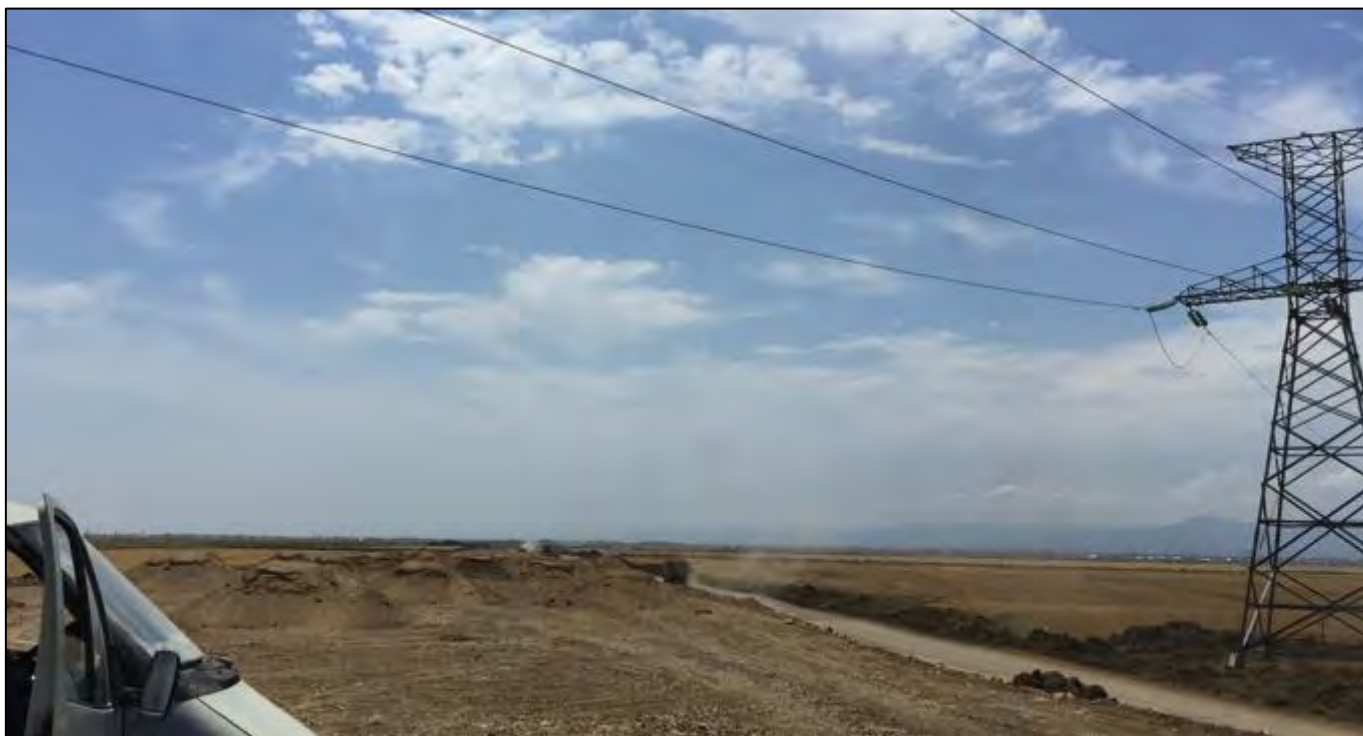
Figure I-9: Low hanging transmission lines at Km113.

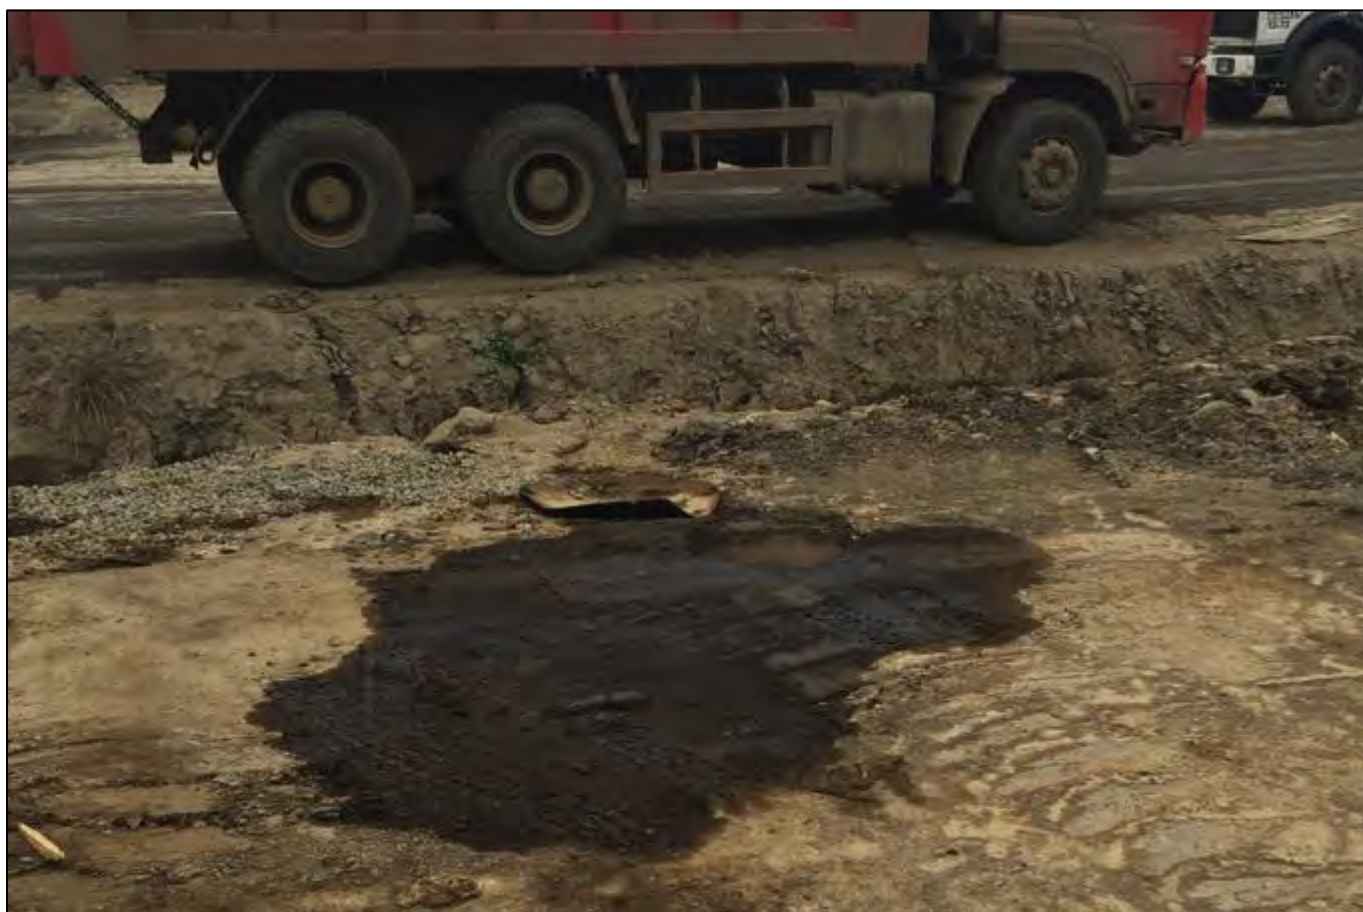
Figure I-10: Oil spills adjacent to maintenance area and drainage ditch

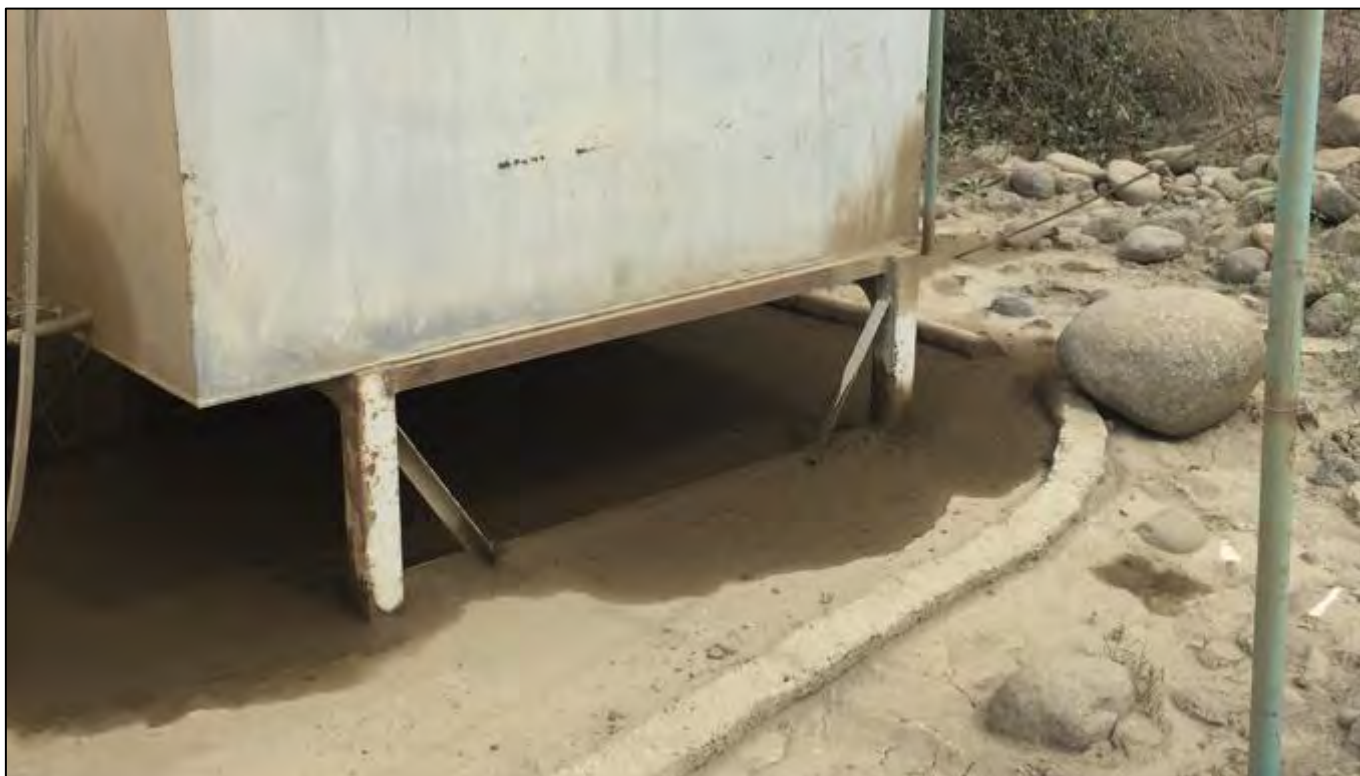
Figure I-11: Poorly sized bund, now with hole – adjacent to rock crushing plant

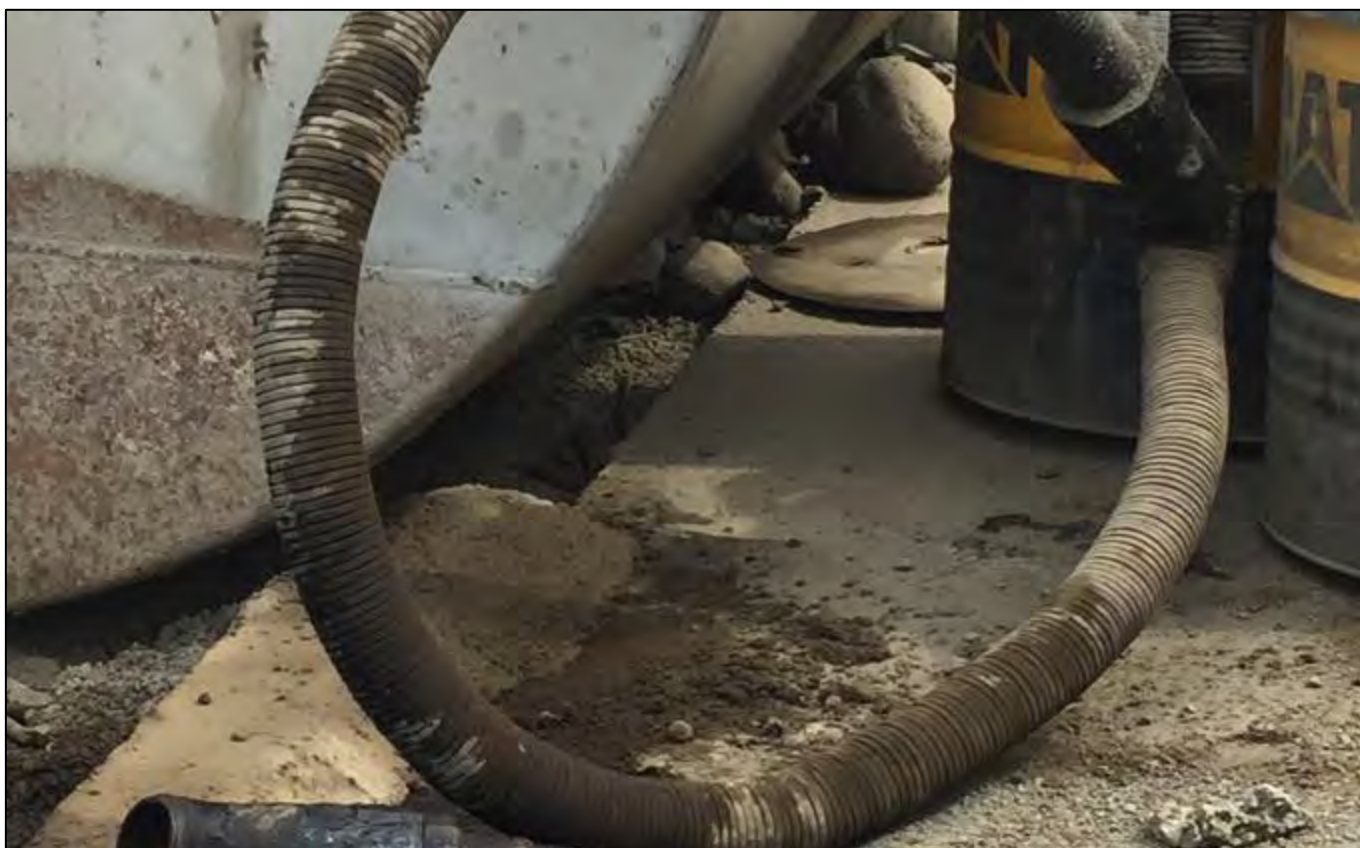
Figure I-12: Mysteriously this bund stops at this point in the asphalt plant area.

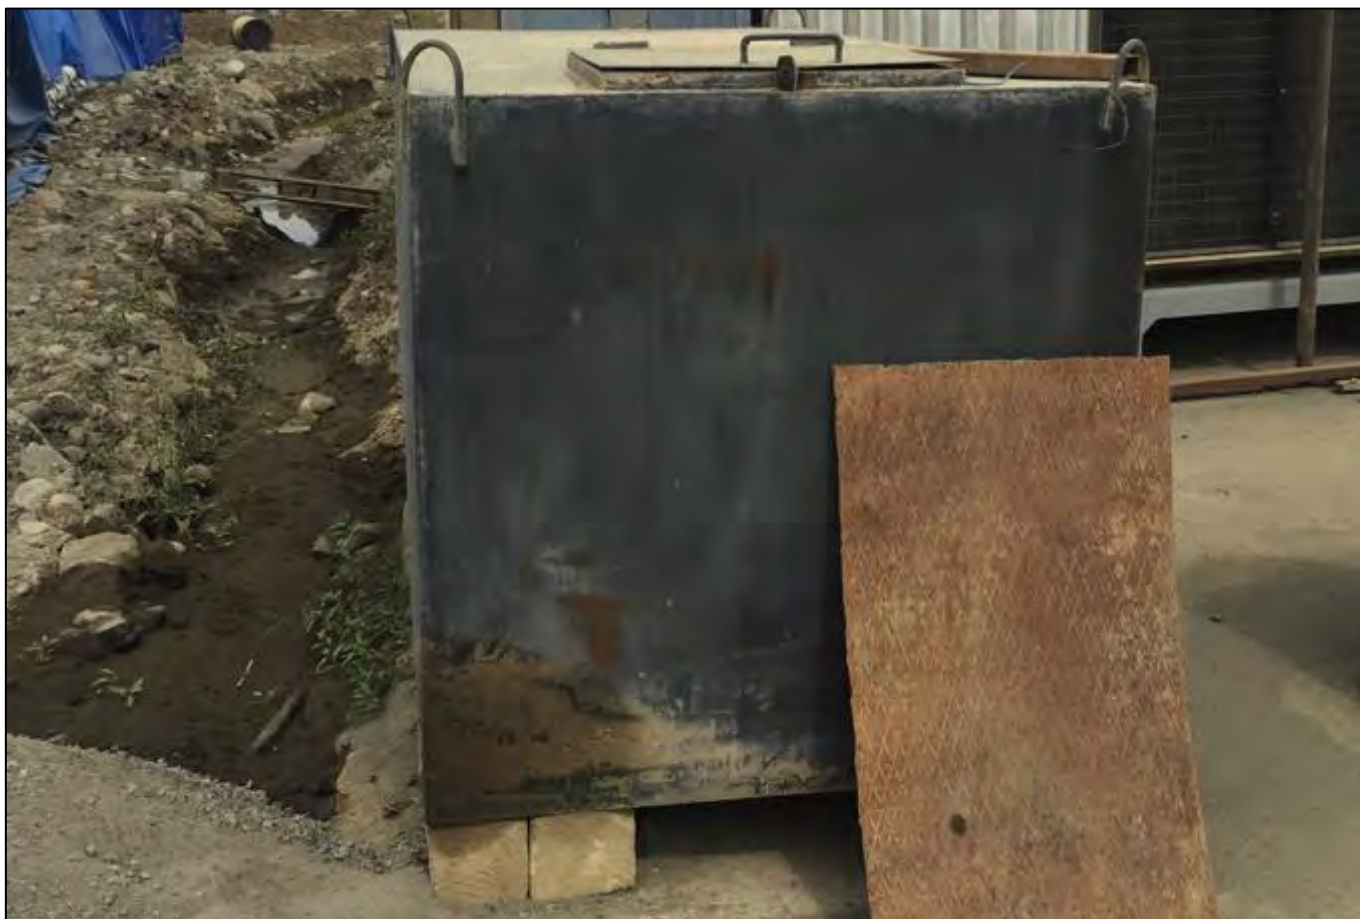
Figure I-13: A new fuel storage tank without bunding close to the asphalt plant

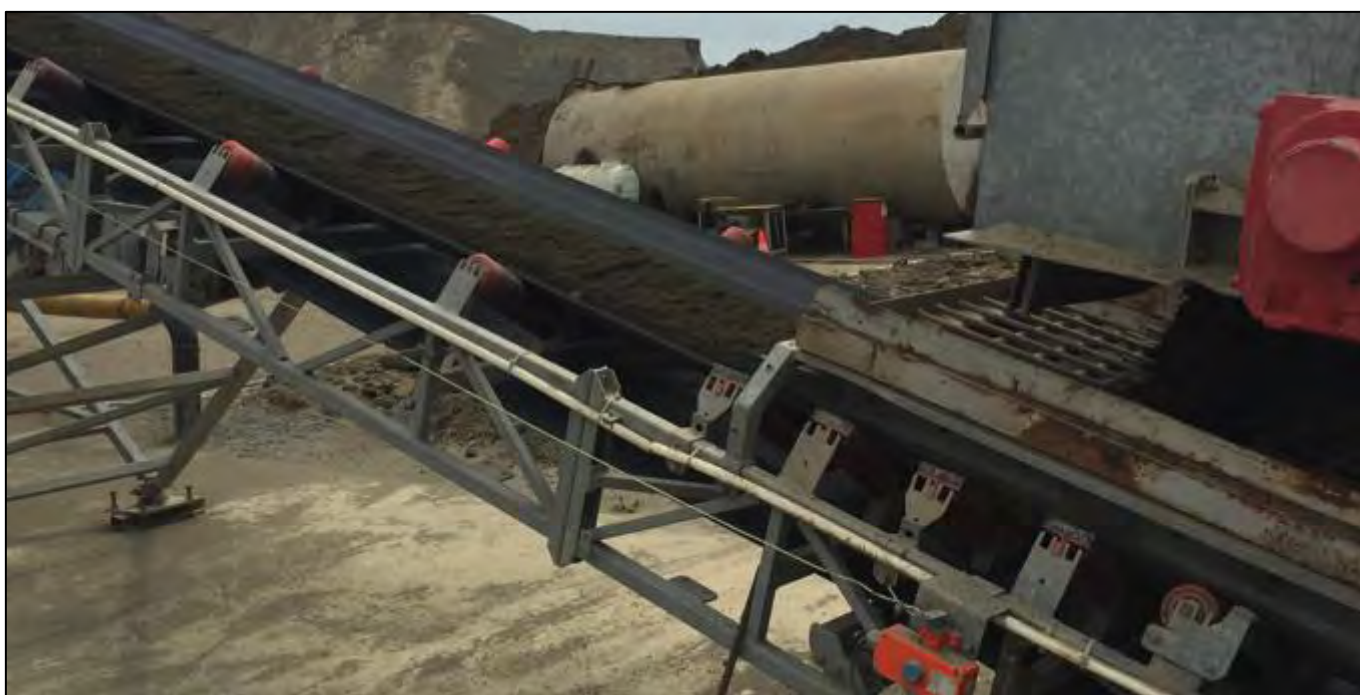
8. Asphalt Plant	Multiple issues exist with the asphalt plant, some of which have been discussed above such as the lack of bunding and the storage of hazardous chemicals. Another significant issue in this area is dust. Multiple sources of dust are emitted from the plant. In addition there are no covers on conveyors	1. Develop a method statement to control dust from the asphalt plant without the use of water spraying, e.g. covering conveyors, etc.	Item 1: Kolin HSE Team	Item 1: 08/07/16

Figure I-14: Uncovered conveyor belts at the asphalt plant area

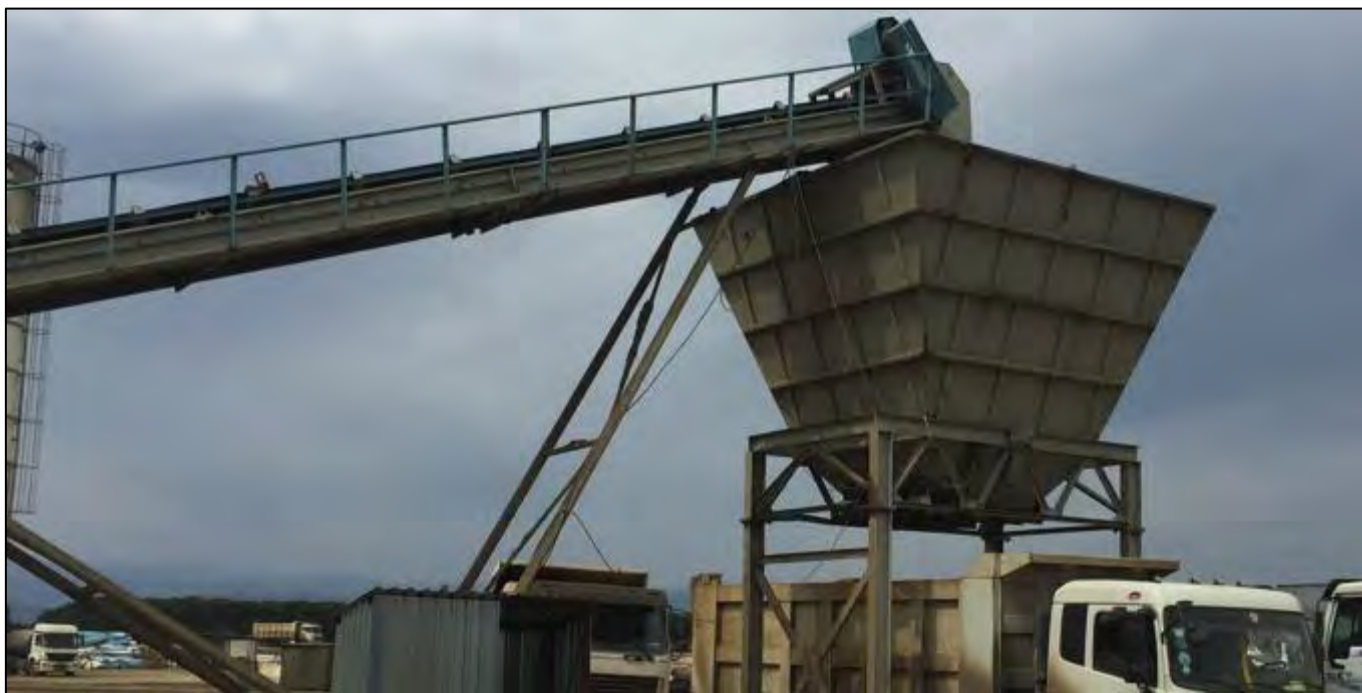
Figure I-15: Another uncovered conveyor belt

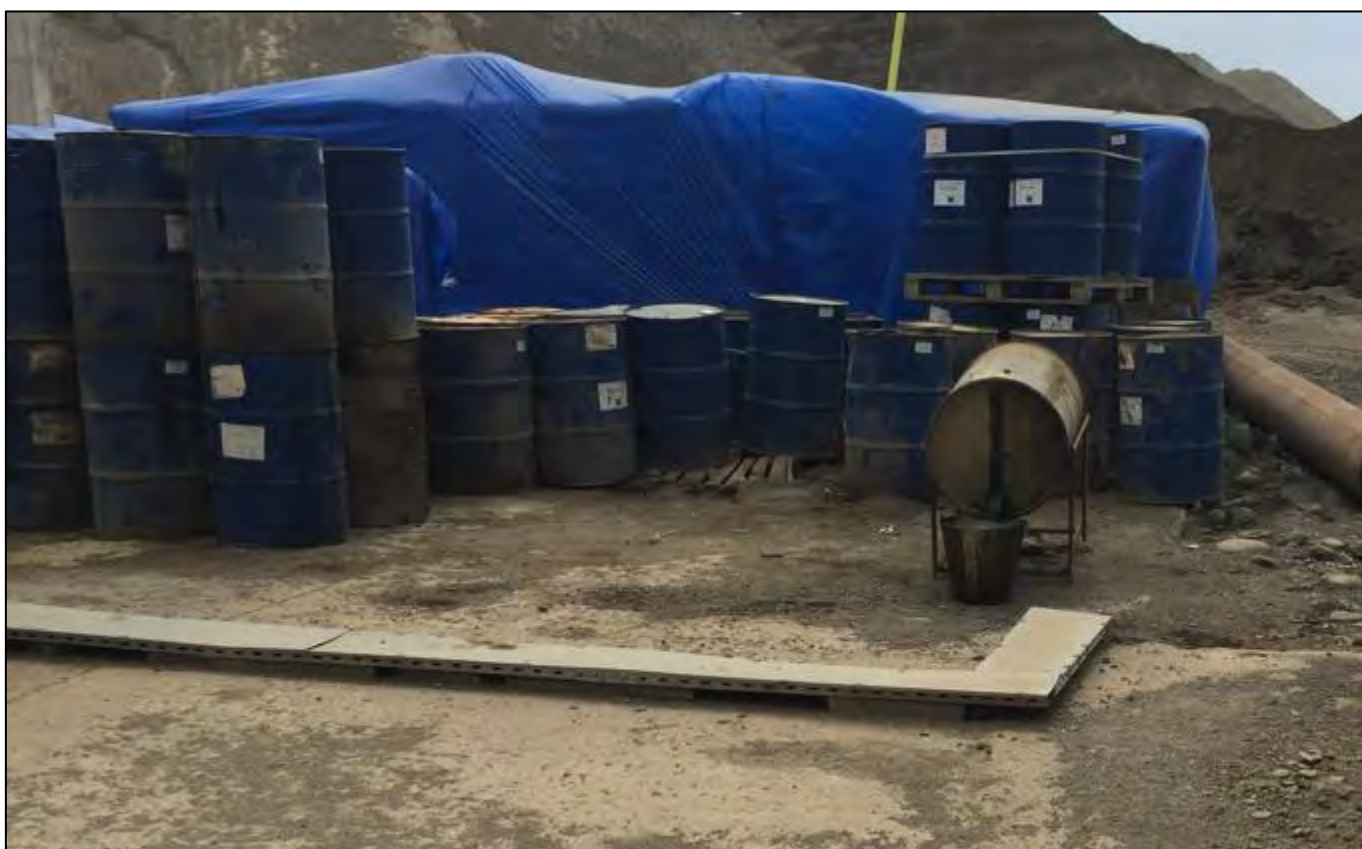
3. Storage of Hazardous Chemicals	Approximately 50 tonnes of Kraton (a polymer used in asphalt) is currently stored in the asphalt plant	1. All hazardous materials and liquids need to be stored	Items 1-5: Kolin HSE	Item 1: 15/07/16

<p>area – this chemical is a fire and explosion hazard. There are no warning signs relating to this chemical. The Contractors HSE Manager did not know where this chemical was, or what its hazardous properties were and did not have a copy of its material safety data sheet (MSDS). In addition, around 20,000 liters of Iterlene (a chemical also used in asphalt production) is also stored in this area. The label on the containers states that this liquid is corrosive and toxic. However, the Contractors HSE manager had no knowledge of this chemical, its properties, or a copy of its MSDS.</p>	<p>according to their MSDS – this includes bunding on hardstanding for hazardous liquids.</p> <p>2. Training in the correct use of these items needs to be provided to staff, including application of PPE.</p> <p>3. MSDS must be kept with the materials and in the site office.</p> <p>4. Safety signs need to be provided in the storage locations of these materials indicating, for example, their potentially explosive properties.</p> <p>5. The Contractors HSE team should be aware of all times of the amount and types of hazardous materials at site. They also need to know how to manage these materials in the event of an emergency.</p>	Team	<p>Item 2: 08/07/16</p> <p>Item 3: 01/07/16</p> <p>Item 4: 15/07/16</p> <p>Item 5: 01/07/16</p>

Figure I-16: Storage of hazardous kraton, a polymer which is a fire and explosive hazard.

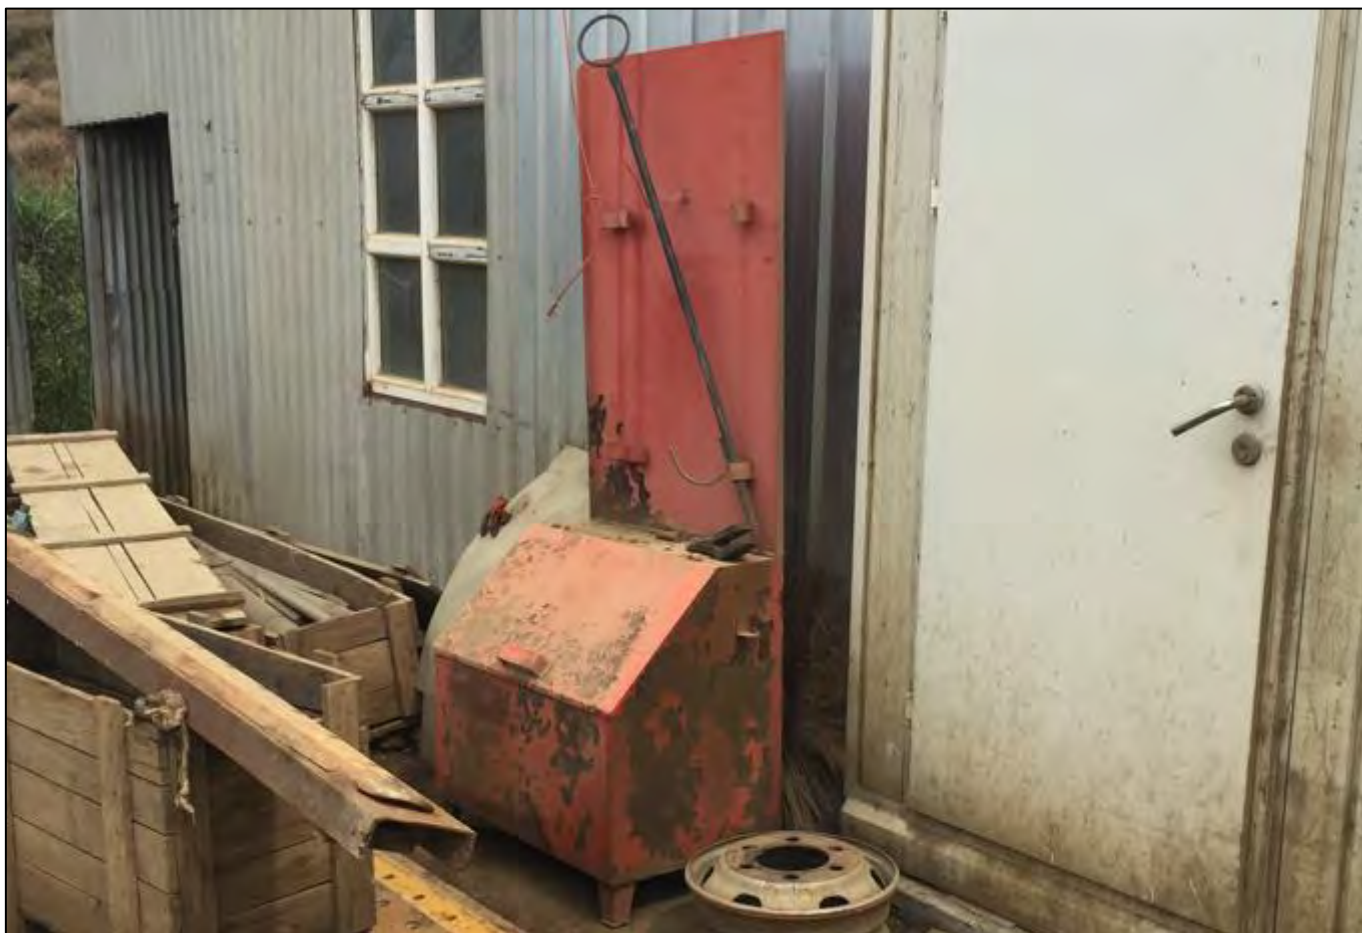
Figure I-17: Status of fire fighting equipment at the maintenance yard.
