Bi-Annual Environmental Monitoring Report

Project Number: 45389-004
June 2018

AZE: Second Road Network Development Investment Program, Tranche 2

Road Network Development Program, Project: Tranche 2
Construction Supervision of the Alat-Astara Highway
Jalilabad Intersection to Shorsulu Intersection

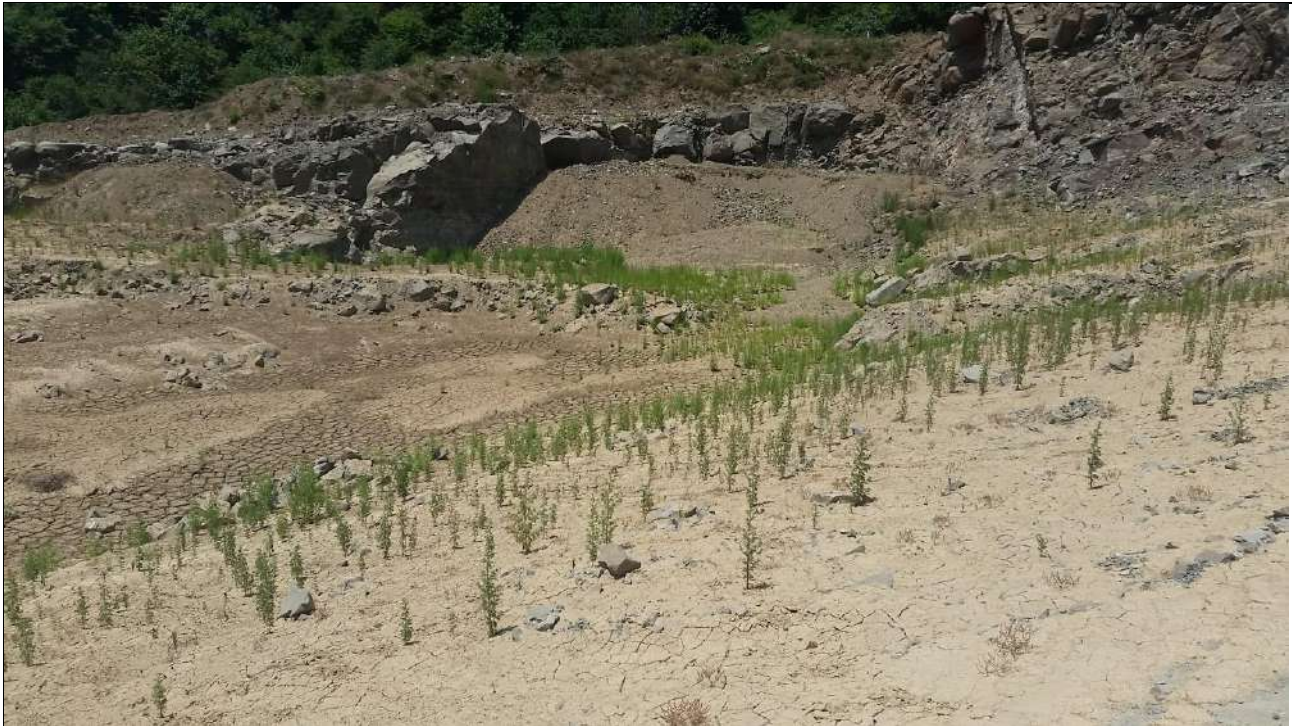
21 Jun 2018

Vegetation naturally regenerating on the site

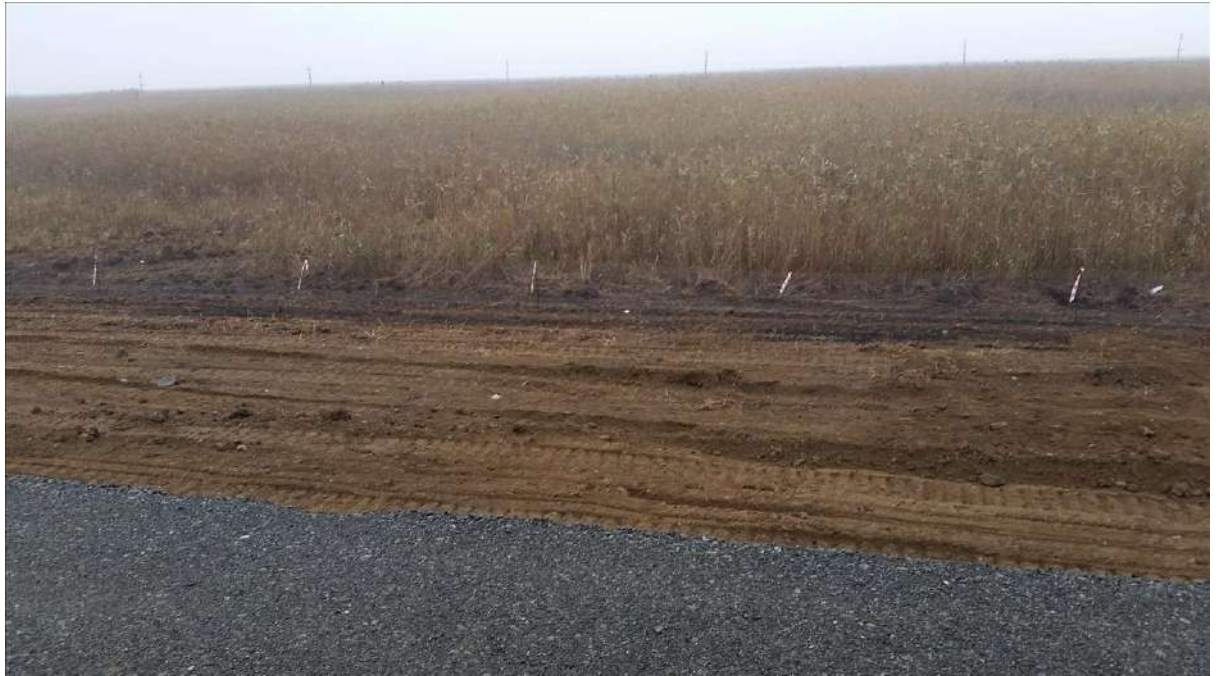
Figure 17: Example of turtle exclusion fencing erected alongside the alignment in wetland areas.

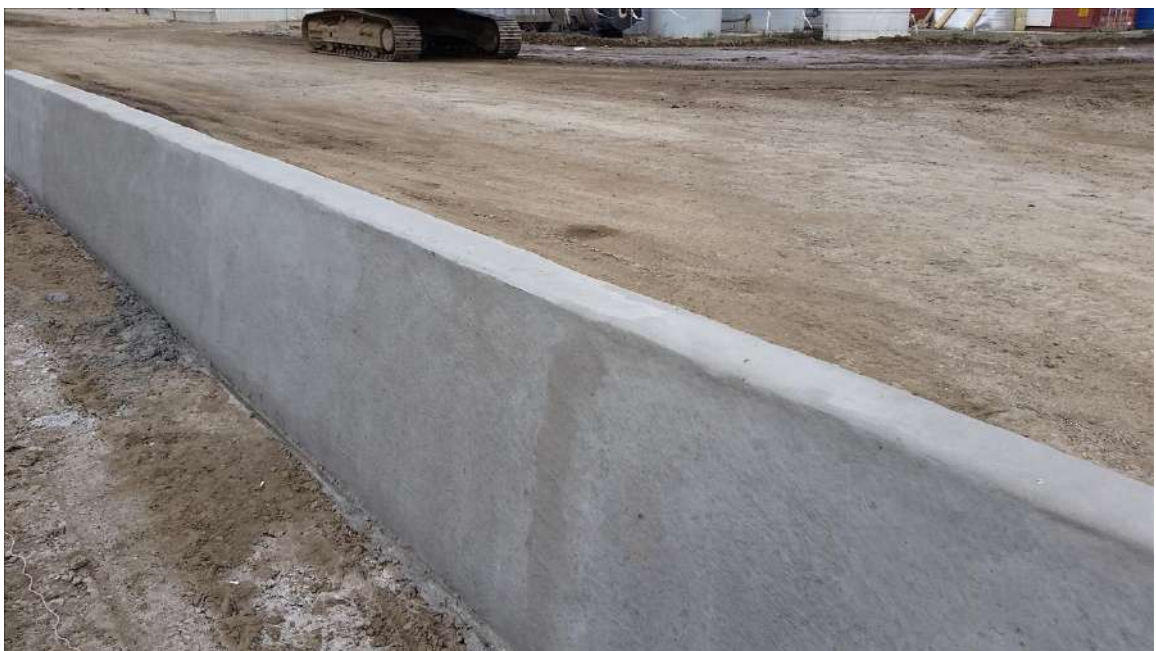
49. The Contractor installed fencing to prevent turtles straying onto the alignment in October 2016. Installation of these physical barriers appears to have significantly reduced the number of turtles straying onto the alignment. The temporary fencing has been replaced by permanent vertical concrete barriers at the edge of the alignment through wetland sections (82+700 to 83+600 [Mahmudchala] and 99+000 to 108+000 [Akchala]) see Figure 21. To allow turtle and other mammal access across the alignment there are 21 hydraulic culverts and vehicular access options through the two wetland areas.

Figure 21: Proposed edge barriers on alignment through wetland sections to prevent turtle access

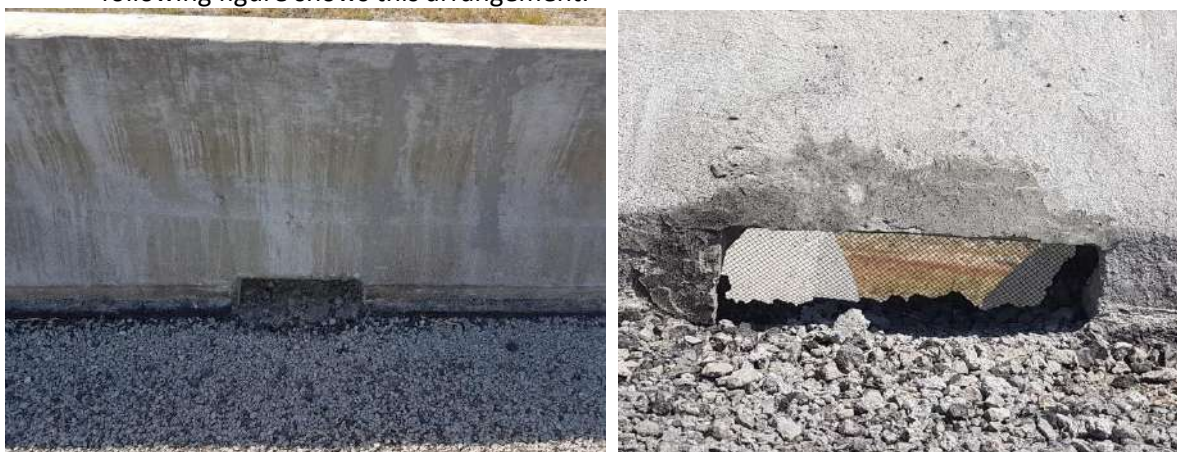
Figure 22: Drainage hole in edge barrier incorporating mesh to prevent turtle access

50. To allow water to drain from the alignment the edge barriers have drainage slots incorporated into the base. It was observed that turtles were using these drain holes and gaining access to

the alignment. The CC was asked to incorporate a grill / mesh to prevent this access. The following figure shows this arrangement.
