Environmental Monitoring Report

Project Number: 45389-004
July 2019

AZE: Second Road Network Development Investment Program, Tranche 2

Upgrading of Yevlakh-Zagatala-Georgian Border road (M5), Section
Lot 1.Khaldan-Suchma (Km 0+300 to Km 33+100)

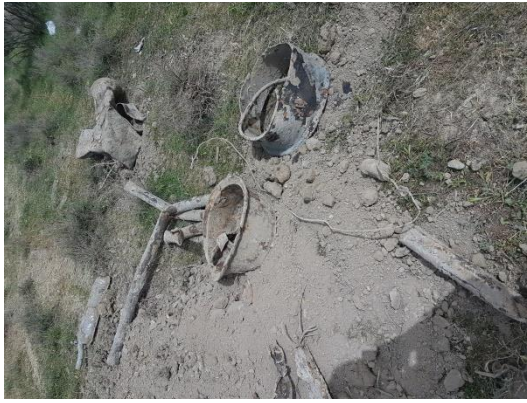
Figure 10. Metal waste

1. Metal, concrete and debris were observed inattentive at the Construction site
 2. During the culvert and pipe construction concrete waste were observed during unattended

4. Dust problem
42. The consultant reminded the Contractor via official letter via official letter AH-AVT-19-M5- Lot 1-079 Environmental shortcomings at the construction site in May, 2019
