# Environmental and Social Due Diligence Report

Project Number: 47083-004  
September 2021

## INDIA: Accelerating Infrastructure Investment Facility in India – Tranche 3

Ashoka Ankleshwar Manubar Expressway Private Limited (Part 24 of 24)

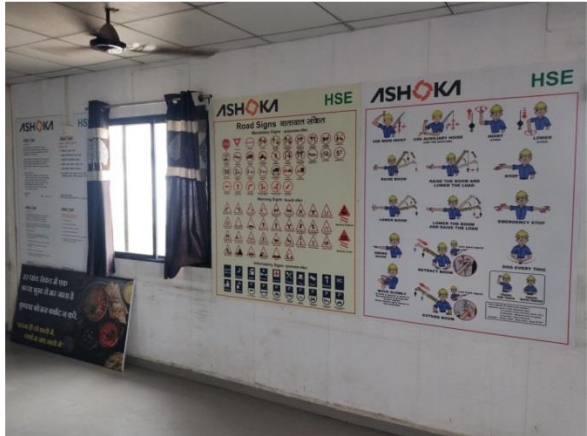
Sr. No.	Location	Points	Closing Photographic Evidence
01	Base camp	Establishment of local control office (LCO) for the training and HSE program purpose.

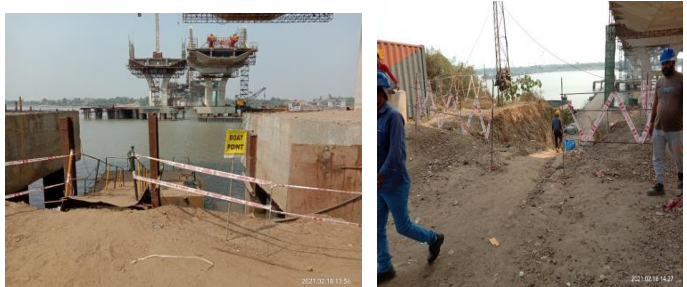
02	Site A1, A2, Dept: Boat Area Side	Barricading with tape found at high and medium risk areas such as Excavation, roads at sites, Boat site

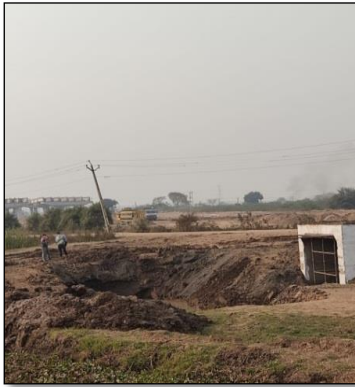
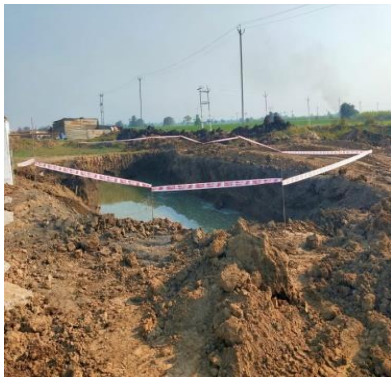
Sr. No.	Location	Observation	Closing Photographic Evidence	
1.	CH279+600	There was no Barricading provided to excavated area and there was found poor access and egress

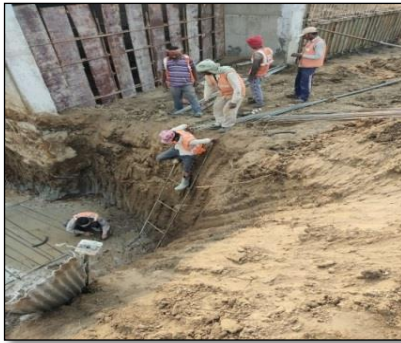
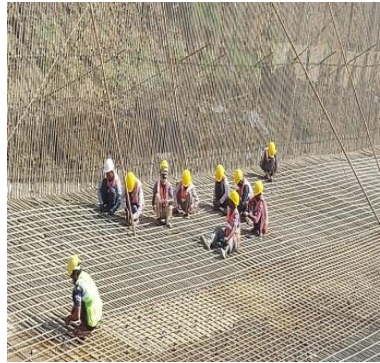
2.	CH. 281+373	1. There was no Barricading in the excavated area and the access was also not proper. 2. Workers were not using required PPE's

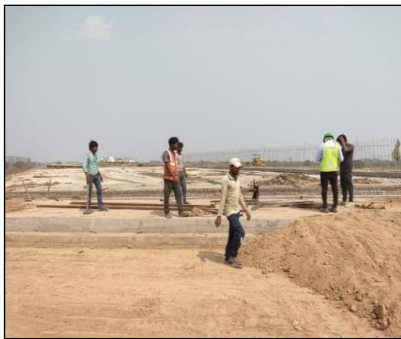
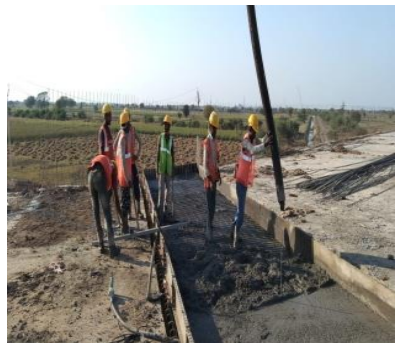
3.	CH291+295	ABL staff's & workers found without mandatory PPE's at site

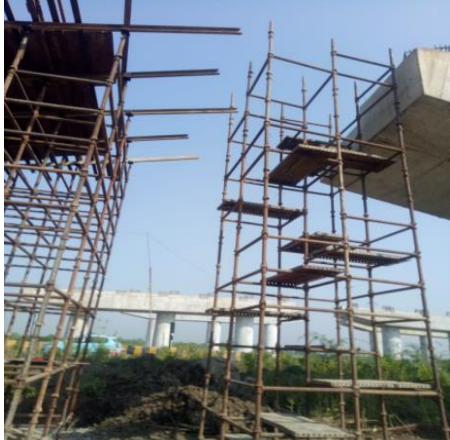
Sr. No.	Location	Observation	Closing Photographic Evidence	
12	Location:- Ch.279+353  Hazard:- Falling Hazard  Risk Level :- High	Observation:- Ladder was not provided to reach at working location. Access issues  Recommendation- should be provide proper ladder to reach at working location.

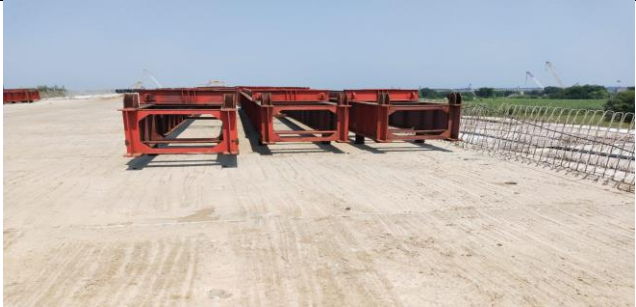
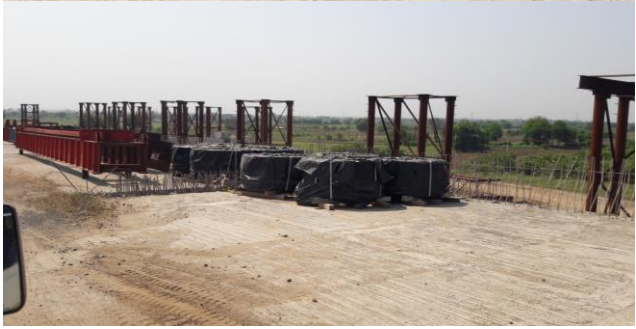
Sr. No.	Observation	Observation Photographs
Good Points		
01	GL -Sliders are stacked separately at site with Good Platform

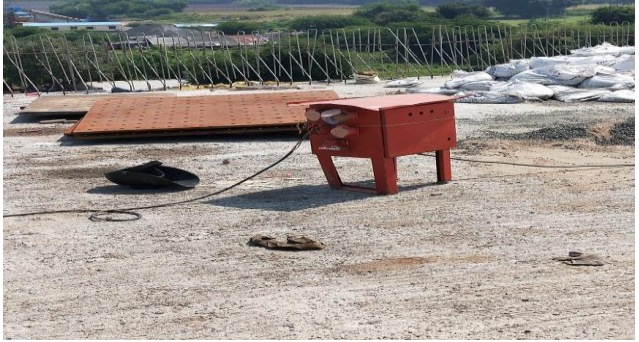
Sr. No.	Observation	Observation Photographs
02	Power distribution box provided for clerical connections at Pear No 12
