# Environmental Monitoring Report

Semi-Annual Report no. 8  
For the period covered July-December 2020  
Project Number: 47381-002  
January 2021

## Sri Lanka: Mahaweli Water Security Investment Program – Tranche 1

## Semi Annual Environmental Monitoring Report (SAEMR) No. 08 (July to December 2020) for Upper Elaheera Canal Project (UECP)

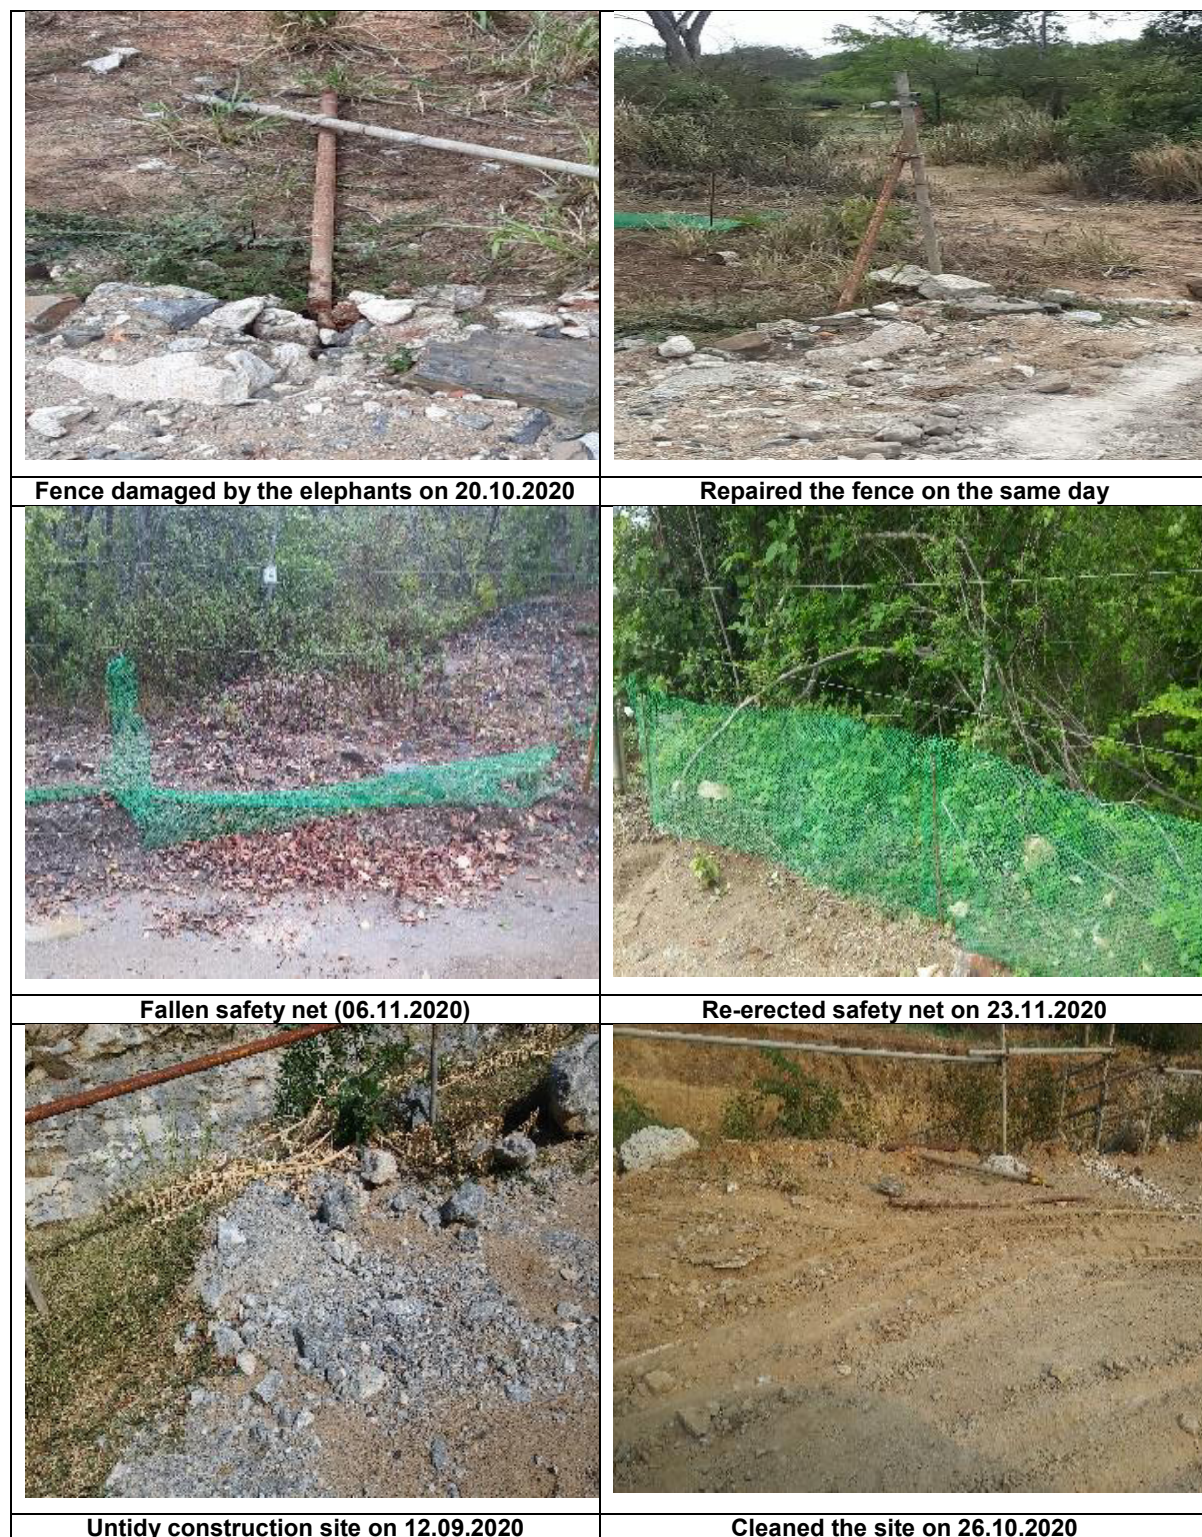
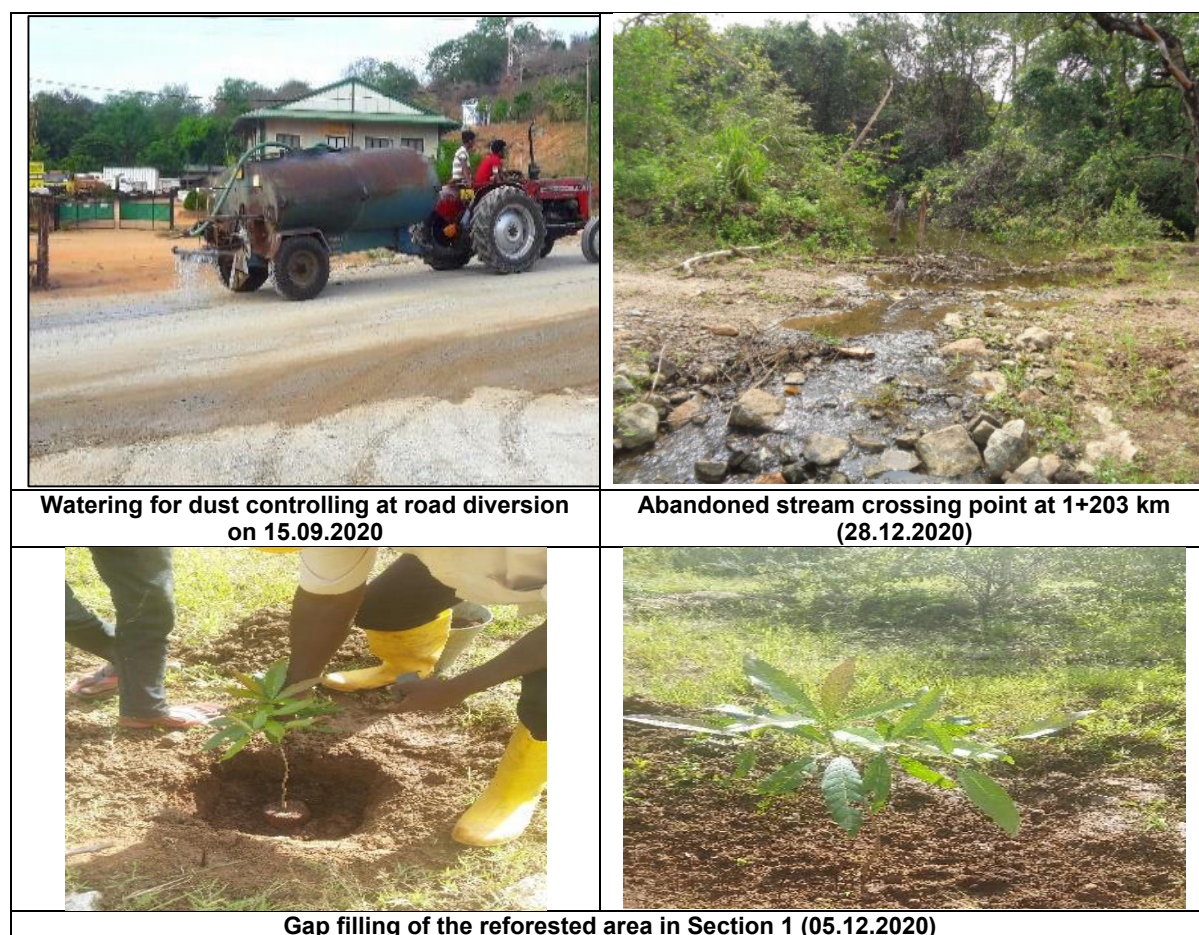
**Figure 2-1: Photographic records of Environmental Monitoring in UECP-ICB-1**

19. The photographic evidence for the environmental issues and incidents recorded by PMDSC in the UECP-ICB-1 area during environmental monitoring period is shown in **Figure 2-1**.

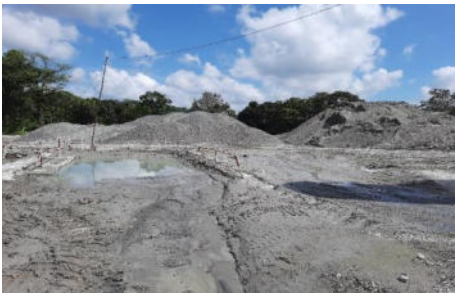
Reference	Environment Issue/concern	Photographic evidence
PMDSC-KMTC-RE/ICB-2B/ShCL/L1007 on 14 December 2020	(i) Absence of effective wastewater treatment facility to Lel Oya Batching plant area, and operating batching plant against EPL conditions (ii) Poor housekeeping at Lel oya batching plant premises (iii) The wastewater treatment unit has not been connected to the wastewater conveying pipe and wastewater is still

<p>Lel Oya batching plant with sludge</p>

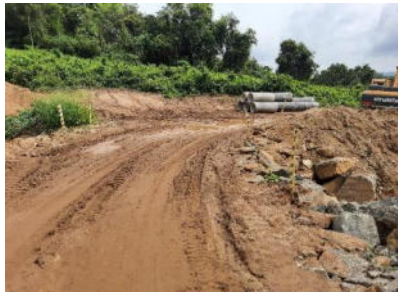
Reference	Environment Issue/concern	Photographic evidence
	collected in the temporary sedimentation tank constructed for storm water at tunnel 1 inlet area

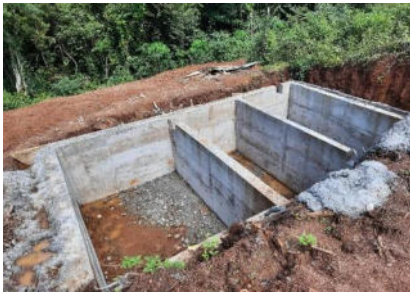
(iv) No proper stream diversion, and drainage arrangements across the access roads is established, resulting erosion, water pollution due to siltation in the associated sensitive stream network at tunnel 1 inlet area	Lack of stream diversion / drainage arrangements at T1 inlet

(v) exposed slope areas in the tunnel 1 inlet area without adopting required slope protection, erosion control measures

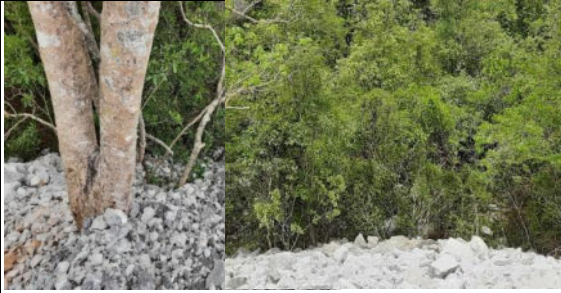
(i) Dumping of the mucking materials beyond the given boundaries at Kabarawa T2 outlet area. This was immediately stopped, and action was taken to use the DS no.01 with the approval of the CEA. On the request made by RE to PMU/PIU to identify alternative lands for this disposal, PIU informed (through letter UECP/ PD/ KMTC/ 01-ii on 26/11/2020) that FD verbally said that there is no possibility of expanding the land with no addendum / supplementary EIA is done to assess possible impacts, and hence to optimize the disposal land without disturbing existing wetland/ streams of the area.

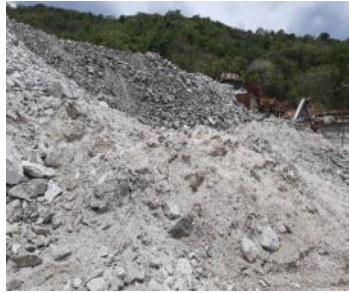
(ii) Operating Lel oya batching plant area violating EPL conditions	Capacity exceeded Disposal site
	(iii) Wastewater discharged to Lel oya from tunnel 2 inlet by overflowing the sedimentation tanks. Immediate attention was taken to stop flowing sediment by putting sand-bags across the stream, and cleaned the section by de-watering/ flushing

Unmanaged sludge disposal

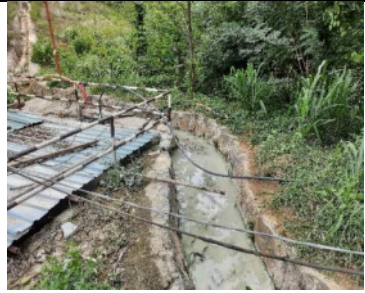
Overflowed sedimentation tanks

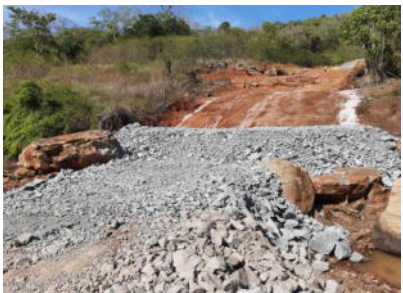
Reference	Environment Issue/concern	Photographic evidence																											
	<p>(iv) A platform and access have been made for drilling purposes of the proposed aqueduct (which traverses over the Lel Oya) by blocking Lel Oya natural stream. Removed all the materials and facilitate stream flow immediately</p> <p>(v) Oil leaks from generator at Lel Oya T2 inlet / T1 outlet</p>

<p>Platform prepared blocking stream</p>

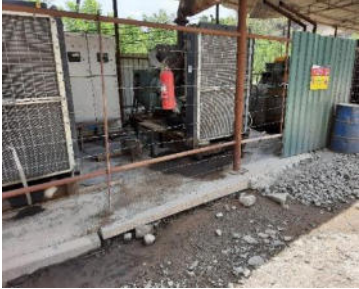
<p>Oil leak from generator</p>																											
PMDSC-KMTC-RE/ICB-2B/ShCL/L246 on 25 November 2020	<p>(i) PMU /PIU was informed through the referenced letter on 25 Nov 2020, submitting additional lands for disposal of 56,000 m<sup>3</sup> tunnel muck resulted from Tunnel 2 inlet at Lel oya. The additional land is located at Lel oya with an extent of 1.09 ha which is an abandoned paddy land</p> <p>(ii) PIU informed through Letter Ref. UECP/PD/KMTC/01-ii on 26/11/2020 that PIU will inform relevant authorities and see the possibilities to get the land, but the time taken for this process will be lengthy as it is required to carry out required environmental studies prior to approve</p> <p>(iii) PIU has informed FD seeking approval on 08 Dec 2020 though letter Ref. UEC/DPD/Env-16</p>

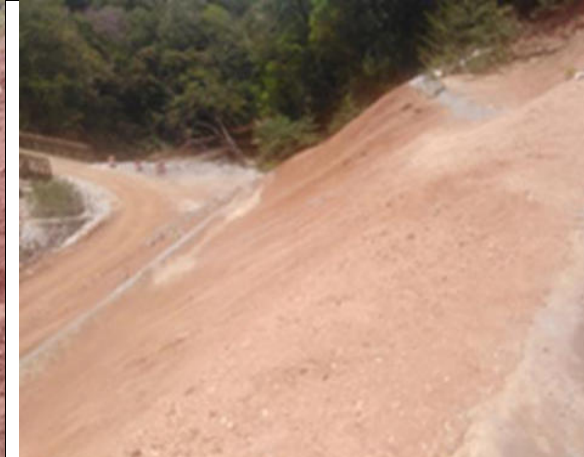
<b>Dust issue and no watering (19 Feb. 2020)</b>	<b>Watering arranged (21 Feb 2020)</b>

<b>Erosion / scouring in Lel oya batching plant area due to no base protection (19 August 2020)</b>	<b>Base protection to manage the issue (action completed on 25 August 2020)</b>
