# Environmental Monitoring Report

July – December 2019  
March 2020

## KGZ: CAREC Corridors 1 and 3 Connector Road Project (Section “Epkin [Km 89] to Bashkugandy [formerly Dyikan] [Km 159]”)

Prepared by Gentek Consulting Muhendislik for the Ministry of Transport and Roads of the Kyrgyz Republic and the Asian Development Bank.

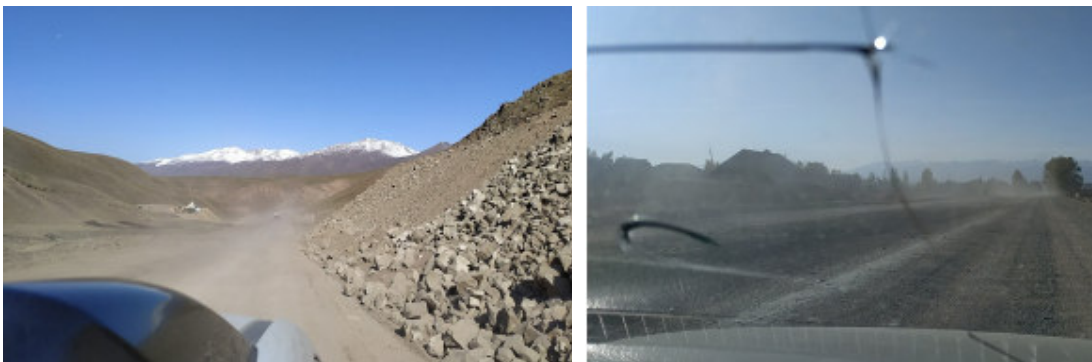
46. Dust formation has the main impact on the environment during the execution of earthworks. The increased air temperature led to increase of dust formation on existing road, which is currently on the Contractor's balance. However, dust suppression activities are exercised at sites where road construction works are taking place. In this regard, the Contractor was instructed to increase the intensity of road watering sprinkling, including shoulders, at construction sites from 6 a.m. to 19 p.m. Currently, six watering trucks are allocated for this task and each of them do watering activity 3 times per day. However, still dust suppression measures are not sufficient, increase of dust leads to road safety issues and increased air temperature lead to water stress in the region and competition with local farmers over the water access.

**Figure 9. Increased dust formation at construction sites.**

47. With decreasing air temperature and increasing precipitation, dust formation in the roads decreased, but water sprinkling was carried out before the onset of frost.

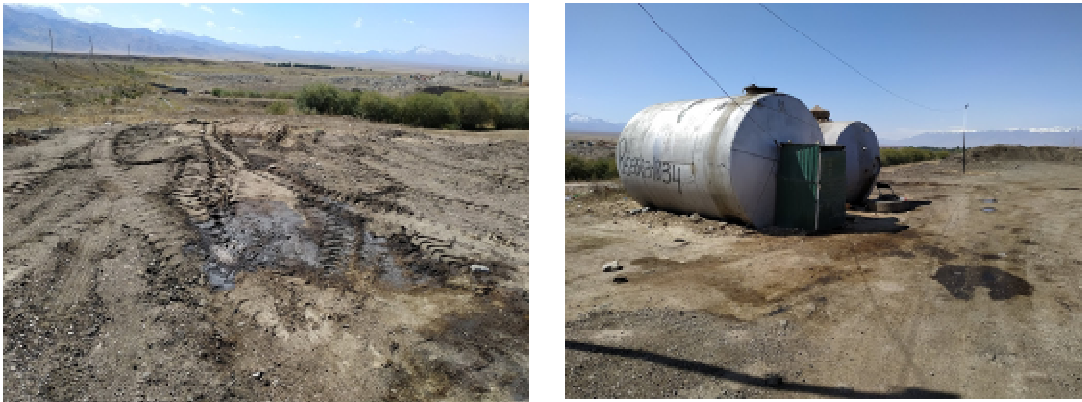
52. It has been found that the stone-crushing plant operates without following good housekeeping practice with separate handling of construction and household wastes, burning some construction waste and no fire extinguishers arranged on site. Non-compliance letter was sent to the Contractor and issues were resolved by the sub-contractor.
53. Fuel and oil spillage detected during the walk around the plant and fueling station of the sub-contractor. Oil and Lubricants were stored on the ground and causing potential oil leaks to the ground.

**Figure 10. Oil spillages at fueling station of the Crushing Plant.**

6.	Fueling station of the sub-contractor next to Crushing Plant.	Date:19.10.2019		During the walk around the plant and fueling station, fuel and oil spillage detected. It is recommended to protect the soil around the oil tanks from leaks and spills of hazardous materials with an impermeable protective coating.	Fueling station area was covered with milled asphalt material for the purpose of prevent spillage of the oil and saturation of oil to the ground.	Date:21.10.2019 REF.#: KRII479I2019

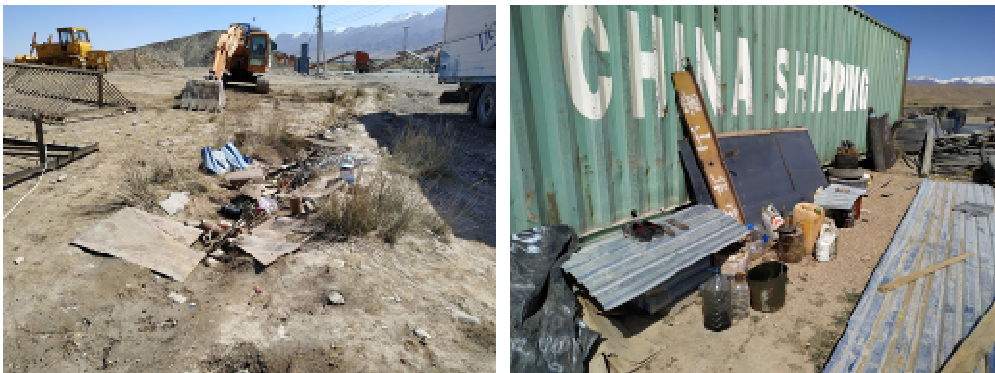
55. There no household and construction waste containers installed on site. It is recommended to install separate waste containers for household and hazardous wastes as per Waste Management Plan of SSEMP;

**Figure 11. Hazardous and construction waste at Crushing plant site.**

**Figure 12. Oil and lubricants stored without arranging impermeable platform.**

7.	Crushing Plant	Date:19.10.2019		There no household and construction waste containers installed on site. It is recommended to install separate waste containers for household and hazardous wastes as per Waste Management Plan of SSEMP;	Trash-cans were made and put on the Site.	Date:21.10.2019 REF.#: KRII479I2019	Resolved

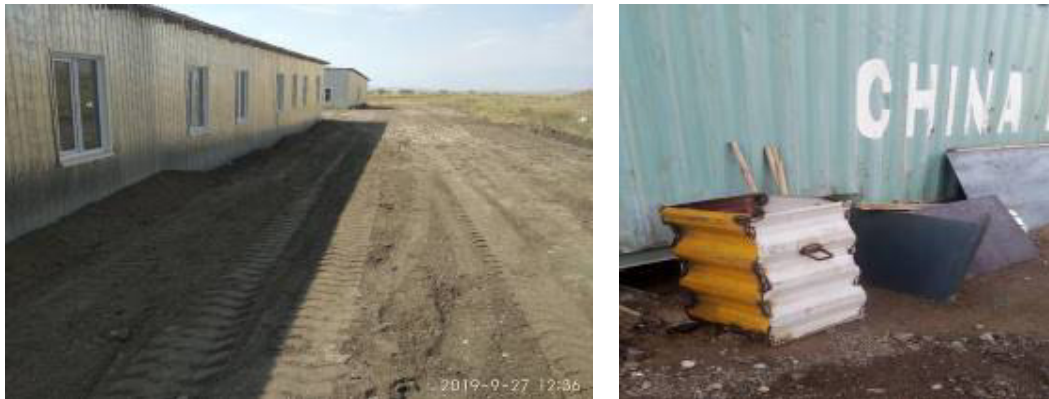
57. The workers' camp site has identified and established, but it will serve as construction office for Contractor and Engineer with dining premise and laboratory building.
58. The territory of the camp was cleaned from construction waste. All noted violations are eliminated. Garbage cans are installed. Worker's camp is not in operational mode yet, therefore, fire safety measures has not been yet put in place.

**Figure 13. Office area is cleaned up from garbage and waste**

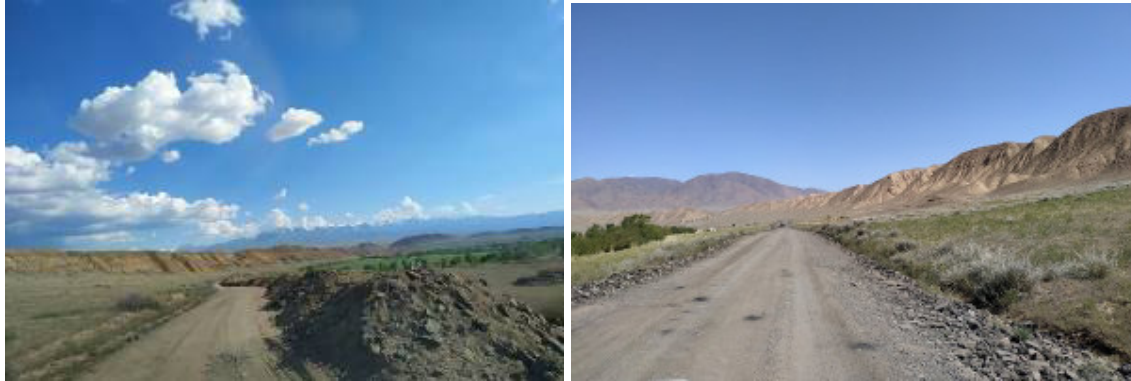
80. With the beginning of road works at sections 152+500 and 152+740 there was a problem with the getting the permission from Bash-Kuugandy Ayil Okmotu disposal of old asphalt, since Municipality was proposing the site not-suitable for disposal of old asphalt, since it was located close to water body. The Contractor's environmental specialist, Nurlan Nurdinov, dealt with the disposal of old asphalt and the old asphalt was taken out for backfilling of rural streets and without leveling of large pieces of old asphalt in villages, since RMU and village inhabitants will do it on their own, as per their letter of request. The old asphalt was not taken out to any nearby wetland areas.

81. Local authorities proposed secondary roads for backfilling of rural streets with old asphalt. The Contractor's specialists conducted a preliminary analysis of all the proposed roads.
82. During the reporting period, the streets of two Ayil Okmotus: Kuyruchuk and Bashkugandy were backfilled.

**Figure 14. Taking out of old asphalt for backfilling of rural streets.**

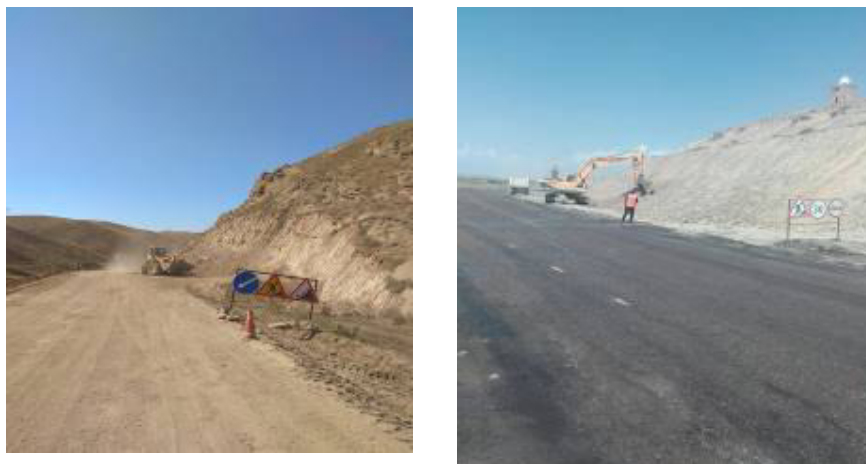
84. During the reporting period, there were not any incidents which resulted in or could have resulted in Community Health and Safety issues. However, the Safety Inspector of Gentek Consult Ltd. issued 9 prescriptions on safety and road safety from which 7 items have been executed. The following road signs are installed at construction site to ensure road traffic safety: - Warning signs – 93 - Prohibitory -59 - Information board – 48 of 90cm by 180cm in size Signal and barrier devices as well (cones, reflecting tapes). Additionally, contractor use flag-men with whistles and signal sticks to ensure road safety activities on project sites as part of Traffic Management Plan.

**Figure 15. Implementation of road safety measures.**
