Environmental Monitoring Report

January – June 2020
September 2020

KGZ: CAREC Corridors 1 and 3 Connector Road Project (Section “Epkin [Km 89] to Bashkugandy [formerly Dyikan] [Km 159]”)

Prepared by Gentek Consulting Muhendislik for the Ministry of Transport and Roads of the Kyrgyz Republic and the Asian Development Bank.

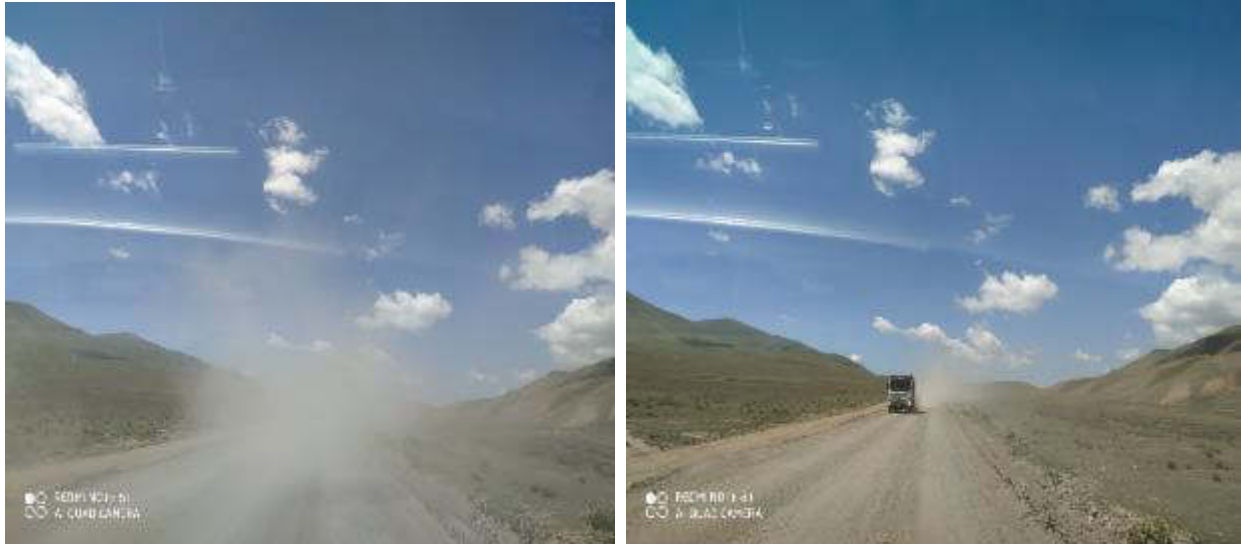
54. Dust formation has a major impact on the environment during earthworks. The increased air temperature has resulted in increased dust formation on the existing road, which is currently on the Contractor's balance. Dust control measures are carried out in the areas with ongoing road construction works. In this regard, the Contractor was instructed to increase the intensity of spraying of the road, including roadsides, at construction sites from 7 am to 7 pm. At present time nine watering machines are allocated for this task, and each of them watering 4-5 times per day. However, dust control measures are still inadequate, increased dust leads to road safety problems, and elevated temperatures lead to water lack in the region and competition with local farmers for access to water. The Contractor was instructed to draw up a road irrigation schedule with a 30 minute interval between irrigations and to open a log to track dust control work. The Safety Engineer of the Consultant recommended to the Contractor to install the Hydrant pump in the places where the watering machines take in water.

Figure 16. Increased dust formation on project sections

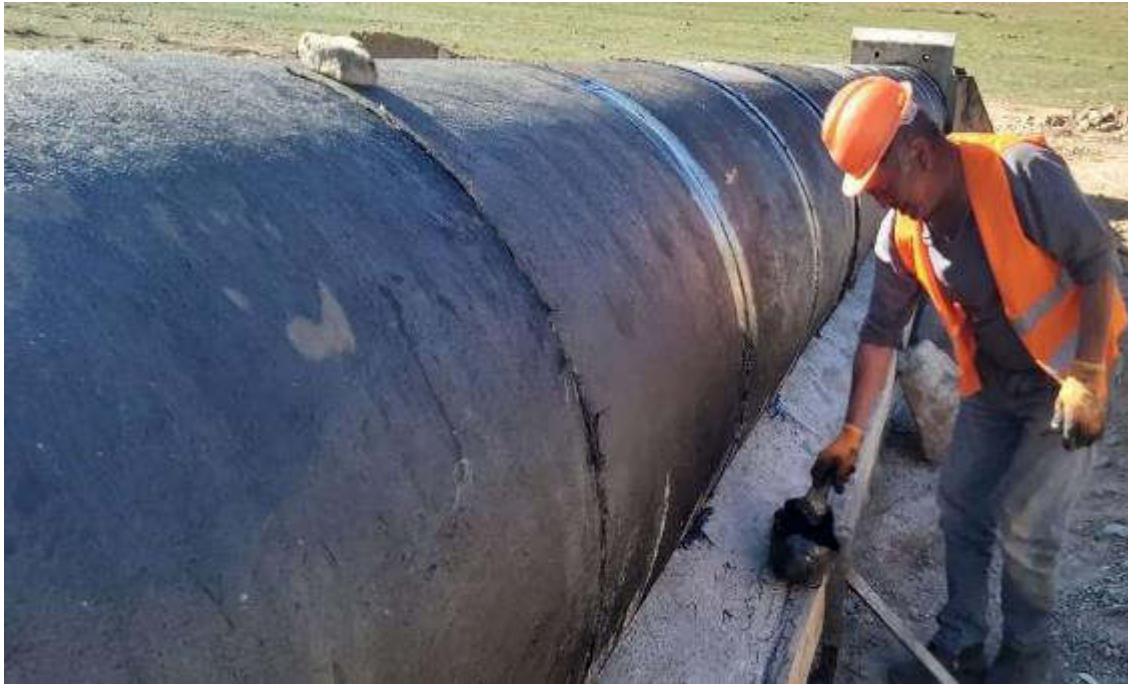
55. A partial impact on the environment during the construction of culverts may be waterproofing with bitumen.
56. Bitumen for waterproofing culverts and bridges is usually melted at the construction site. If the Contractor does not provide dry firewood for these purposes, the workers will have to maintain the fire by burning bitumen or worn out old tires from trucks. As a result, the black smoke generated by this will negatively affect the health of workers and residents of nearby villages.

Figure 17. Waterproofing culverts with bitumen

57. The Contractor was given a verbal warning indicating this issue and it was recommended to conduct an explanatory work with the specialists responsible for waterproofing works.

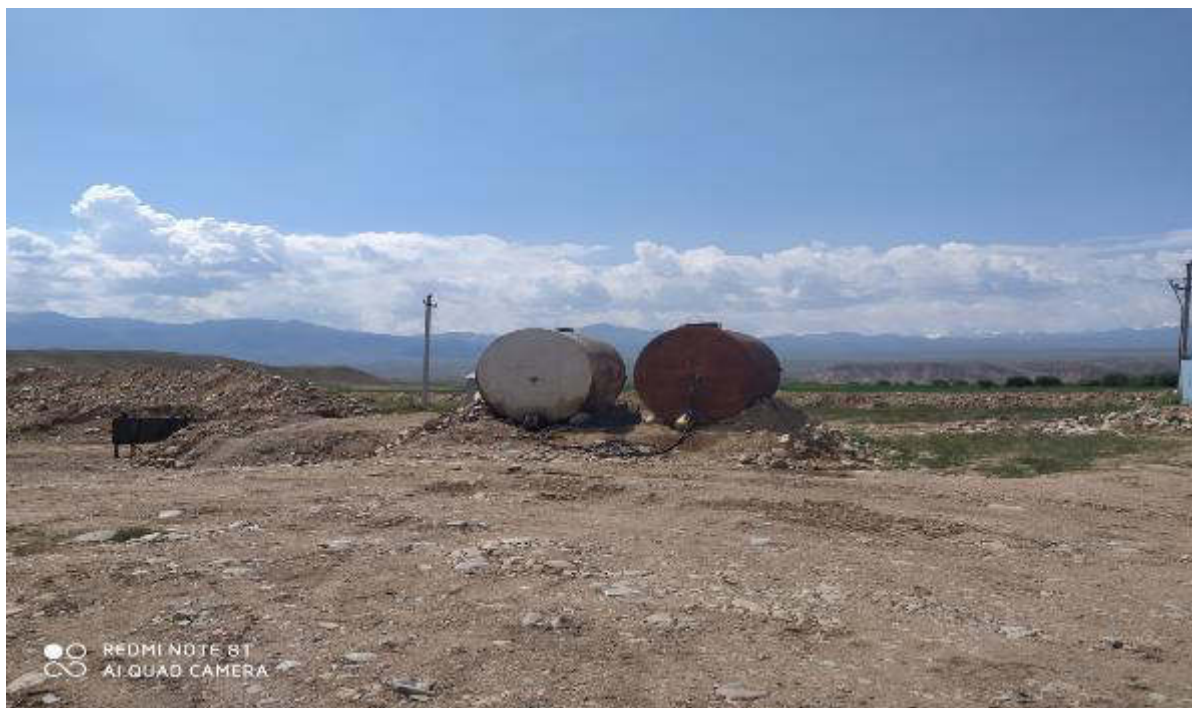
Figure 24. Tanks for fuels and lubricants

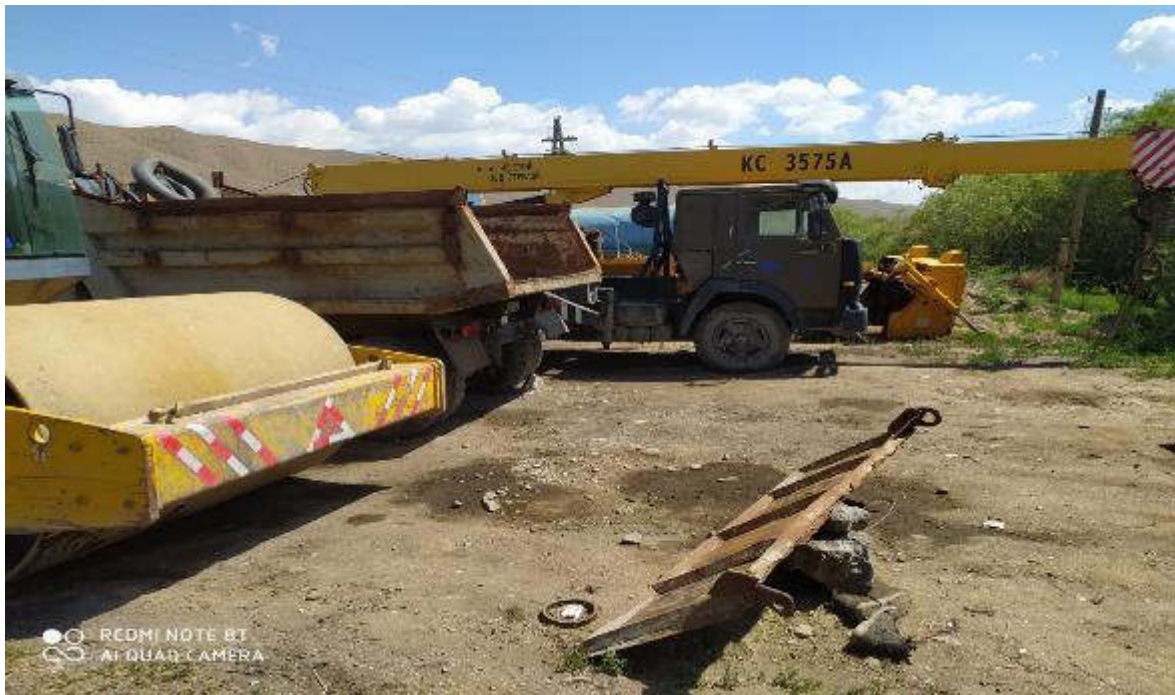
Figure 25. Oil leaks at subcontractor's equipment parking lot

68. Oil leaks from the equipment were found at the parking lot of the subcontractor's heavy vehicles. The Contractor received comments on the detected leaks, which were promptly eliminated (the contaminated soil was removed and taken to a specially designated place).

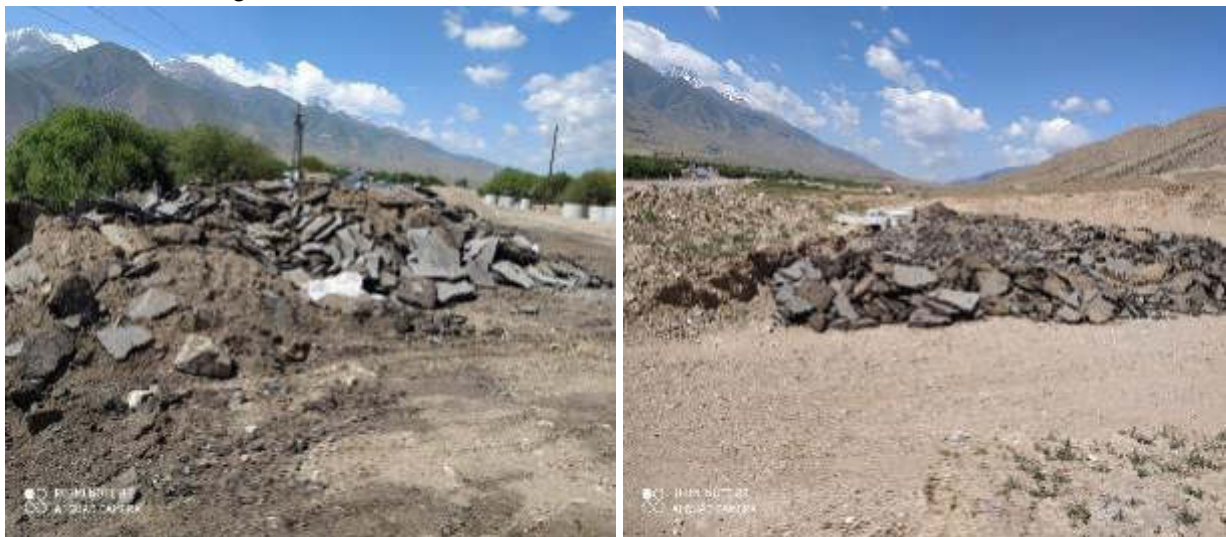
Figure 27. Old asphalt at km 91+600

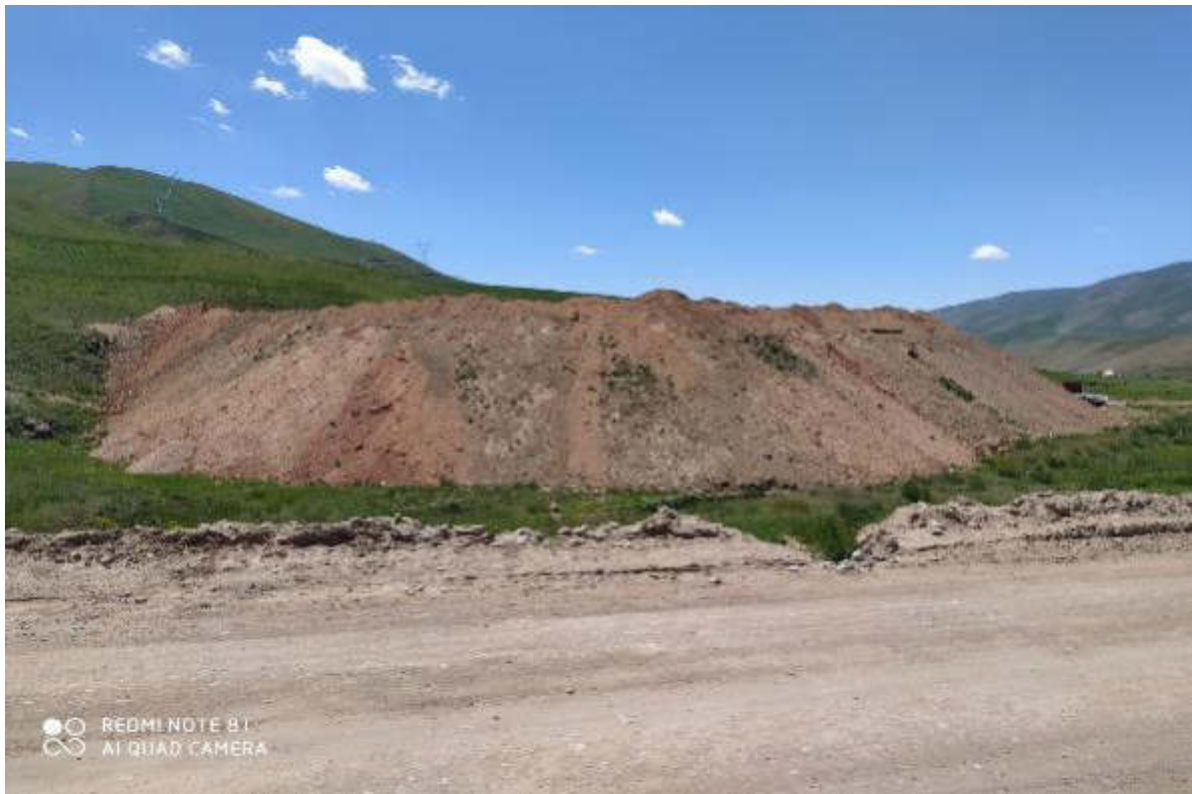
93. A letter was sent to the Bash-Kuugandy aiyl okmotu for storing inert material on a new dump at km 155 + 760, RHS 39 m.
94. At km 112 + 600, the dump was stacked close to the bank of the stream, thereby creating a risk of blocking the river and flooding the bank. In this regard, the contractor was given a written notice not to carry out storage of dumps near the banks of rivers, streams or mudflows in the future.

Figure 31. Dump at km 112+600

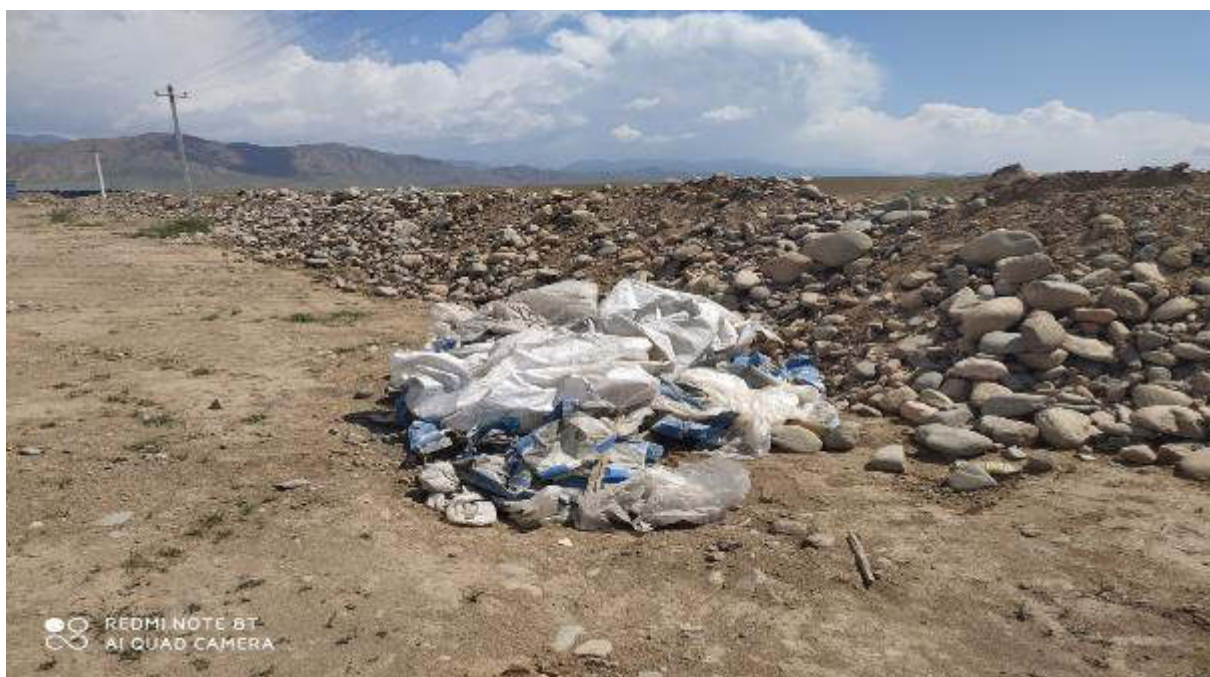
Figure 33. Waste on the production base territory

and hazardous waste in accordance with the Waste Management Plan of the SSEMP and draw up an agreement with local waste collection organizations.

97. Based on the notification, the territory of the production site was cleared of construction waste. All noted violations were eliminated. Separate waste containers were installed. Fire safety measures were taken, fire shields were completed.

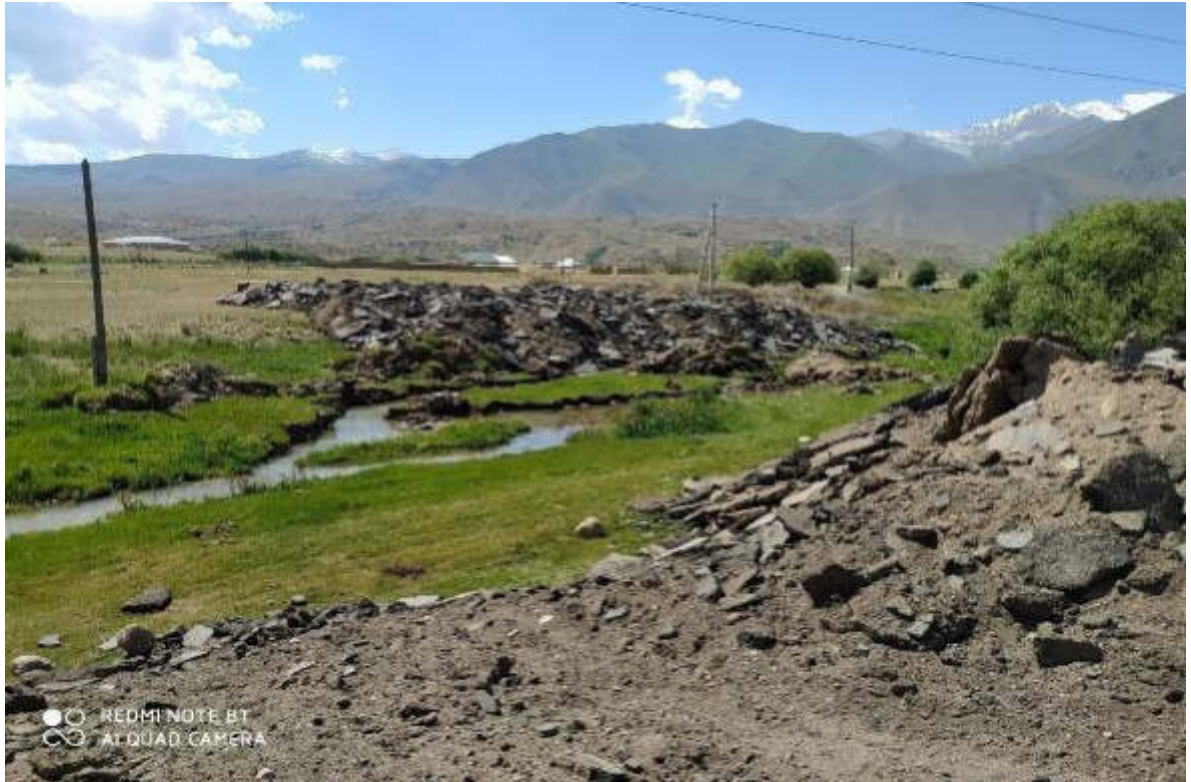
122. The total volume of stripped and removed old asphalt by the reporting period is 6806 m³. According to BoQ the estimated volume of asphalt to be removed is approximately 11,946.71 m³;
123. The stripped asphalt is mainly transported at the request of the heads of aiyl okmotu and local residents for the arrangement of country roads and embankments at private sites. The owners themselves make the leveling of private plots.
124. The recycling of old asphalt is handled by the Contractor's environmental specialist, Nurdinov Nurlan.
125. At km 90 + 100, the stripped old asphalt was transported to a swampy area on the bank of the stream.

Figure 40. Stripped old asphalt transported to swampy area

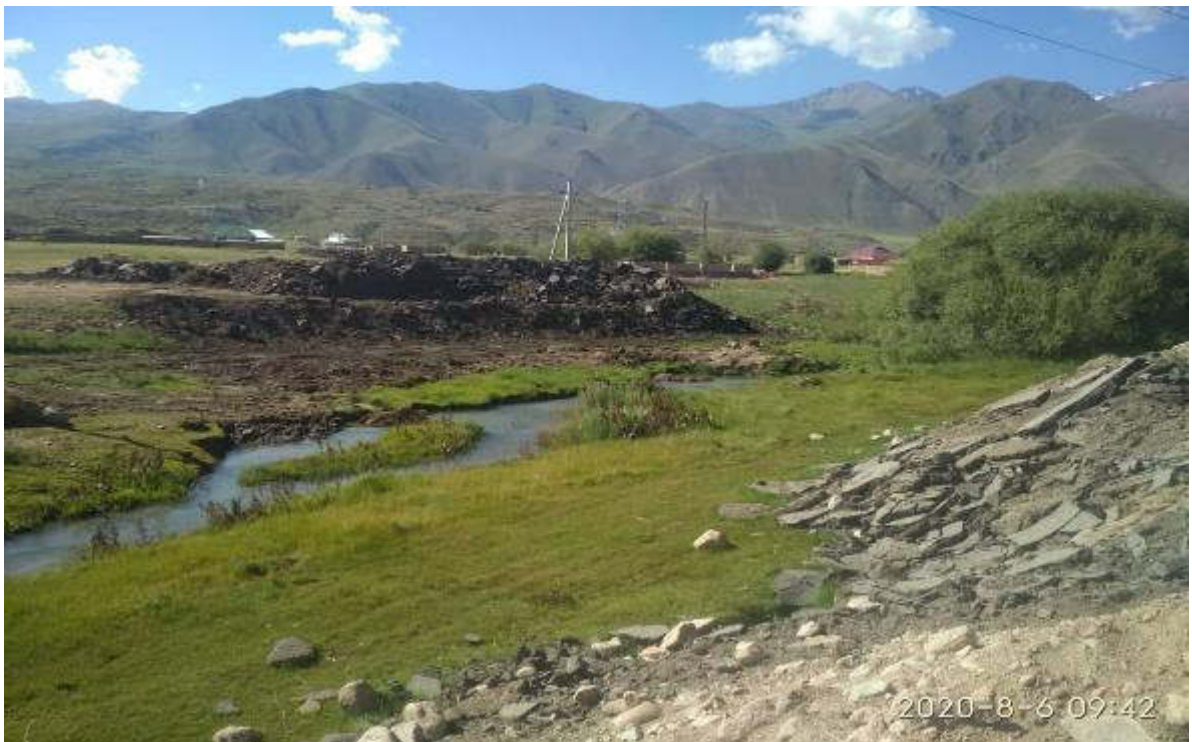
Figure 41. View of the cleared area from the old asphalt

126. Upon written notification from the Consultant, the Contractor removed the old asphalt and cleared the site.

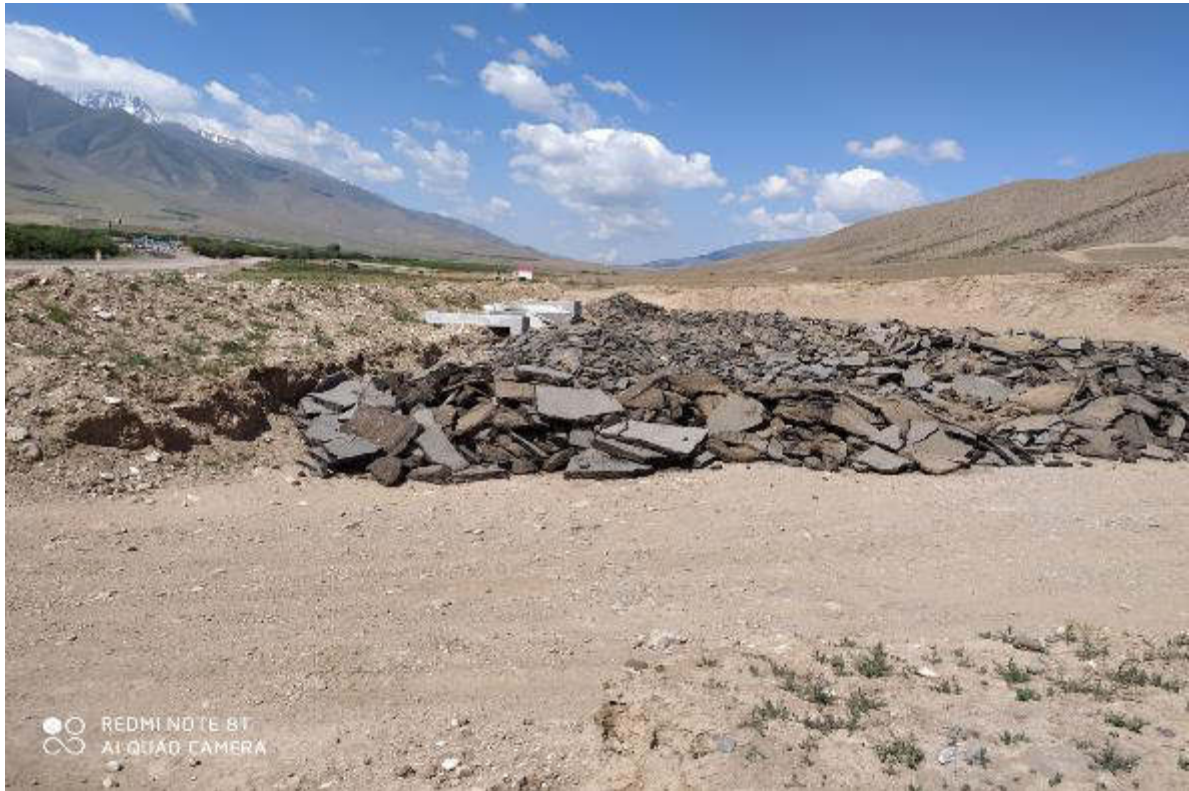
128. At km 91 + 360, the stripped old asphalt was stored on the territory of the quarry

Figure 42. Old asphalt at km 91+360

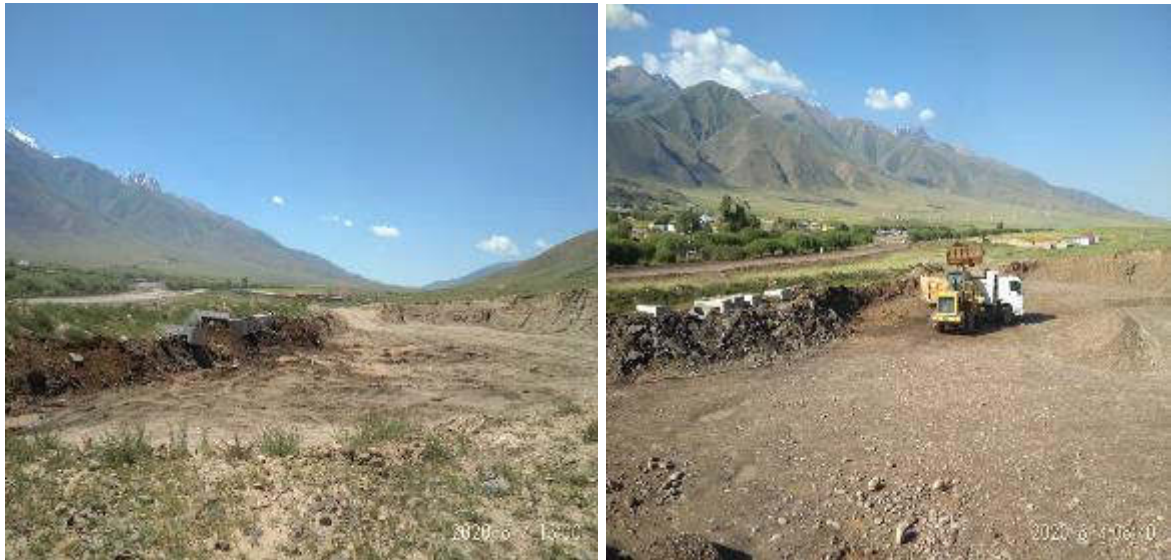
Figure 43. Old asphalt removed and cleared at km 91+360

129. Later, the old asphalt in this area was taken out to fill the roads of Ak-Chiy v.

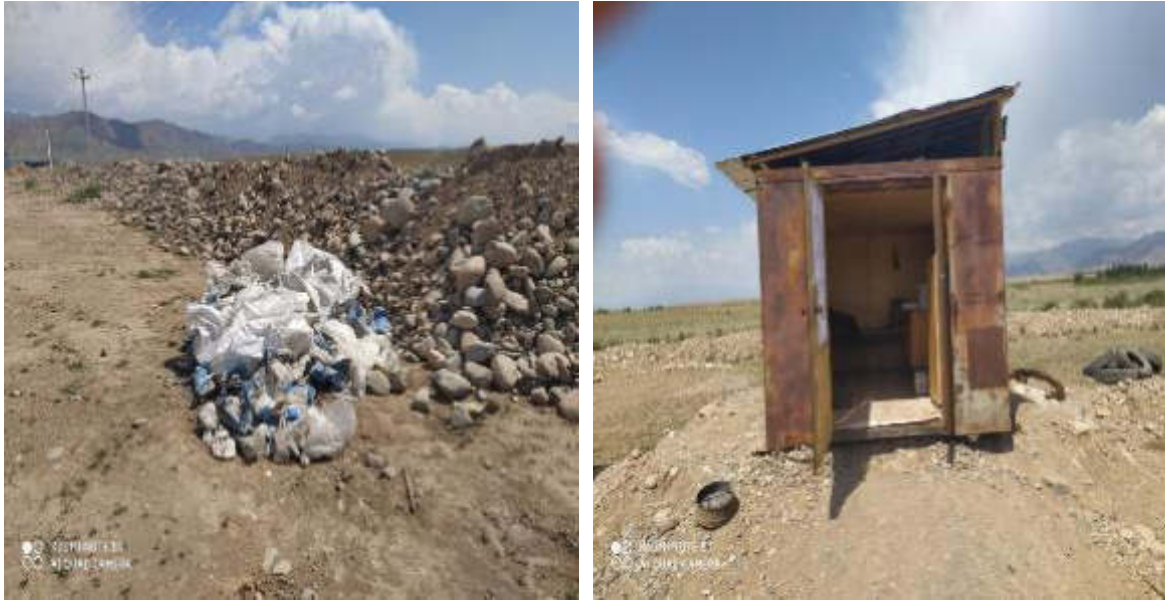
Figure 44: Waste at the contractor's site, cement bags and scattered old truck tires near the checkpoint

134. Following remarks and written notification from the local environmental specialist, these discrepancies were corrected by the contractor:
- fire shields were completed;
 - containers were organized and marked;
 - an agreement was drawn up with the Tugol-Sai aiyl okmotu on waste disposal;
 - household and construction waste was removed;
 - bottom of tanks for fuels and lubricants was concreted;
 - the territory of the construction base was cleared of oil spills and removed;

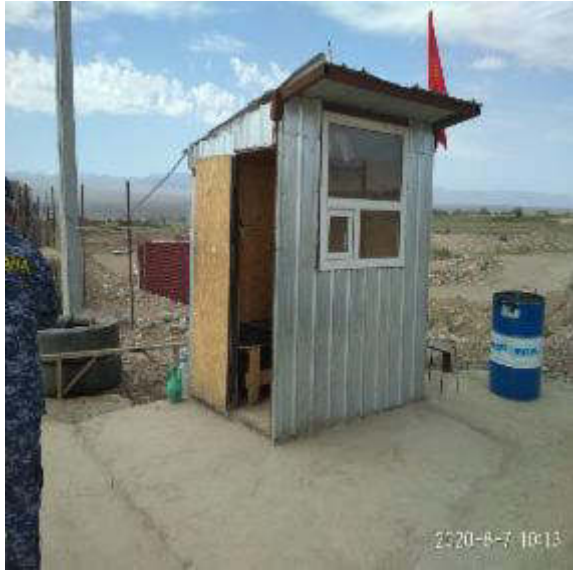
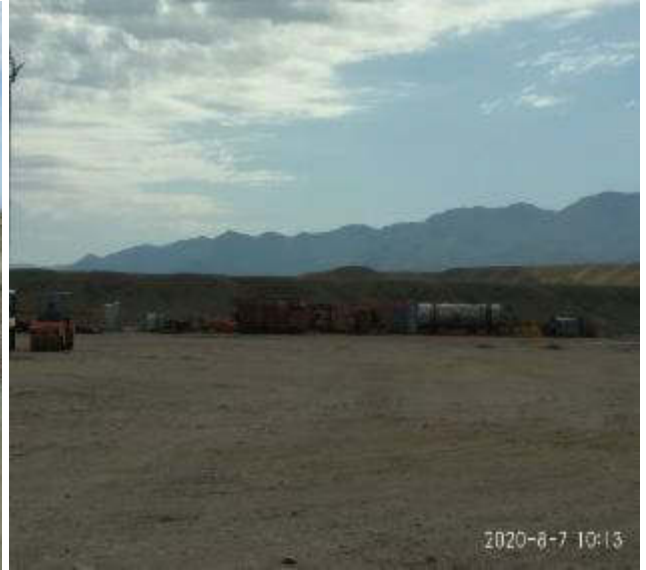
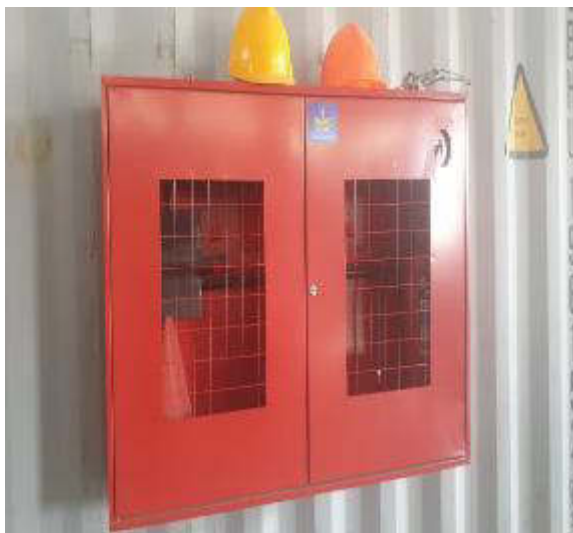
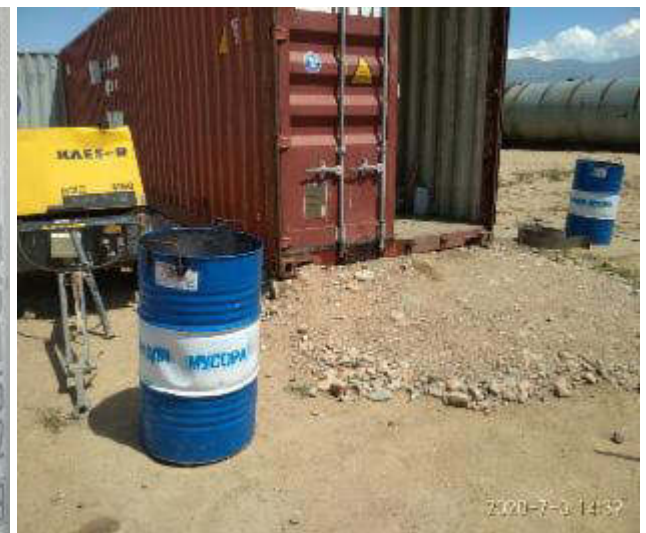
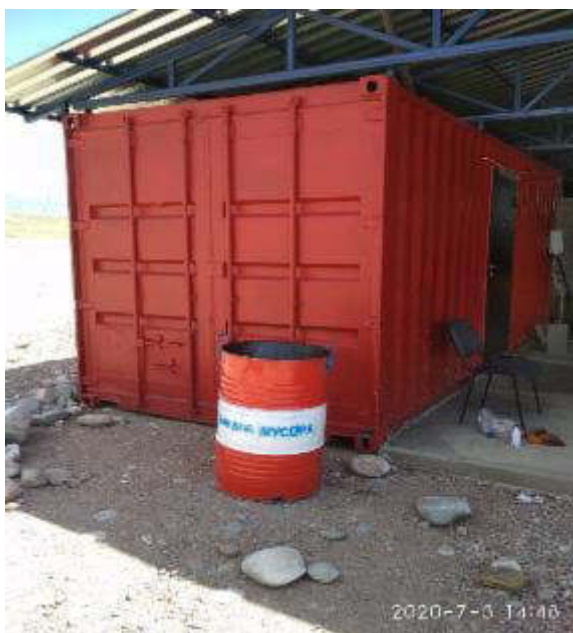
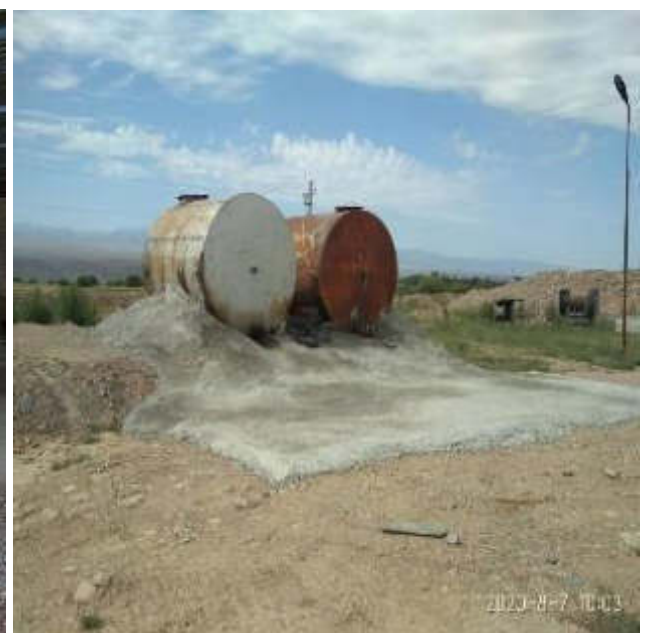
Figure 45. Fixed inconsistencies
