Environmental Monitoring Report

Project Number: 48424-002
Semestral Reporting: January–June 2021
August 2021

Kazakhstan: CAREC Corridors 1 and 6 Connector Road (Aktobe–Makat) Reconstruction Project

Reporting period: January–June 2021

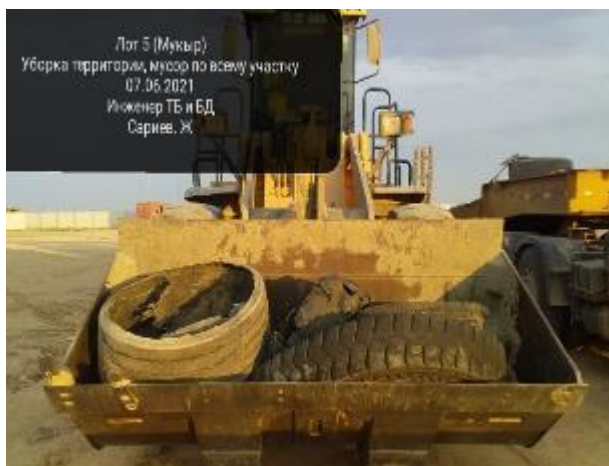
Picture 1. Tyres removal from the project road to the temporary storage on Lot 5, 07.06.2021

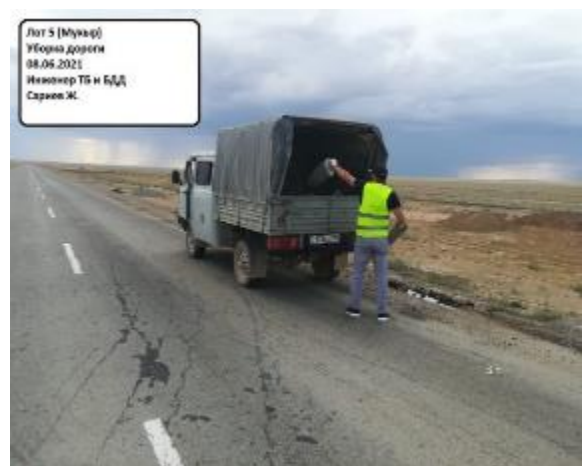
Picture 2. Waste collection from the project road to Lot 5, 08.06.2021

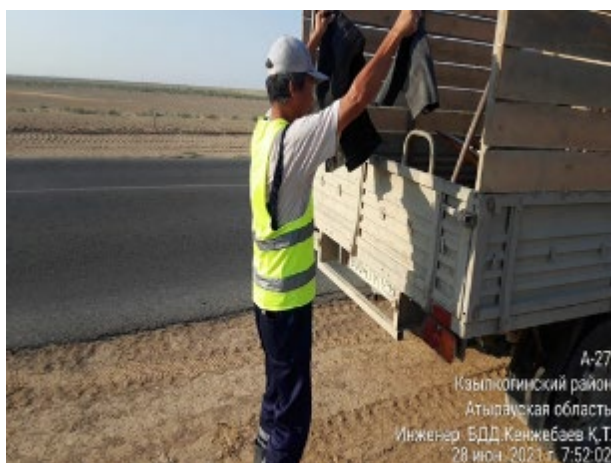
Picture 3. Waste collection from Lot 6 site
28.06.2021

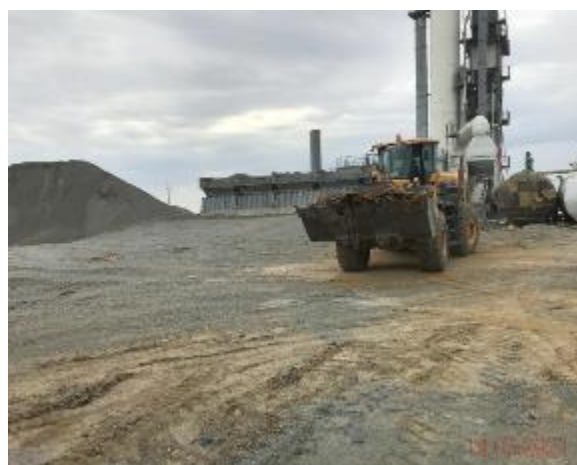
Picture 4. Solid waste removal from the temporary storage on Lot 4, 14.05.2021

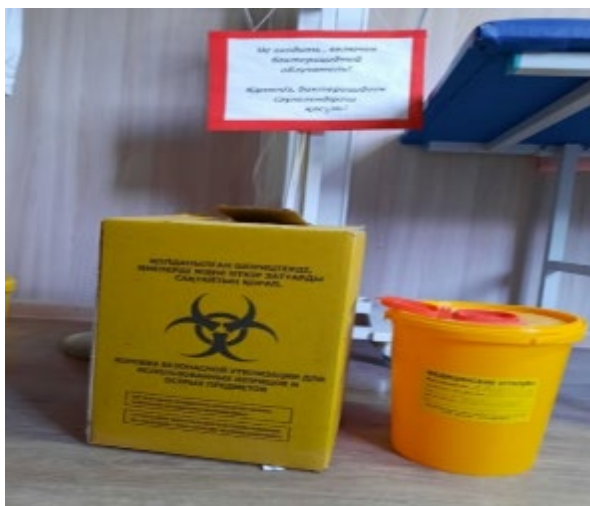
Picture 7. Lot 7, temporary storage of medical waste for subsequent removal for disposal, 12.04.2021

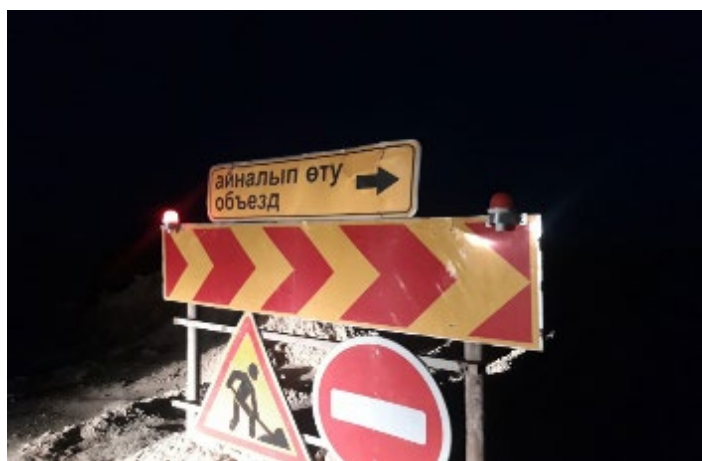
Picture 9. At PK 100+00, Lot 6. View of road safety sign at night time

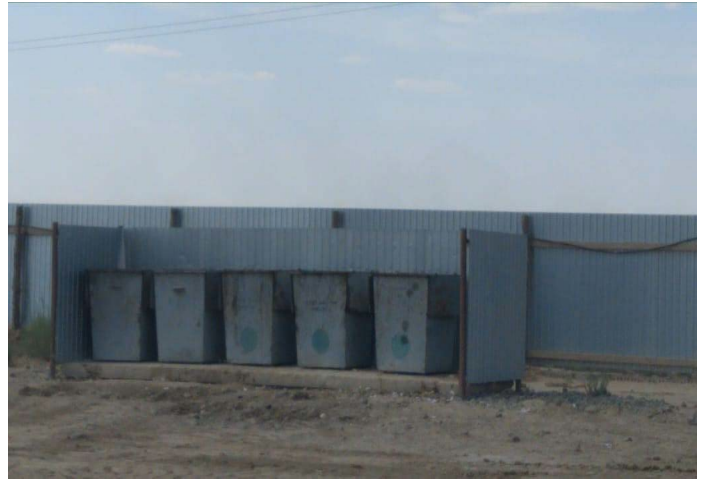
Solid waste storage place, Lot 6, April 2021

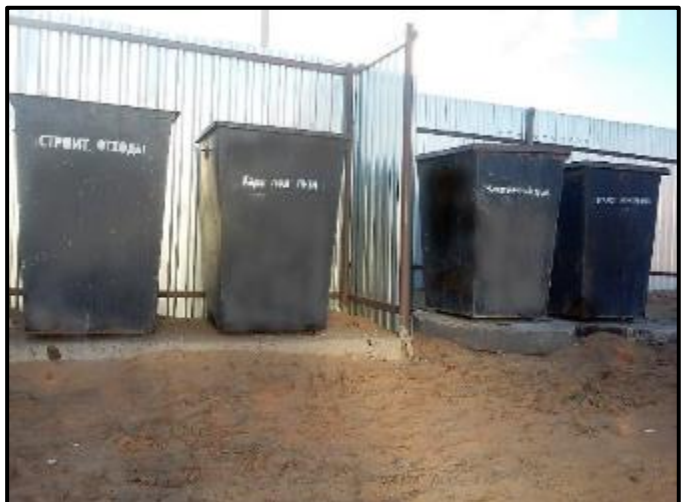
Temporary storage place for solid waste, Lot 7 base camp ,
May 2021
