Environmental Monitoring Report

Annual Report

January-December 2019

L3284-ARM: Seismic Safety Improvement Program

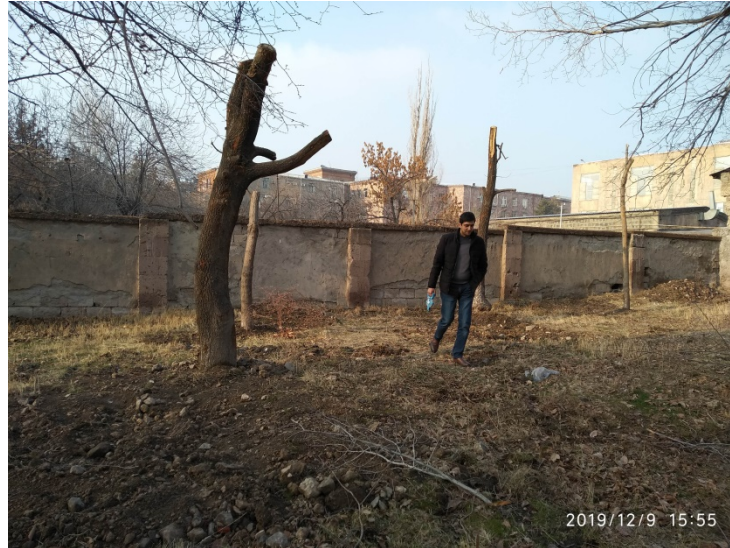
51. During the reporting year, trees were successfully replanted at “Heratsi” school site. The growth and viability of the trees are monitored during each site visit.

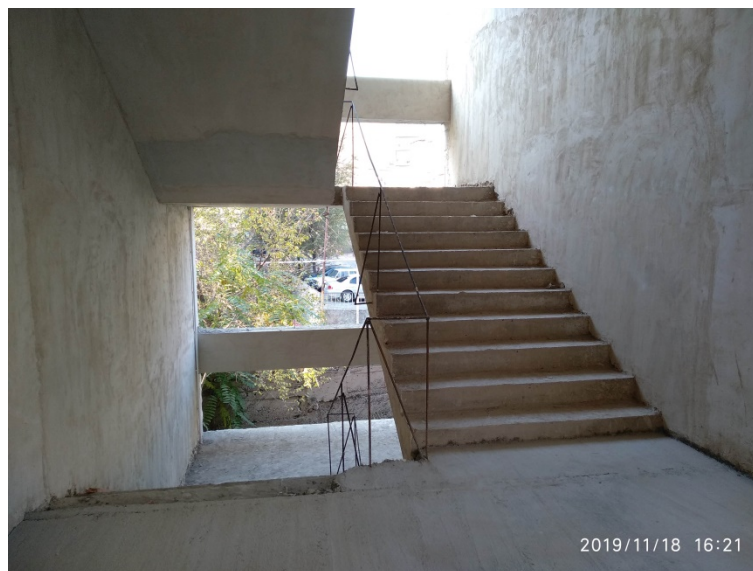
52. Temporary safety handrails were implemented around the newly built staircases to avoid falling risks in school buildings.

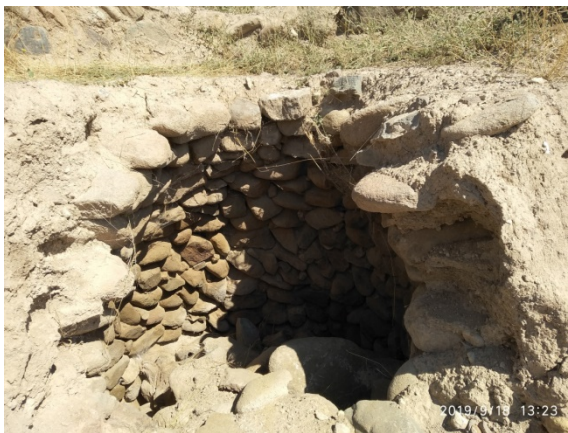
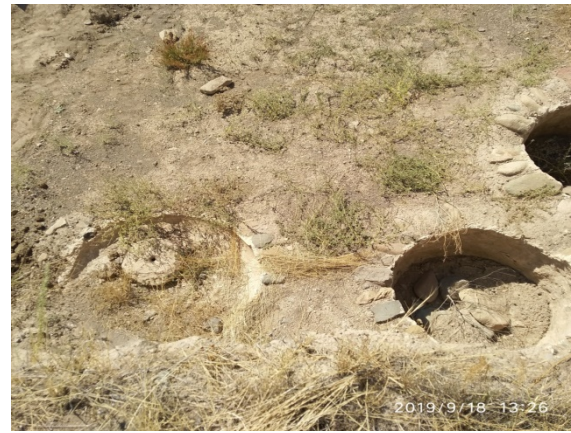
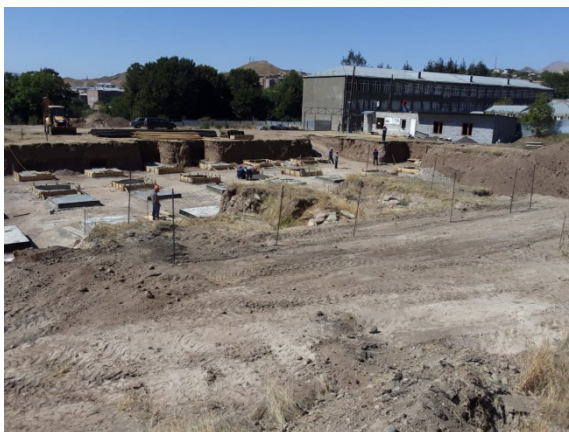
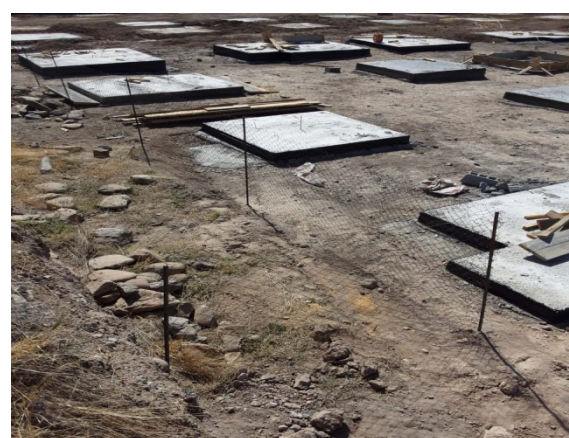
53. In the scope of preservation of archaeological values opened at Yeghegnadzor No 2 school site, a working group was formed to inventory the state of archaeological values at the beginning of construction works. A working group was formed by the representatives of the following entities: the Ministry of Education, Science, Culture and Sport (MoESCS), administrative division of Vayoc Dzor Marz, ATDF and contractor. The initial state of the archaeological site was recorded with photos and signed by the members of the working group. A temporary metallic net was implemented around the archaeological site by the contractor to ensure the site's initial state preservation until the conservation design is developed. The works related to the design of archaeological site conservation are coordinated by the MoESCS as earlier decided by the GoA.

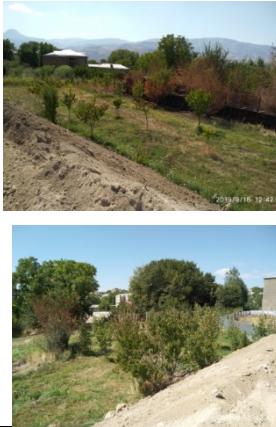
All activities	1.	Person in charge on environmental/ health & safety management is appointed and is present on-site	Yes Ashot Asatryan- site manager	JV of “Europe” and “Bideg” LLCs		
Management measures						
All activities	2.	Any use of land outside the school footprint including camps and parking sites is excluded	Yes	JV of “Europe” and “Bideg” LLCs		
All activities	3.	Tree cutting is implemented in accordance with permission. Other trees and vegetation are properly protected	Yes

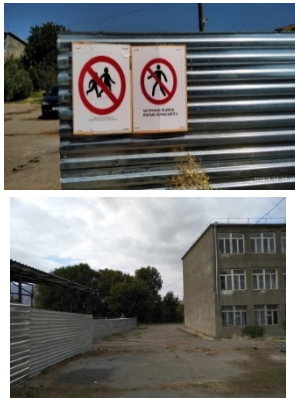
JV of “Europe” and “Bideg” LLCs		
Health & safety						
All activities	4.	Warning signs, fencing and exclusion barriers erected around all open pits and work site areas	Yes

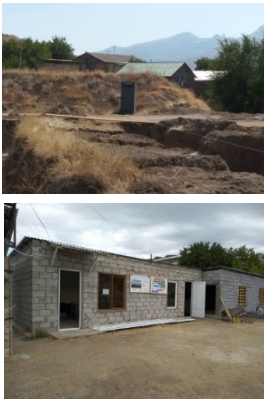
JV of “Europe” and “Bideg” LLCs		
All activities	10.	Sanitary-hygienic conditions for workers are provided: drinking and washing water supply, mealtime utilities, toilets, rest time, etc.	Yes

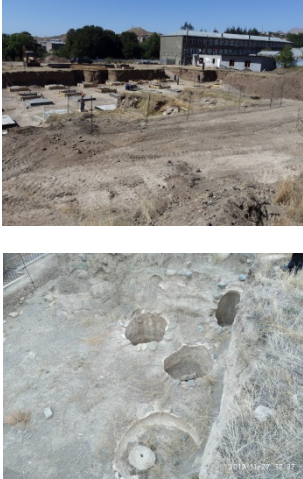
Use of territory	42.	SMP for the site use is available	Yes	JV of “Europe” and “Bideg” LLCs		
Use of territory	43.	The use of the site is in accordance with SMP	Yes	JV of “Europe” and “Bideg” LLCs		
<i>Cultural heritage preservation management</i>						
<i>All activities</i>	44.	The cultural heritage opened on-site is preserved until its conservation design/plan is completed	Yes
