Environmental & Social Monitoring Report (July to September 2014)

Project Number: 44914

PAK: Patrind Hydropower Project

Prepared by Star Hydro Power Limited

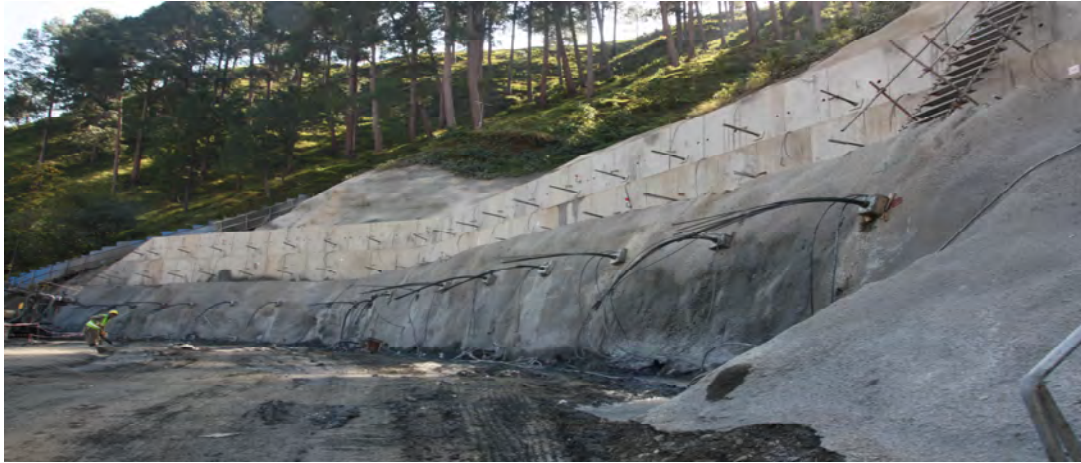
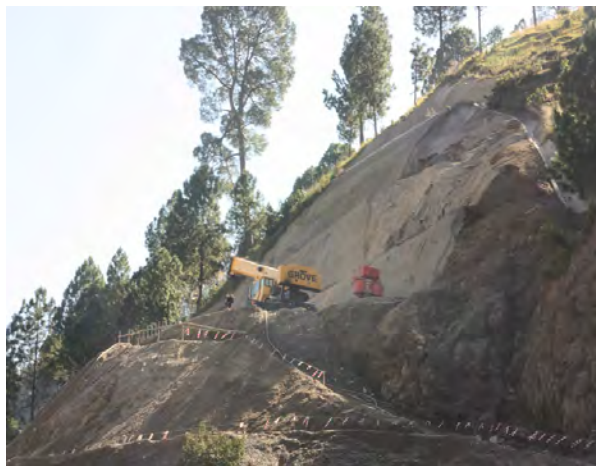
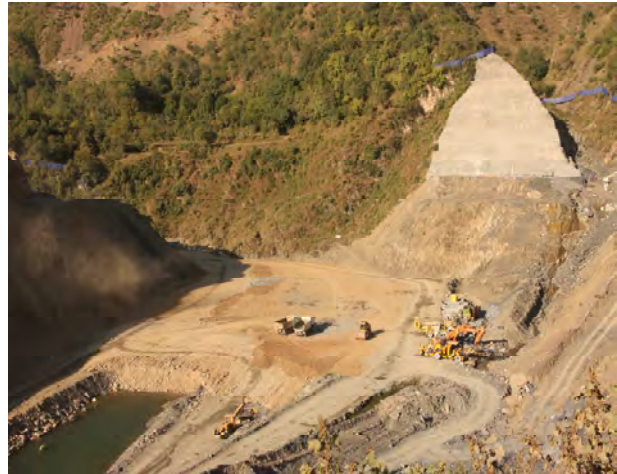
Slope protection works on both sites

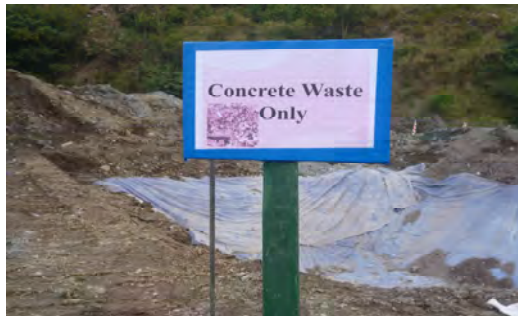
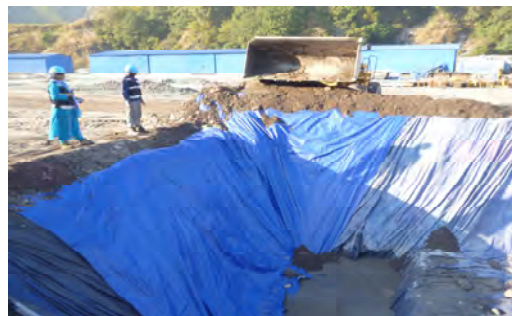
New trenches established for concrete and solid waste with proper lining

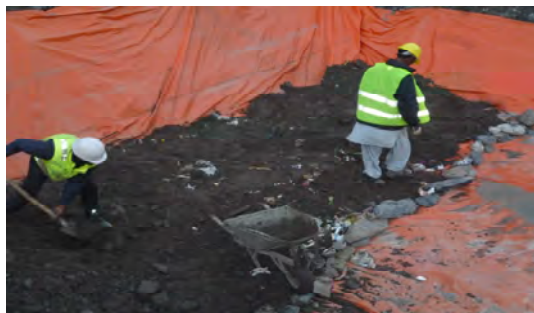
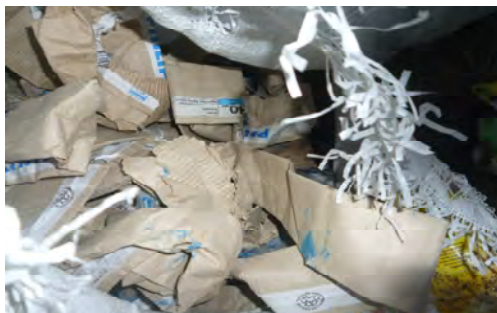
Soil Compaction has been done

Cardboards segregated from the Waste

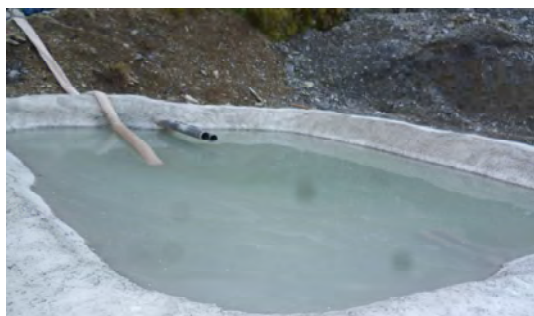
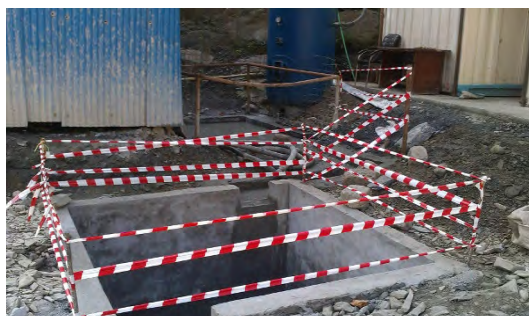
- HRT waste water sedimentation/treatment tank was damaged at upper site which has been reconstructed. Whereas, at lower site new settling chambers and tanks have been established to treat the waste water before entering in river. Overtopping (rarely) due to delayed cleaning has resulted into downstream water contamination.

Newly developed settling tanks to treat HRT waste water at weir site

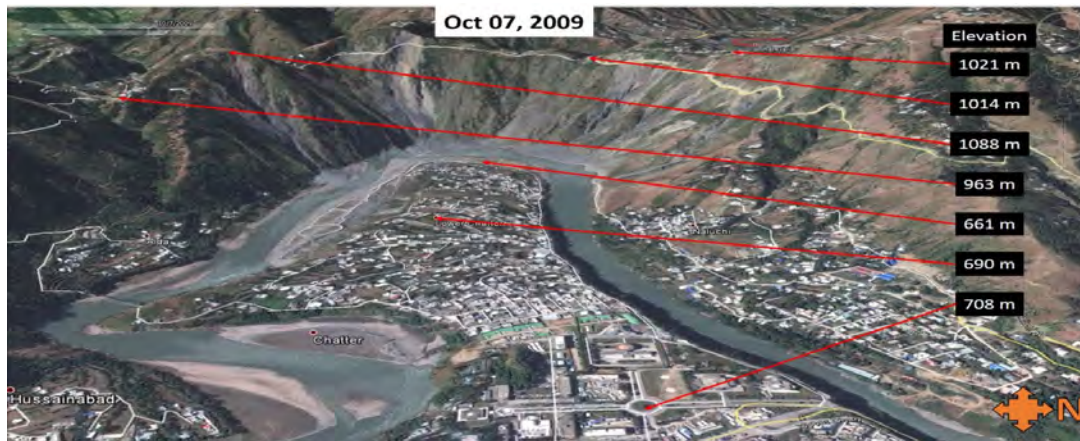
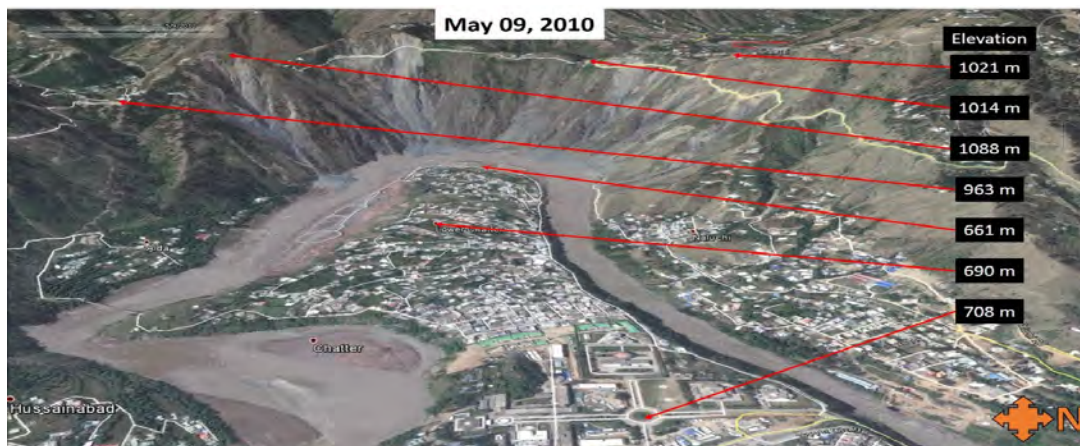
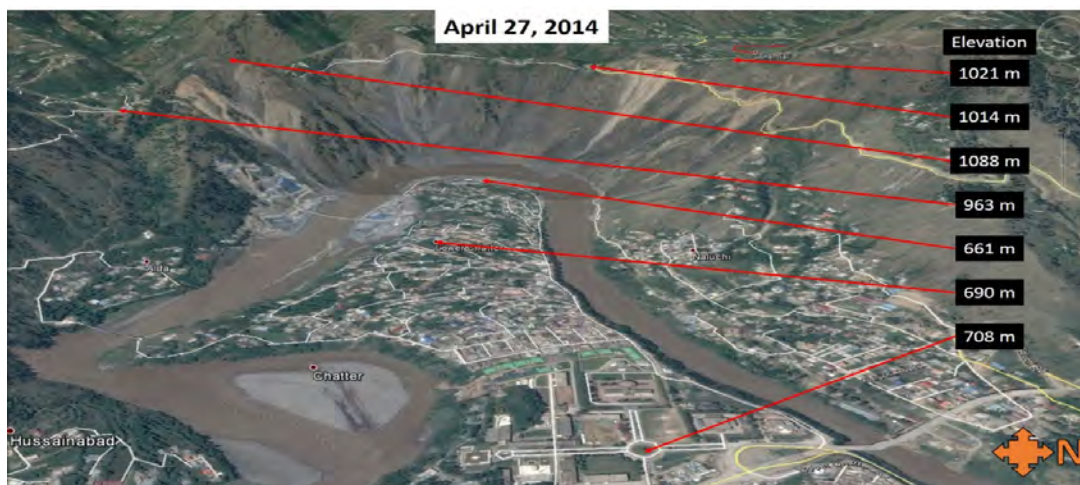
The increase in landslides area for the post few years, showing a very slight change in landslide activity except one massive landslide triggered right at the head of under-constructed power house site.

The following images show the changes in the landslide area through time

To manage and mitigate the potential impacts of landslide hazard, massive close spacing plantation of fast growing trees and appropriate engineering measures are recommended to mitigate the landslide hazard in future. There is a need to establish proper drainage pattern to reduce the instability of the area. Monitoring of slope movement and ground-water levels are required to assess potential movement of landslides. Discontinuing the landslide slope through terracing. Provision of cut off drains to divert the flow towards the natural course.

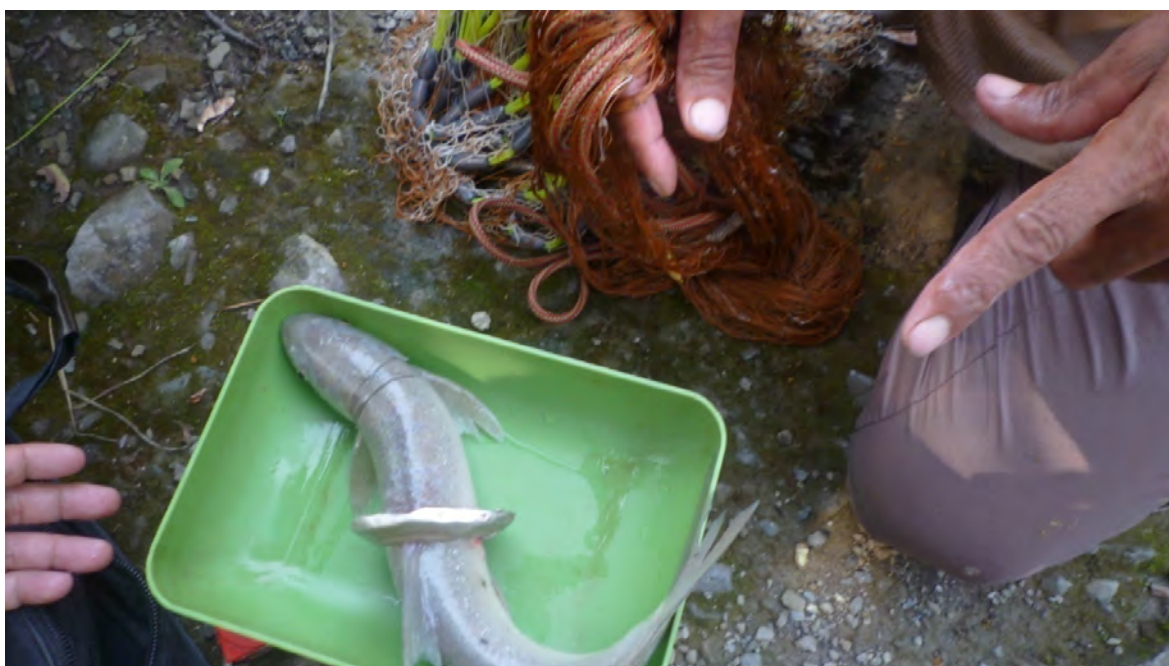
Fig: Fish encircled by a tin ring causing injury

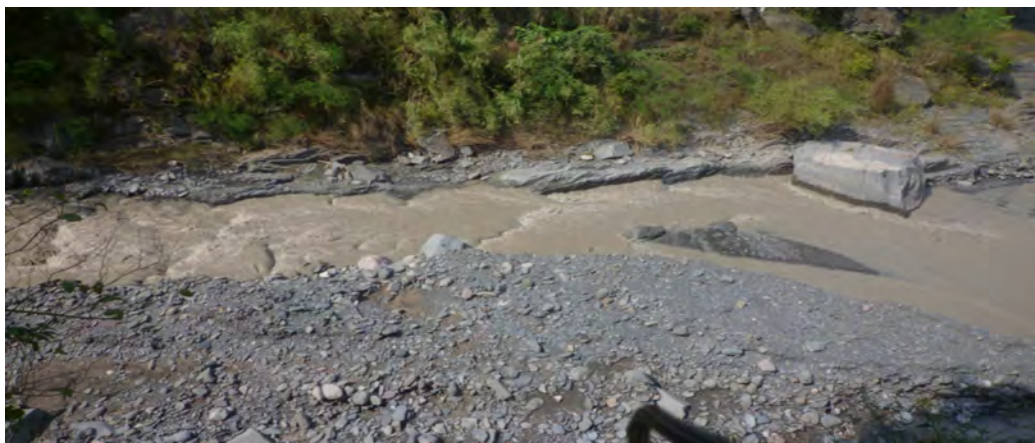
Fig 4. Turbid water of Nallah Boi

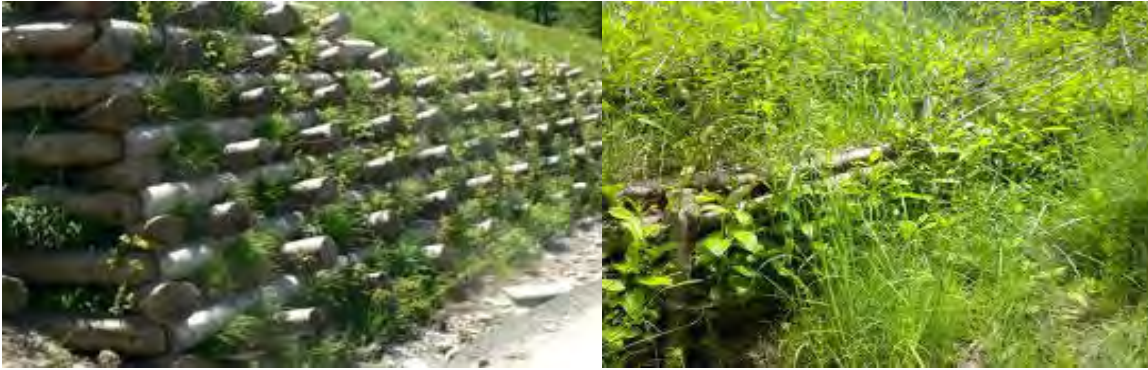
Fig: Bioengineering structure showing control of erosion
