Initial Environmental Examination

Cambodia: National Solar Park Project

**Hydrological Study
Preliminary Study**

APPENDIX VI: ENVIRONMENTAL AUDIT OF EXISTING FACILITY (GS6)

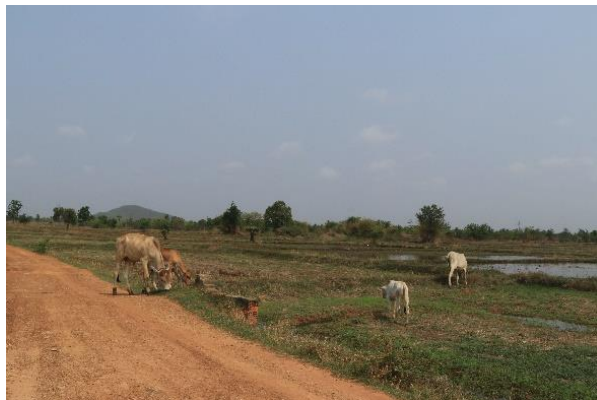
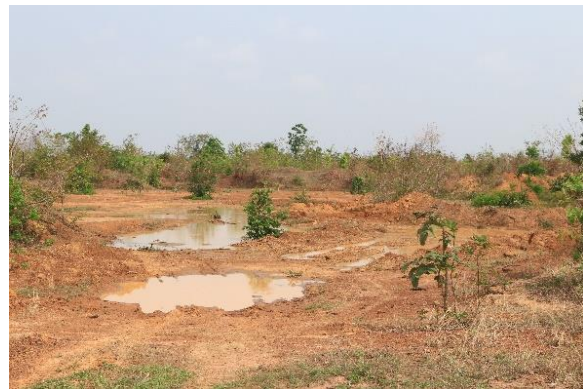
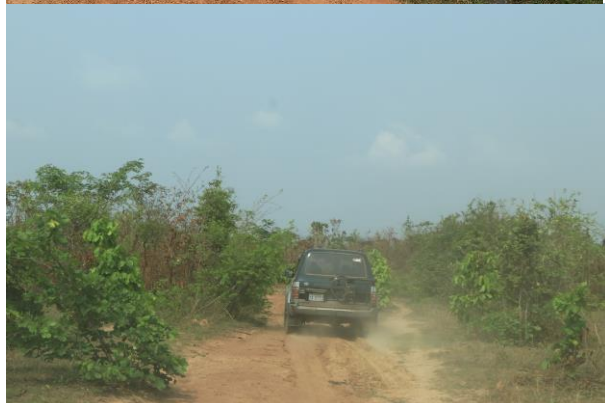
Figure 4 Pictorials Condition of Site 5

Site 5 is considered as a site among the two pre-selected sites. The site is located in the southern of Thpong commune, Amlang District, Kampong Speu Province (See figure 3). By Road N132, the site is approximately 40km from Chbarmon Town of Kampong Speu province. The administration map is seen in the figure 3 below. The site has an area above 1,300ha. The site is mainly covered by 70% of shrubland and the remaining are paddy rice and villages. The topography at the site is ranged from ± 92 to ± 77 m based on google earth. Access road to the site area was built with laterite material. Based on field surveying on the existing layout; borrow pits activities were found, and it is clearly seen that site 5 is covered by laterite layer. The figure 4 below presents the imagery of site 5 conditions.

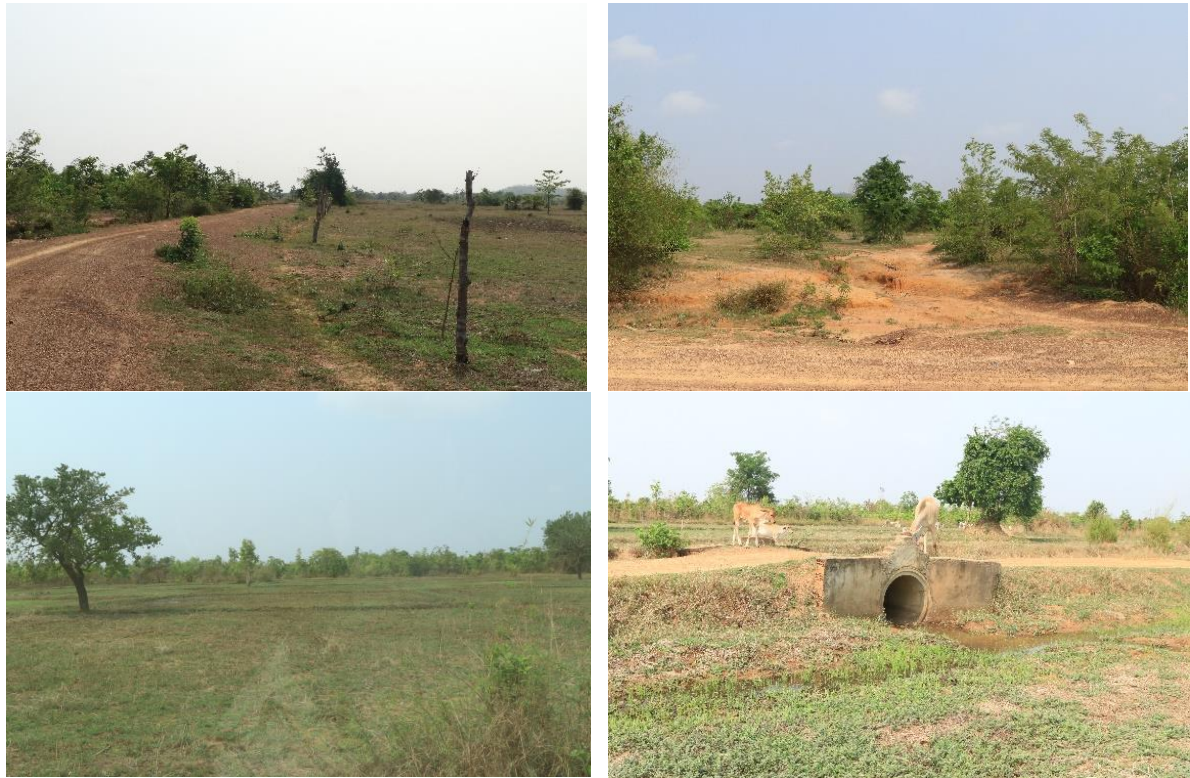
Based on the site observation, the natural stream at the site area was not found during site visiting. It was clearly seen that the drainage is in poor condition and small capacity where it was built along the laterite access road. The figure 5 below displays out the hydrological and drainage system for site 5.

Figure 5 Pictorial of Hydrological and Drainage system for Site 5
A stream drains out the water from the site basin which is located out of the setup boundary of the study area (see figure 6). It connects to a reservoir at the lower part of the site by a drainage

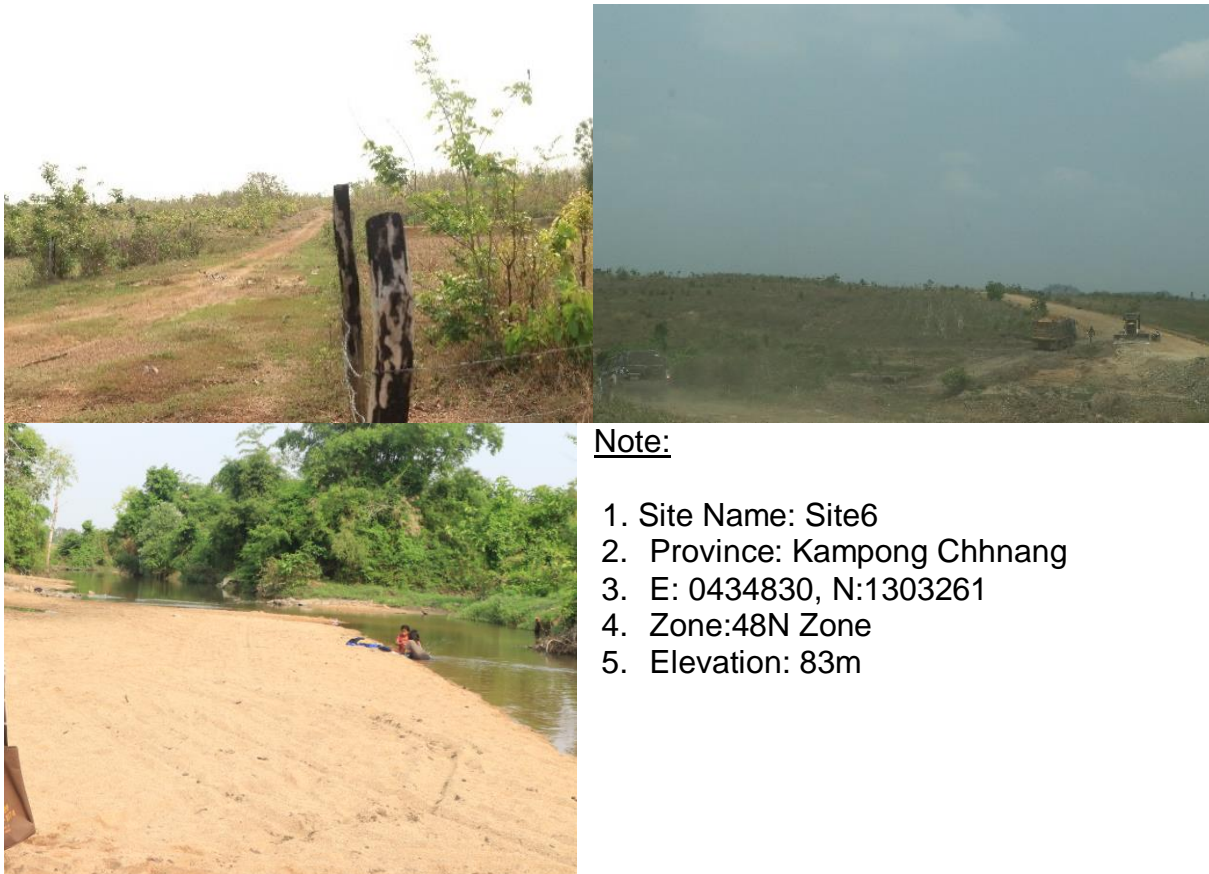
Figure 8 Pictorial Condition of Site 6

Site 6 is contemplated as another option site for the solar power voltaic plant, where it is situated at the high topography. The topography of the site is ranged from $\pm 100\text{m}$ to $\pm 80\text{m}$ based on google earth. It is based in major part of Kbal Teouk commune, Teuk Phos district and another part is in Chhean Laeung commune, Sameakki Mean Chey District, Kampong Chhnang Province. The administration boundary is clarified in the figure 7 below. The site is situated northward to the Site 5 about 6km. It is roughly estimated by field surveying and observing on google earth imagery; that the site is covered by 70 % of open area and 20% by shrubland and water body. The figure 8 below shown the condition map of site 6.

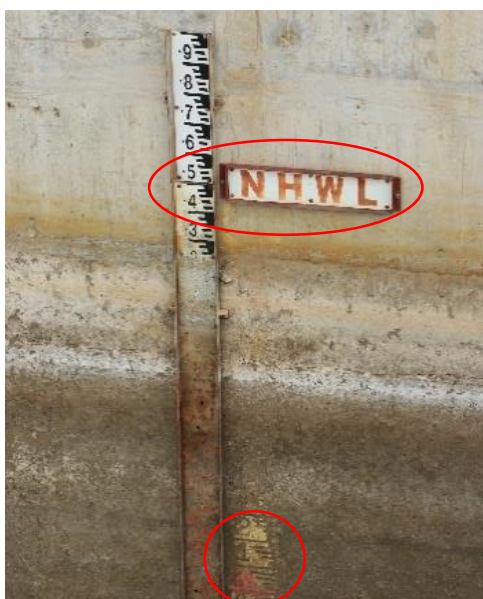
Figure 12 NHWL at the dike

The reservoir has the area of 479km², it allowed to construct hydropower with the capacity of 170 kW (see figure 11). It was noted by water level mark on the water level guage that the water level stored in the reservoir was not reached to the NHWL of 69.5m (see figure12).

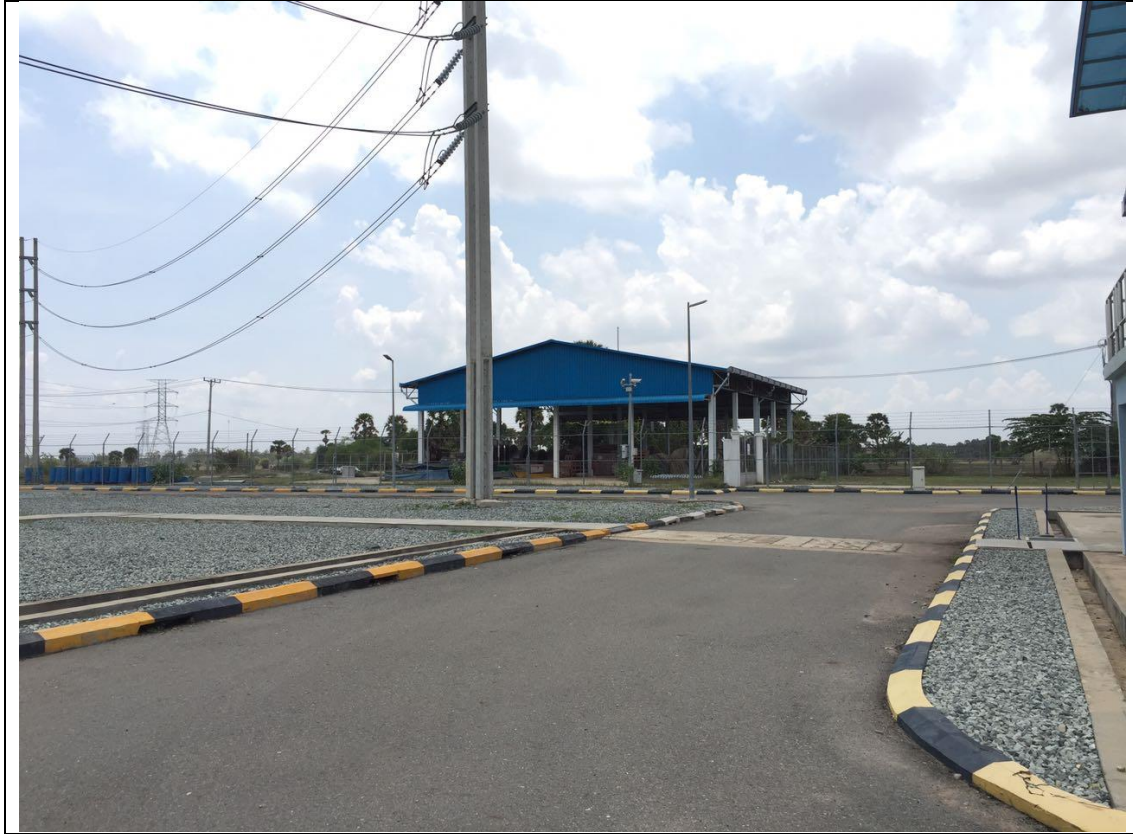
12. **Drainage.** For rainwater runoff, the substation has an existing lined drainage (L 500 m x W 2 m x D 1 m approx.); the drain connects to an outlet at the substation periphery with final rainwater discharge to the adjacent open field. At the time of the site visit, the drain was dry.

Existing road and rainwater runoff drainage at GS6

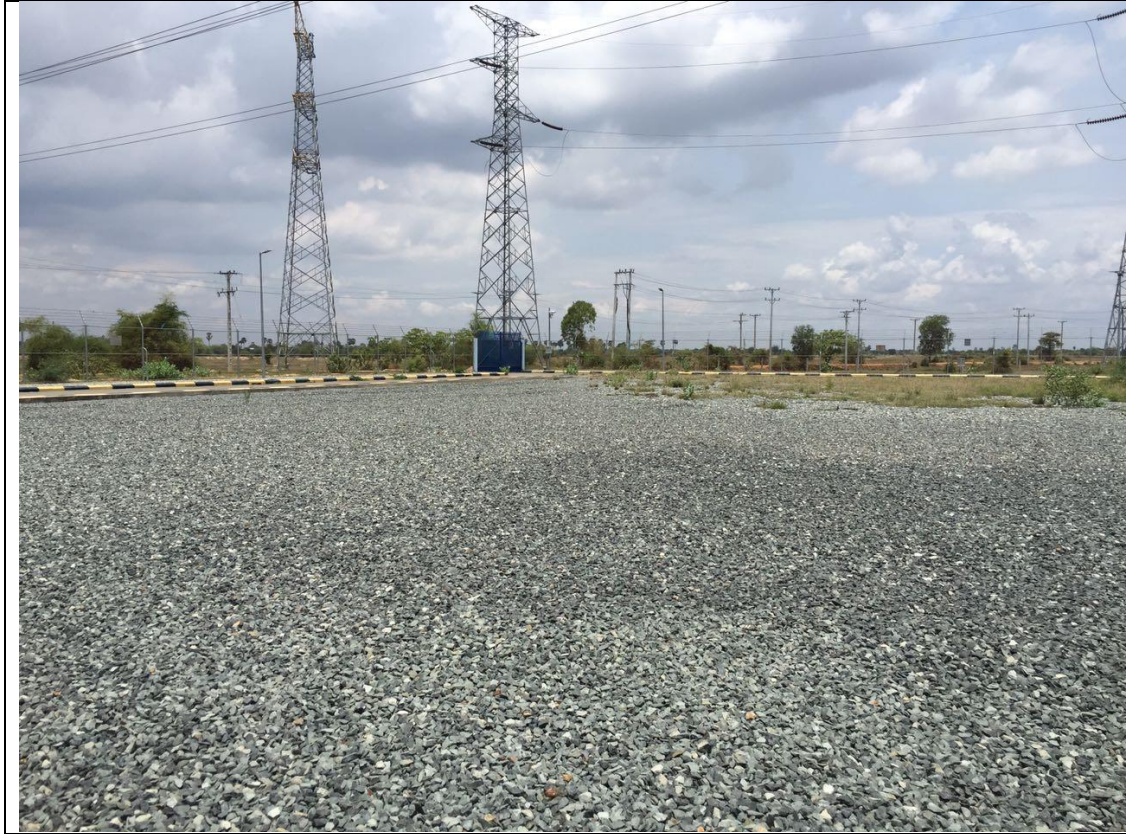
Area proposed for two new bays and switchgear

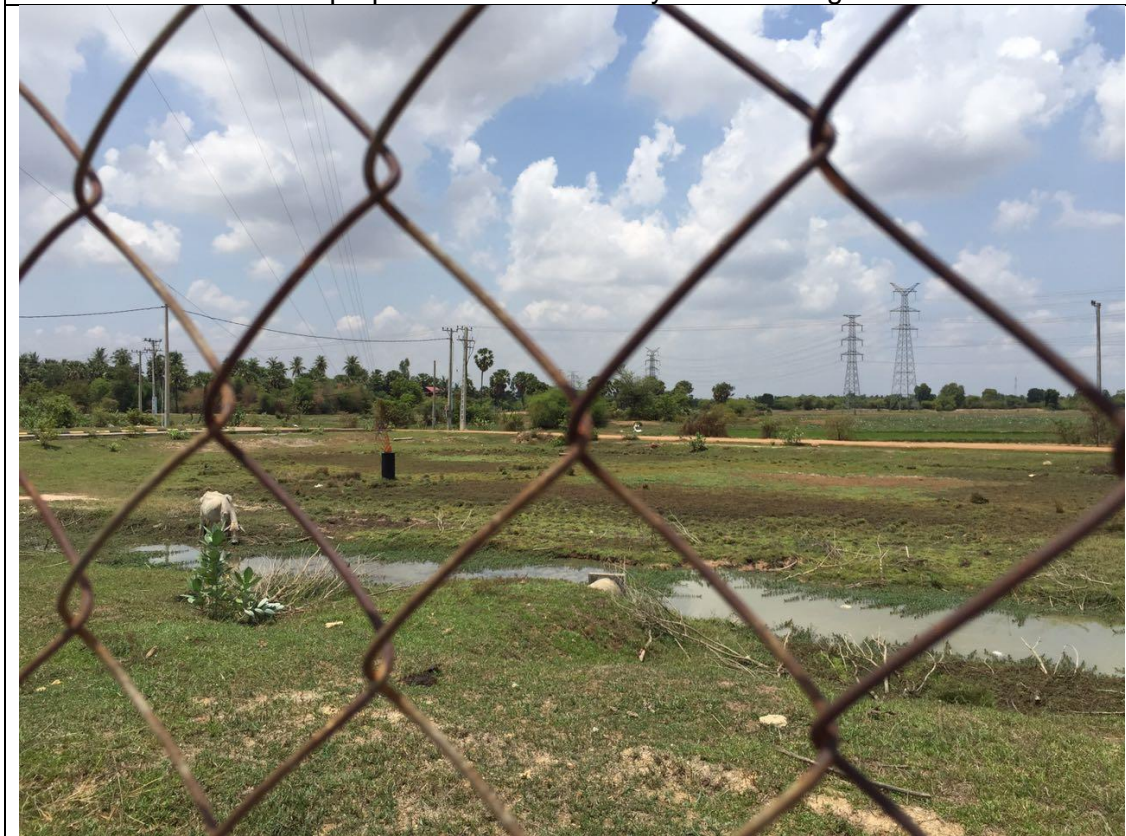
Area adjacent to the GS6, where the main drain discharges offsite
