Environment Monitoring Report

Project Number: 35354-013
December 2015

PRC: Lanzhou - Chongqing Railway Development Project

Environmental Monitoring Report

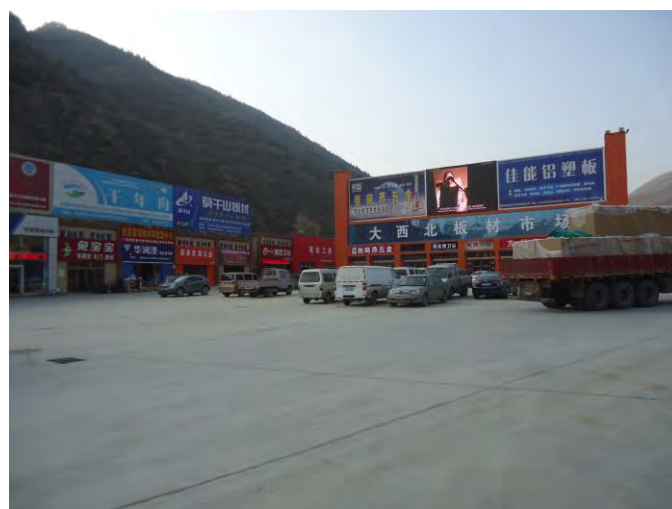
Photo 2. The spoil grounds of Taoshuping 2# tunnel by China Railway 21th Bureau Group Co., Ltd. have been locally developed and used to build the commercial operation site.

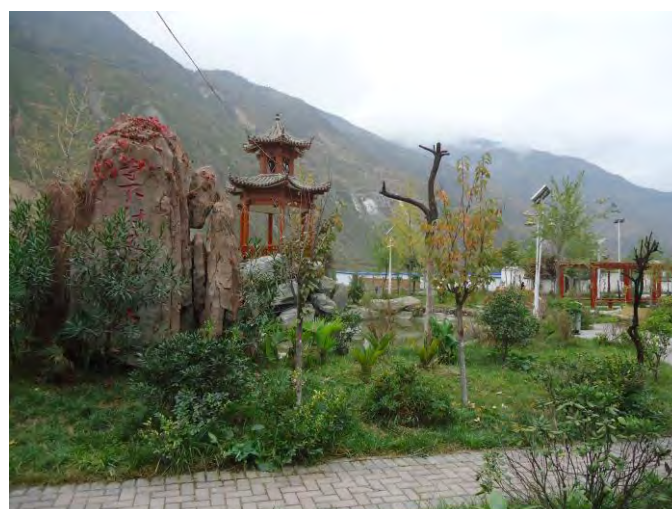
Photo 3. The spoil grounds at the exit of Huama Tunnel by China Railway 13th Bureau Group Co., Ltd have been locally used to build to be Shixia village cultural square.

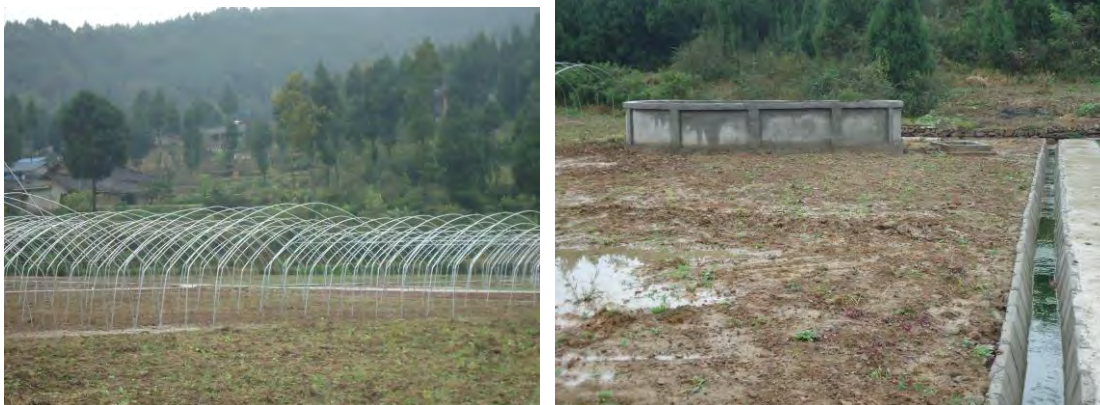
Photo 4. The spoil grounds at the exit of Minglingguan Tunnel by China Railway 18 Bureau Group Co., Ltd have been built the retaining walls and the drainage ditches, after the completion, they have been locally built to be mushroom breeding bases and the farm irrigation system has been established.

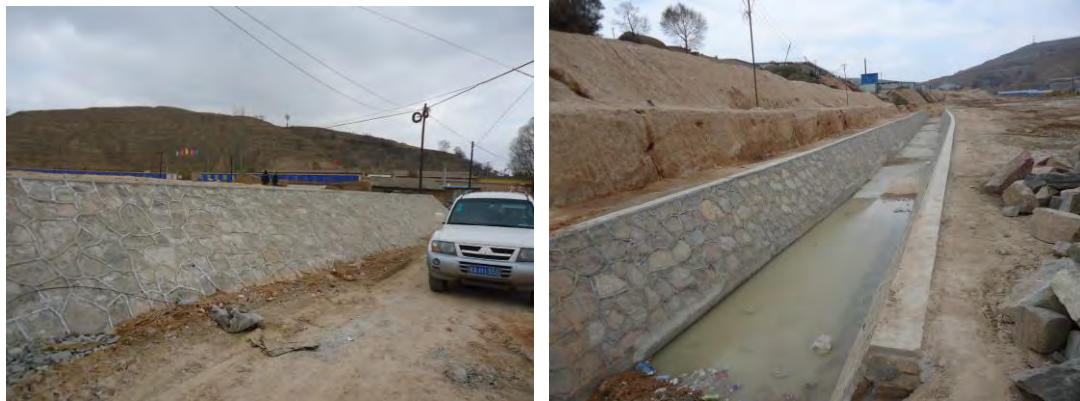
Photo 5. The retaining wall and the spillway for spoil grounds along the Donggu Road by China Railway 19th Bureau Group Co., Ltd. have been built.

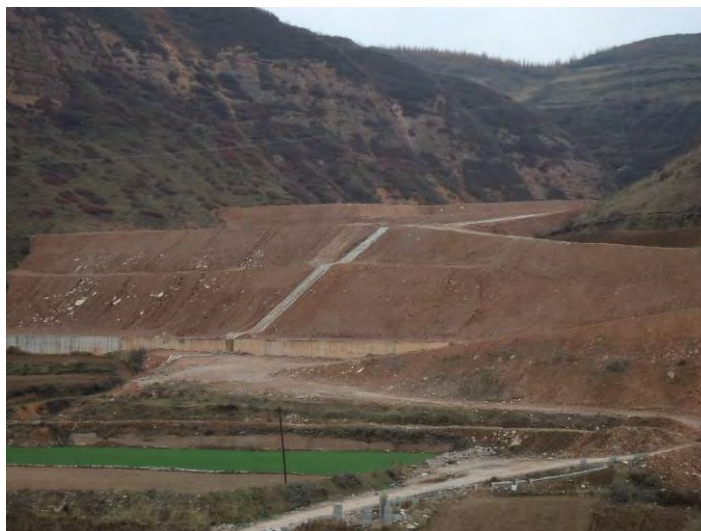
Photo 6. The retaining walls for spoil grounds at the exit of Shouyangshan Tunnel by China Railway 16th Bureau Group Co., Ltd. have been built and the rectification for surface of the drainage ditch has been completed.

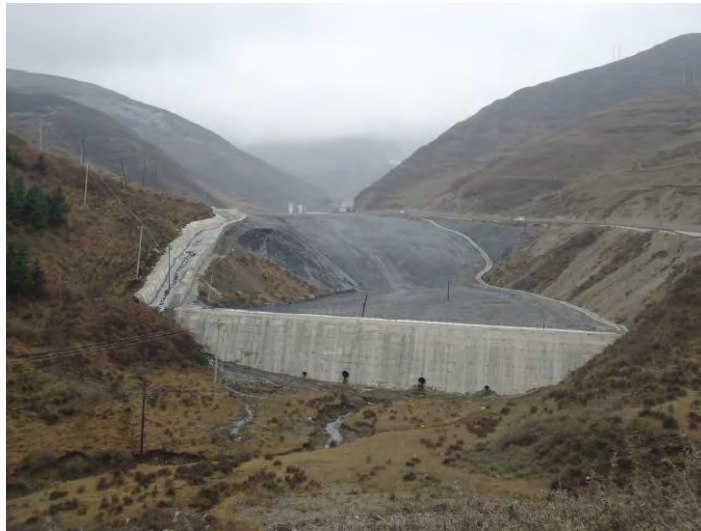
Photo 7. The blocking dregs dam and the drainage ditch for spoil grounds of Daping Track by China Railway Tunnel Group have been built.

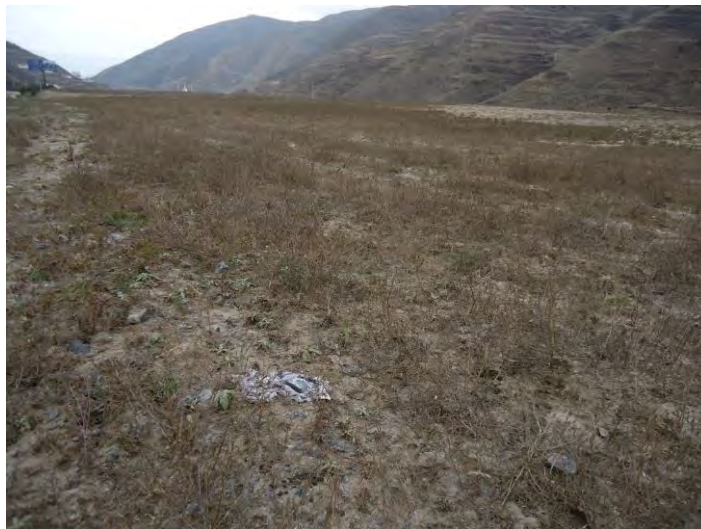
Photo 8. The Luzha newly added spoil grounds by China Railway Tunnel Group have sent forth the vegetation.

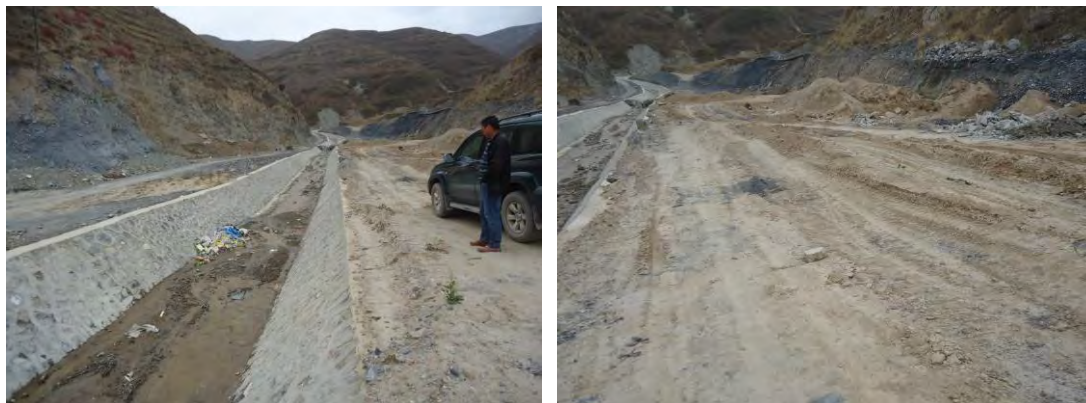
Photo 9. The built drainage ditches for spoil grounds at the entrance of Zhifang Tunnel by China Railway 7th Group Co., Ltd. have been covering with the soil.

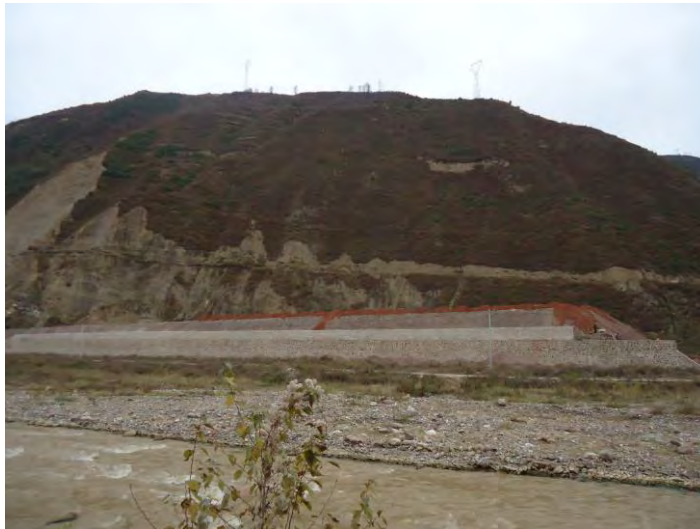
Photo 10. The retaining walls along the river for spoil grounds of water carrying ditch of Xinchengzi Tunnel by China Railway 11th Group Co., Ltd. have been built and the intercepting dikes built along the foot of a mountain have been covering with the soil for recovery.

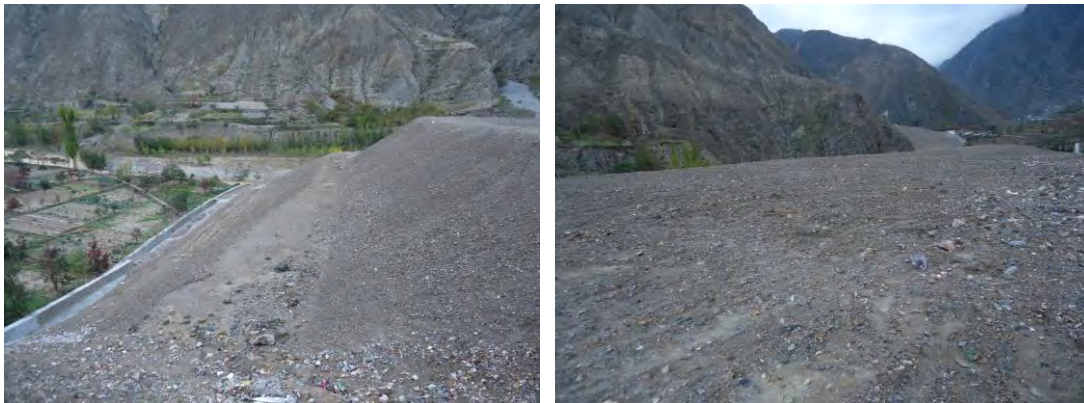
Photo 11. The rectification for 2# spoil ground at the exit of Tianchiping Tunnel by China Railway 13th Bureau Group Co., Ltd. has been completed and being covered with the soil.

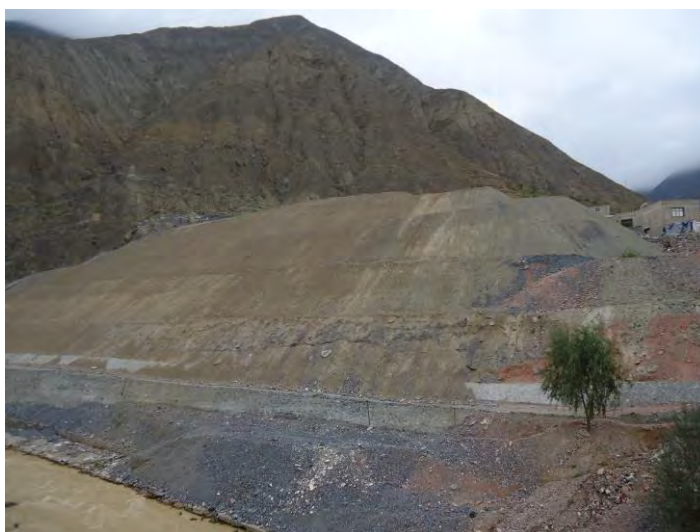
Photo 12. The rectification for 1# spoil ground at the exit of Tianchiping Tunnel by China Railway 13th Bureau Group Co., Ltd has been completed and being covered with the soil.

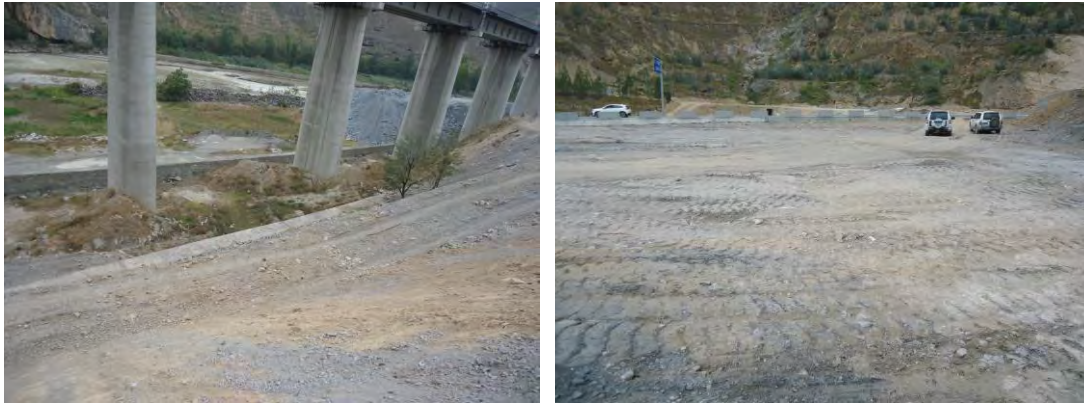
Photo 13.- The retaining walls for spoil grounds of Dayuanba by China Railway 18th Bureau Group Co., Ltd have been built and the site has been leveled.

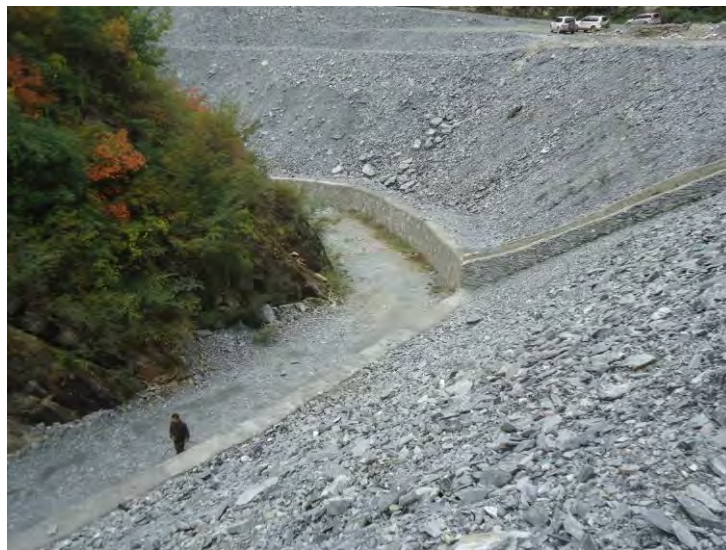
Photo 14. The spillway for spoil grounds at the entrance of Yangjiashan Tunnel by CCCC FIRST HARBOR ENGINEERING COMPANY LTD. has been built.

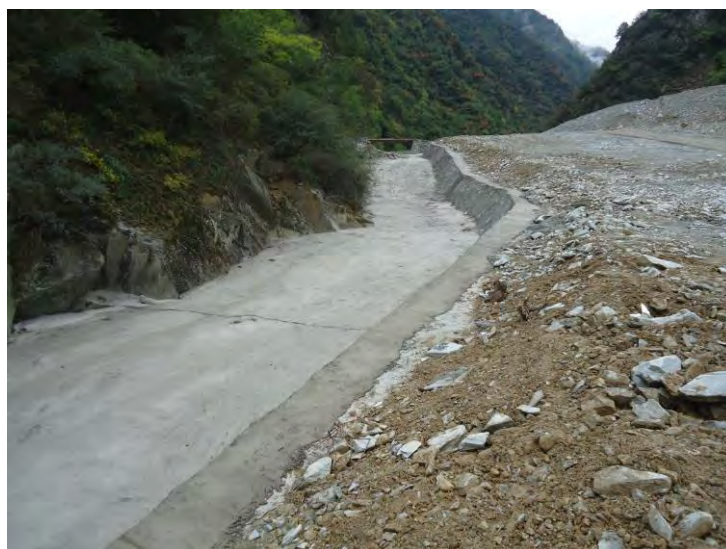
Photo 15. The drainage ditches for spoil grounds of Guanziling Tunnel by CCCC FIRST HARBOR ENGINEERING COMPANY LTD. has been built and the site has been leveled.

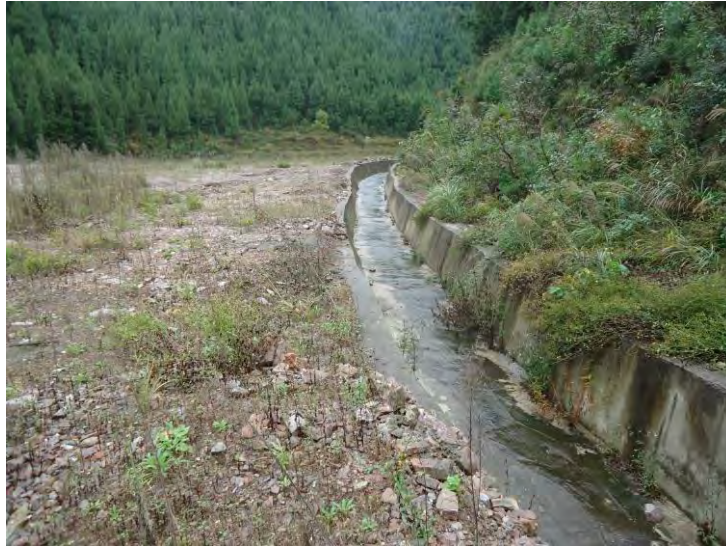
Photo 16. The retaining walls and drainage ditches for 2# spoil grounds at the entrance of Xiongdongwan Tunnel by China Coal No.3 Construction (Group) Corporation Ltd. have been built.

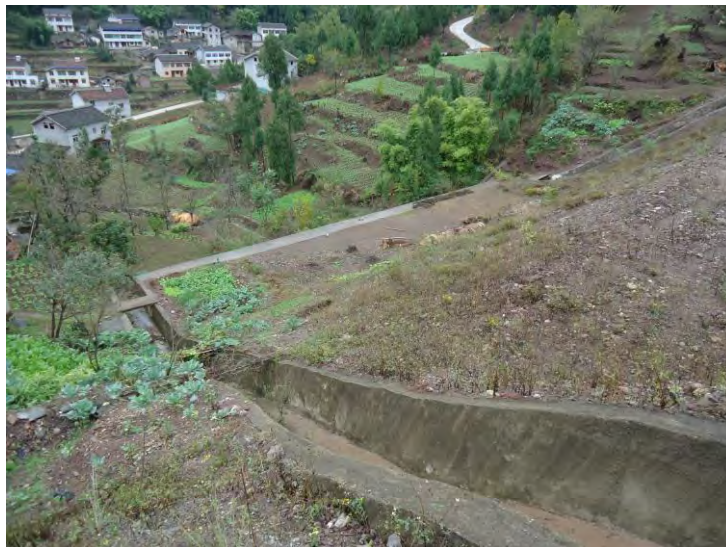
Photo 17. The retaining walls for 1# spoil grounds at the entrance of Xiongdongwan Tunnel by China Coal No.3 Construction (Group) Corporation Ltd. have been built and the rectification for the drainage ditches has been completed.

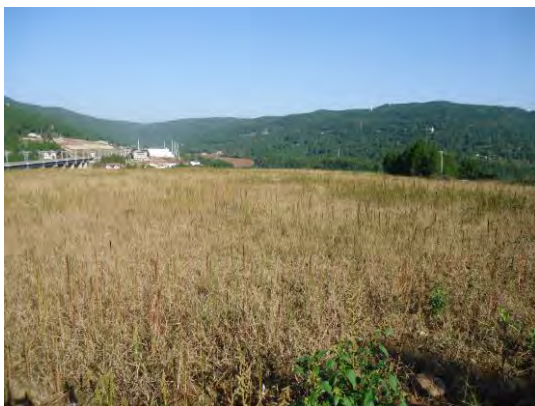
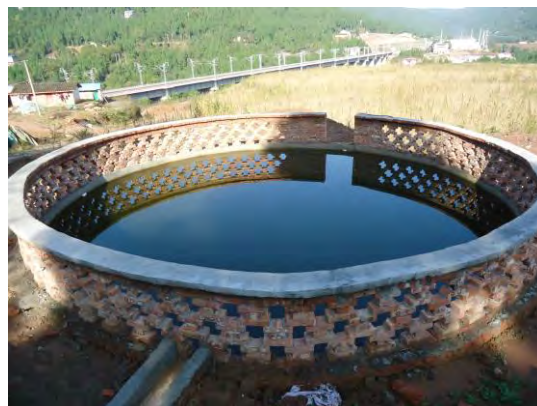
Photo 18. The spoil grounds at the entrance of Xuanzhenguan Tunnel by China Railway Erju Group Co., Ltd.

have restored the vegetation and repaired and built the irrigation pond.

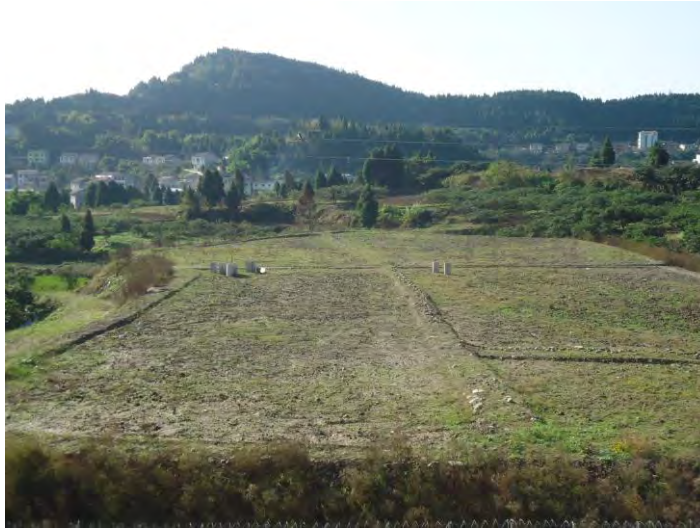
Photo 19. The spoil grounds of DK712+400 subgrade by Road and Bridge International Co., Ltd. have been restored.

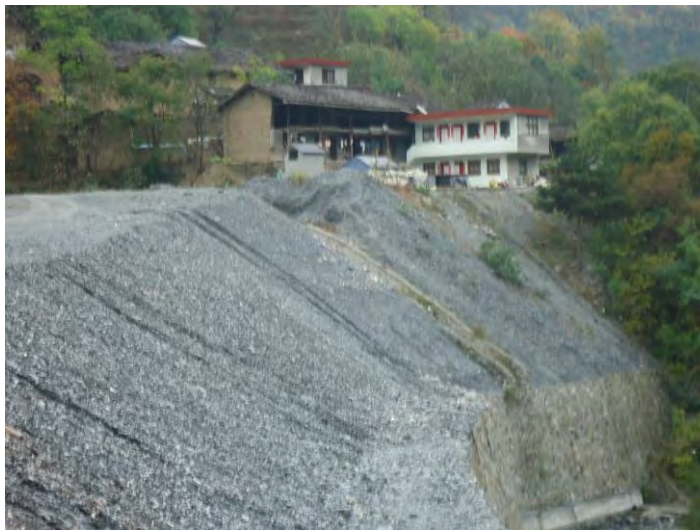
Photo 20. The retaining walls for spoil grounds of Liuangou by China Railway Tunnel Group have been built, but the site has not been restored and leveled.

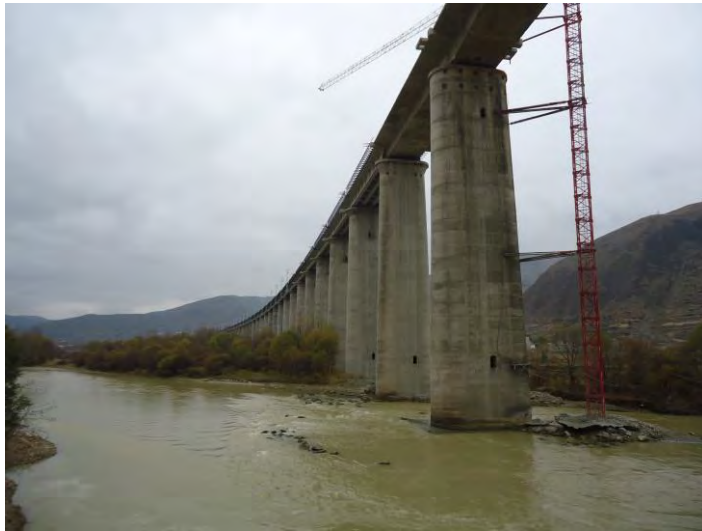
Photo 21. The construction for 1# Super-major Bridge across the Taohe River by China Railway 7th Group Co., Ltd. has been completed and the construction under the bridge has been restored.

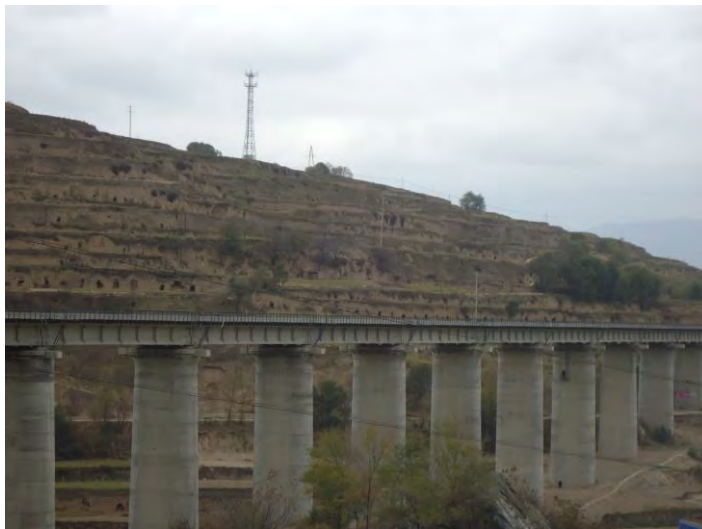
Photo 22. The construction for 2# Super-major Bridge across the Taohe River by China Railway 7th Group Co., Ltd. has been completed and the construction under the bridge has been restored.

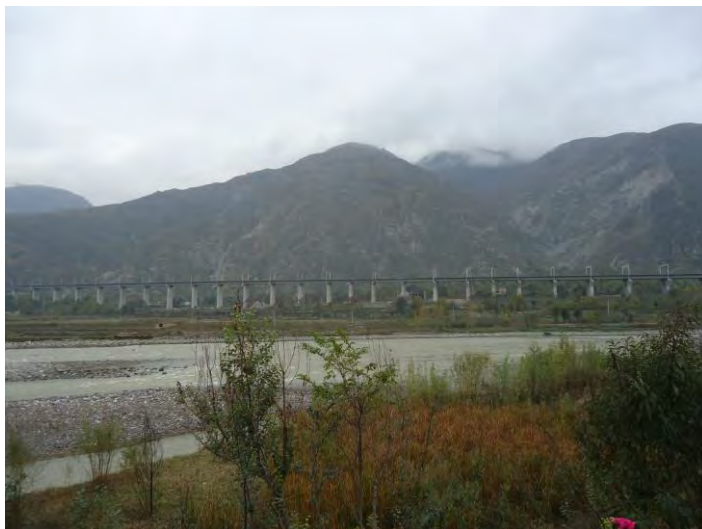
Photo 23. The Yayuan Super-major Bridge by China Railway 13th Bureau Group Co., Ltd. has been completed.
Beijing OASIS Environmental Protection Technology Co., Ltd.

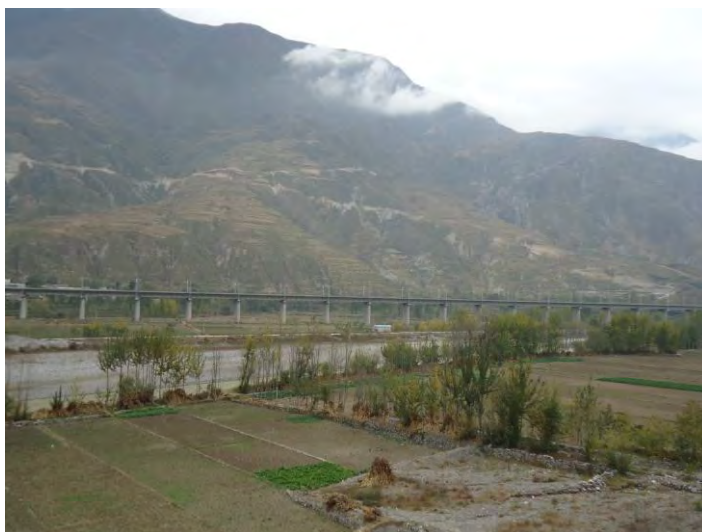
Photo 24. The Chenjiaba Super-major Bridge by China Railway 13th Bureau Group Co., Ltd. has been completed.

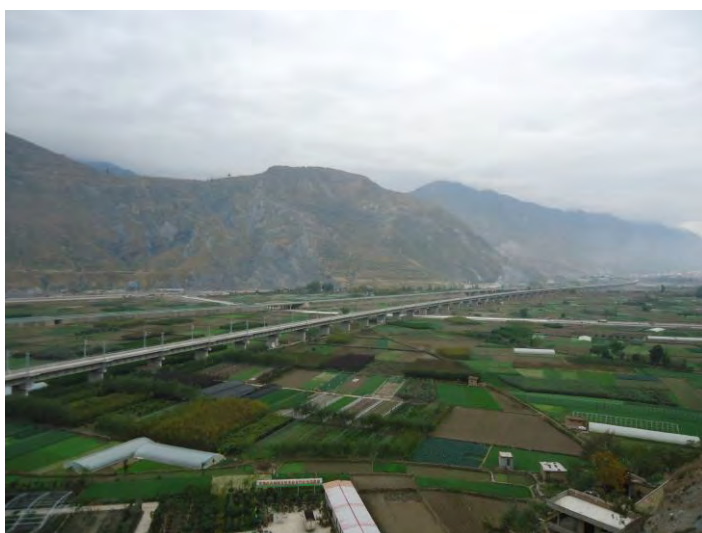
Photo 25. The 3# Super-major Bridge across Bailong River by China Railway 13th Bureau Group Co., Ltd. has been completed.

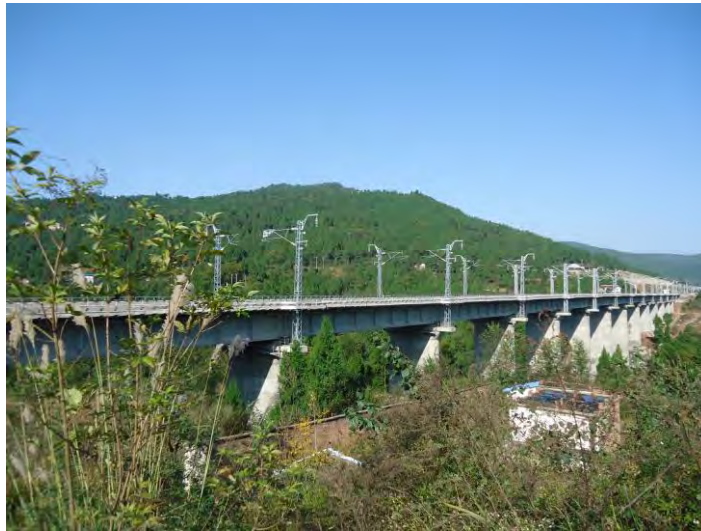
Photo 26. The double track major bridge China of Mujiajiao Miaozigou by China Railway Erju Group Co., Ltd. has been completed.

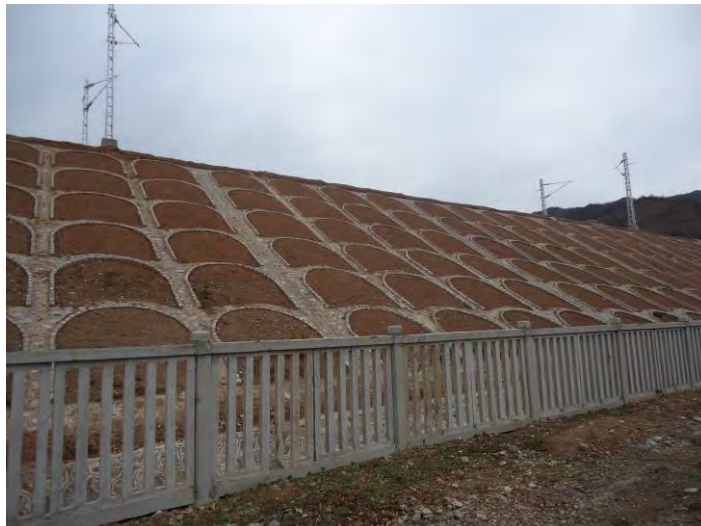
Photo 27. The arch skeleton of subgrade greening at the exit of Shouyangshan Tunnel by China Railway 16th Bureau Group Co., Ltd. has been completed.

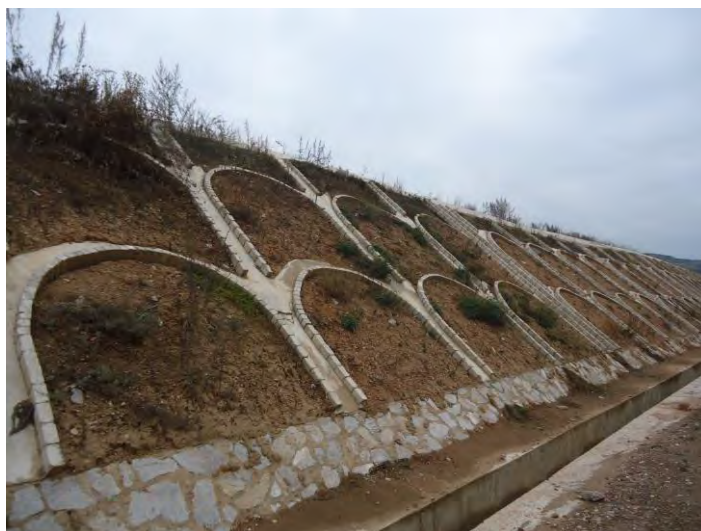
Photo 28. The arch skeleton of DK136+376 cutting slope greening by China Railway 16th Bureau Group Co., Ltd. has been completed.

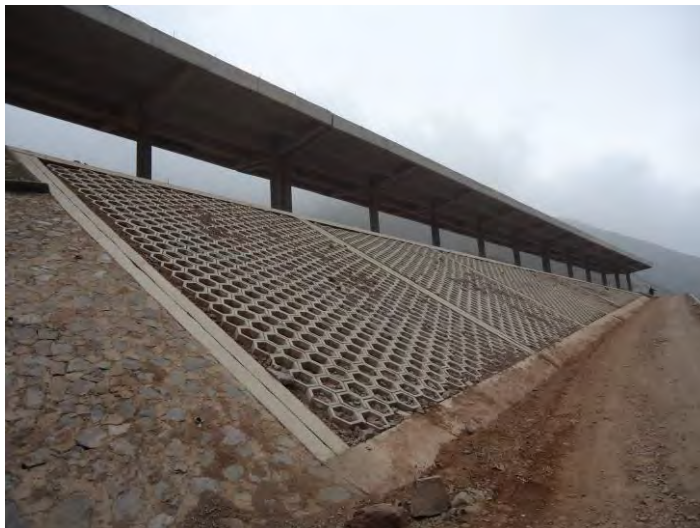
Photo 29. The gridding of subgrade and slope greening at the station of Zhang County by China Railway 16th Bureau Group Co., Ltd. has been completed.

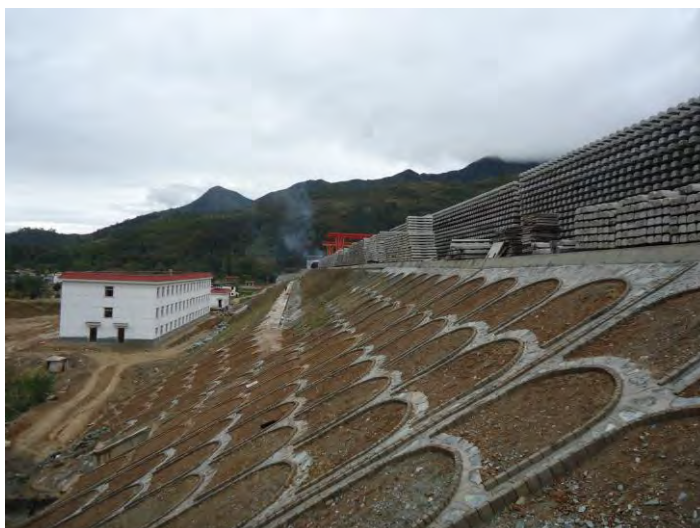
Photo 30. The gridding of subgrade and slope greening at the station of Yaodu by CCCC FIRST HARBOR ENGINEERING COMPANY LTD. has been completed.

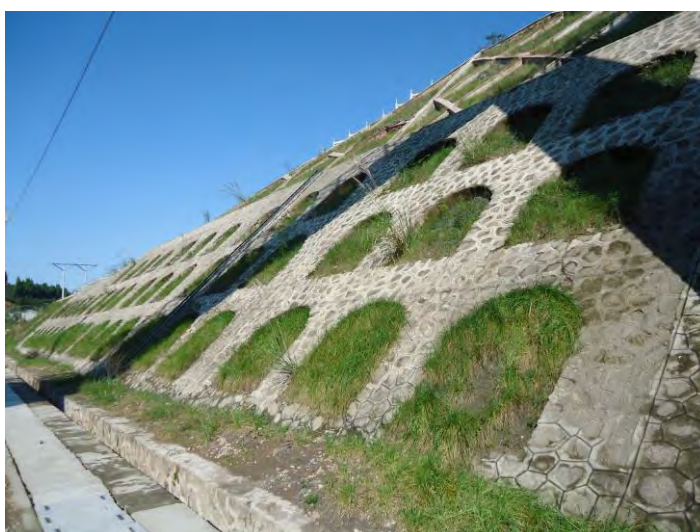
Photo 31. The greening for DK712+270 cutting slope by Road and Bridge International Co., Ltd. has been restored.

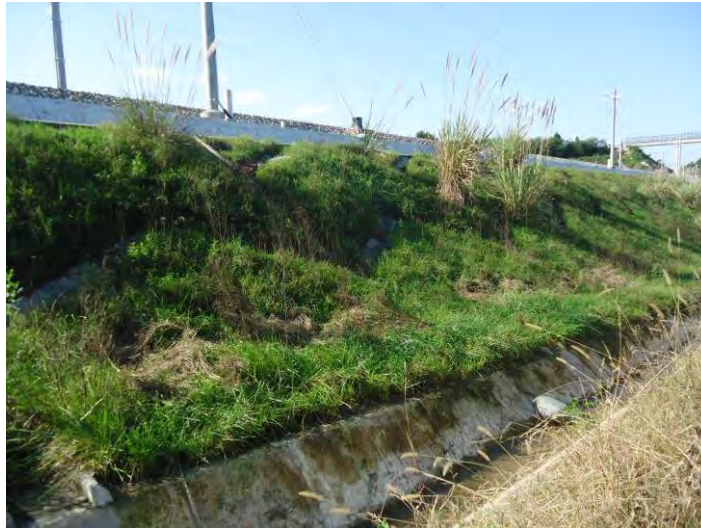
Photo 32. The greening for DK712+410 cutting slope by Road and Bridge International Co., Ltd. has been restored, some have been put into use or the station building, the platform and the canopy have been completed. The slope protection and greening engineering has been carried out one after another.

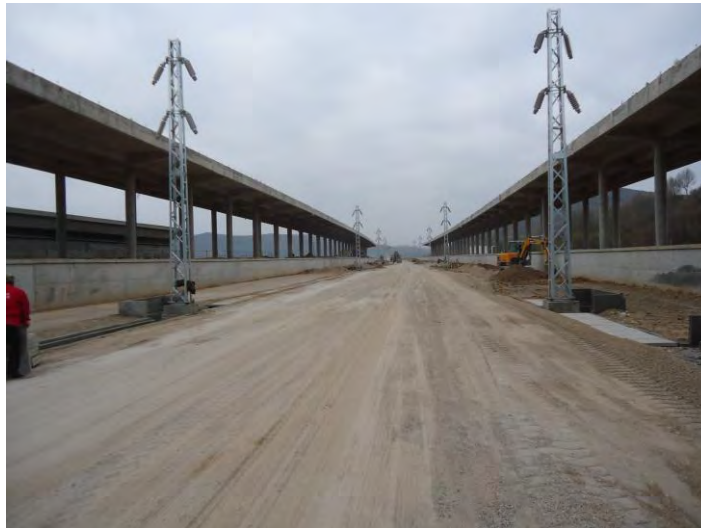
Photo 33. The platform and subgrade at the station of Weiyuan by China Railway 16th Bureau Group Co., Ltd. have been completed.

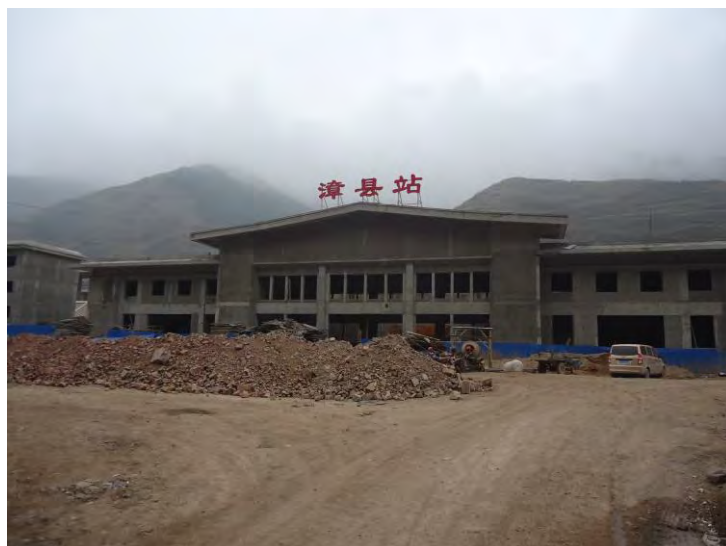
Photo 34. The main engineering of the station building at the station in Zhang County by China Railway 16th Bureau Group Co., Ltd..

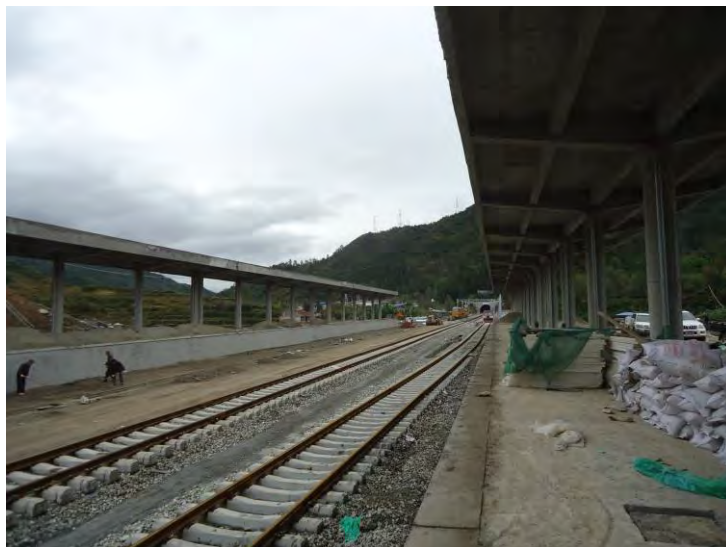
Photo 35. The platform and the canopy at the station of Yaodu by CCCC FIRST HARBOR ENGINEERING COMPANY LTD.

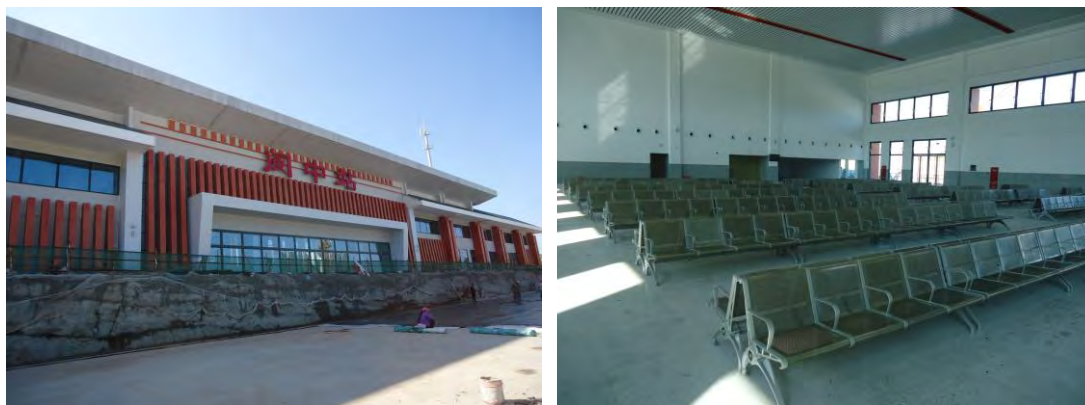
Photo 36. The main station building and waiting hall at the station of Langzhong by Road and Bridge International Co., Ltd. have been completed for use.

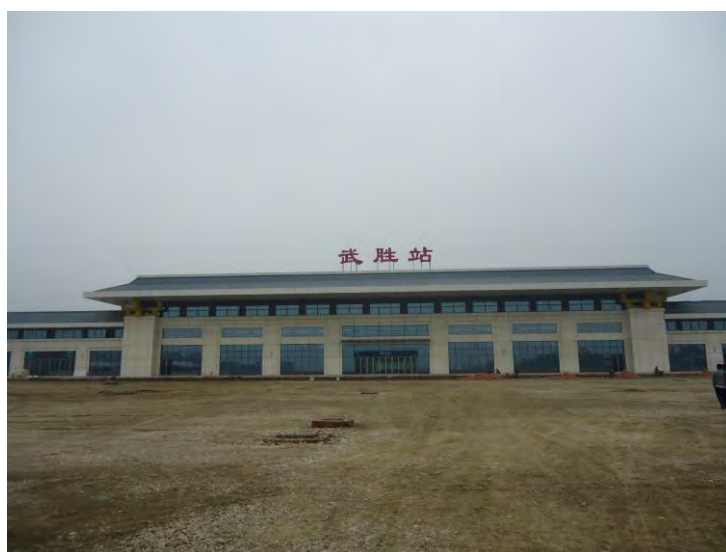
Photo 39. The main station building at the Wusheng station by CCCC First Highway Engineering Company Ltd. has been built.

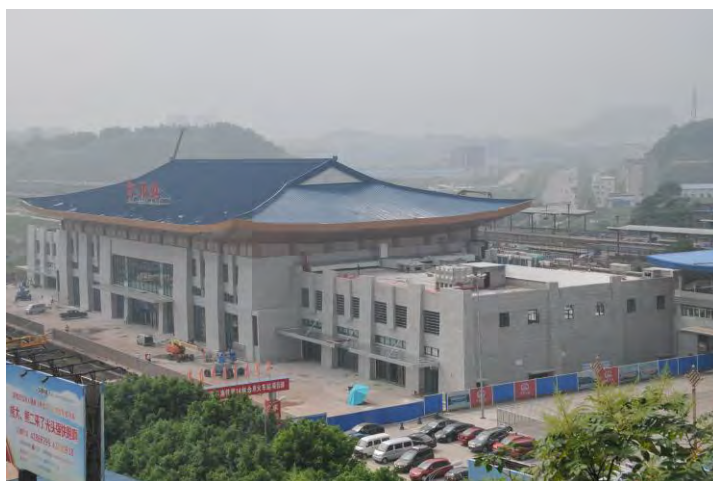
Photo 40. The station building at the Hechuan station has been put into use.

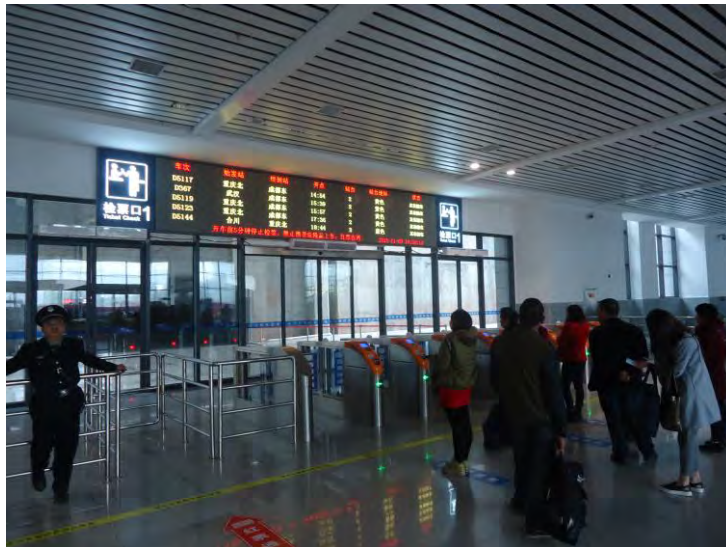
Photo 41. The waiting hall at the Hechuan station by China Railway 10th Bureau Group Co., Ltd. has been put into use.

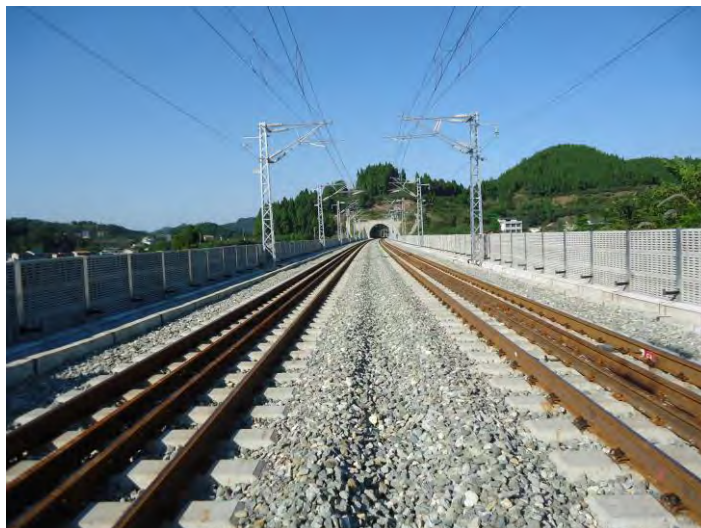
Photo 42. The sound barriers on both sides of DK711+814~712+080 Wangyue Major Bridge by Road and Bridge International Co., Ltd. have been completed.

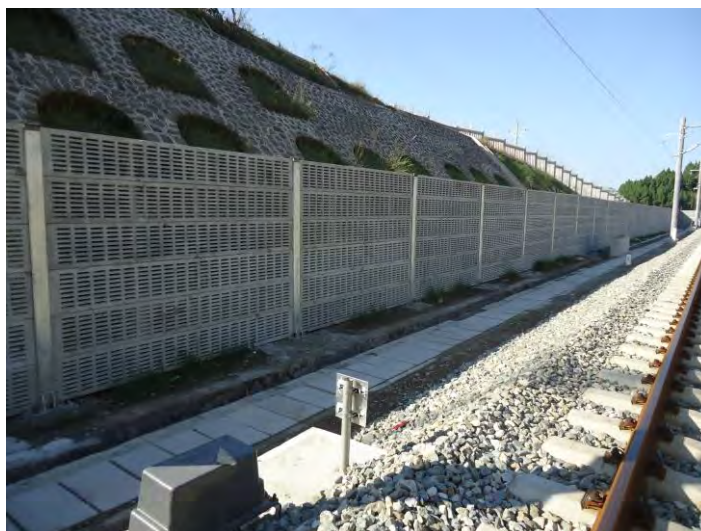
Photo 43. The sound barriers of DK712+080~712+190 subgrade by Road and Bridge International Co., Ltd. have been completed.

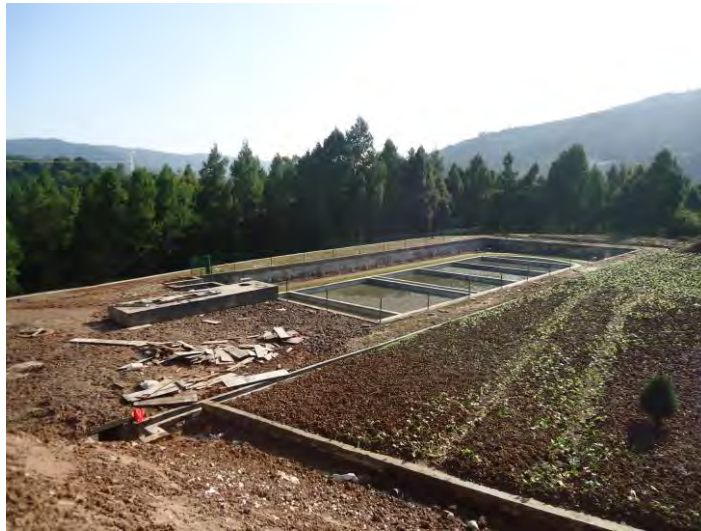
Photo 44. The s-300 constructed wetlands at the Taigong station by China Railway Erju Group Co., Ltd. have been built.

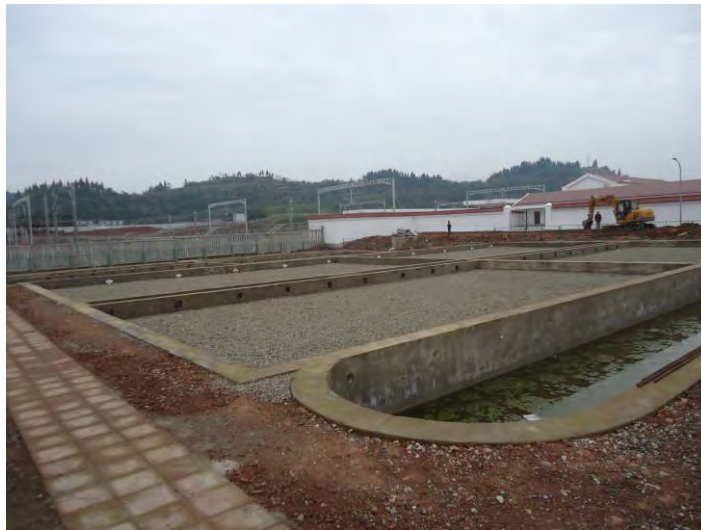
Photo 45. The engineering of constructed wetlands at the north station of Nanchong by CCCC First Highway Engineering Company Ltd. has been completed.

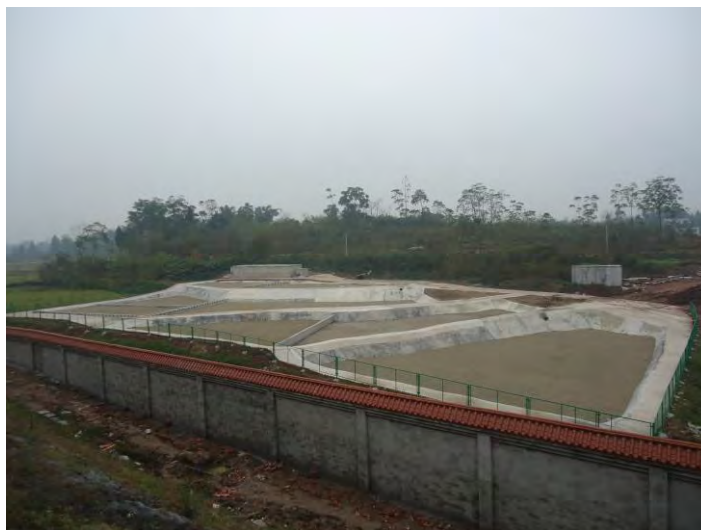
Photo 46. The engineering of constructed wetlands at the Wusheng station by CCCC First Highway Engineering Company Ltd. has been built.

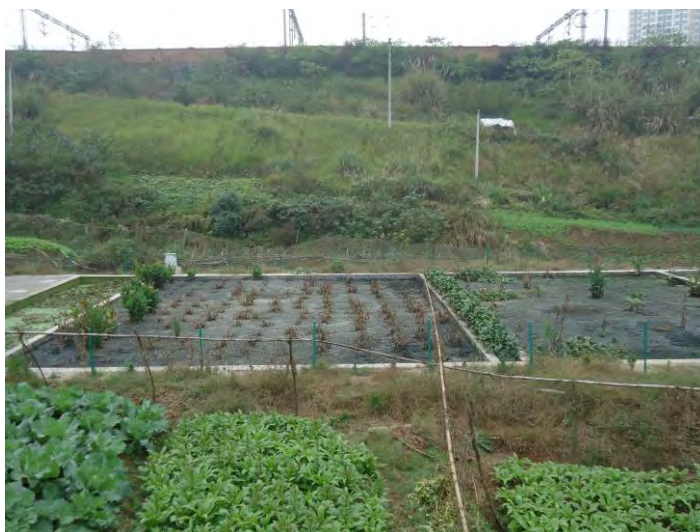
Photo 47. The constructed wetlands at the Hechuan station by China Railway 10th Bureau Group Co., Ltd. have been put into use.

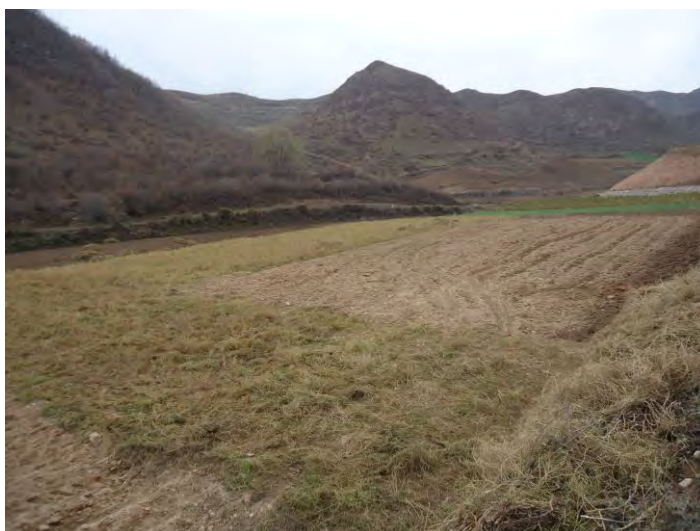
Photo 48. The cultivation for the construction and living areas at the exit of Longjiamen Tunnel by China Railway 16th Bureau Group Co., Ltd. has been restored.

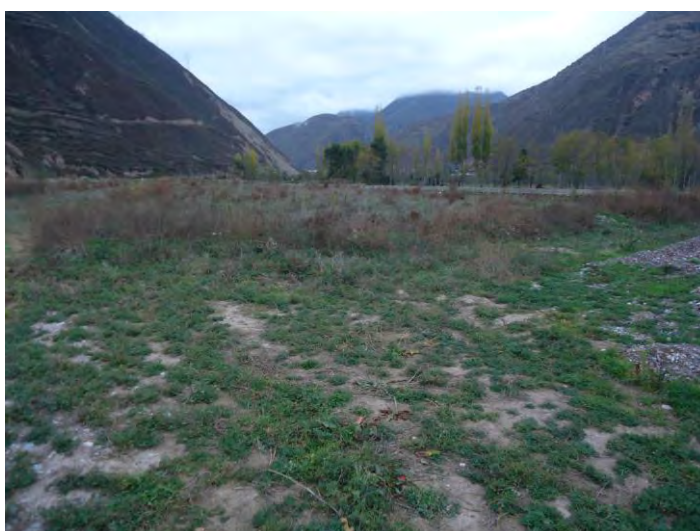
Photo 49. The construction camps of Taishuigou of Xinchengzi Tunnel by China Railway 11th Group Co., Ltd. have been dismantled to restore its original landform.

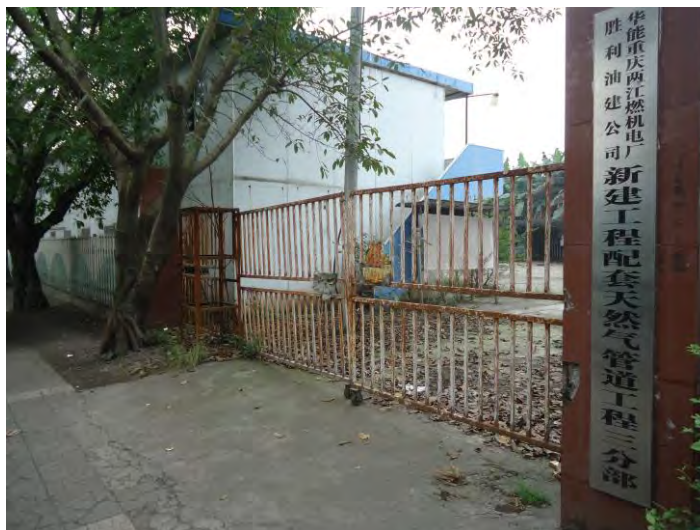
Photo 50. The 4th branch camps by China Railway 10th Bureau Group Co., Ltd. have been turned over for local use.
