Environmental Monitoring Report

Semi-Annual Report (January - June 2015)
July 2015

CAM: Rural Roads Improvement Project

Detailed Design and Implementation Supervision (DDIS) Consulting Services

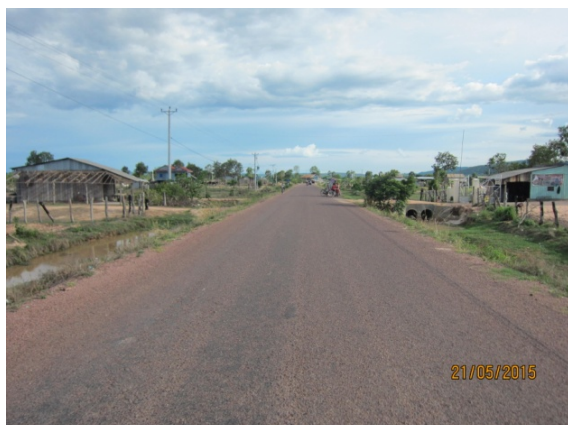
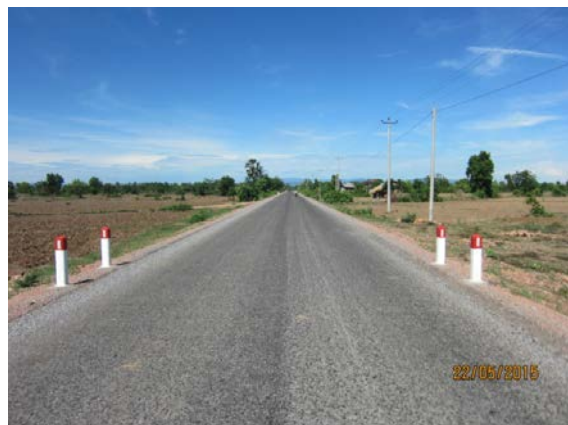
Figure 1 Completed view of 1BB1

24. **Road 1BB1** is the longest road among the four roads in Battambang. It has been completed and is being made ready for being handed over. Borrow pits have been graded and residual debris removed. The roads and slopes are cleaned and there are no environmental issues.

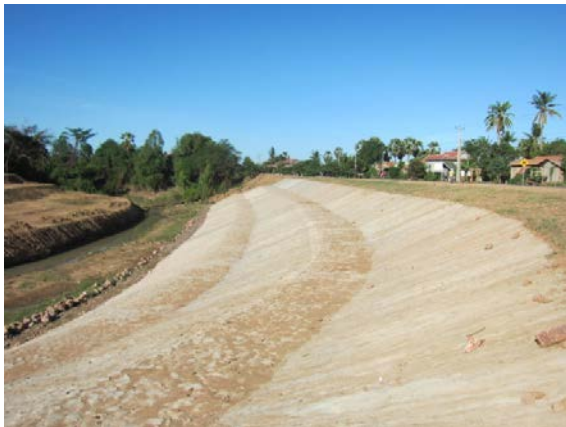
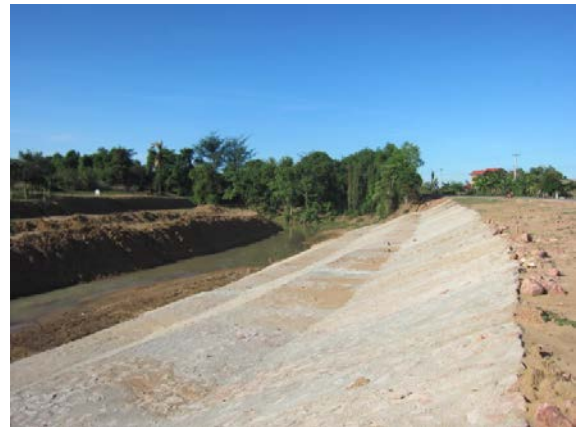
Figure 4 Slope protection works along 1BB2

25. **Road 1BB2** has been completed. Borrow pits have been graded and residual debris removed. Slope protection works along the project roads at Sta. 6+700-6+800 and Sta. 7+805- 7+875 which have been eroded by flood water have been safely finished. The roads and slopes are cleaned and there are no environmental issues.

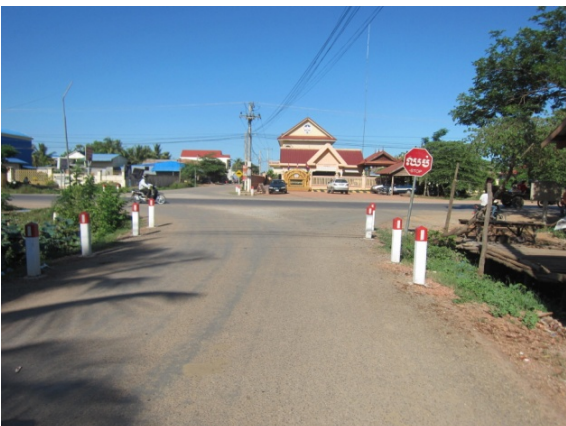
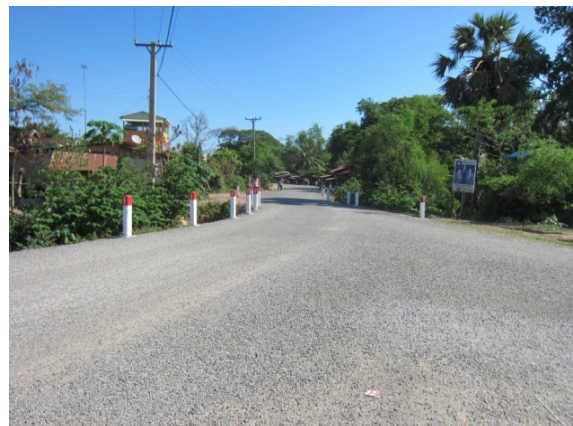
Figure 5 Beginning point of Road 1BB3 leading to 1BB4

26. **Roads 1BB3 and 1BB4** are contiguous and have been completed. The roads and slopes are cleaned, and all contractor's temporary camp and debris have been removed. There are no more dusts and no environmental issue was found.

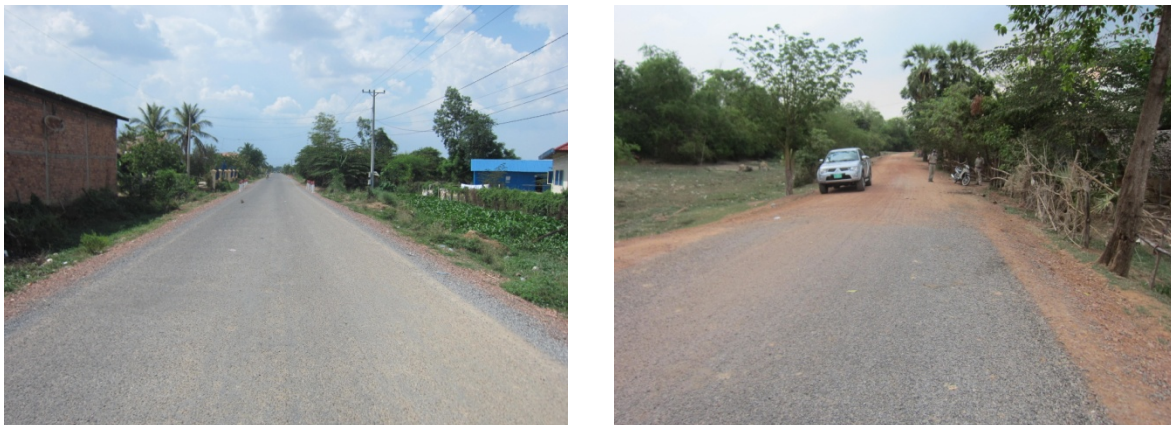
Figure 7 Beginning Point and End Point of 154D

27. **Road 154D** has been completed. The roads shoulders are cleared, borrow pit slopes graded, and there are no environmental issues connected with the road. The majority of the debris has been removed however some remains. The contractor's camp near the main bridge has been demobilized. 30 oil drums left on the site that contained bitumen and those drums have been removed by the contractor.

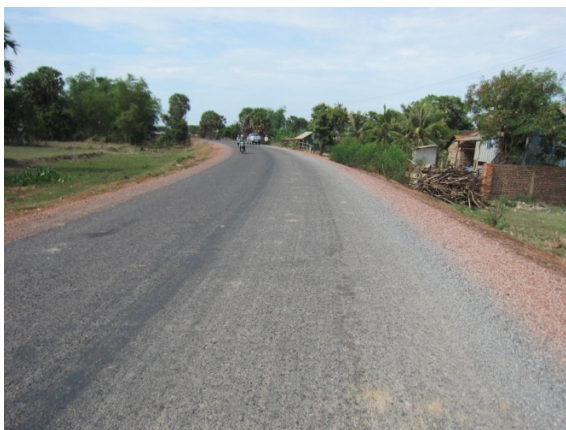
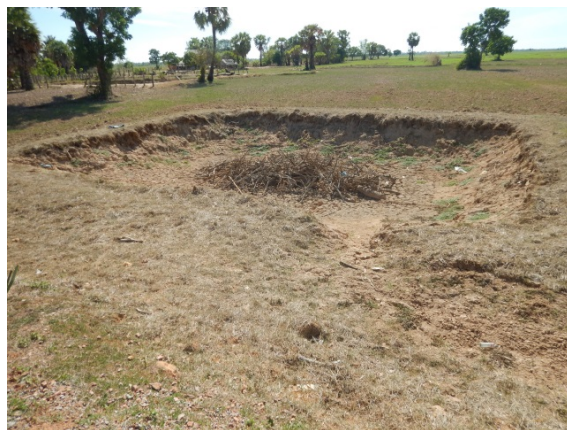
Figure 10 Road 155D shoulders and graded borrow pit

28. **Road155D** runs south from NR5 for 19.4 kms and then becomes **Road 1PS2** for 18.7kms. A spur from 1PS2 designated **Road 155C** of length 22.3kms runs back to NR5. A camp site was located near the end point of 155C. This has been closed and cleared. The roads have been completed, road shoulders cleared, borrow pit slopes are graded, debris has been removed and there are no environmental issues.

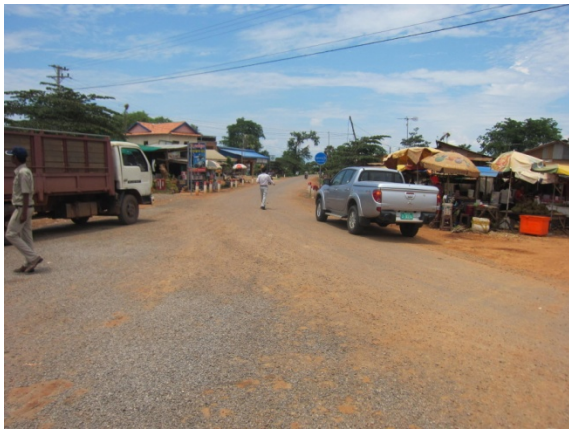
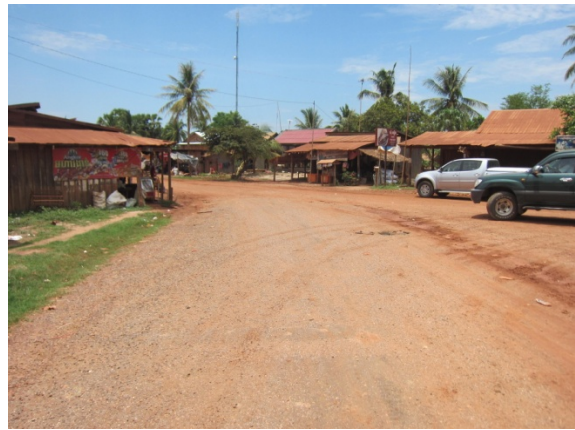
Figure 11 Road 1PS2 Beginning Point and End point

29. **Road 1PS2** is connected with 155D, and runs for 18.7 kms and terminates at the cross point with provincial road. The roads have been completed, road shoulders cleared, borrow pit slopes are graded, debris has been removed and there are no environmental issues

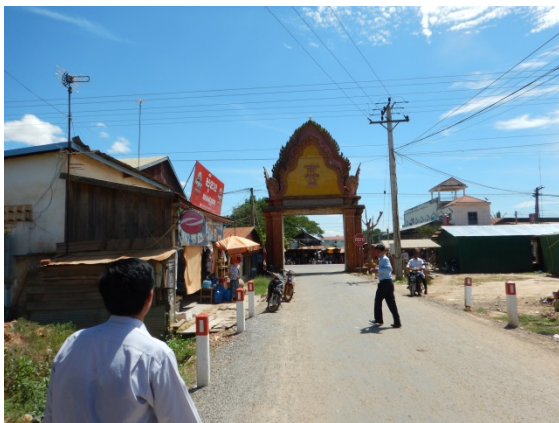
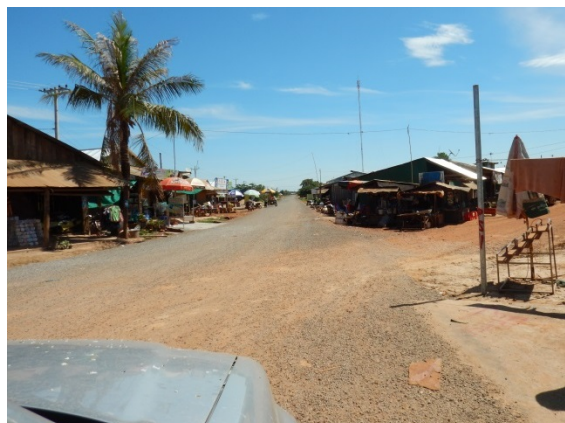
Figure 12 Road 155C Beginning Point and End point

30. **Road 155C** starts from national road No.5 and runs to south until meet with 1PS2 and the length is 22.3 kms. A camp site has been located near the end point of 155C and bridge site. These temporary camps have been closed and cleared. The roads have been completed, road shoulders cleared, borrow pit slopes are graded, debris has been removed and there are no environmental issues

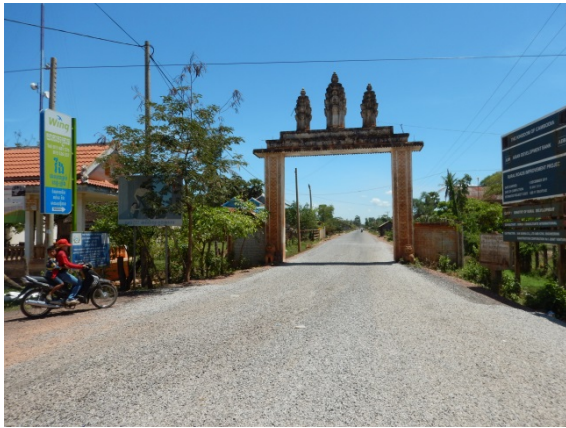
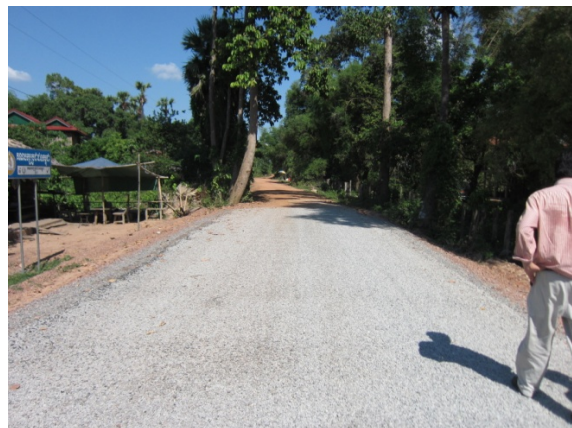
Figure 13 Beginning point of Road 152E and end point view

31. **Road 152E** runs north from Sovann Mouly pagoda on NR5 for 8.8 kms. The road has been completely. The roads have been completed, road shoulders cleared, debris has been removed and there are no environmental issues

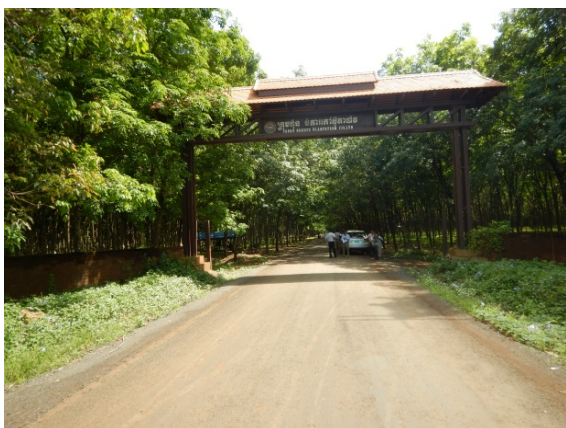
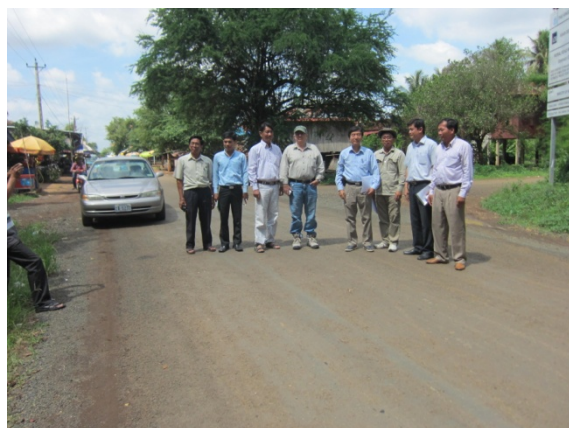
Figure 14 Beginning point of road and inspection team

32. **Road KC10** of 12.5 kms length has been constructed under Contract CW-D, one of three additional civil works packages which started in February 2014. All the works of the road KC10 have been completed., The contractor maintained workers camp for remaining activities by renting narrow piece of land between residential properties. Good use has been made of the available space and in general the site displays a high standard of housekeeping. The land has been vacated in June 2015.

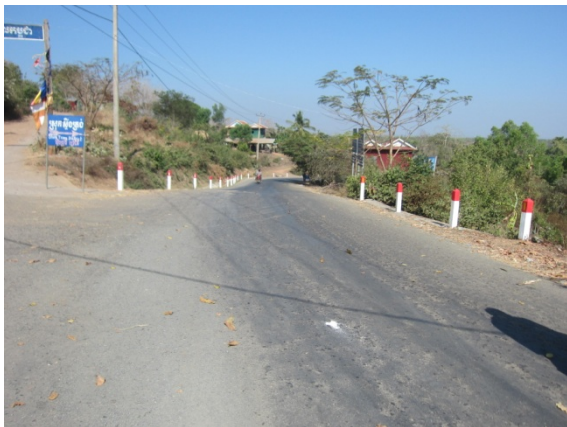
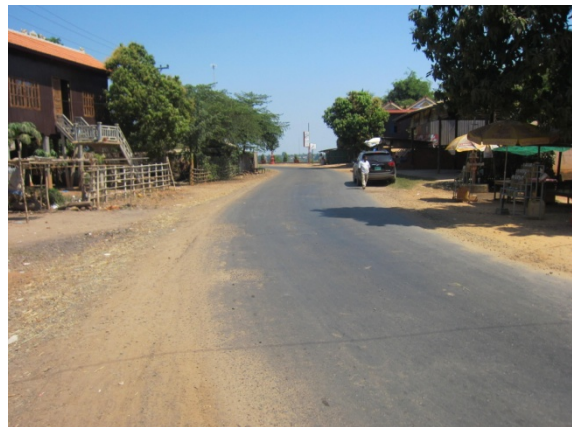
Figure 16 Beginning point and end point of Road KC2 (CW-E)

33. **Road KC2** of length 10kms, one of three additional civil works packages which started in February 2014, has been completed in February 2015. No environmental issues were observed on the road.

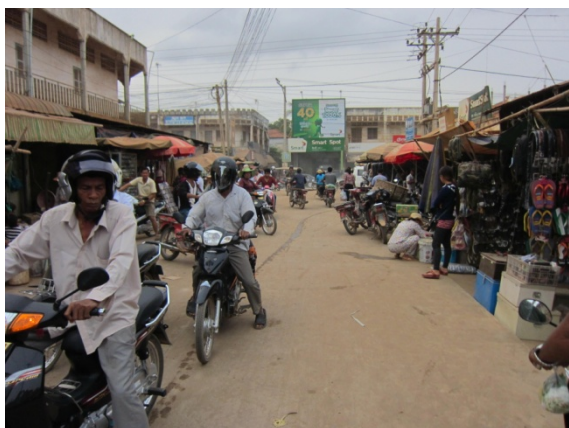
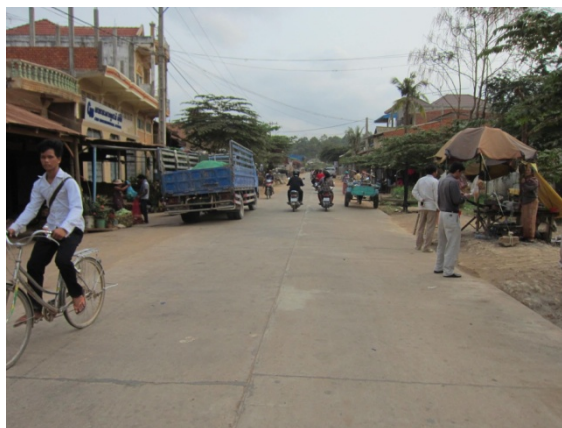
Figure 17 Beginning point of Road KC11 with concrete road section

34. **Road KC 11** is of length 16.7kms, one of three additional civil works packages which started in February 2014, has been completed in March 2015. No environmental issues were observed on the road. The contractor's camp has been removed and all debris cleared from the site. No environmental issues were observed on the road.
