Environmental Monitoring Report

#2 Semestral Report
January 2016

GEO: Sustainable Urban Transport Investment Program – Tranche 2

GEORGIA: GEORGIAN SUSTAINABLE URBAN TRANSPORT INVESTMENT PROGRAM, Tranche 2

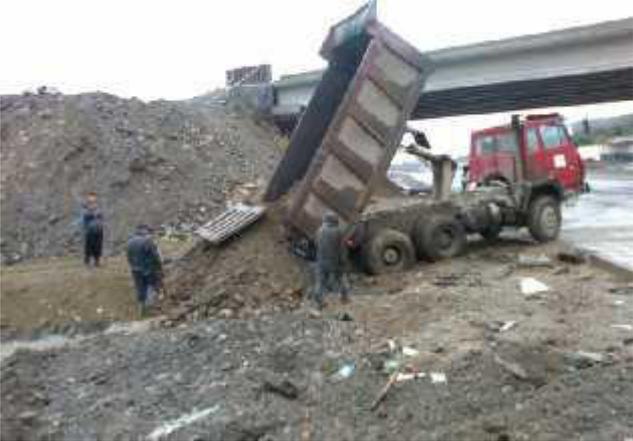
<p>PK21.80 Construction waste is disposing on landfill, assigned for spoil</p>	<p>PK111; Significant oil spill on the access road to the construction camp</p>

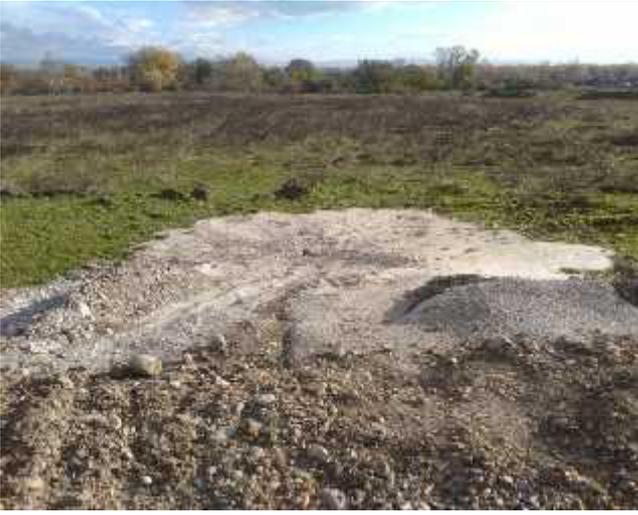
<p>PK128; Water with concrete was discharged outside ROW, directly on topsoil</p>	<p>PK126-128; Construction waste was disposed on the private land plot without agreement with the land owner</p>

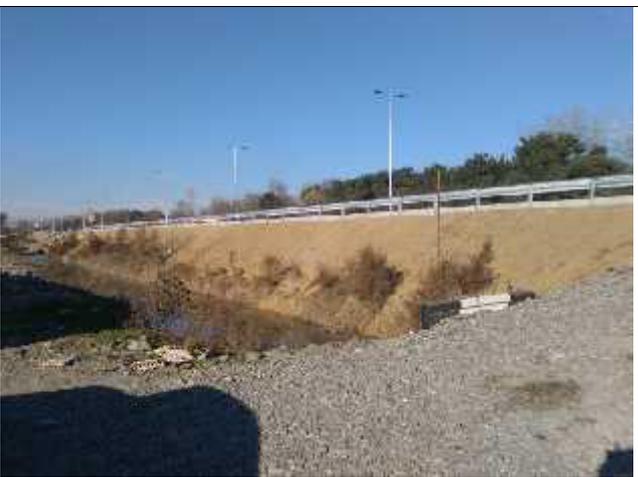
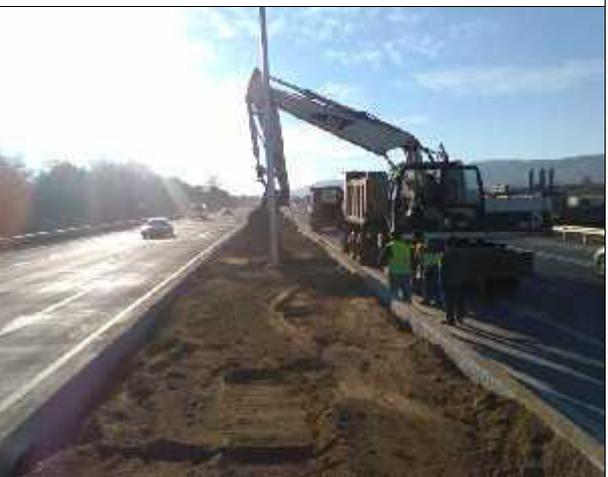
<p>PK105-128; Dividing strip and slopes of embankment are covering by subsoil instead of topsoil</p>

Most part of top soil, removed from the RoW was mixed with subsoil. Currently the Contractor has not enough topsoil for filling of the top of dividing strip and stabilization of slopes of embankment. According IPC the Contractor has removed about 20.000 m³ topsoil from sections 1 and 3. After finishing of construction activities the Contractor was started spreading of borrow material (subsoil and gravel) on the slopes of embankment and disposing it in the dividing strip.

The contractor was instructed to use only material, mentioned in the Contract for reinstatement of slopes and filling of top of median.

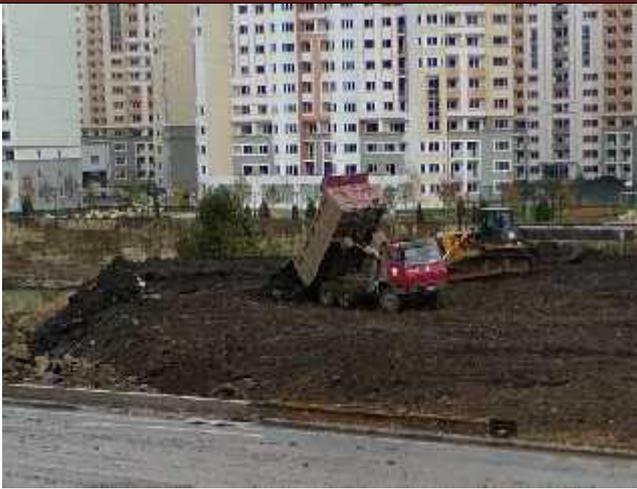
Construction waste is disposing on landfill, assigned for spoil

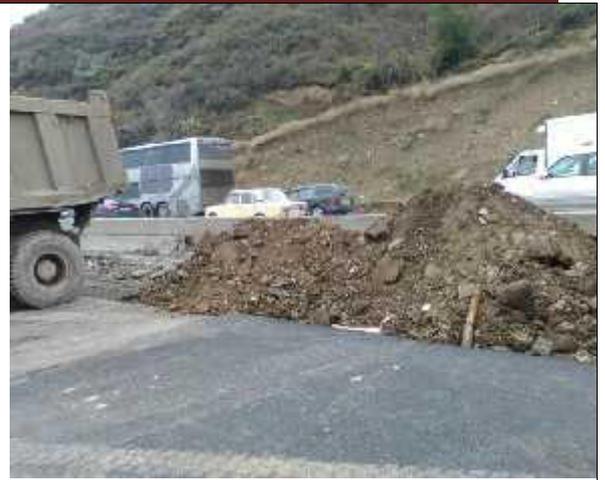
Construction waste is disposing in dividing strip

08.10.2015	Disposal of construction waste in dividing strip	PK22-24	Excavate all improper material from dividing strip	Immediately	Improved
12.10.2015	Disposal of construction waste in dividing strips	PK19-22	Excavate all improper material from dividing strip	Immediately	Improved
