#1 Semestral Report  
August 2016

## GEO: Sustainable Urban Transport Investment Program – Tranche 2

## **GEORGIA: GEORGIAN SUSTAINABLE URBAN TRANSPORT INVESTMENT PROGRAM, Tranche 2**

## Modernization of Tbilisi-Rustavi Section of the Tbilisi- Red Bridge (Azerbaijani Border) Road Project (Sections 1 and 3)

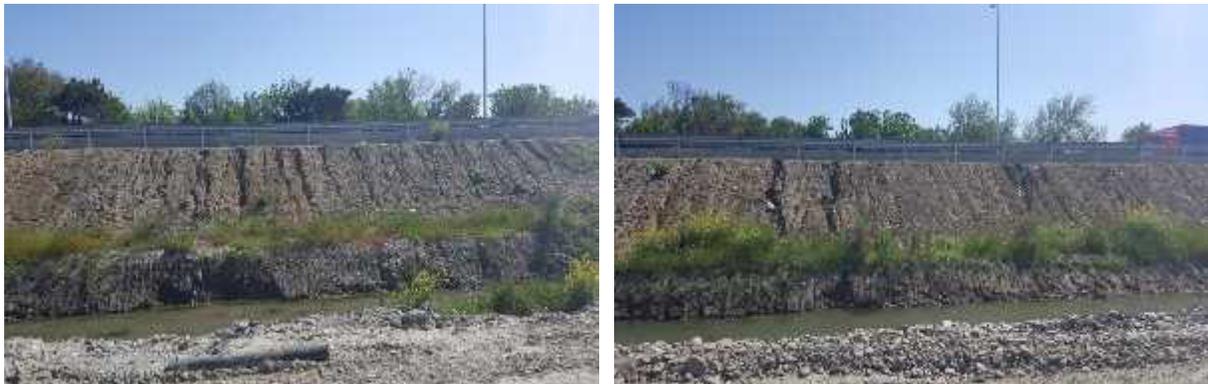
Figures 1 and 2: Erosion of slopes of embankment

**Existing situation:** Slopes of the Embankment at section 3 are covered by subsoil instead of topsoil. Erosion processes on slopes were activated.

**Proposed Corrective action:** The Contractor shall fill all cracks and ensure growing of grass on the slopes of section 3. In the case, if in May 2017 cracks on the slopes will be visible and grass will not grow, the Employer will deduct adequately calculated amount from the Contractor's guaranty and appoint another contractor to restore the slopes of embankment.

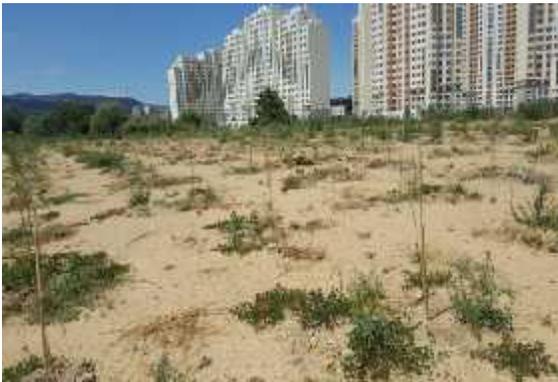
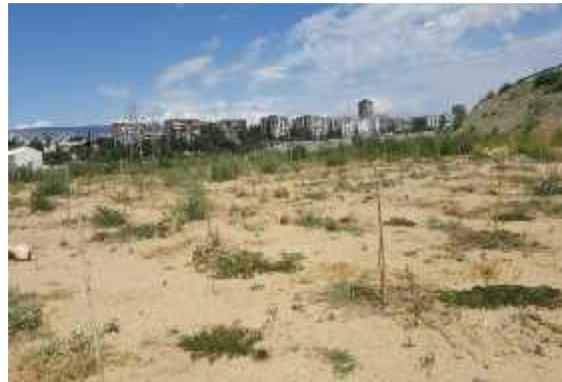
**Figures 3 and 4: 30% of trees, planted on PK20 of section 1 were withered**

42. **Non-Compliance 2:** At section 1 on PK20 195+823 = 1,018 trees were planted in total, from which approximately 300 trees were withered, which is 30% of planted trees on mentioned location. It should be noted that at this place withering rate was highest. In other places withering was quite low. In general only 13-14% of all planted trees (5,474) were withered.

**Proposed Corrective action:** The Contractor shall plant new trees instead of withered ones in autumn 2016. Important, that guaranty period (1 year) should be started from autumn 2016. The Employer will monitor planting activities and check condition of trees in May and in autumn 2017.
