Environmental Monitoring Report

Semestral Report from January to June, 2011
November 2012

VIE: Phuoc Hoa Water Resources Project

Prepared by Institute of Coastal and Offshore Engineering for the Hydraulic
Project Investment and Construction Management Board No.9 - Ministry of Agriculture
and Rural Development and the Asian Development Bank.

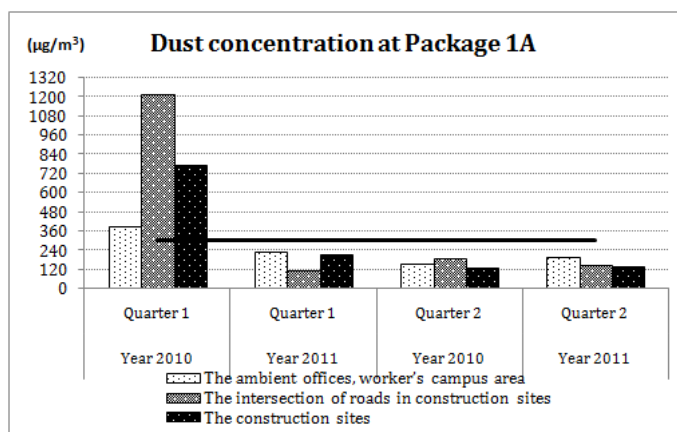
Figure 1: Graph of dust concentration at Package 1A

In comparison with the same period in 2010, dust pollution problem at the Package 1A in the first 6 months of 2011 was trending decrease [Table 3]. In all quarters, the dust concentration was in the range of allowable limit (QCVN 05:2009/BTNMT is $300 \mu\text{g}/\text{m}^3$). The treatment for the reduction of dust concentration is using water spraying to increase the moisture of the soil surface.

This means the dust pollution at the package 1A was paid attention and resolved. However, out of the contractor's effort, the solution also laid on other conditions such as weather, quantities and type of construction. Therefore, it is requested that the package 1A should pay more attention to the solution to minimize the dust pollution in the coming time.

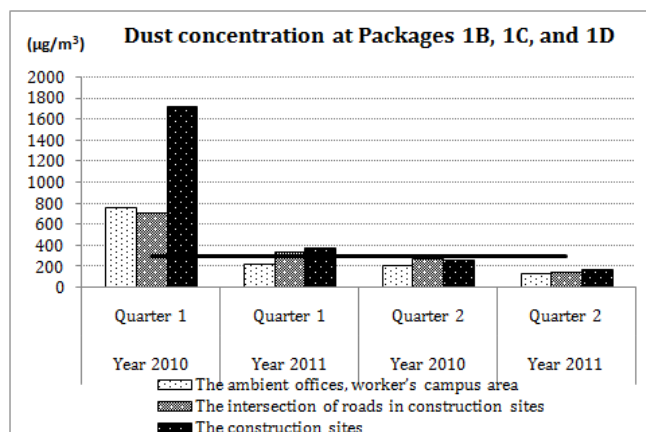
Figure 2: Graph of dust concentration at Packages 1B, 1C, 1D

As same as the case of the head works, at the transfer canals and main canal packages, the average dust concentration in Quarter I was still higher than Quarter II. The intersection of roads in construction sites is always appearing the highest dust concentration.

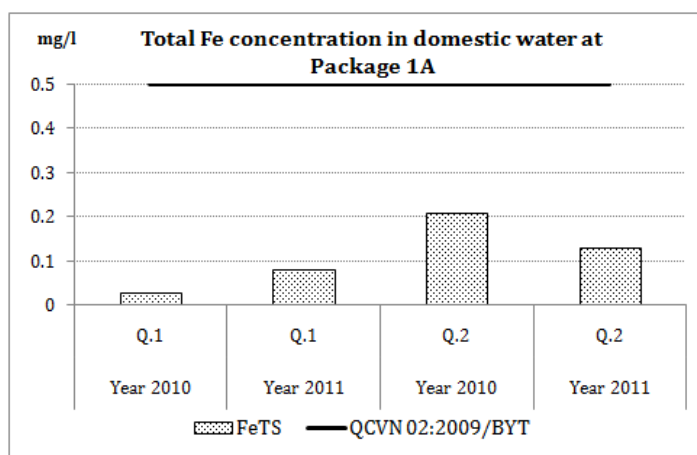
Figure 4: Graph of total Fe concentration in domestic water of Package 1A

The monitoring and analysed results of domestic water at construction packages show that most of analysed factors met the standard for domestic water quality of the Ministry of Public Health QCVN 02:2009/BYT. However, in the first two quarters of 2011, the micro-organism infection and low pH still appeared. These are the causes affecting to the domestic water resources. The contractors need to pay attention and apply the solution to improve the water quality as advised by environmental consultants.

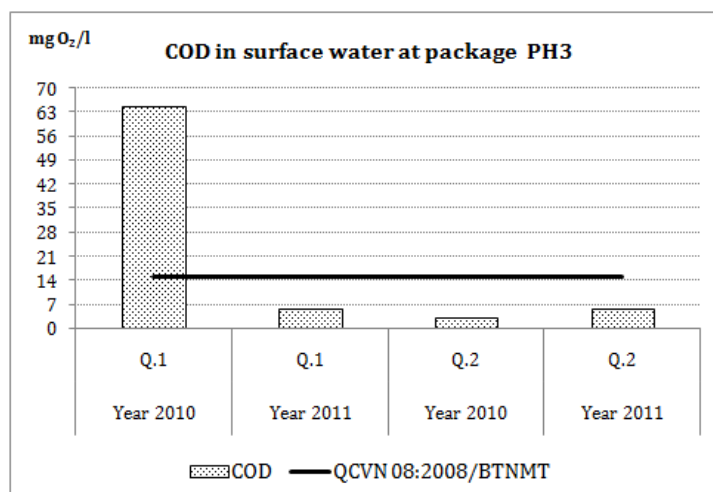
Figure 8: Graph of COD in surface water of package PH3

Most of packages (except PH3 package), physical and chemical factors (pH, COD, total Suspended Substances (SS), Oil, and Total Fe) met the QCVN 08:2008/BTNMT standard. Particularly, at Tan Bien irrigation area (package PH3), the value of COD, total Fe, and E.Coli exceeded the requirement of the QCVN 08:2008/BTNMT standard. Constructors and the employer need to pay more attention to the surface water quality for this area.

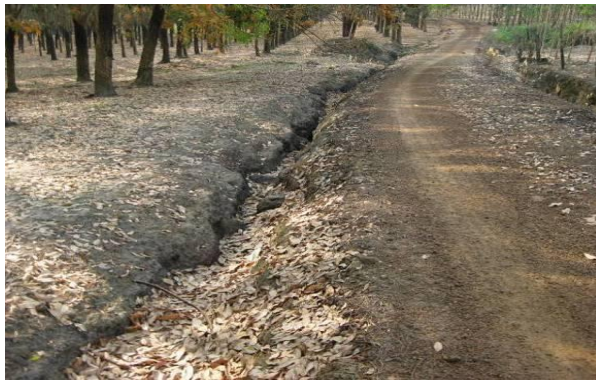
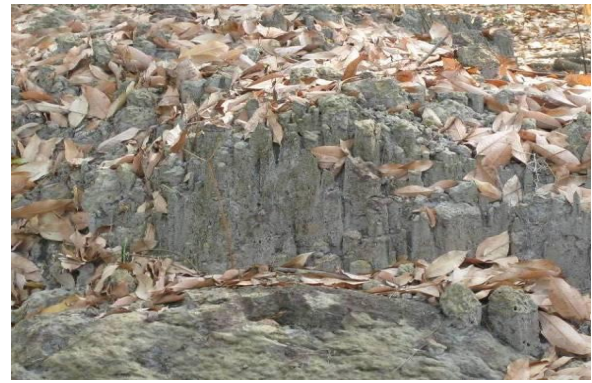
Erosion caused by rainfall

Out of the erosion caused by human activities, there are some natural eroded locations occurred along 2 banks of Suoi Dong stream of hamlet 4, Minh Thang commune. The erosion and collapse partially occurred in an area of the length 100m, this stream located between 2 rubber tree gardens of local people. The stream collects big water flows but the bottom of stream is small, creating a high velocity of flow and causing erosion and collapse at some bends where there is no vegetation or very little vegetation at both sides of the stream.

Figure 10: Erosion status in the project area

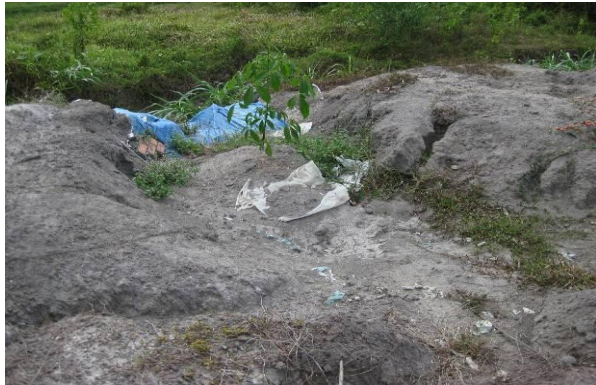
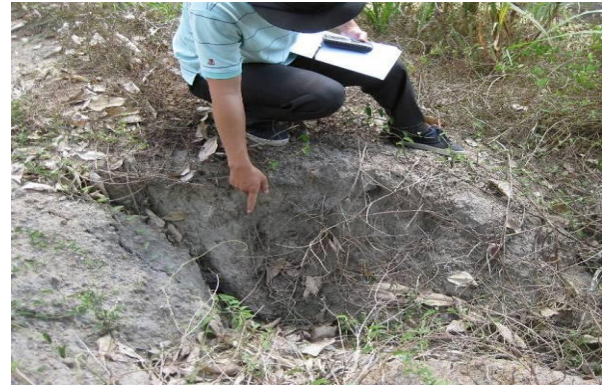
Erosion caused by human activities

Most of the surface soil erosion in the project occurred at rubber tree areas, the erosion occurred lightly and partly at areas without vegetation. Recently, the local people excavated soil in the project area nearby streams to fill their gardens. This causes minimizing the area for forestation, and the newly backfilled areas were eroded seriously and a part of eroded soil entered into the adjacent streams.

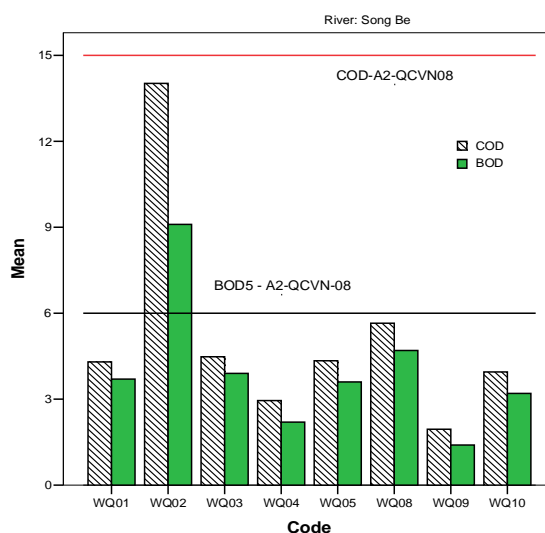
Figure 11: Variables of COD and BOD in Be River

The water quality of Be River was quite good, most of monitoring indicators (pH, NO_3^- , COD, BOD, and heavy metals) reached the column A1, A2 of QCVN08:2008/BTNMT, due to the population of this region is sparse, and production activities have not yet increase. In 2010 and early months of 2011, construction activities of Phuoc Hoa project did not significantly affect to the Be River's water quality. Only TSS content at construction site was increasing.

According to monitoring results report in April 2011 of package MT6, it showsthat the surface water quality in Be river was trending worse in comparison with the same period of last year (April 2010). Due to streams which flow to Be river directly received the domestic and industrial wastewater with bad water quality. For example, at the Suoi Thon stream, during the inspection period, water flow was very small, with brownish color water. The reason of pollution problem at WQ02 was that the Suoi Thon stream received untreated wastewater from the township and a part wastewater from Chon Thanh industrial park. The low water quality of streams will significantly affect to water quality of Phuoc Hoa reservoir, especially in the begining of impoundment.

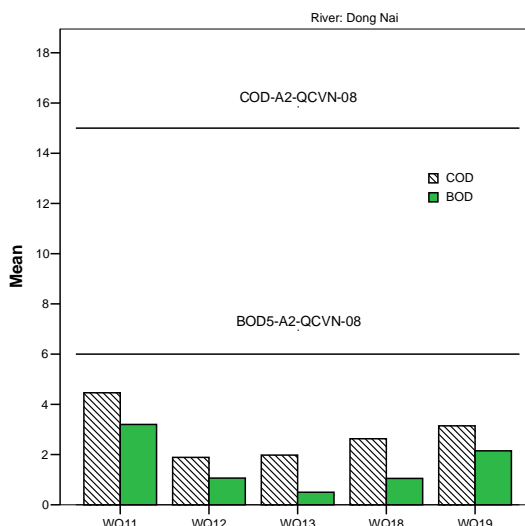
Figure 12: Variables of COD and BOD contents in Dong Nai river

The monitoring results of package MT6 found that construction activities of the Phuoc Hoa project did not affect to the changes of water quality in Dong Nai River in 2010 and 2011.

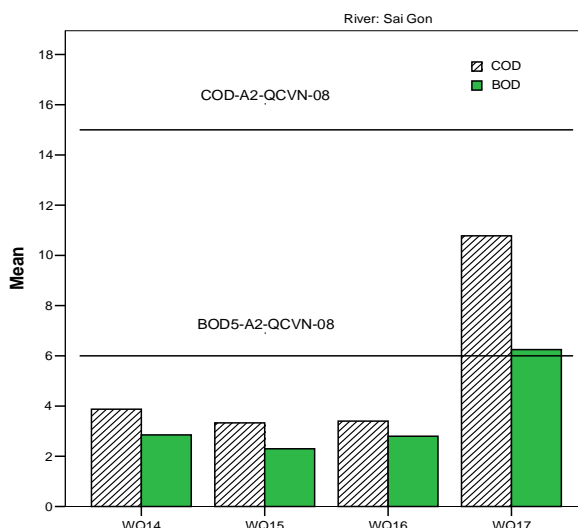
**Figure 13: Variables of COD and BOD contents in Sai Gon river****Levels, trends and causes of pollution:**

The monitoring results in Sai Gon River in 2011 show that the water quality was affected by the urban, industrial, agricultural waste resources, especially the lower areas were affected by Ho Chi Minh City, Binh Duong Province that caused organic and microorganism pollutions.

The monitoring results of MT6 show that the Phuoc Hoa Reservoir construction activities have not affected to the degradation of the water quality in Sai Gon River.

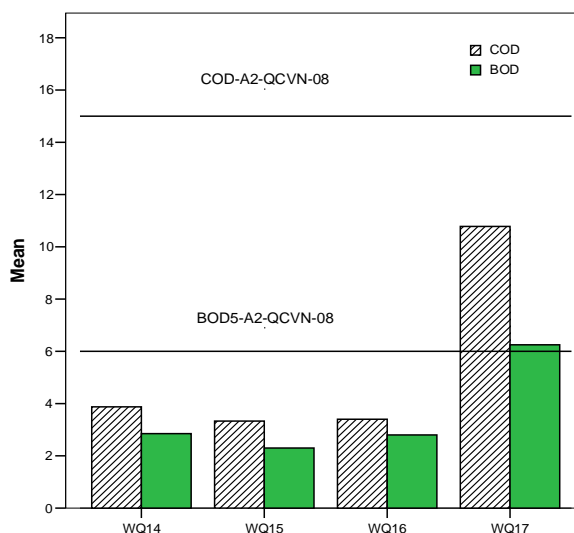
Figure 14: Variables of COD and BOD contents in Vam Co Dong river Levels, trends and causes of pollution:

In early months of rainy season, the water sources were affected by acid sulphate soils. This caused difficulties in using domestic and agricultural water.

For Phuoc Hoa project, it found that the Phuoc Hoa Reservoir construction activities have not affected to the degradation of the water quality in Vam Co Dong River in the periods of 2010-2011.

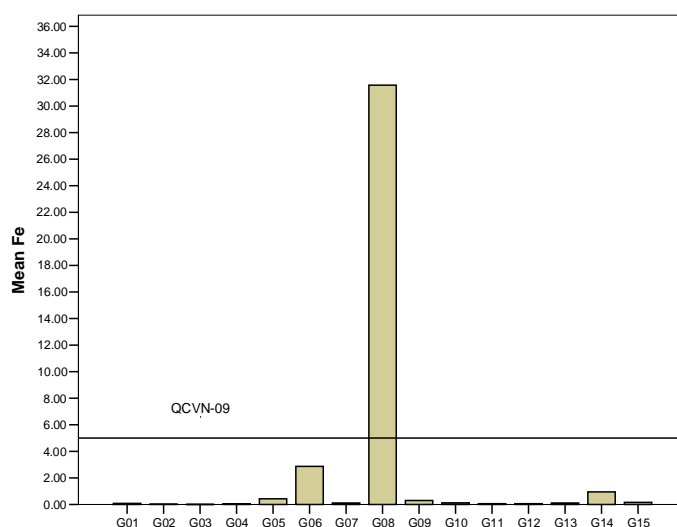
Figure 15: Total Fe content in ground water of the project area

In comparison with ground water data between April 2011 against September 2005 at Nha Bich commune, Chon Thanh district, Binh Phuoc province shows that there were no significant difference of physical and chemical compositions, many indicators such as Fe, Mn, Nitrate have its value lower than those in 2005. Only the quantities of Fecal Coliform were higher than the quantities in 2005 at the most of monitoring wells.

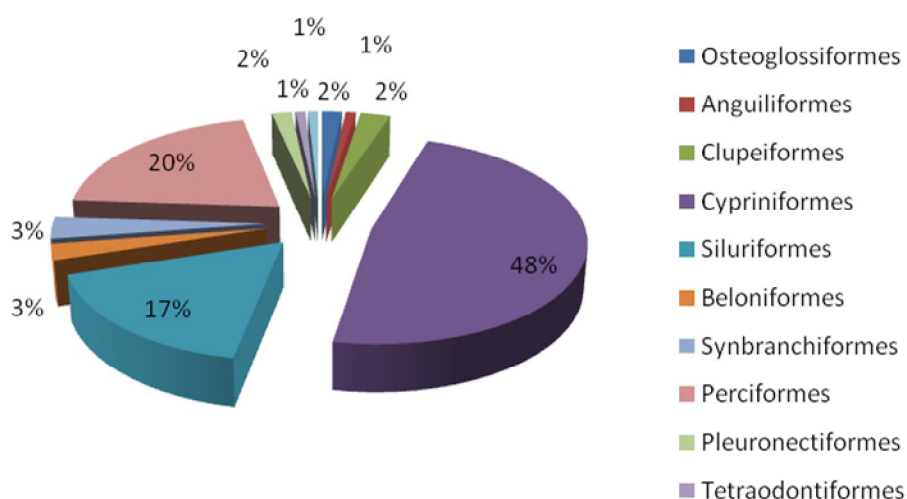
Figure 16: The composition of fishes and shrimps species

Monitoring results found 116 species of fish and 1 *Macrobrachium rosenbergii* belong to 11 orders, 31 families and 81 genera. The dominant orders such as *Cypriniformes* with 56 species (47,86%), *Perciformes* with 24 species (20,51%), *Siluriformes* with 20 species (17,1%). Some orders have a few species such as *Anguiliformes* (1 species), *Beloniformes* (3 species), *Osteoglossiformes* (2 species).

Among 116 monitored species of fish, there were 7 rare fish species appeared in the Red book of Viet Nam, in range VU (Vulnerable) and needed to protect such as *Chitala ornata*, *Anguilla marmorata*, *Cirrhinus microlepis*, *Probarbus jullieni*, *Bagarius bagarius*, *Hemibagrus filamentus*, *Wallago micropogon* (Red book of Vietnam-2007).

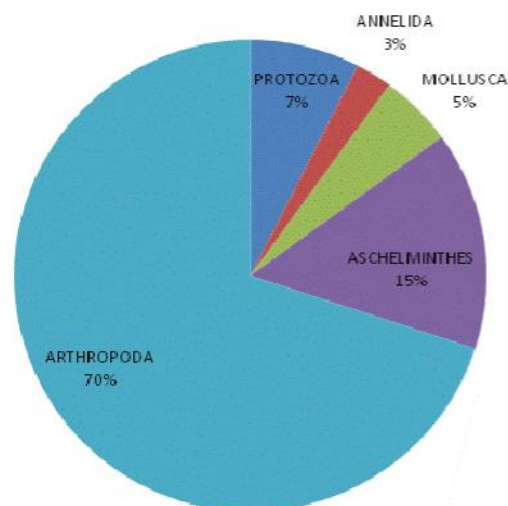
Figure 17: The composition of zooplankton species

Through the analysed results from 11 monitoring stations, it was found 40 zooplankton species of 5 phylum. *Arthropoda* phyla contained the biggest number of species with 28 species (70%). Due to the samples were taken in dry season, samples at some monitoring stations were infected by salinity. Therefore, out of the freshwater species as previous surveys, at the station TS7 also appeared brackish water species such as *Acartia*, *Oithona*.

Zooplankton density distribution was high, varying from 1,000 - 21,500 individuals/ m³. Except stations TS10 and TS5 containing a low density (1.000 -1.500 individuals/m³), the TS2 stations containing the most plentiful density distribution with 21,000 individuals/m³, the next density distribution level is station TS7 containing 14,500 individuals/m³.
