Environmental Monitoring Report

Semestral Report
September 2012

VIE: Phuoc Hoa Water Resources Project

Prepared by Institute of Coastal and Offshore Engineering for the Hydraulic Project Investment and Construction Management Board No.9 - Ministry of Agriculture and Rural Development and the Asian Development Bank.

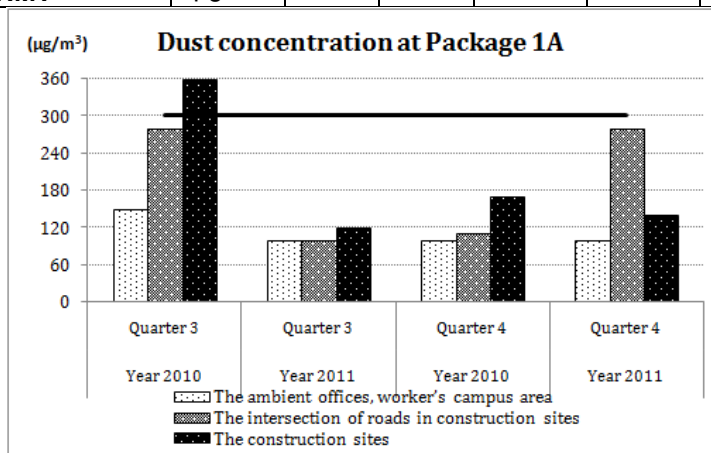
**Figure 1: Graph of dust concentration at Package 1A**

Based on the analysis results, it shows that dust concentration at the Package 1A in the last 6 months of 2011 is in the range of allowable limit of QCVN 05:2009/BTNMT. In comparison with the same period in 2010, most observed positions dust concentration value is equal or lower. Especially at the intersection roads in the construction sites, in the quarter IV of 2011, the dust concentration was high significantly (255% of the same period in 2010). The reason is that most of the roads in the project area completed and connected with the local transportation system. Thus, the transport of local people become more favourable, making the increasing of the traffic density, it means that air pollution levels rising again. Therefore, it is proposed that MT7 Consultant conducts surveys in order to identify the high polluted positions, cooperate with Constructors to increase watering until the project complete and hand over to local authorizes.

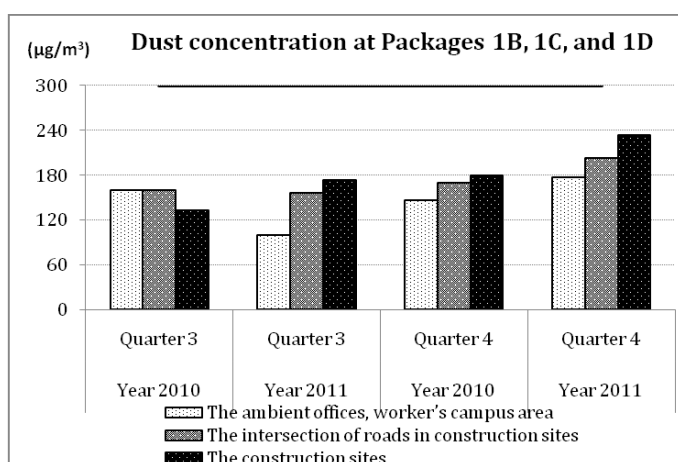
**Figure 2: Graph of dust concentration at Packages 1B, 1C, 1D**

Based on the analysis results, it shows that, along the construction

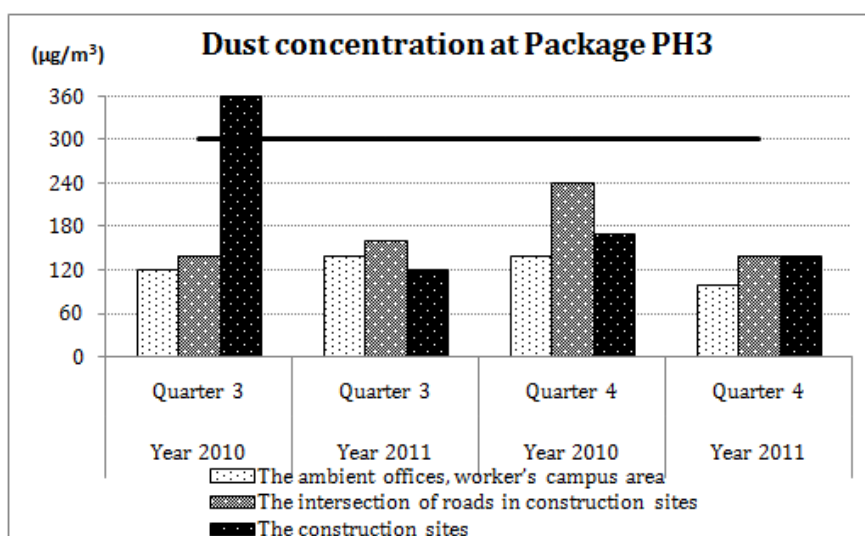
Figure 3: Graph of dust concentration of Packages PH3

In general, at Tan Bien irrigation area, in the last 6 months of 2011, the most monitored locations met the allowable limit of QCVN 05:2008/BTNMT. In the quarter IV, at construction sites, dust concentration was exceeded the permitted limit (exceeding 30%), and equivalent to 160% compared to the same previous time in 2010. The constructors need to conduct mitigation methods to reduce the air pollution at the construction sites.

Although dust in the air fluctuates constantly, sometimes it exceeds the regulation, but is not too serious. This has not affected to the local people living around the project. It is recommended that contractor uses proper solution so that the dust concentration in package PH3 can meet stipulated environmental norms.

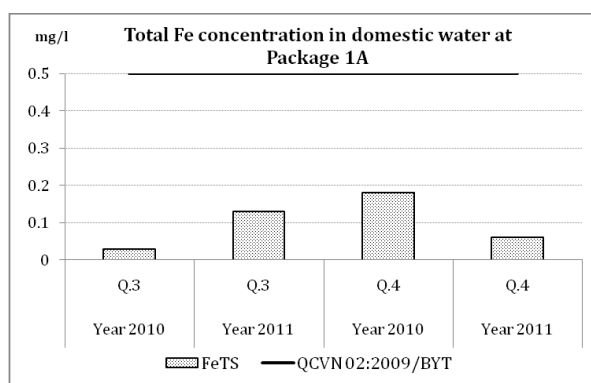
Figure 4: Graph of total Fe concentration in domestic water of Package 1A

The monitoring results show that: at Package 1A, pH value in the domestic water does not reach the QCVN 02:2009/BYT. The other chemical factors are achieved the permitted standard. The microorganism pollution factor does not meet the permitted standard (E. coli: 200 CFU/100ml; Coliform: 3900 MPN/100ml). The micro-organism pollution level of domestic water at package 1A in the quarter IV/2011 reached an alarming level (increased 26 times in comparison with the permitted limit, and increased many times in comparison with the same period in 2010). Contaminating micro-organism in the water of the bid packages may result from groundwater at depths ranges from 20 m to 50 m infected with bacteria, and tanks are not cleaned regularly, pipe leakage, etc., also are major causes. Due to the construction works in these packages is completed, MT7 consultant needs to learn from these experiences, and propose appropriate solutions for the next phase to be used for Duc Hoa irrigation area.

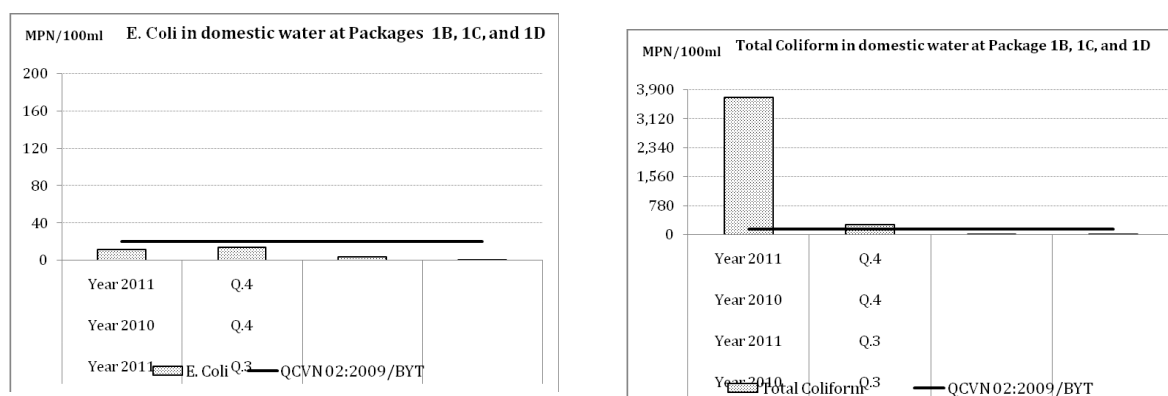
In comparison with the same period in 2010 and the situation of pollution at Package 1A, the drinking water pollution status at the transfer canal (packages 1B, 1C, 1D) have been improved remarkably, and most of them met the permitted of QCVN 02:2009/BYT standard for the domestic water quality.

Figure 6: Graph of microorganism pollution in domestic water of packages 1B, 1C, and 1D❖ At the Tan Bien irrigation (Package PH3):

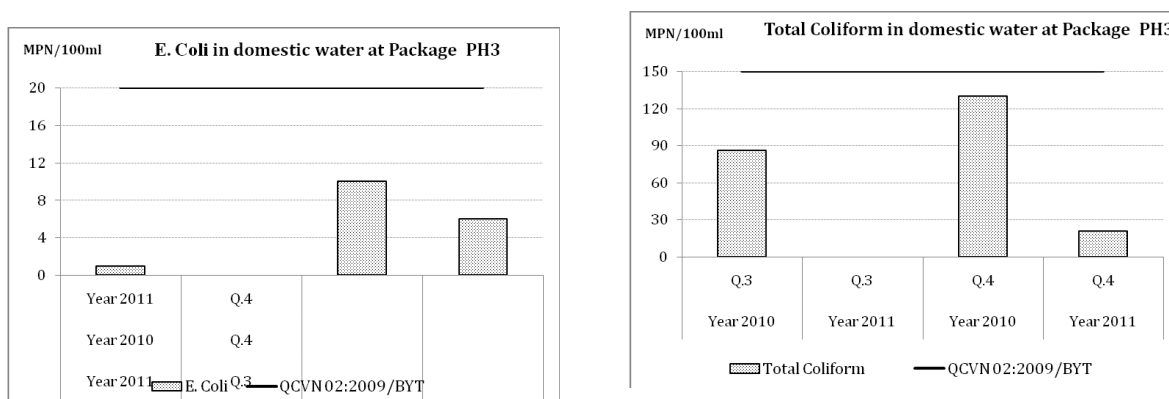
As the same case as the transfer canal construction packages, the condition of domestic water quality at Tan Bien irrigation area have been improved considerably, and most of them met the permitted QCVN 02:2009/BYT standard for the domestic water quality.

**Figure 7: Graph of microorganism pollution in domestic water of package PH3****4.3.4. Drinking water**

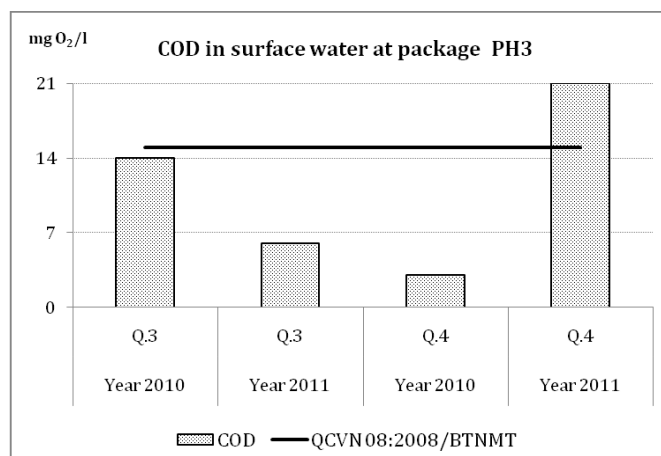
Figure 8: Graph of COD in surface water of package PH3

Most of packages (except: PH3), physical and chemical factors (pH, COD, total Suspended Substances, Oil, and Total Fe) met the QCVN 08:2008/BTNMT standard. Particularly, at Tan Bien irrigation area (package PH3), the value of COD, total Fe, and E.Coli exceeded the QCVN 08:2008/BTNMT standard. Constructors and the employer need to pay more attention to the surface water quality in Tan Bien irrigation area.

In general, the hauling of materials is not affected to water quality. Some causes could affect to water quality such as dust, soil sand, cement, and asphalt ... falling down the road or to be swept to streams causing polluted water. The consultant should pay attention to the surface water in the Tan Bien Irrigation Area (package PH3).

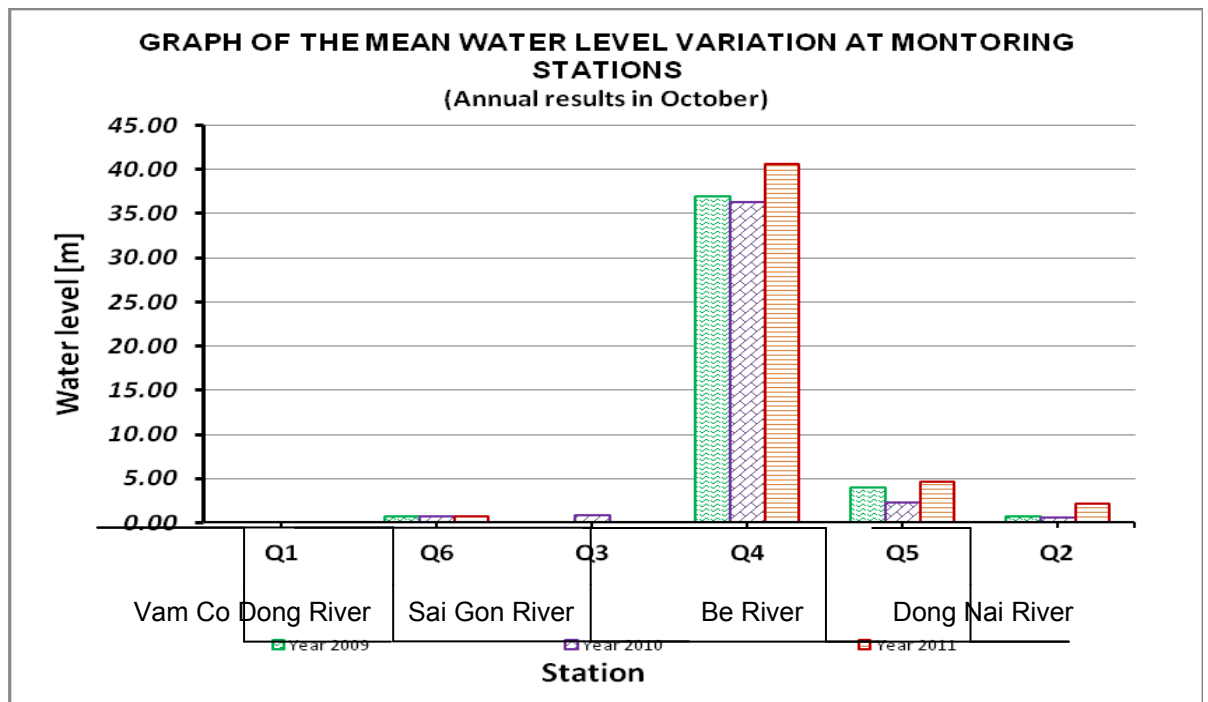
Figure 10: Graph of the mean water level at monitoring stations (Annual results in October)

The observed data of the mean water level (H), and discharge (Q) in the dry season 2011 were lower than 2010. Conversely, the rainy season in 2011, H and Q at Q4 station is remarkably higher than 2010, can be explained as follows:

In the dry season 2011: because of the reduction of precipitation in 2010 then the water came to Srock Phu Mieng and Can Don were declined compared with 2010. Thus, in order to maintain the water supply for the whole dry season, the run-off water from these reservoirs have been reduced compared with 2010;

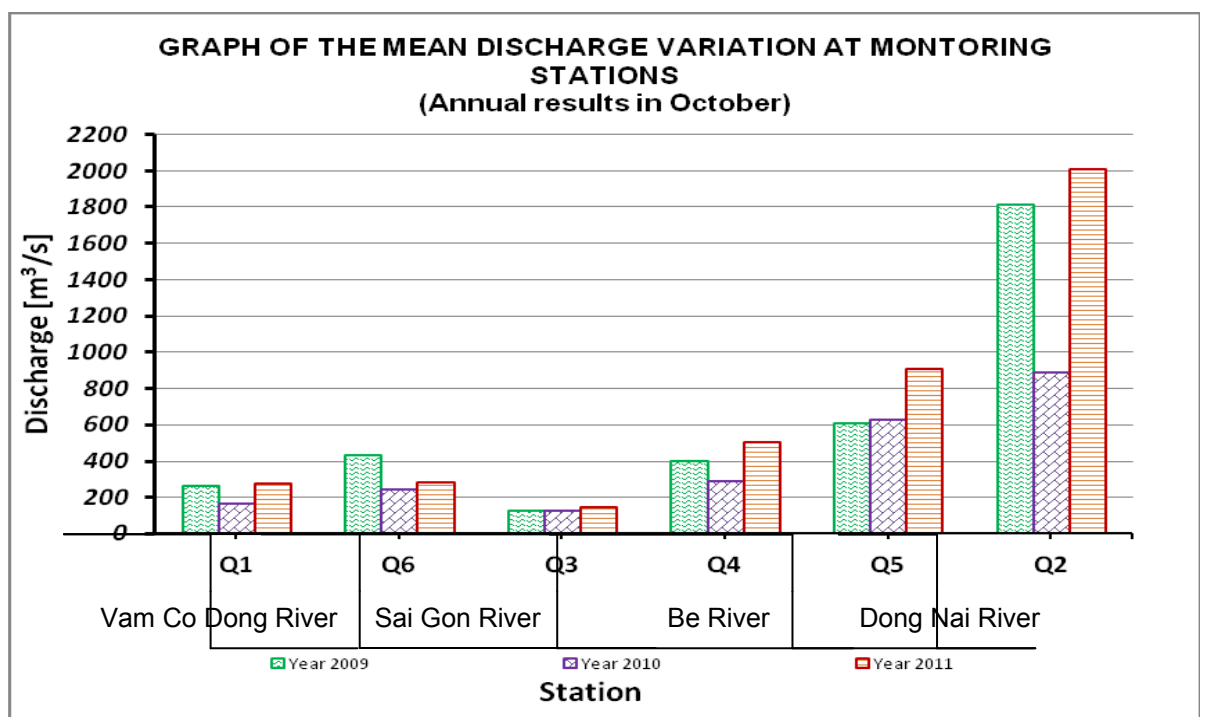
Figure 11: Graph of the mean discharge at monitoring stations (Annual results in October)

In rainy season 2011: there was the existing extreme flood upstream, thus, the water discharge came to reservoirs were increased, so that these reservoirs must drain the water out. The water discharge flows to downstream; beside the normal discharge for operation, a remarkable amount of water has been spilled to ensure safety.

Observed data at Q5 show that mean discharge during monitoring period in October 2011 was 1.5 times higher than those 2010. If not consider the cross section change at Q5 due to shifting gauging station to new location. We can conclude that Phuoc Hoa dam has no impacts on the water flow of Be River downstream of the dam.

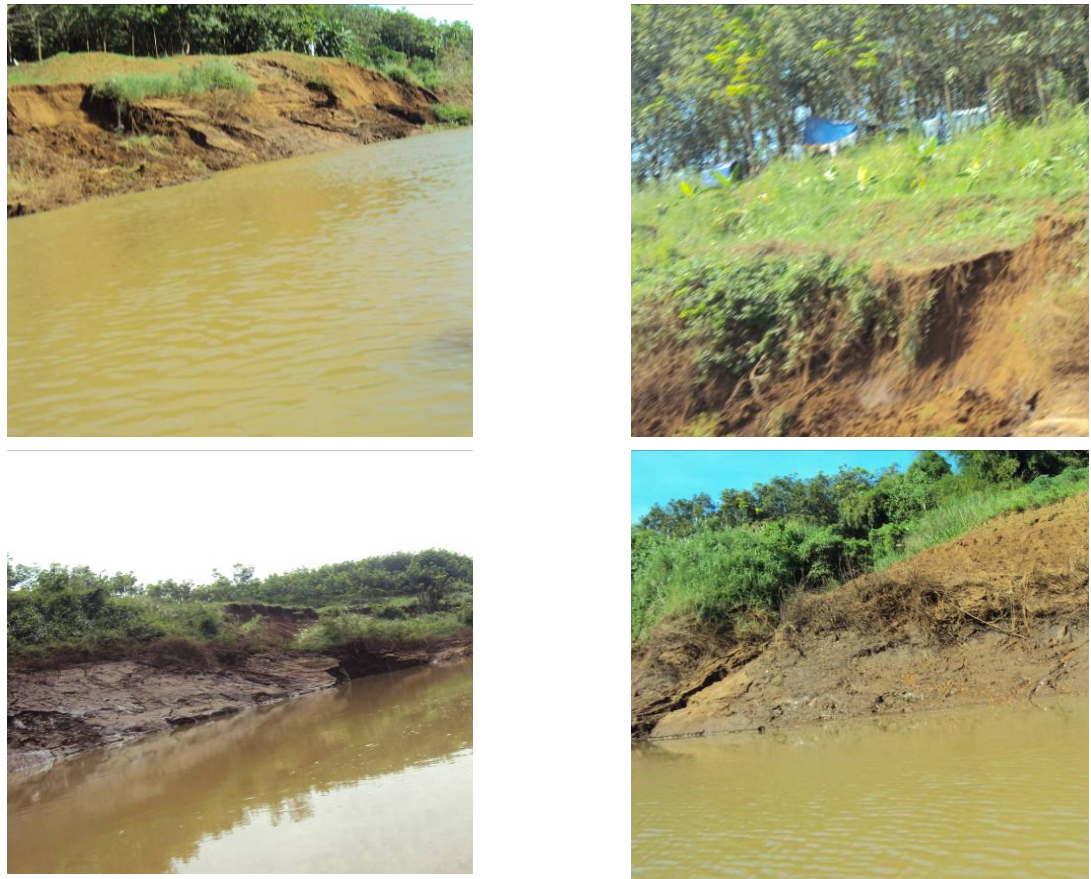
Figure 12: Typical collapsed locations along the downstream of Be Riverbanks

Observed results show that the natural winding morphology of river creates the phenomenon of one side is eroded, one side is deposited. On the erosion side, the riverside is nearly vertical with angle from 15° to 30°, with vegetation such as grass, brushwood, bamboo hemp, and La Nga bamboo. The soil composition on the erosion side includes heavy clay layer at the water contact side, the over layer is covered by a new alluvial soil layer that created by falling down of above layer. On the deposition side, the riverbank slopes gentler from 50o to 60o, acidic alluvial soil, and

grey ferralic with coverage vegetation above, and people grow short-day crops such as corn, and breeding grass. Root systems of these plants are very weak, unable to link with soils and the risk of soil erosion on a large scale when the water level suddenly changes is big. Within 15 km of the survey, 66 landslides with length from 20 to 350 m and depth from 5 to 15 m, a number of deep erosion on people arable land.

All collapsed locations appeared after Phuoc Hoa Reservoir had impounded. Hence, it is primarily concluded that the collapses in Be River banks were caused by the sharp subsidence of water level versus the existing level. When the water level is subsided, water content in soil layers along the river is reduced as well, leading to changes of adhesiveness of soil particles. Consequently, soil mass riverside (at the bend of river or the reaches with vertical slope) slide down that caused the riversides collapse.

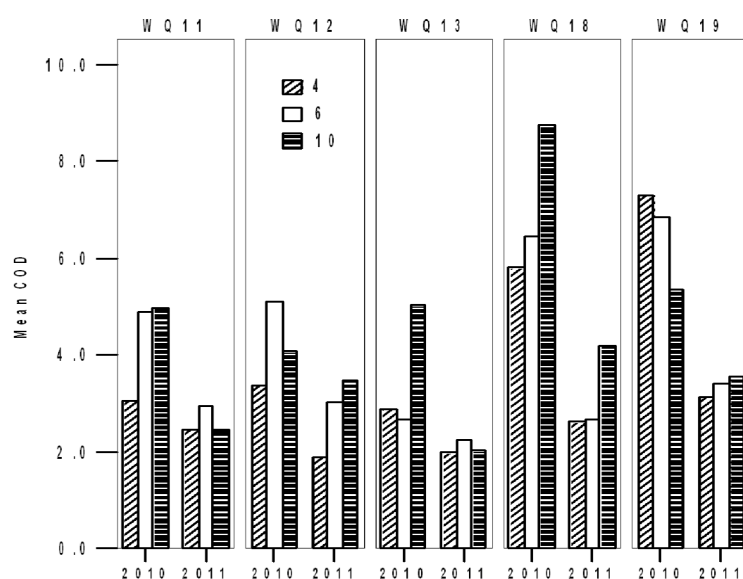
**Figure 16: Comparison of COD at Dong Nai River in 2010-2011**

Nutrient content in 2011 is higher than that in 2010 at the same monitoring period over all monitoring stations, especially the downstream area from Bien Hoa to Nha Be. While, organic contents in 2010 are higher than those in 2011 over all monitoring stations in Dong Nai River [Figure 16].

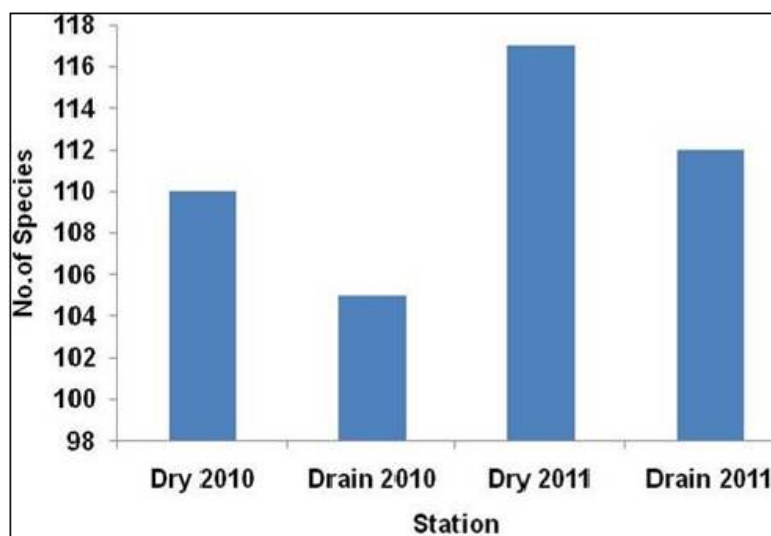
Figure 21: Graph of number of fish seasonal changes

In the above graphs, the number of species were changed by seasons between 2010 and 2011. The trend of the changes in species composition and number of fish species were increased in dry season and decreased in rainy season. However, the change is not much from 105 to 117 species. In short, the number of fish species in 2011 increased in comparison with 2010.
