Environmental, Safety and Health Annual Monitoring Report
Loan/Investment Number: 1769/7162
February 2006 to February 2007

PHI: North Luzon Expressway Project

Prepared by Manila North Tollways Corporation (MNTC)

ENVIRONMENTAL, SAFETY AND HEALTH ANNUAL MONITORING REPORT (ESHAMR)

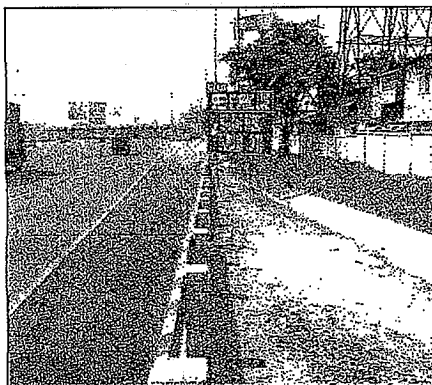
EMERGENCY ARRESTER BED (EAB)

Four (4) wayward trucks were recorded to actually use the EAB. It was effective and no fatalities recorded.

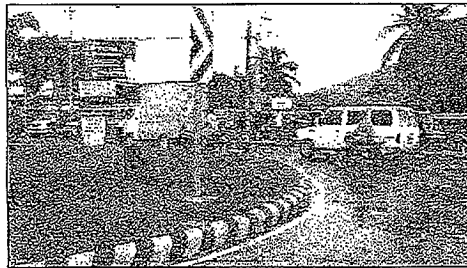
ZEBRA PAINT MARKINGS ON CONCRETE CURBS

COMPLETED 756-LINEAR METERS AT IDENTIFIED PRIORITY AREAS

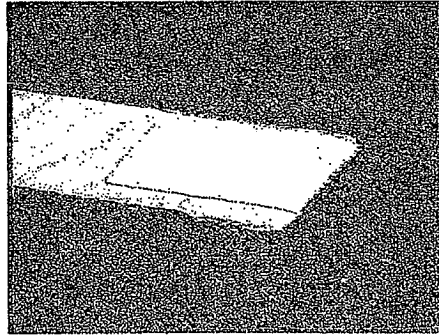
3M HIGHLY REFLECTIVE PAVEMENT STICKER

This covers from Buroi to Sta.Ines at both NB & SB sections.

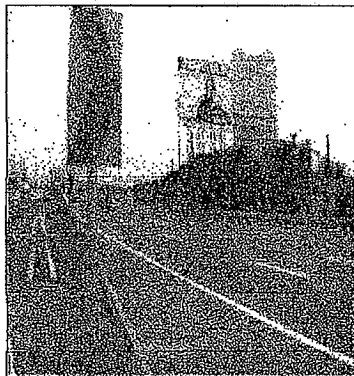
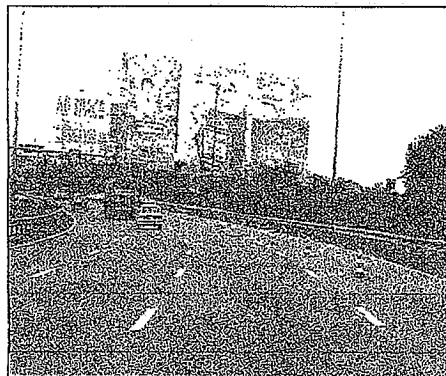
CHEVRON SIGNS INSTALLED – ADVANCE WARNING SIGNS

COMPLETED 21-PIECES INCLUDING BALINTAWAK (NB & SB) AND BOCAUE TOLL BARRIERS (NB SIDE)

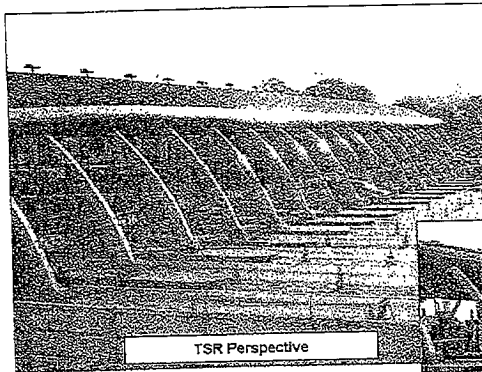
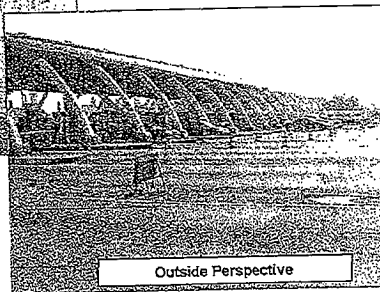
BALINTAWAK TOLL BARRIER – TSR TOLL BOOTH IDENTIFICATION SIGNS

TSR Perspective

Outside Perspective

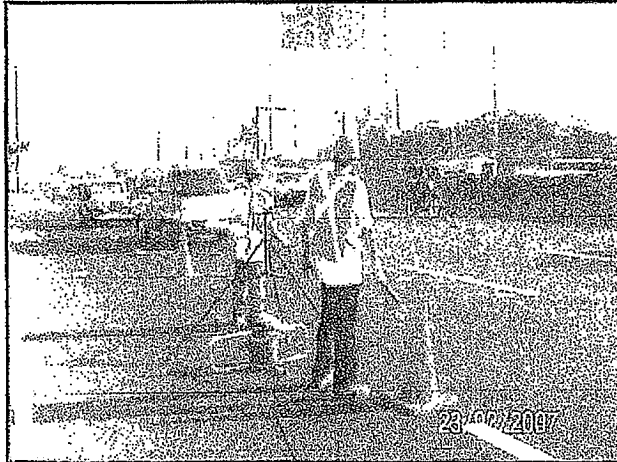
Plate No. 1 Photo of the SO₂ and NO₂ level monitoring conducted at the south bound lane of the Balintawak Cloverleaf on February 22, 2007.

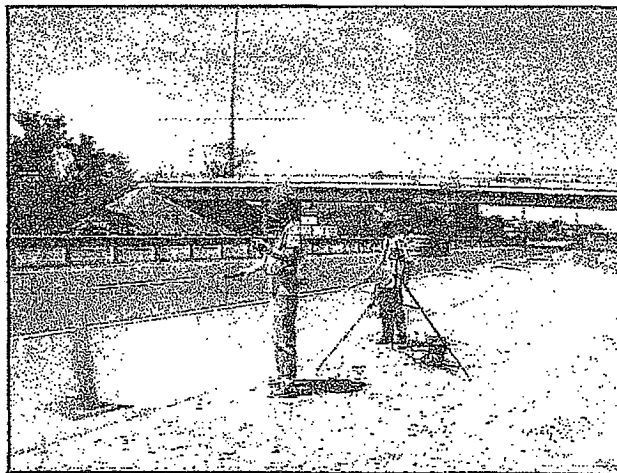
Plate No. 2 Photo taken at the south bound entry ramp of Sta. Rifa Interchange where measurements of HC and CO levels were undertaken on February 22, 2007.

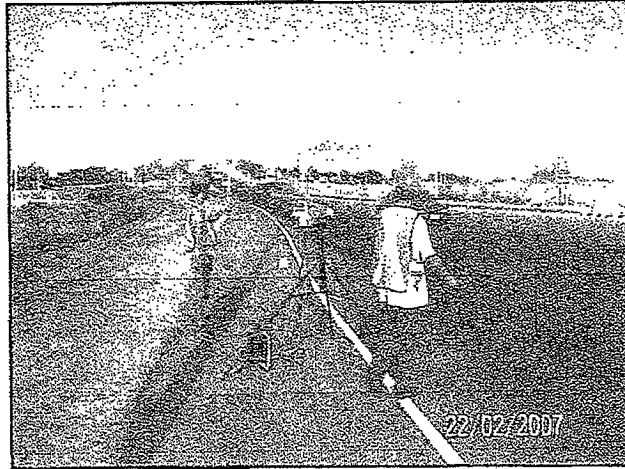
Plate No. 3 CO level monitoring at the north bound exit ramp of the Angeles Interchange.

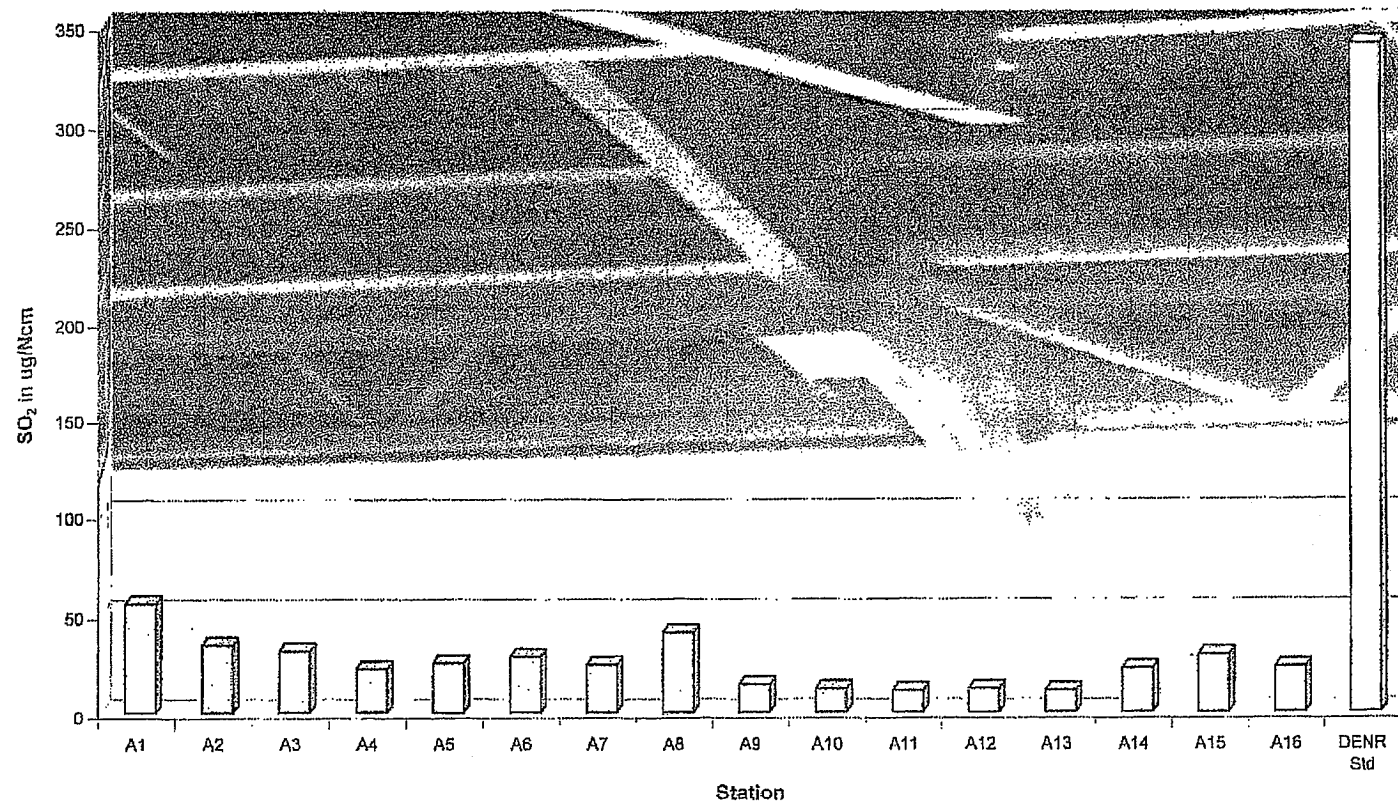
Figure 3.1-2 Observed SO₂ Level along the NLEX on February 20-23, 2007

For the last quarter of this year's monitoring, the observed concentration level of SO₂ at the 16 sampling stations along the NLEX ranged between 11-55 µg/Ncm. Again, the Balintawak Cloverleaf area recorded the highest level of SO₂ at 55 µg/Ncm or approximately 16.2% of the DENR standard of 340 µg/Ncm. On the other hand, the San Simon and Mexico Interchanges exhibited the lowest SO₂ concentration levels of 11µg/Ncm.

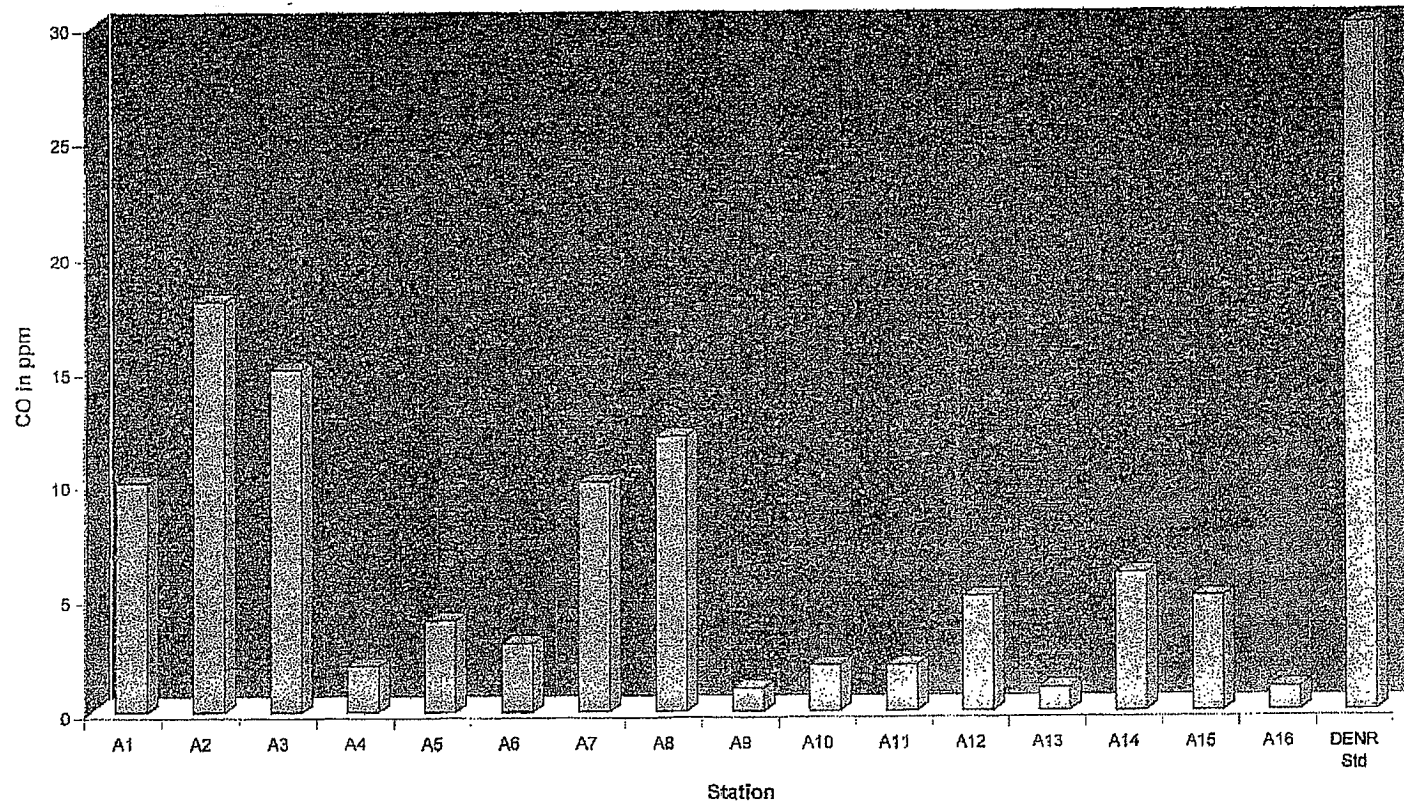
Figure 3.1-4 Observed CO Level along the NLEX on February 20-23, 2007

For carbon monoxide (CO), the measured CO levels ranged from 1.0 to 18.0 ppm. Novaliches Flyover, A2 exhibits the highest concentration level of CO with 18 ppm. Next is the Balintawak Toll Plaza with 15 ppm, followed by Tabang Toll Plaza with 12 ppm. AS for the 16 sampling stations, the average CO concentration is 6.10 ppm. The air quality index for CO is considered as fair with a concentration of 5 ppm. The observed values are still within the allowable DENR standard of 30 ppm. The maximum measured CO of 18 ppm is about 60.0% of the DENR standard of 30 ppm.

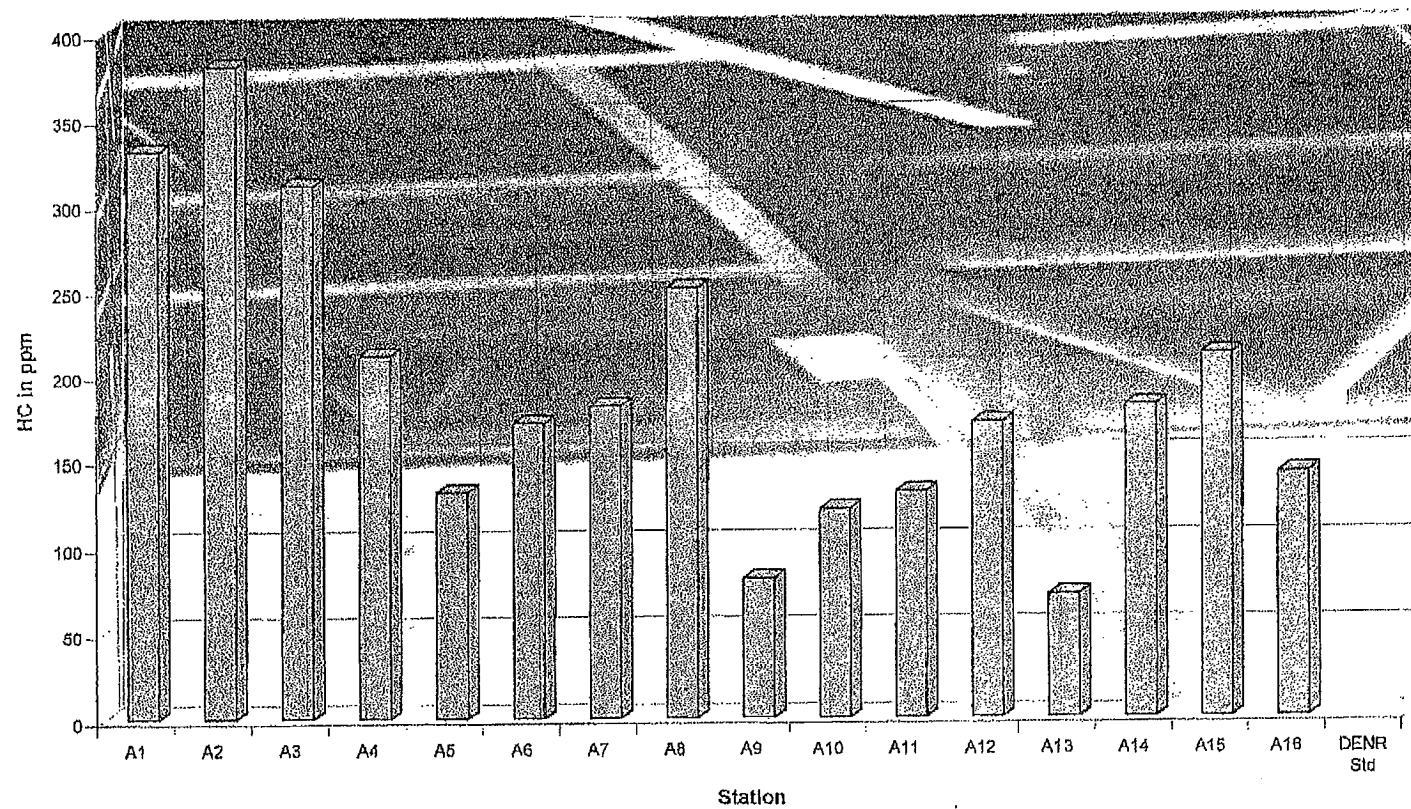
Figure 3.1-5 Observed HC Level along the NLEX on February 20-23, 2007

The measured levels of HC at the sampling sites ranged from 70 to 380 ppm. Hydrocarbon pollutant has no existing DENR standard for ambient air. As

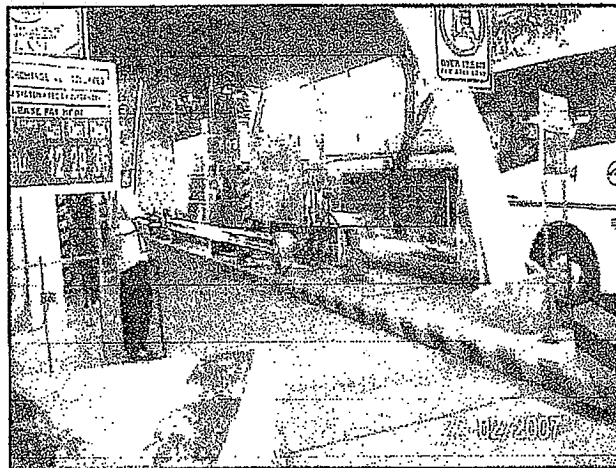
Plate No. 7 Pb sampling at the north bound toll exit of the Dau Interchange on February 22, 2007.

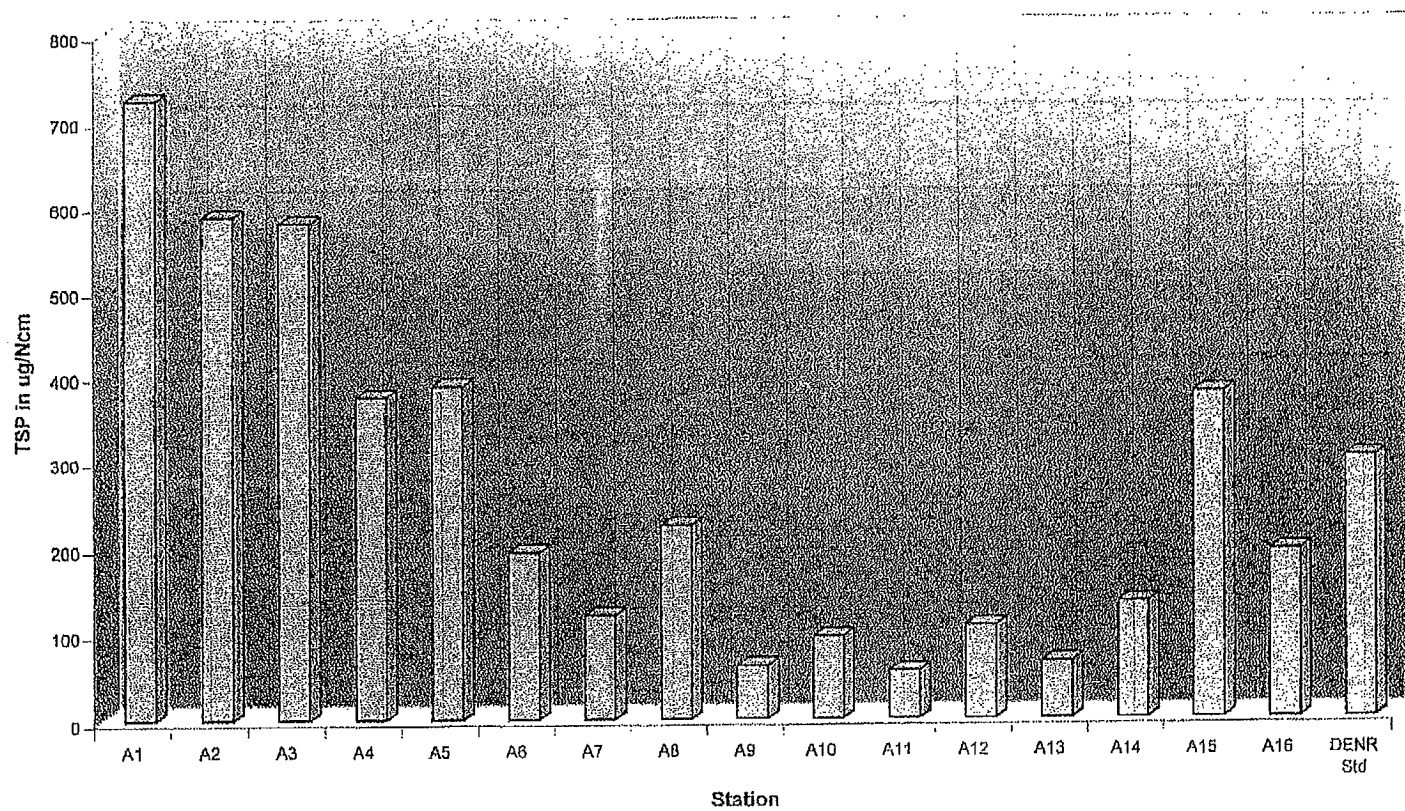
Figure 3.1-6 Observed TSP Level along the NLEX on February 20-23, 2007

Based on the sampling conducted, the observed ambient concentrations of TSP at the six (6) sampling sites exceeded the DENR Standard of 300 $\mu\text{g}/\text{Ncm}$. The results ranged between 373-722 $\mu\text{g}/\text{Ncm}$. These stations include the Balintawak Cloverleaf Interchange (A1), Novaliches Flyover (A2), Balintawak Toll Plaza (A3), Valenzuela Interchange (A4), Meycauayan Toll Plaza (A5), and Dau Toll Plaza (A15).

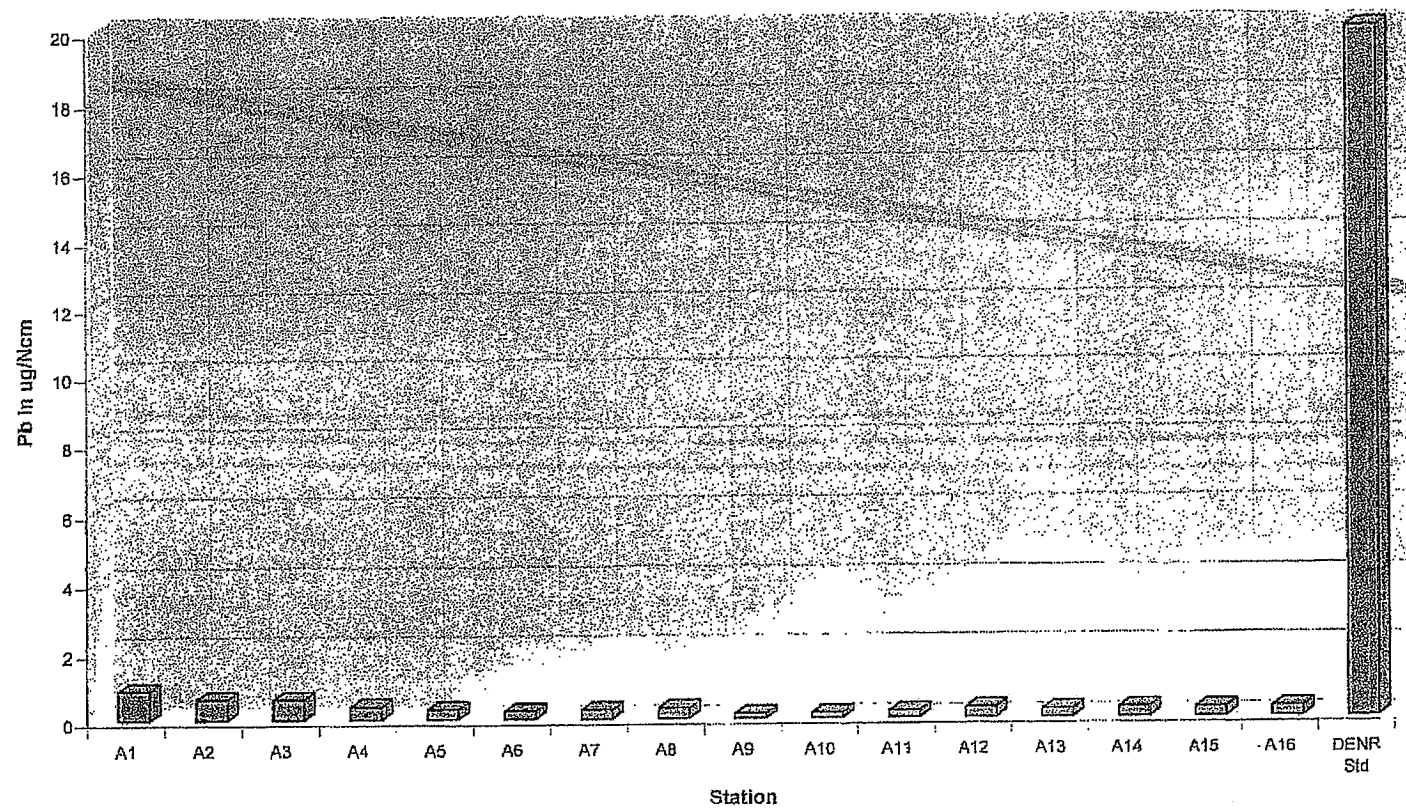
Figure 3.1-7 Observed Lead (Pb) Level along the NLEX on February 20-23, 2007

Like in the previous monitoring conducted, the recorded Pb concentrations are way below the permissible limit (i.e. 20 $\mu\text{g}/\text{Ncm}$) set by the DENR. The values ranged from 0.141 to 0.854 $\mu\text{g}/\text{Ncm}$. The kind and extent of all identifiable effects on public health or welfare that maybe expected in the presence of lead at 20 $\mu\text{g}/\text{Ncm}$ in the ambient air is not recognizable. The observed concentration is less than 1 $\mu\text{g}/\text{Ncm}$, this level is considered as a good air quality that no harmful effect is expected on human. The observed concentrations are less than 5% of the DENR standard for lead
